HIGHLAND PLAZA

ERIE COUNTY, NEW YORK

Periodic Review Report **2020-2021**

NYSDEC Site Number: C 9 1 5 2 9 3

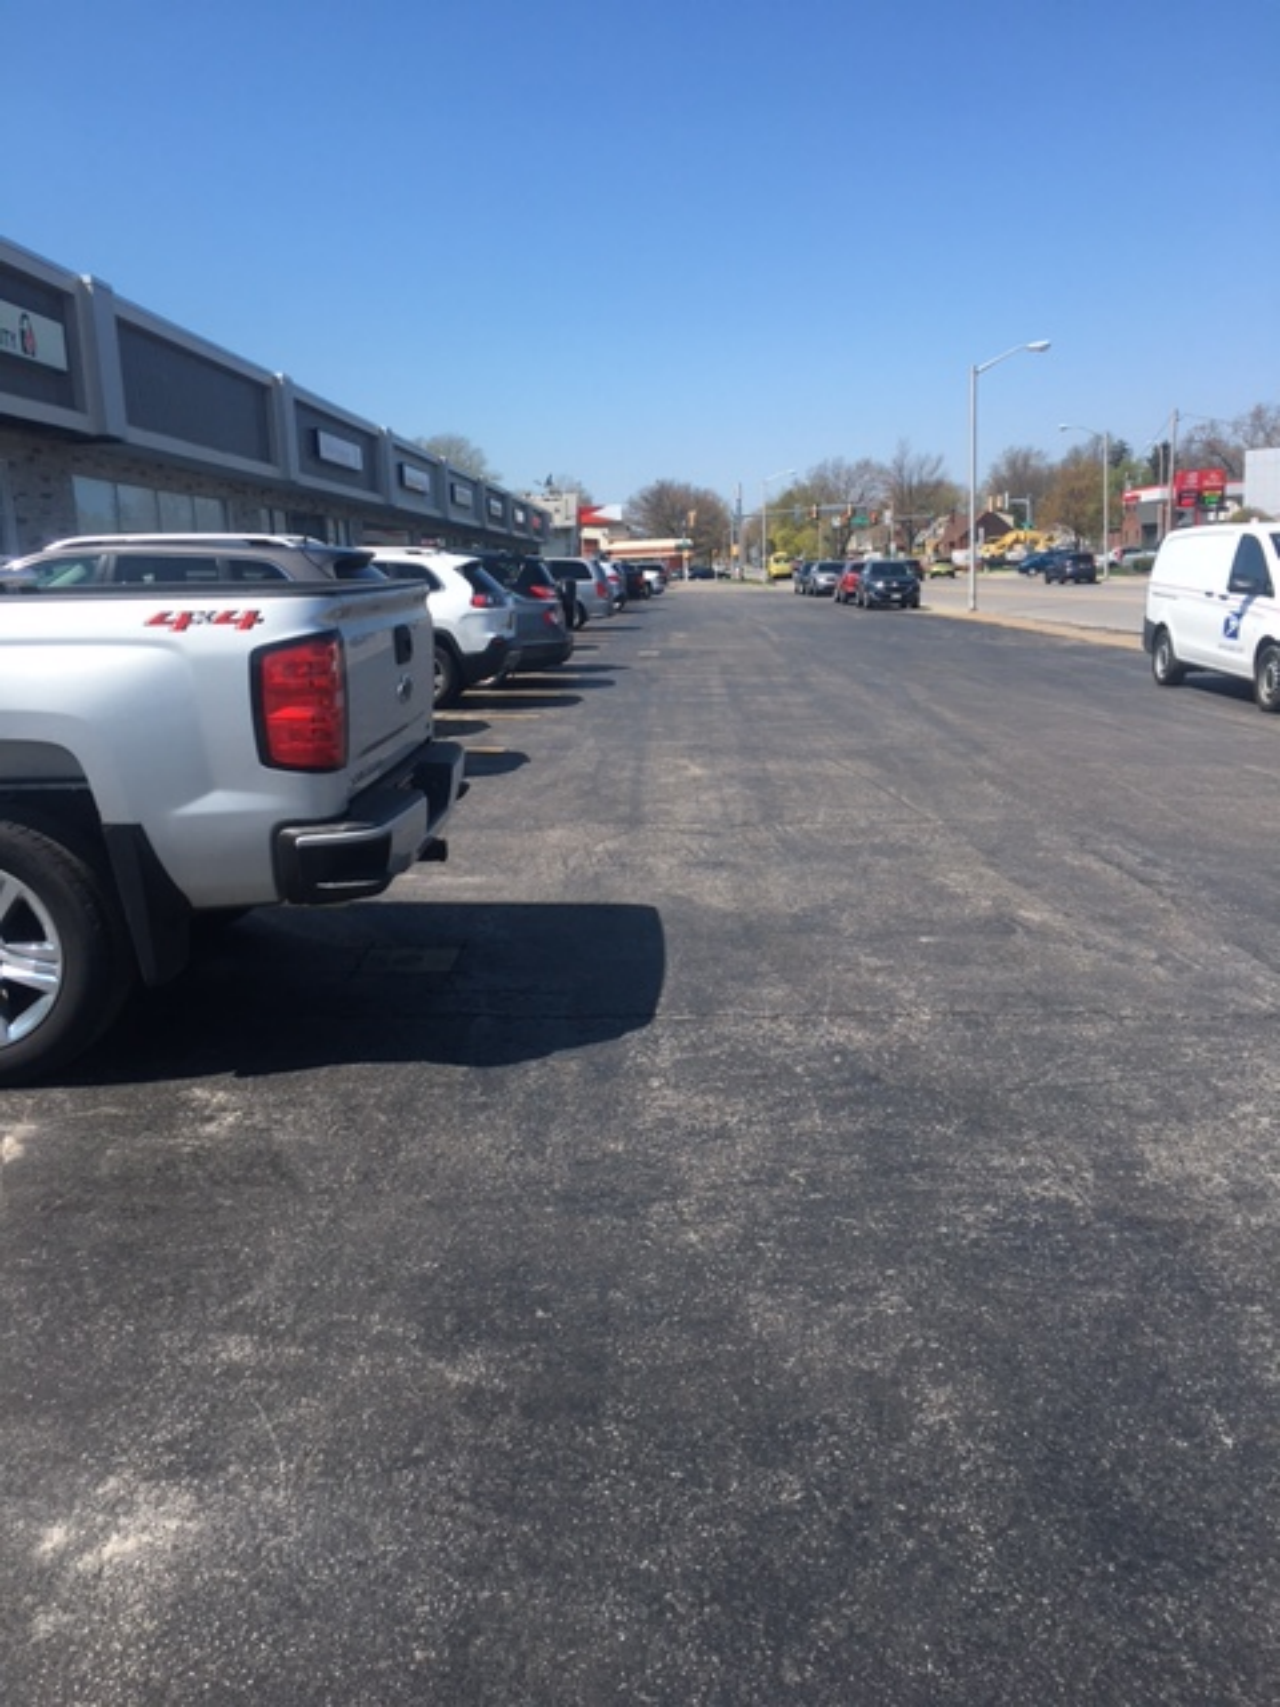
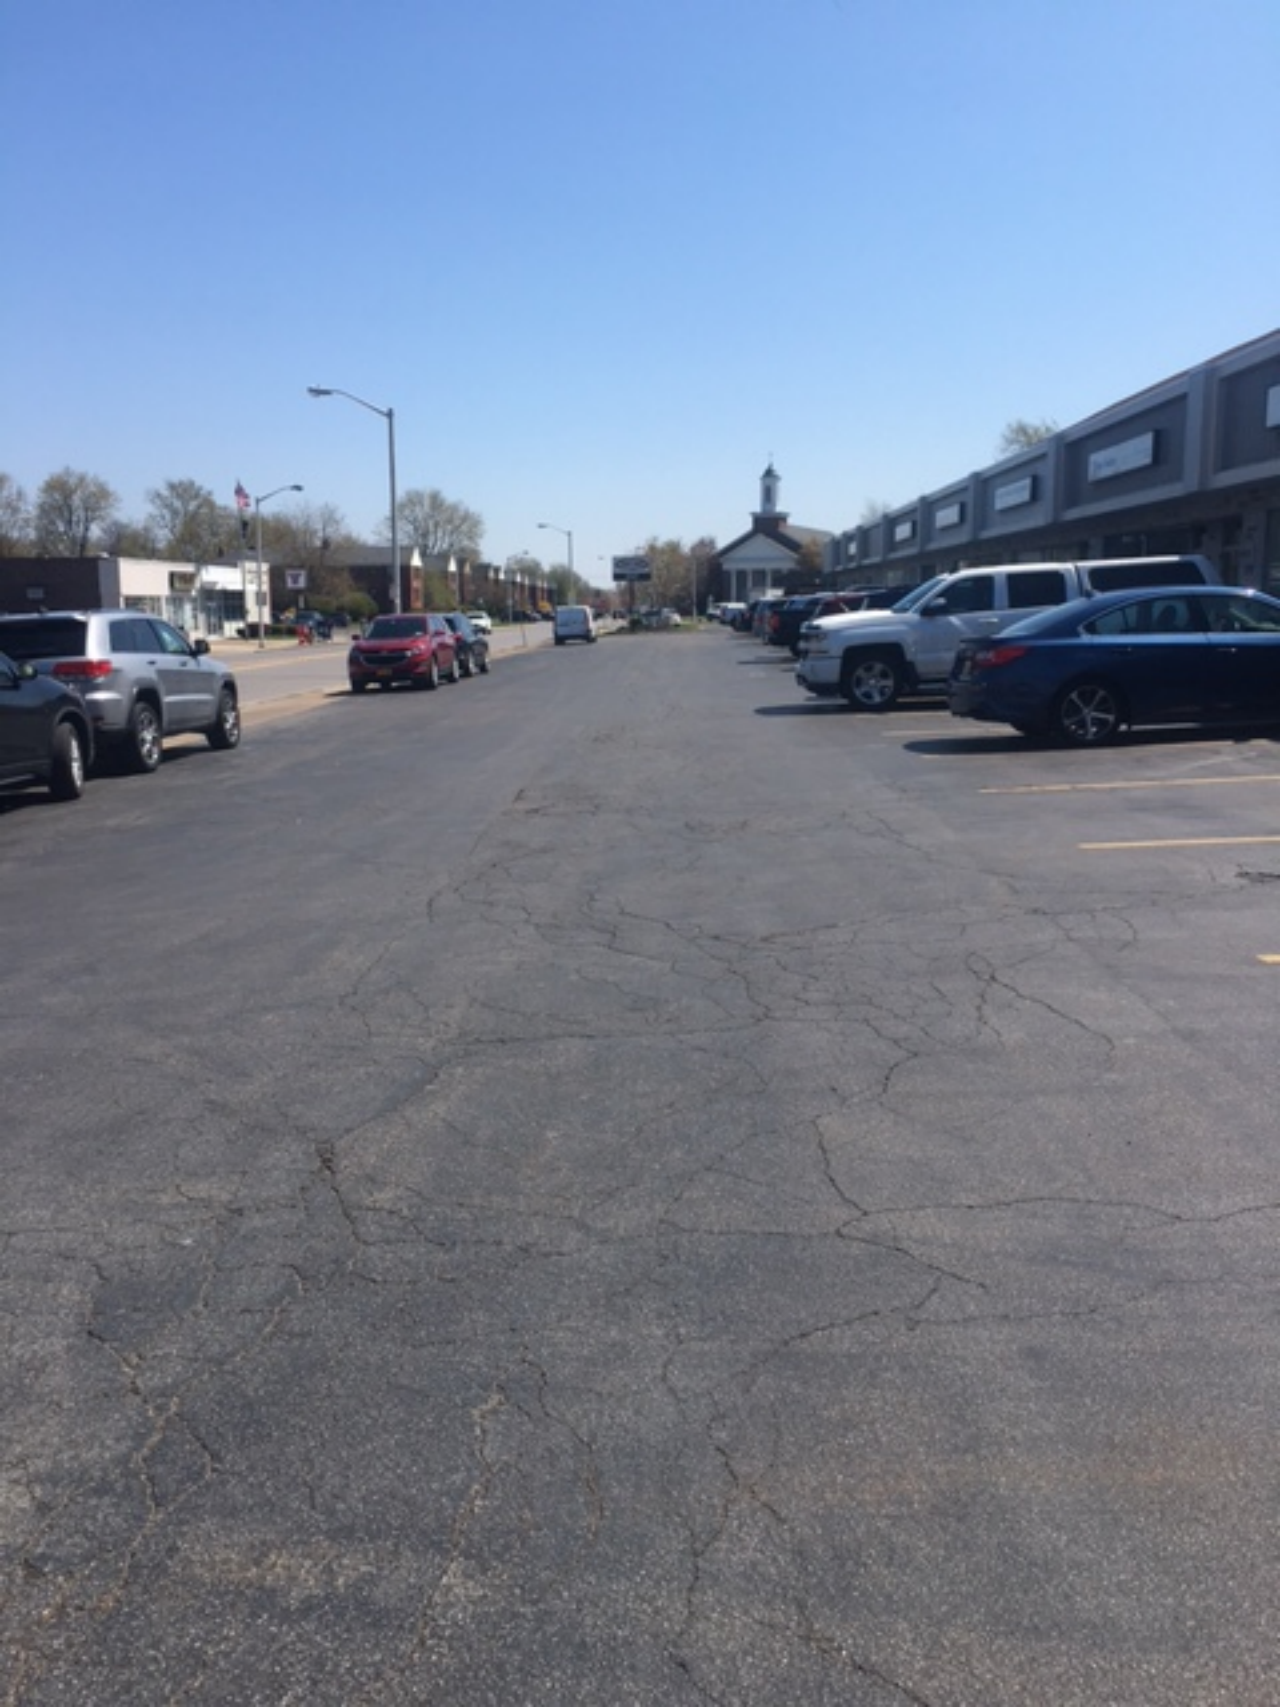
APPENDIX B1

There were no breaches of the asphalt parking lot and concrete sidewalk directly in front of the buildings observed during the site visit on April 23, 2021.

**PHOTOGRAPHS 1 & 2: FRONT PARKING LOT &
SIDEWALK**

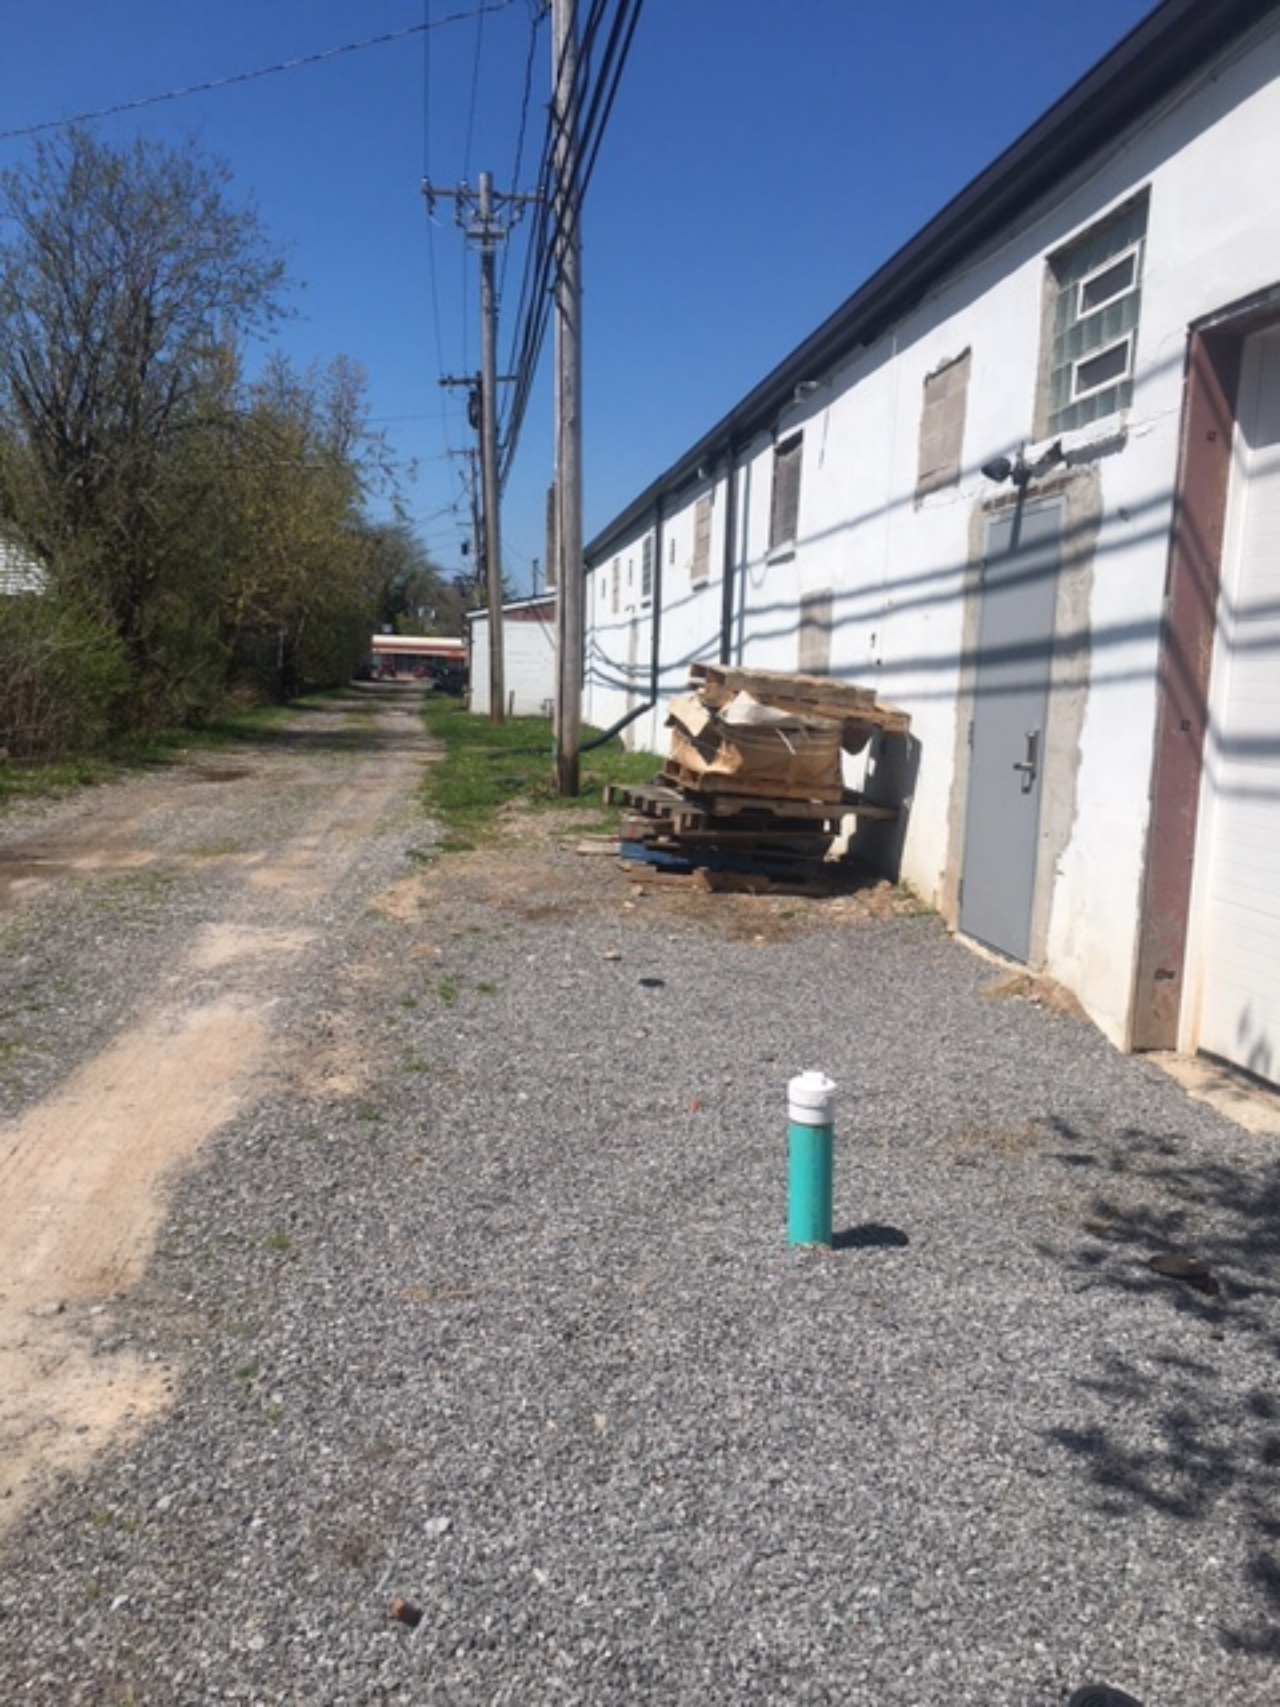
APPENDIX B2

There were no site intrusive activities into the two foot wide clay cap behind the building during this annual reporting period.

**PHOTOGRAPH OF CAP BEHIND BUILDING LOOKING
WEST**

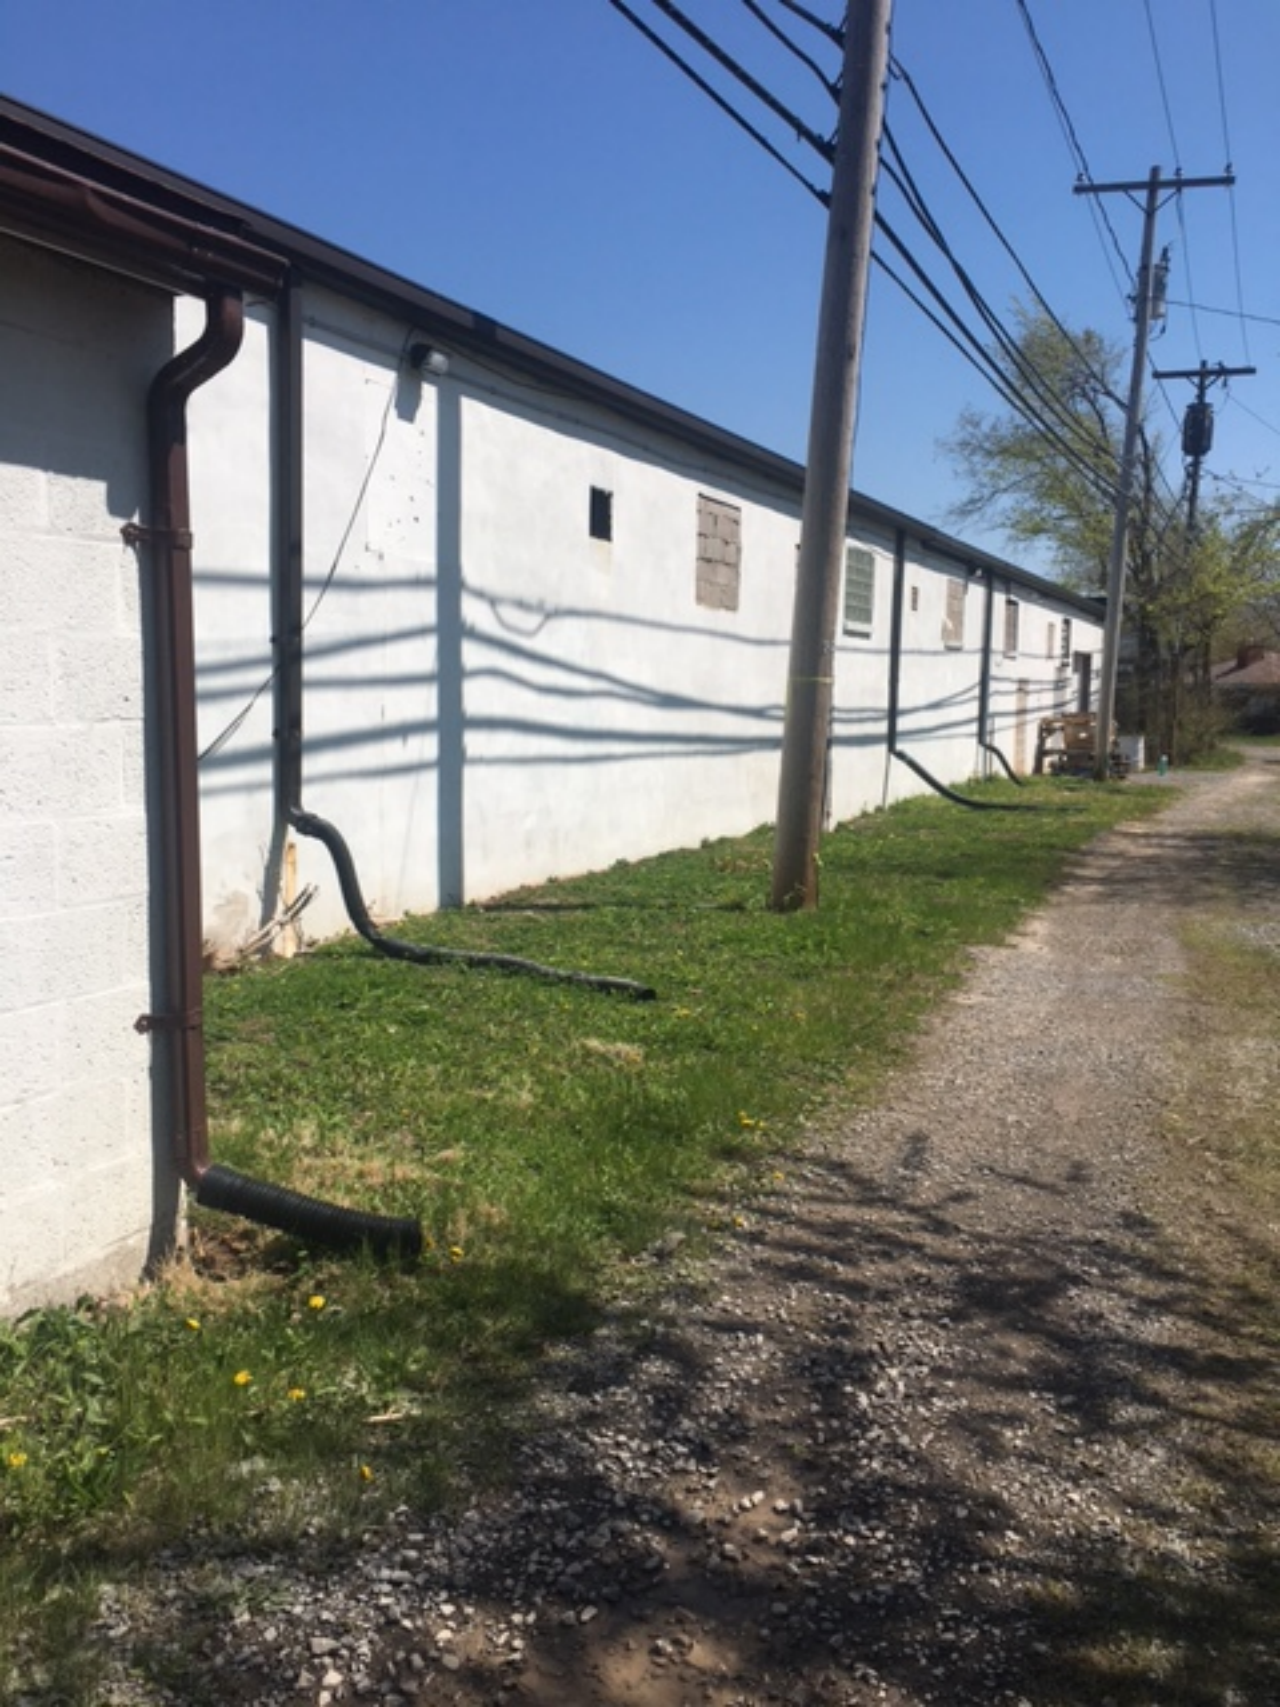
APPENDIX B 3

There were no breaches of the soil cover along the east end of the building during the site visit on April 23, 2021.

**PHOTOGRAPH OF THE EAST END OF THE SOIL CAP
SYSTEM BEHIND BUILDING (LOOKING EAST)**

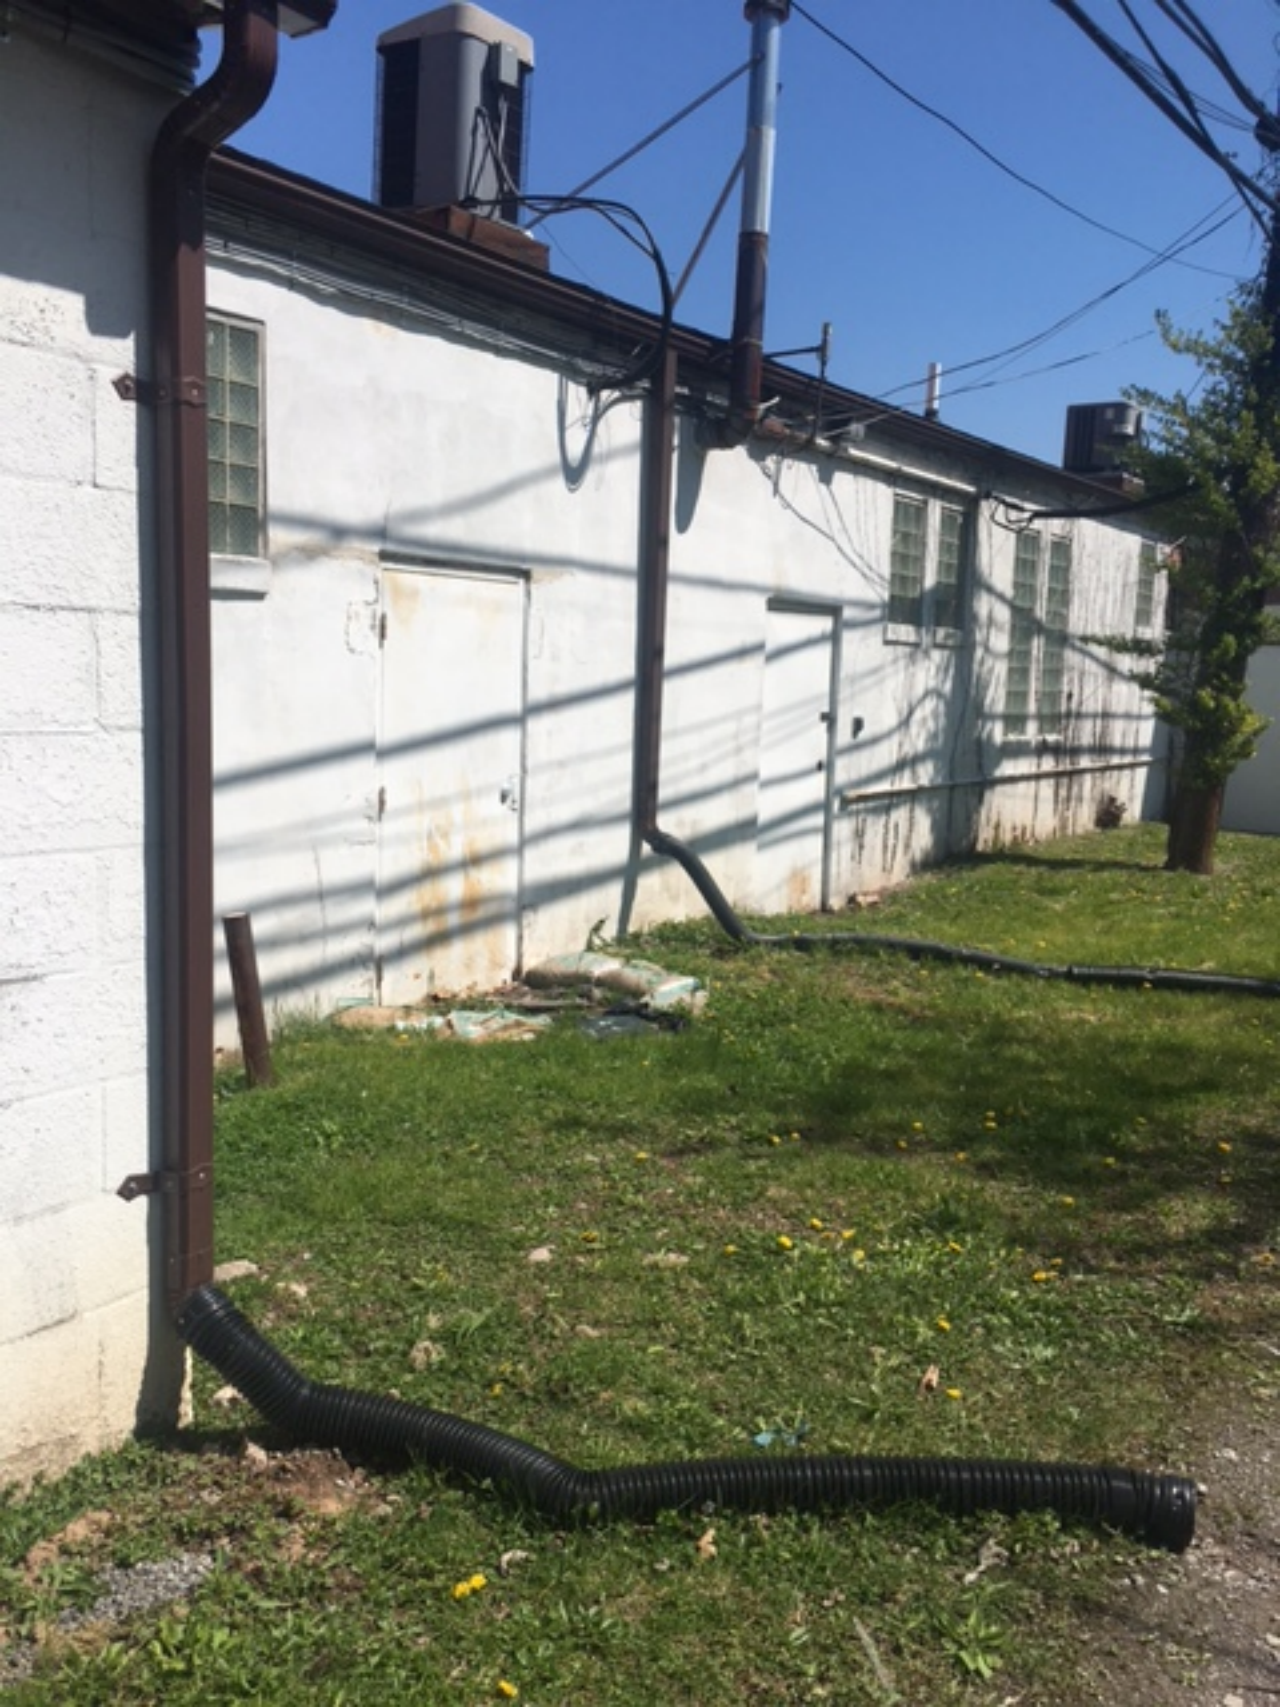
APPENDIX B 4

**PHOTOGRAPH OF THE CENTRAL PART OF THE SOIL
CAP SYSTEM BEHIND THE BUILDING (LOOKING
EAST)**

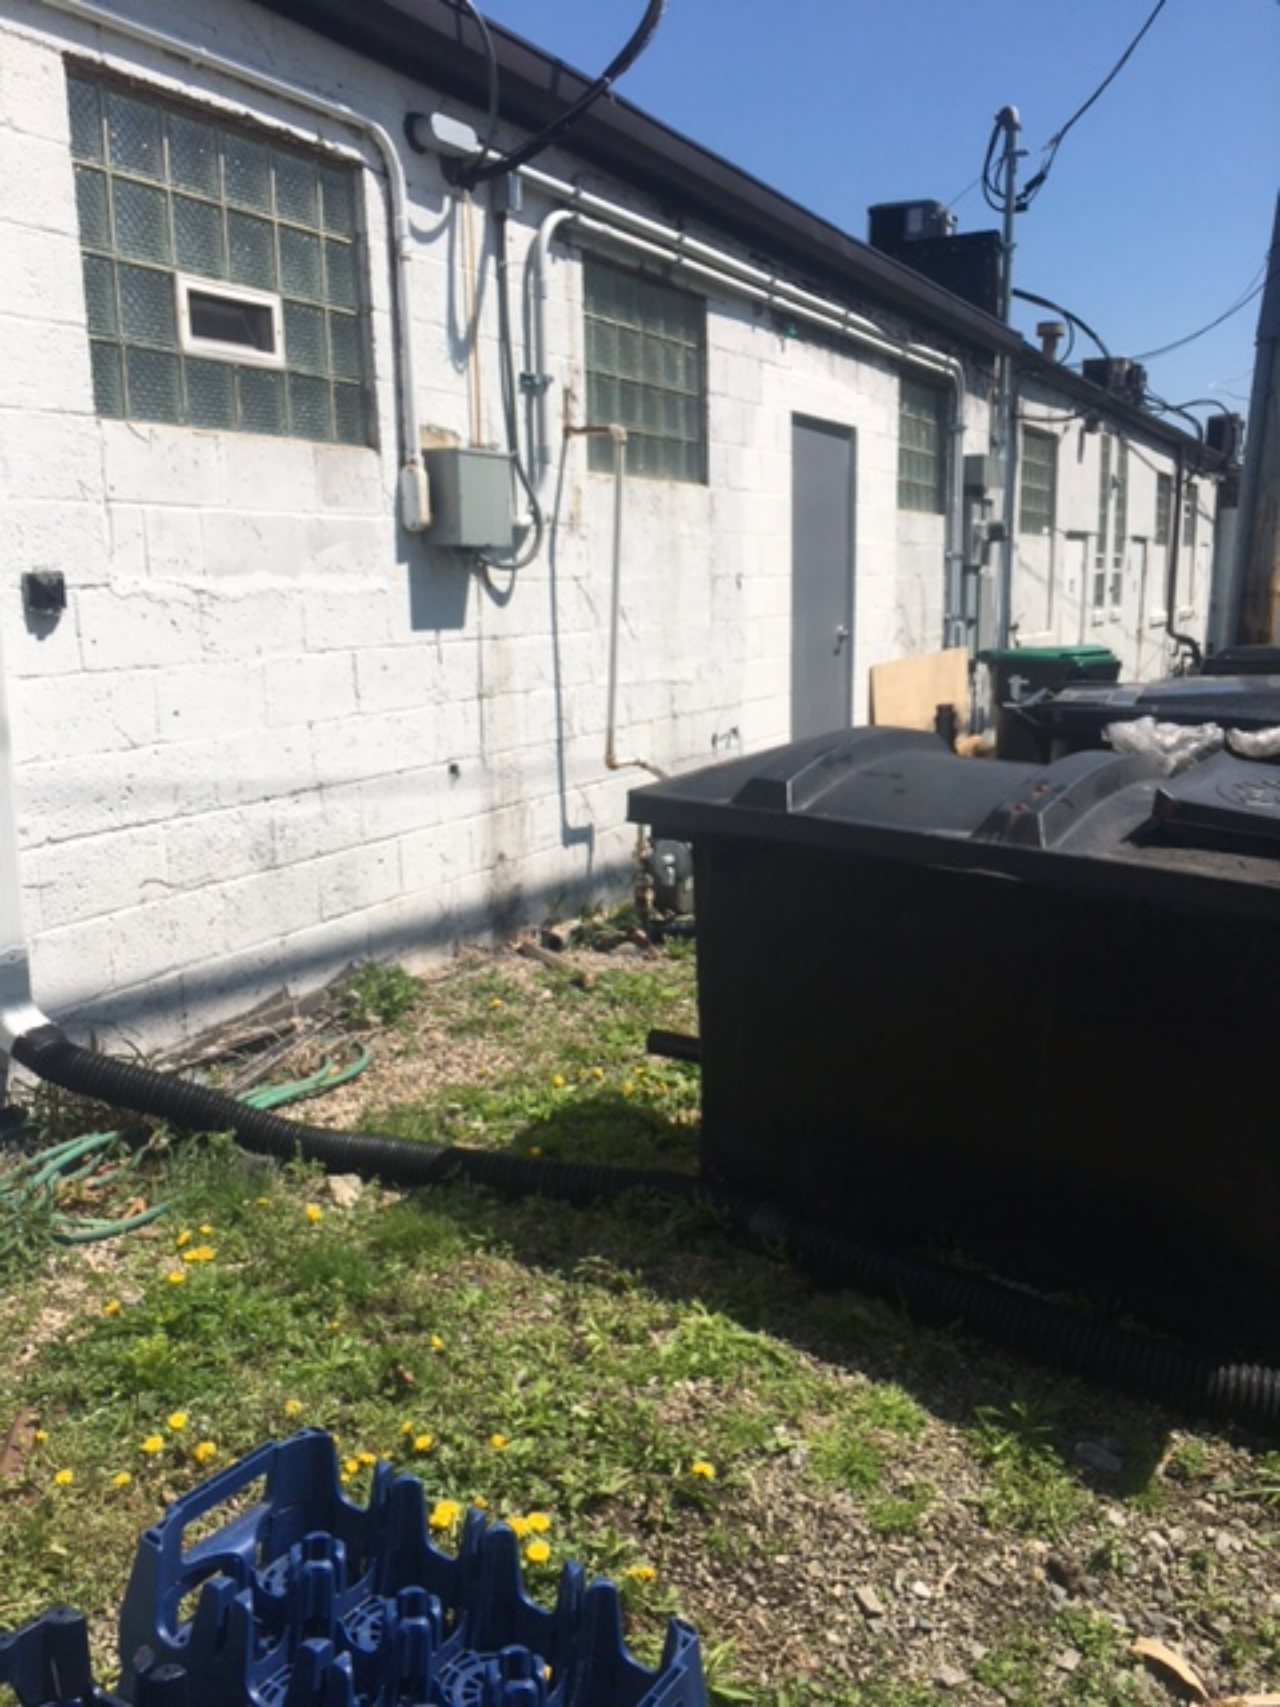
APPENDIX B 5

**PHOTOGRAPH OF THE WEST END OF THE SOIL CAP
SYSTEM BEHIND THE BUILDING (LOOKING EAST)**
