PERIODIC REVIEW REPORT

APRIL 30, 2024, TO APRIL 30, 2025
NYSDEC SITE NO. C915298
837 BAILEY AVENUE
BUFFALO, NEW YORK 14206

Brydges Engineering in Environment and Energy
960 Busti Avenue Suite B-150
Buffalo, New York 14213

June 2025

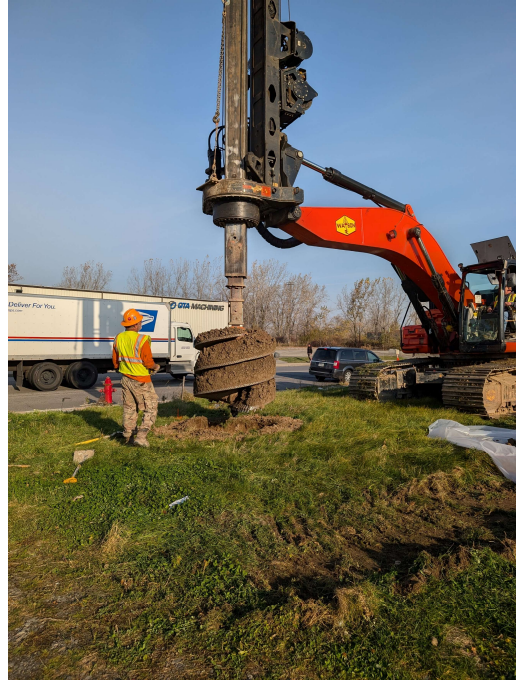
Excavated for building foundation

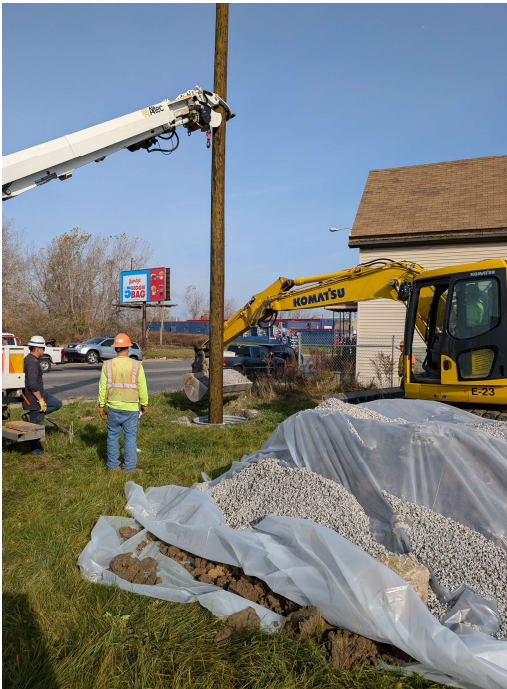
Placing stone base for foundation

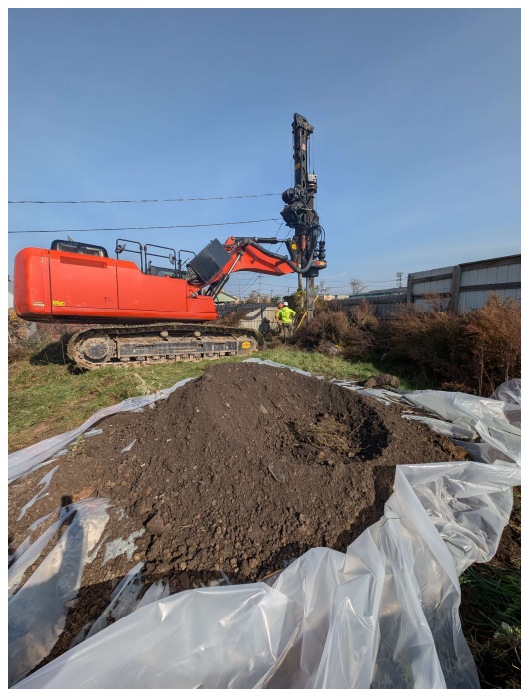
Stockpiled soil

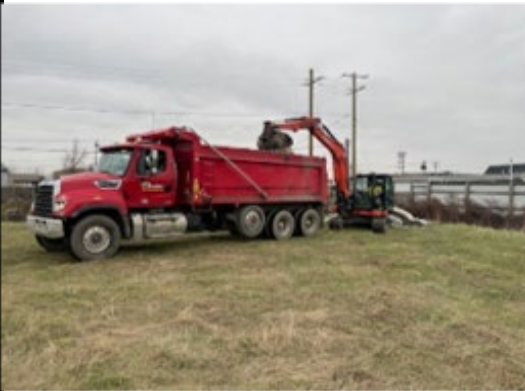
Removal of the pile in the NW corner.

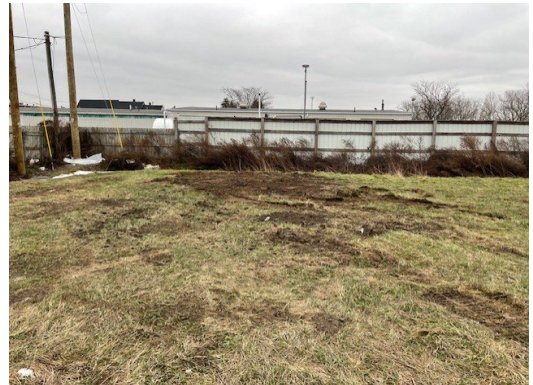
View of the pile removed.

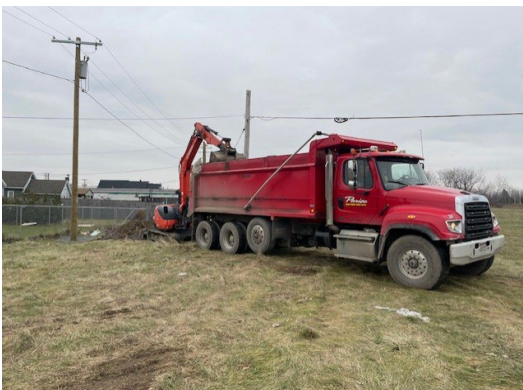
Removal of the pile on the west.

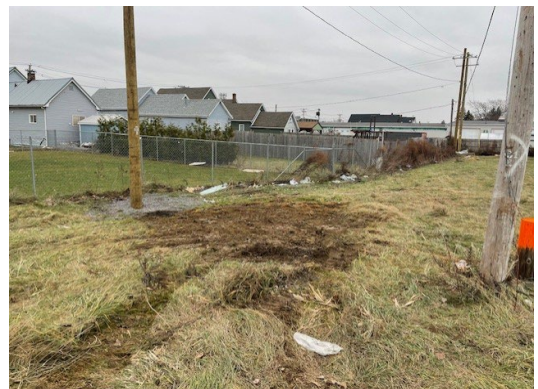
View of the pile removed.

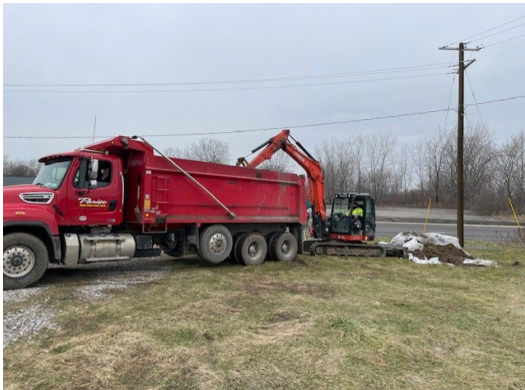
Removal of the pile by Bailey Ave.

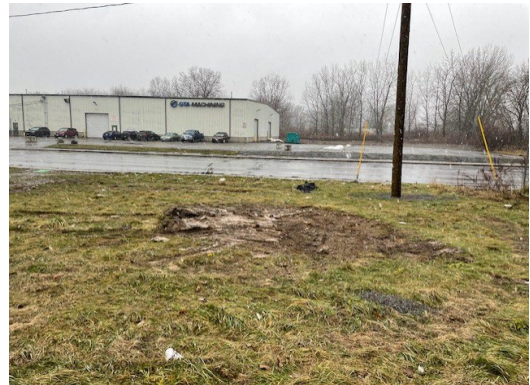
View of the pile removed.

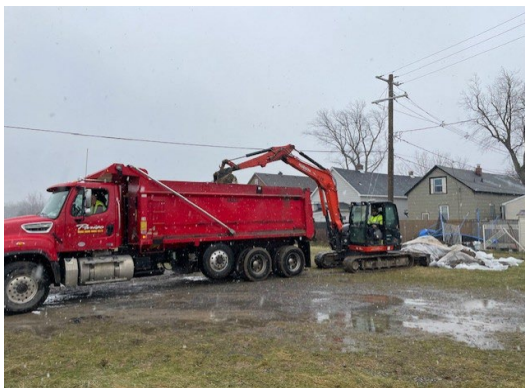
Removal of the pile on the NE side of the property.

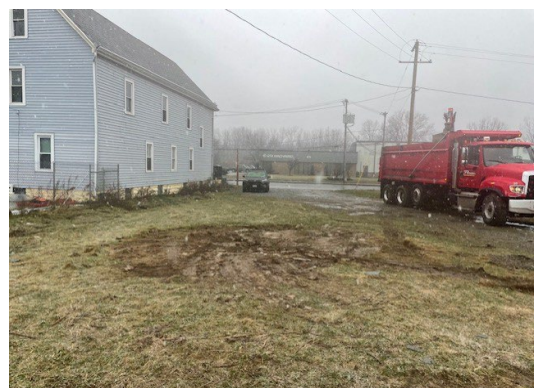
View of the the pile removed.

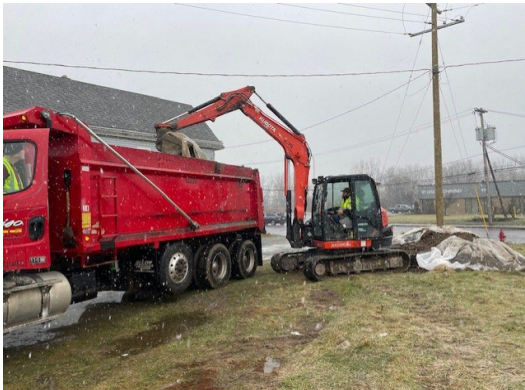
Removal of the pile on the E side by
Bailey Ave.

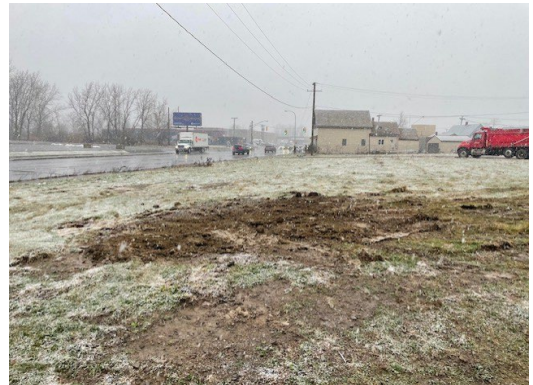
View of the pile removed.

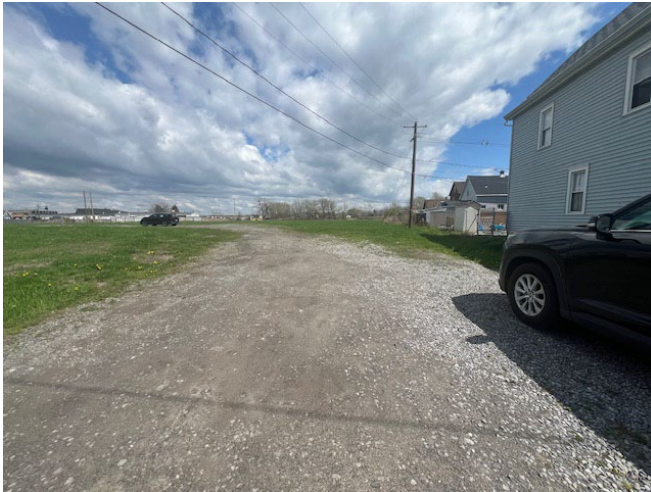
1. SW site entrance along Bailey Avenue, facing E.

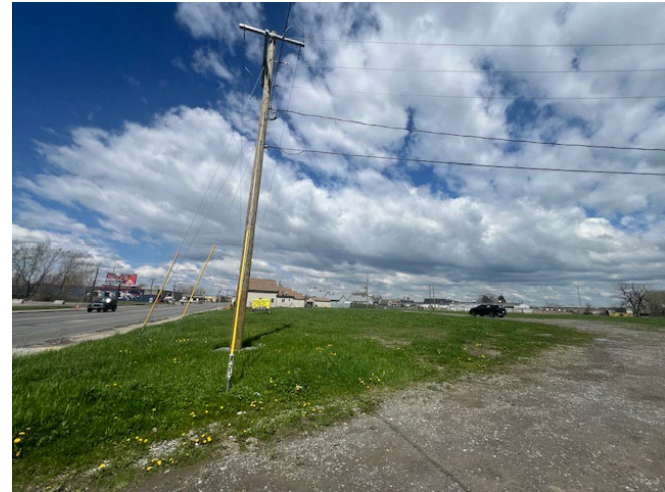
2. SW corner of site, facing N (including view of newly installed electric pole).

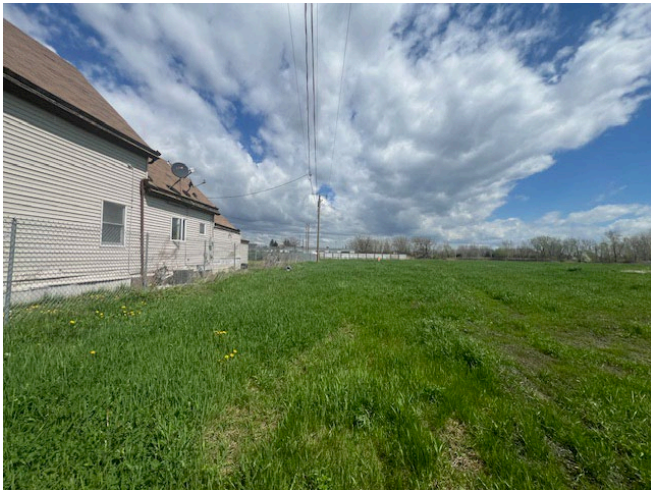
3. NW corner of site, facing E.

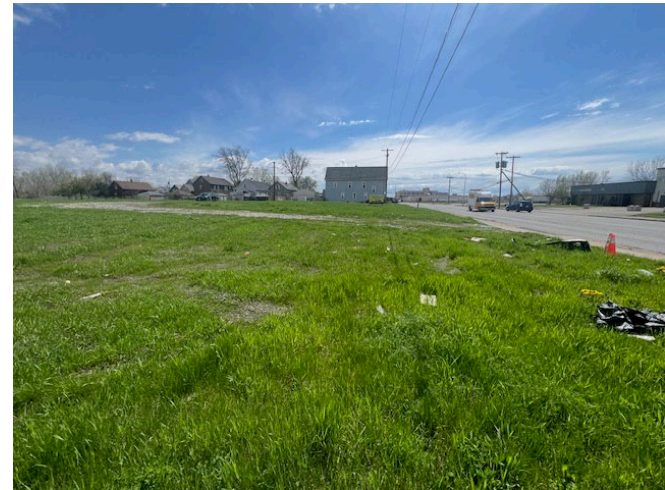
4. NW corner of site, facing S.

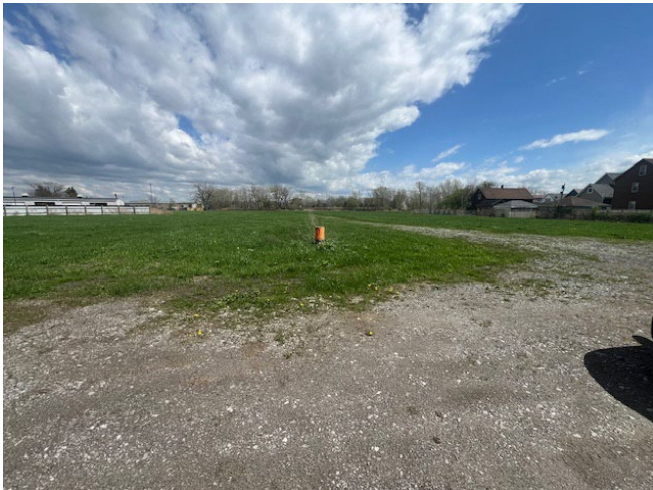
5. W point of gravel loop, facing E.

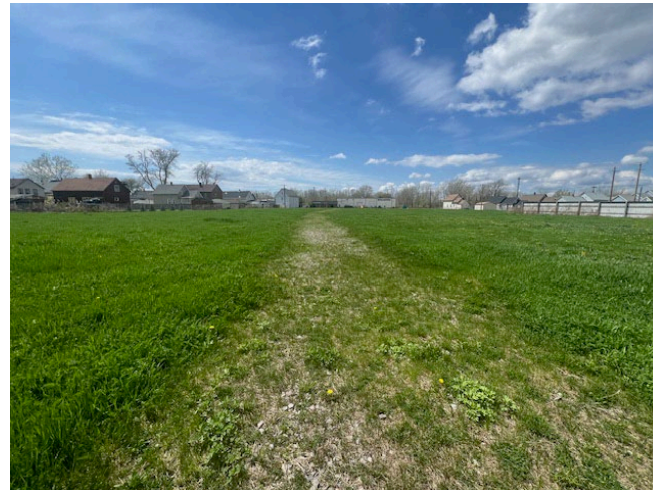
6. Center of site, facing W.

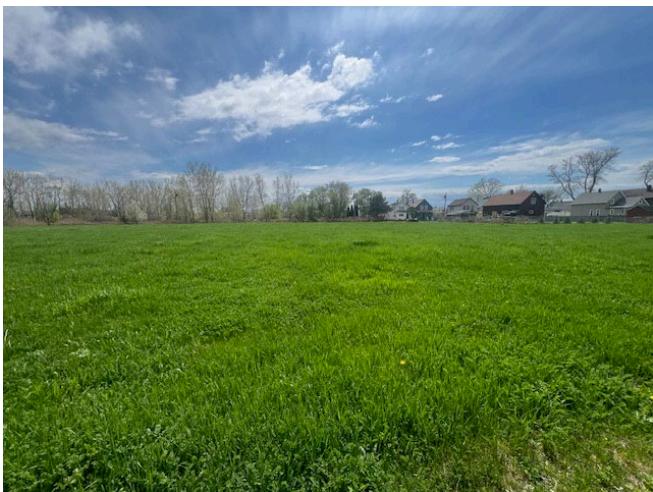
7. Center of site, facing S.

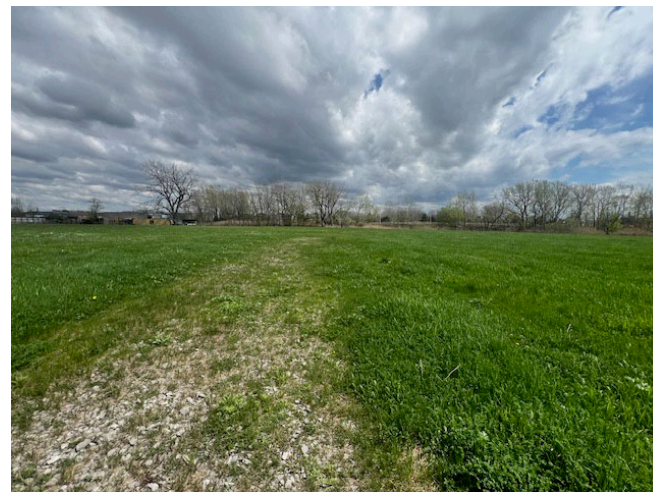
8. Center of site, facing E.

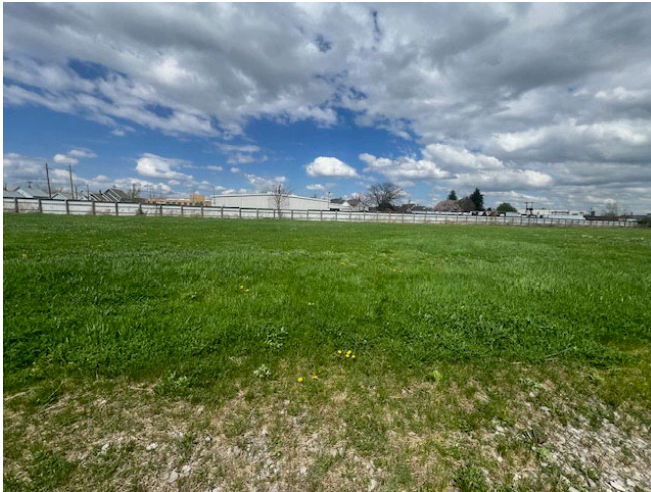
9. Center of site, facing N.

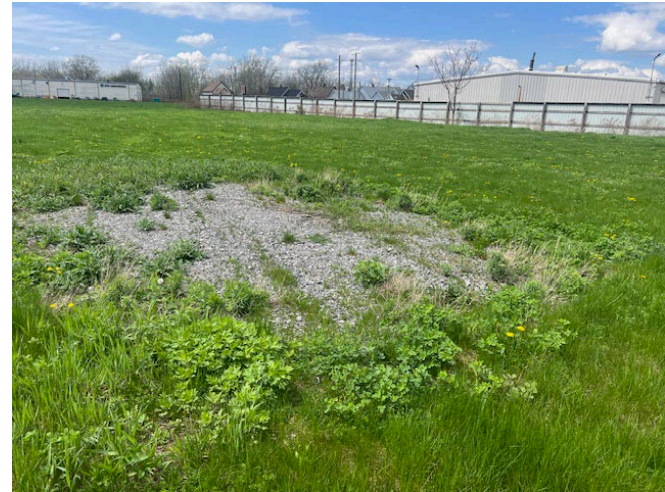
10. Central stone fill from previous reporting period demonstrating vegetative growth.

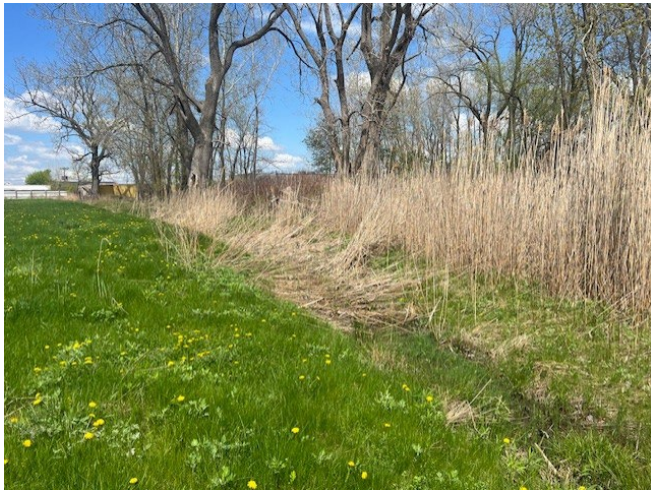
11. SE corner of site, facing N toward E drainage ditch.

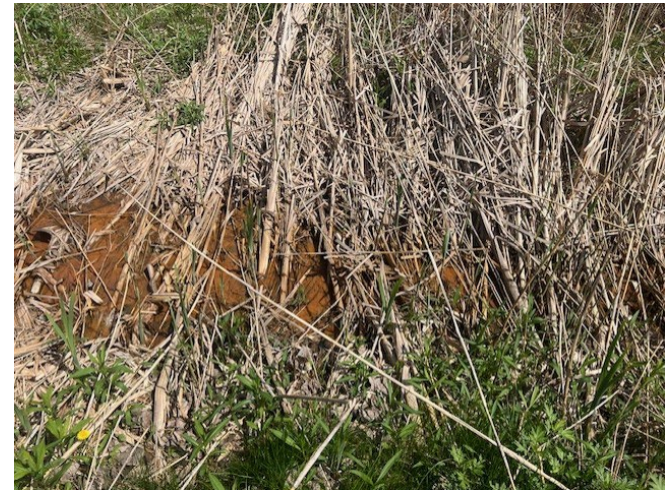
12. Stained vegetation and ponded water in W drainage ditch, similar in appearance to previous reporting periods.

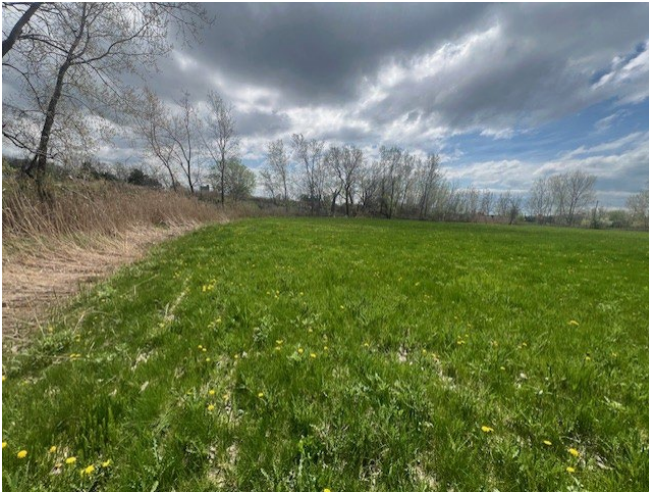
13. NE corner of site, facing S toward E drainage ditch.

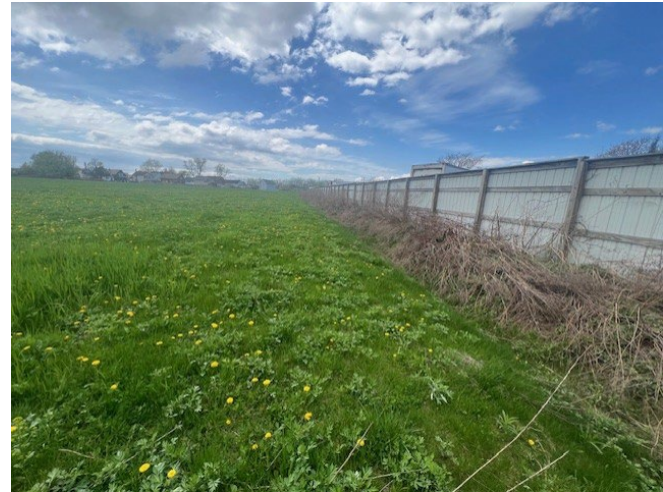
14. NE corner of site, facing W.

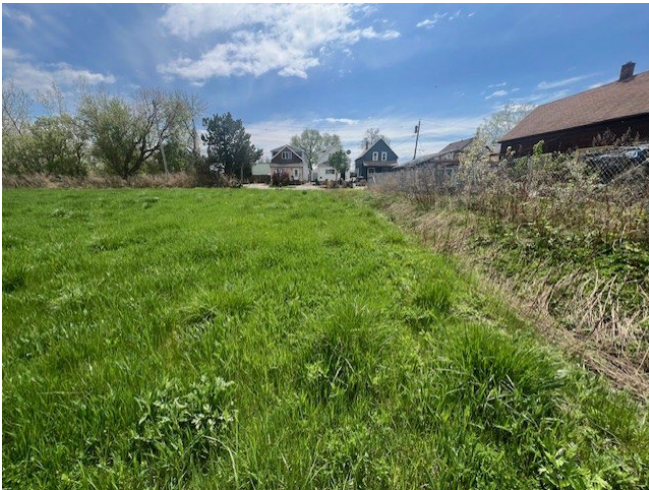
15. Central S portion of site, facing SW.

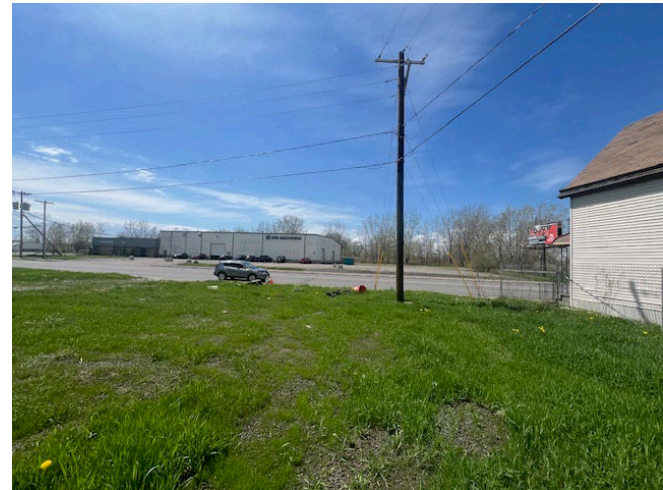
16. New electric pole in NW corner of site, facing W.

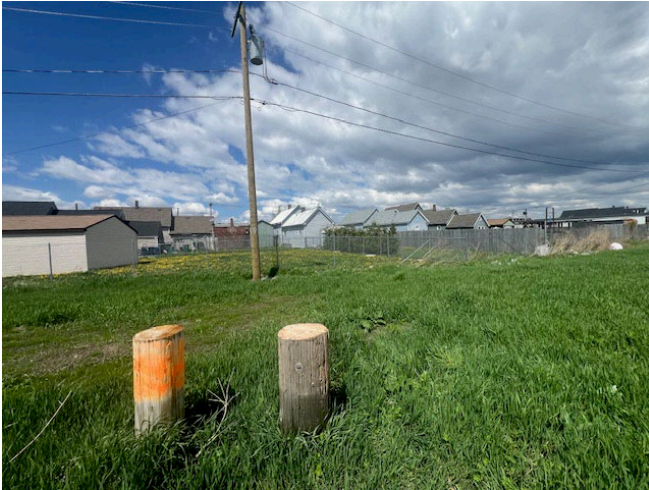
17. New electric pole near NW site border (E of electric pole identified in picture 16) and two cut poles, facing NNE.

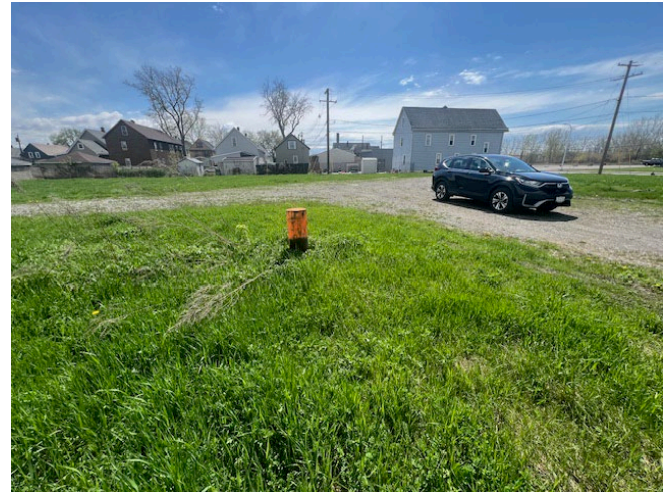
18. Cut pole near central W portion of site, facing S.
