PERIODIC REVIEW REPORT

APRIL 30, 2025, TO APRIL 30, 2026
NYSDEC SITE NO. C915298
837 BAILEY AVENUE
BUFFALO, NEW YORK 14206

Site Name: 837 Bailey Avenue (BCP Site No.C915298)

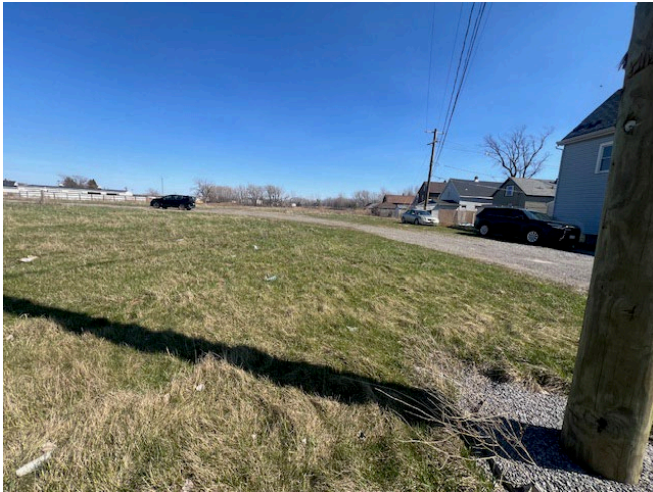
1. SW corner of site along Bailey Avenue, facing E.

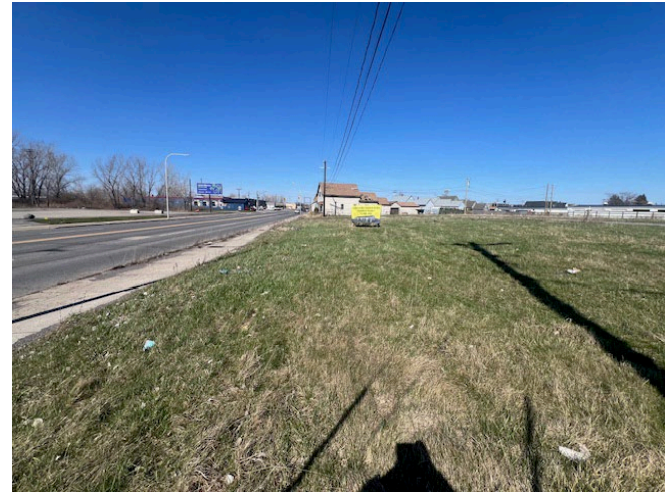
2. SW corner of site along Bailey Avenue, facing N.

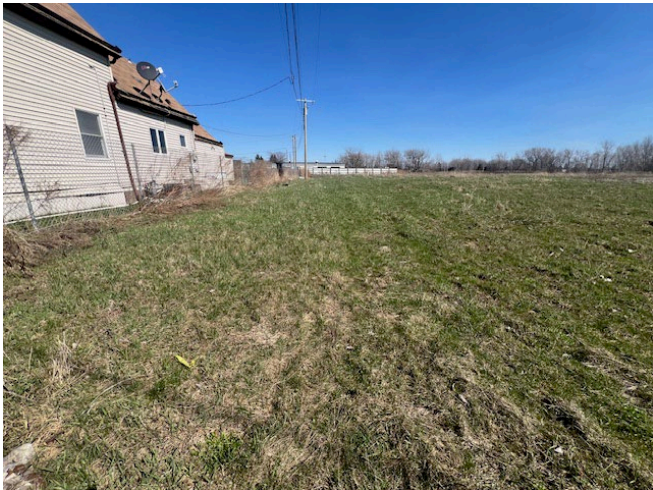
3. NW corner of site, facing E.

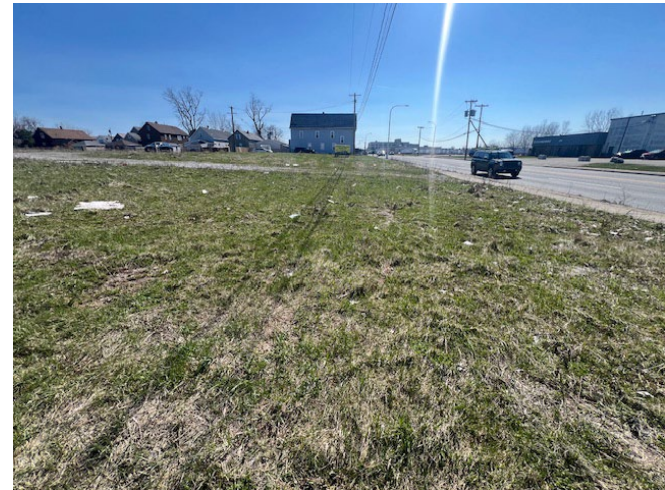
4. NW corner of site, facing S.

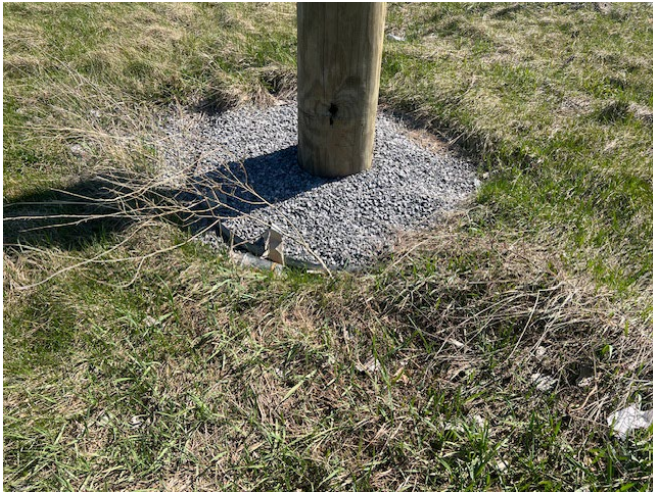
The Site cover system remains in good condition. Continued vegetative growth is apparent in areas previously filled with crusher run stone. The approved crusher run stone surrounding the new electric poles installed during the previous reporting period remains intact. No areas were disturbed during this reporting period. The Site remains vacant/undeveloped and otherwise unchanged since the previous reporting period.

5. View of well-maintained gravel/clean corridor surrounding previously installed electrical pole.

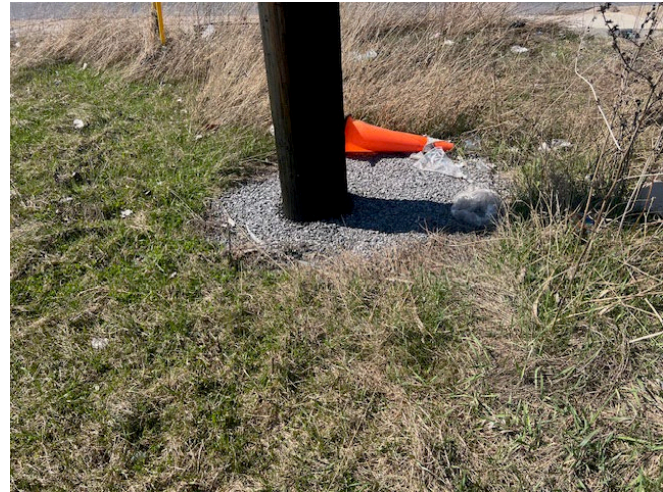
6. Another well-maintained gravel/clean corridor.

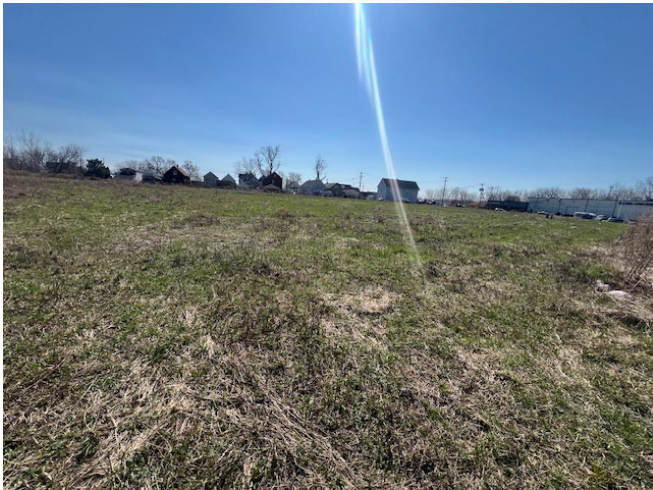
7. Central N corner of site, facing SW.

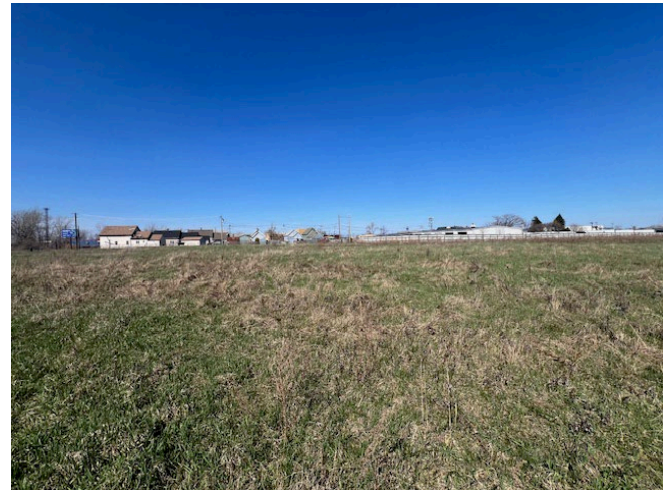
8. Central S corner, facing N.

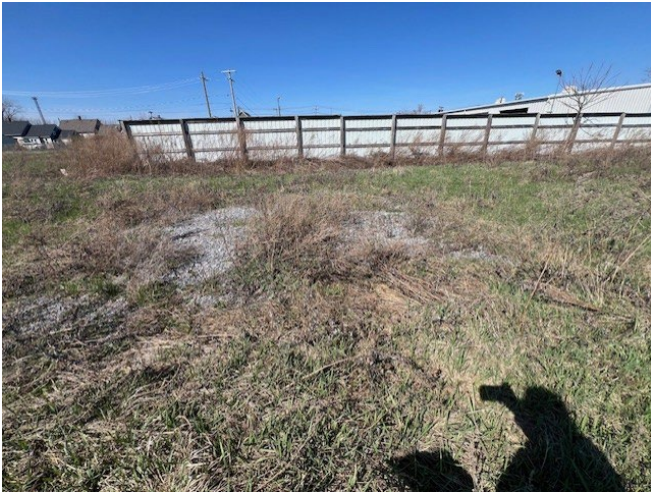
A Site Wide Inspection was completed by BE3 on April 8, 2026, to evaluate the IC/ECs outlined in the SMP. The only EC associated with the site is the cover system which is in good condition. Vegetative growth is evident in areas where crusher run stone was placed during previous reporting periods. The perimeter fencing and stone entry pathway along Bailey Avenue appeared to be in good condition. Minor, scattered debris remains along the southeastern and northwestern site boundary. No change of use or groundwater use occurred during the Certifying Period. No excavation into the cover system or importation of material occurred during the certifying period. No substantial ruts, bare spots or erosion rills were noted.

9. Central stone fill from previous reporting period demonstrating continued vegetative growth.

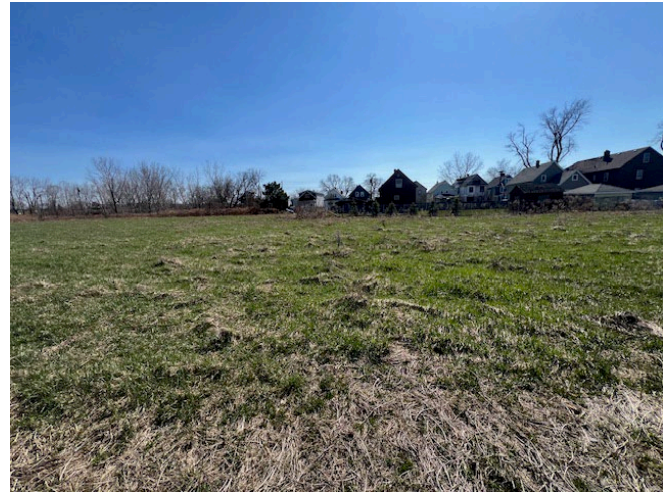
10. Center of site, facing S.

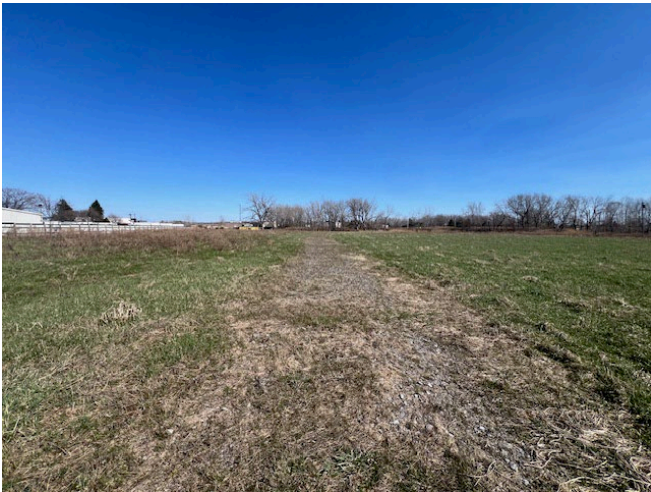
11. Center of site, facing E.

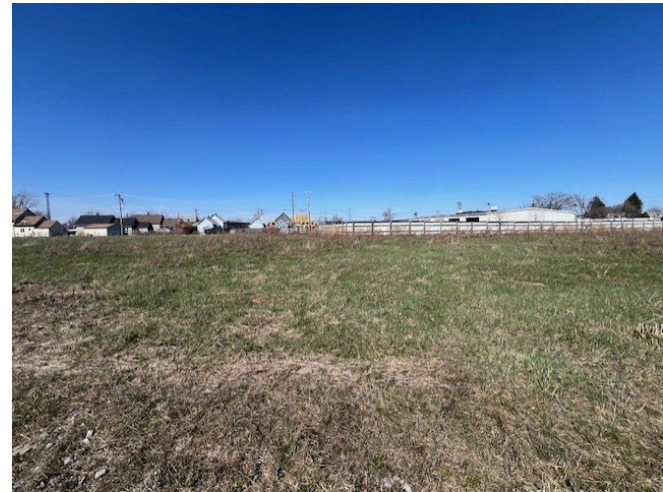
12. Center of site, facing N.

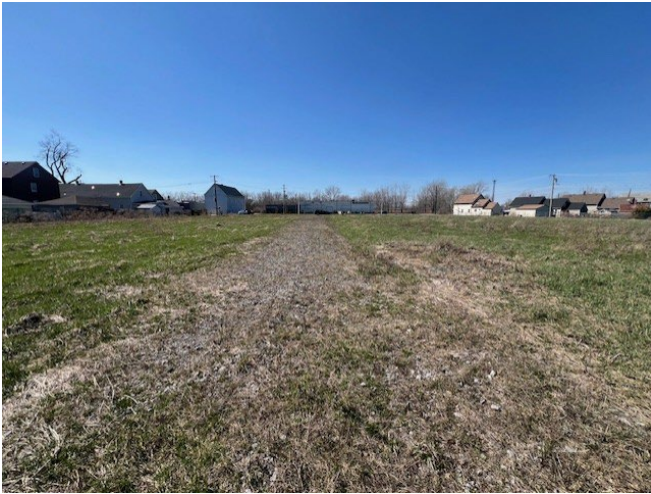
13. Center of site, facing W.

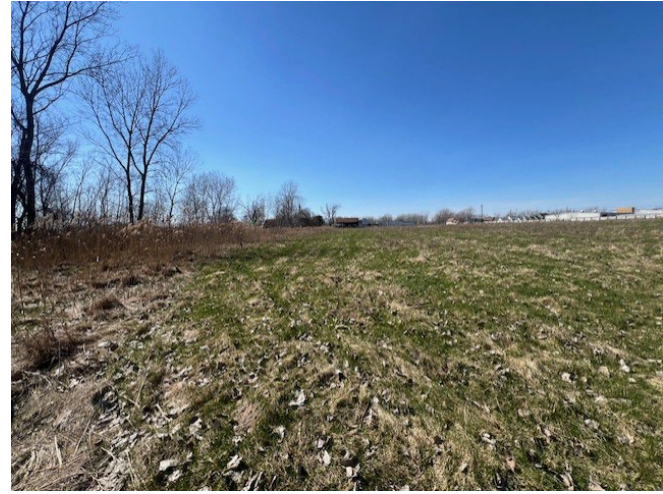
14. SE corner of site, facing NW.

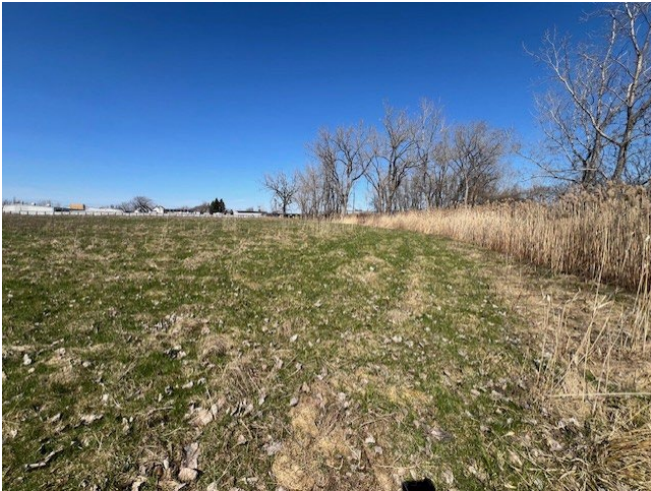
15. SE corner of site, facing NE.

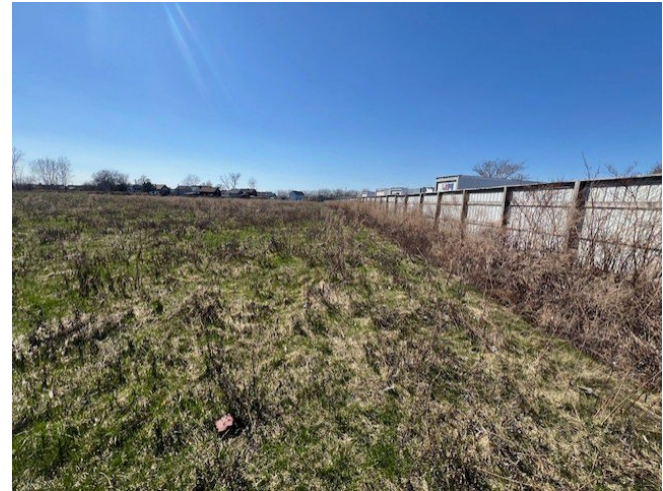
16. NE corner of site, facing W.

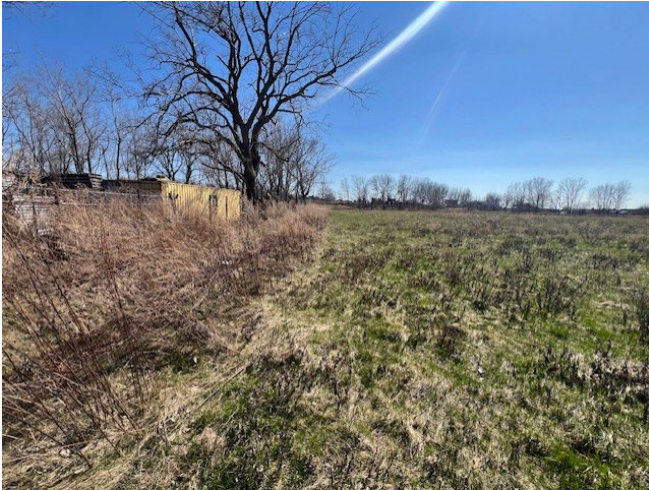
17. NE corner of site, facing S.

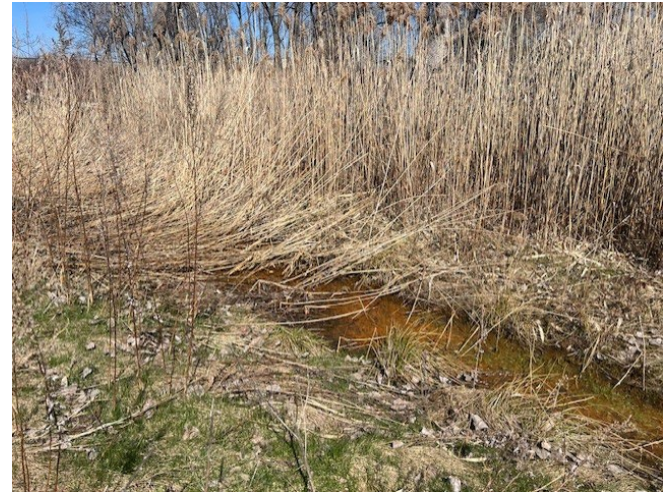
The Site remains in compliance with all ICs and ECs. The only EC is the cover system. There are no substantial ruts, bare spots, or erosion rills in greenspace areas. No excavation into the cover system has occurred. Property uses are consistent with that allowable under the SMP. The previously identified vegetative staining and sheen in the eastern drainage ditch was observed with no notable differences from previous observations.

18. E drainage ditch.
