Panamerican Environmental, Inc.
2390 Clinton Street
Buffalo, New York 14227
Tel: (716) 821-1650
Fax: (716) 821-1607

March 24, 2015

Subject: Limited Sub-Slab Soil/Subsurface Assessment— 31 Tonawanda Street, Buffalo, New York

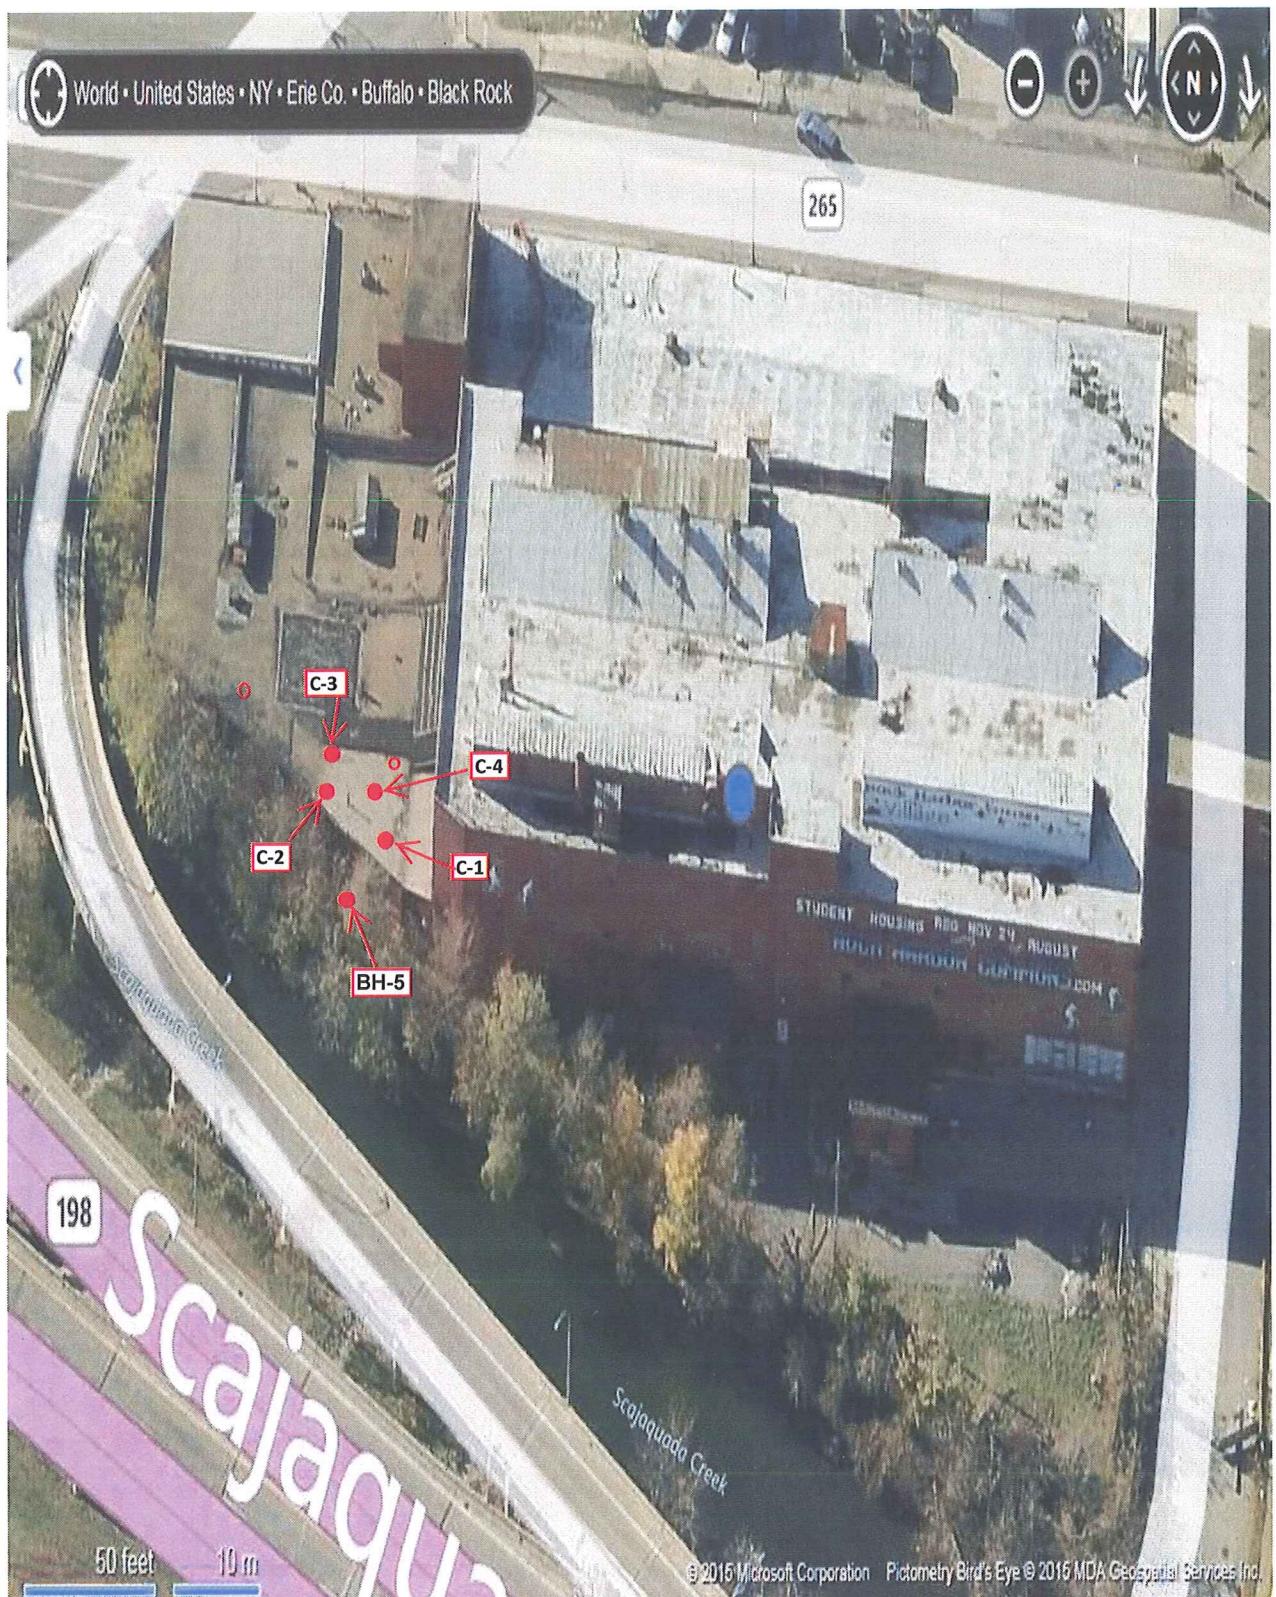
Figure: Inside Floor Core/Boring Locations

A total of four Geoprobe® borings were advanced in an array in the southeast portion of the building. The first two cores/borings were placed adjacent to the east wall and closest to where subsurface soil impacts were encountered during the Phase II ESA. The second two cores/borings were placed deeper towards the west, inside the building in the southeast area (refer to Figure 2 and Photographs showing the core/boring locations).

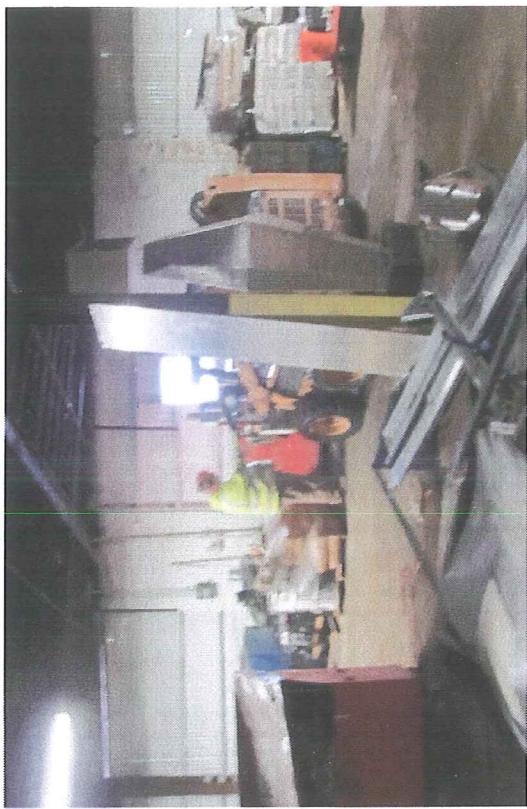
2. Location of C-1 facing east towards creek

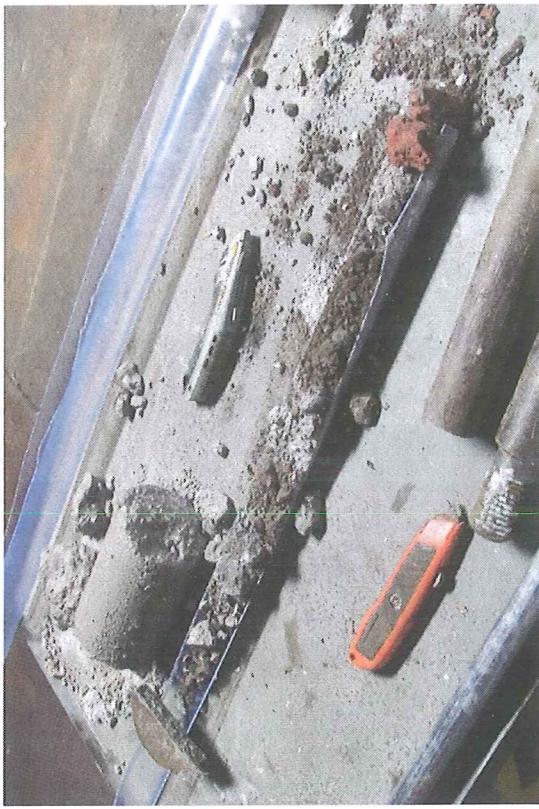
4. Cement core and soil core from 0-4 feet below ground surface at C-1

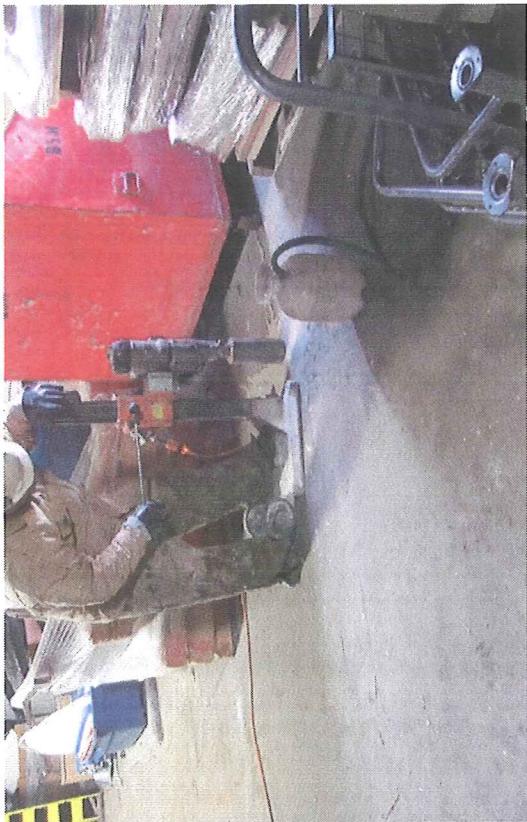
1. Location of Coring C-1

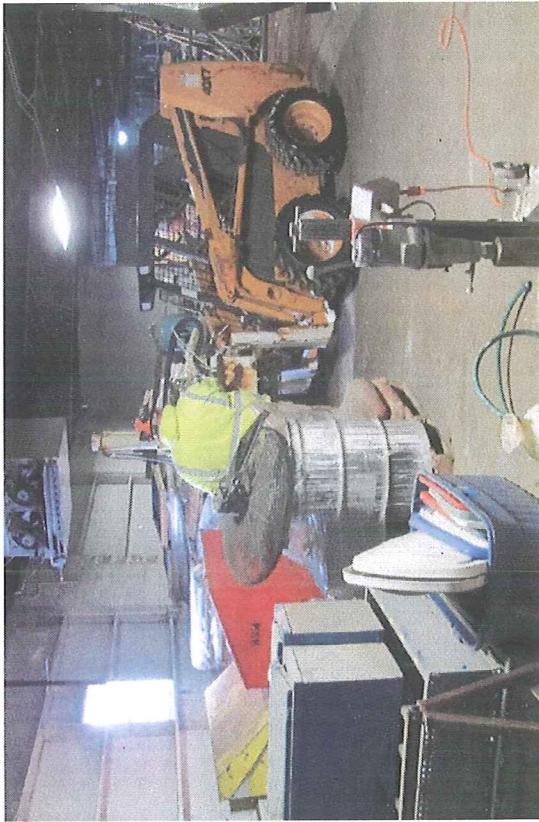
3. Location of C-1

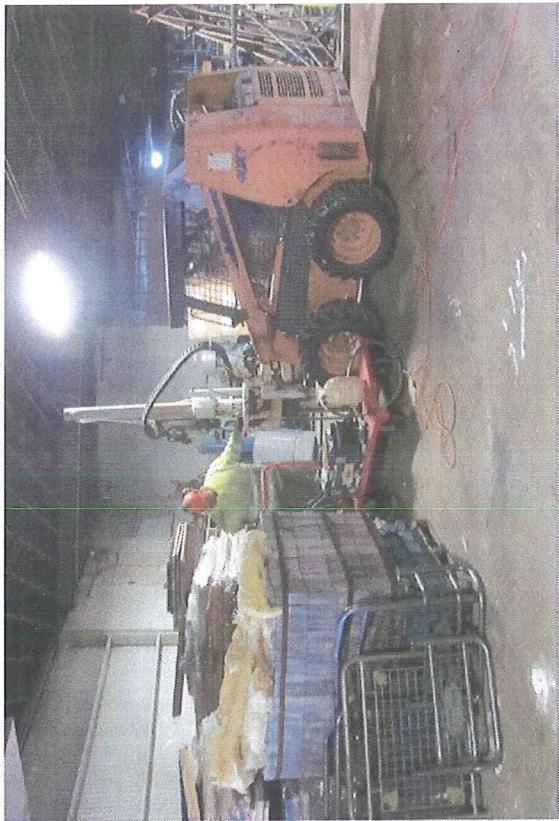
6. Location of coring C-2

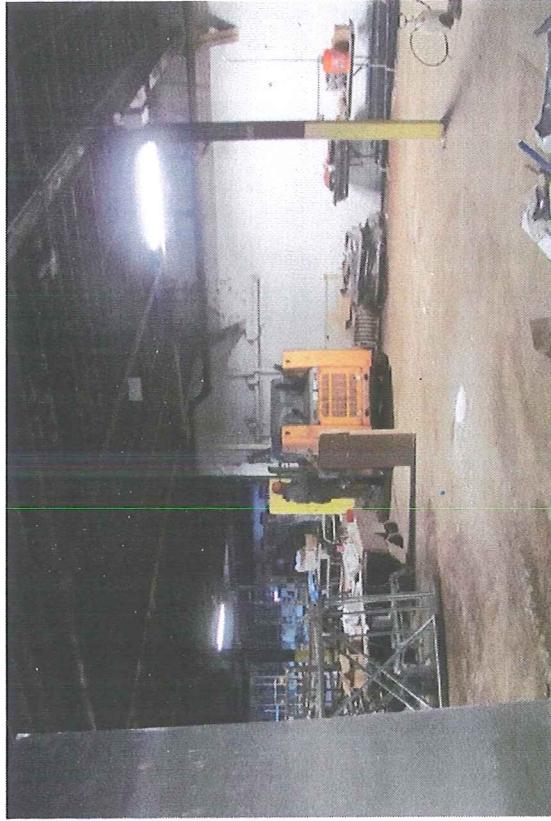
8. Location of coring C-3

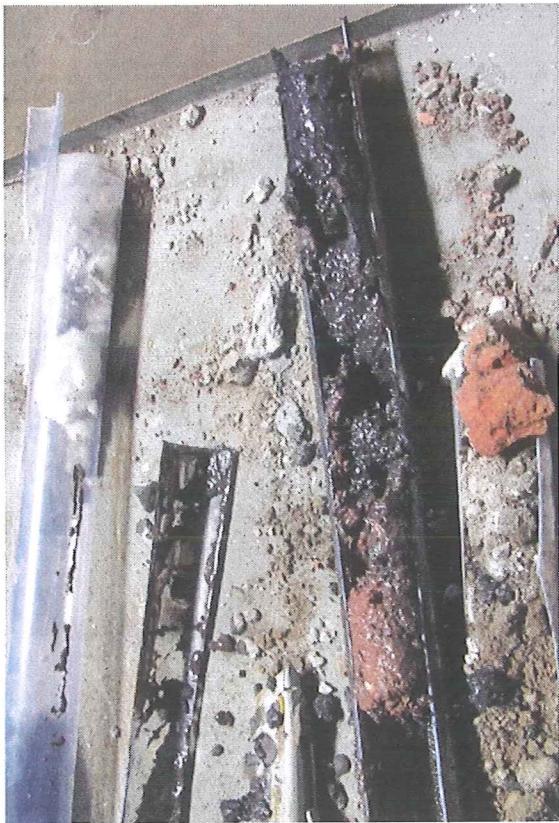
5. C-1 soil core from 4-8 feet below ground surface

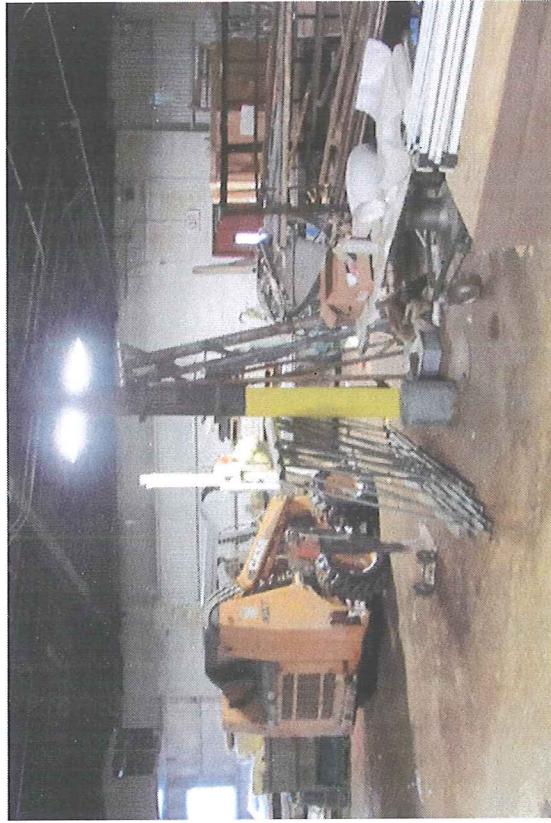
7. Location of C-2 facing east towards the creek

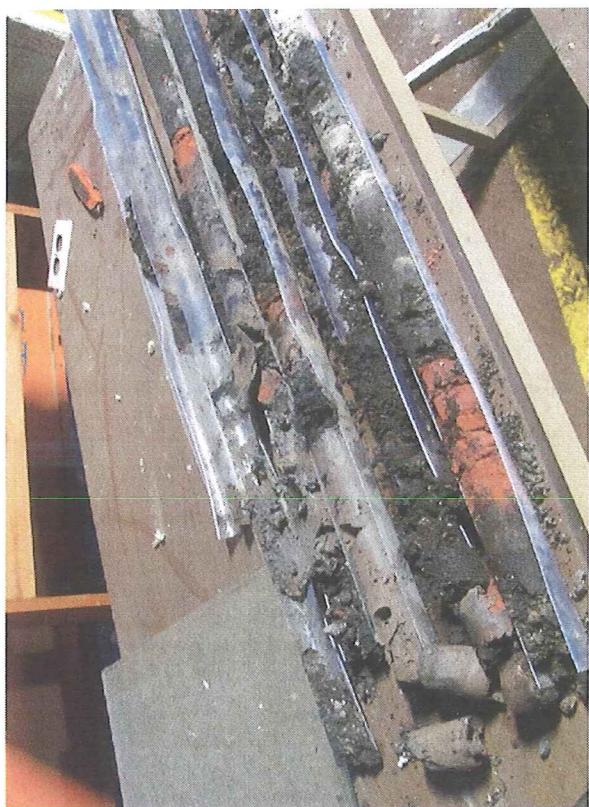
10. Soil cores from C-3

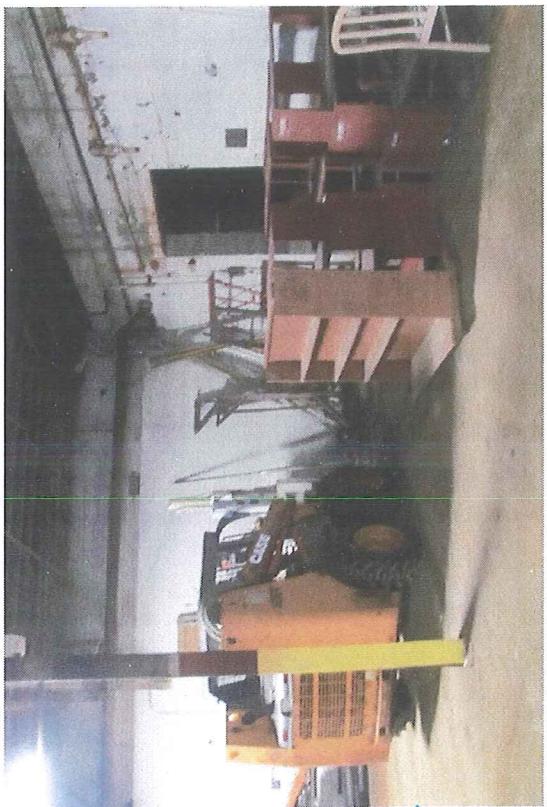
12. Attempted core location with refusal

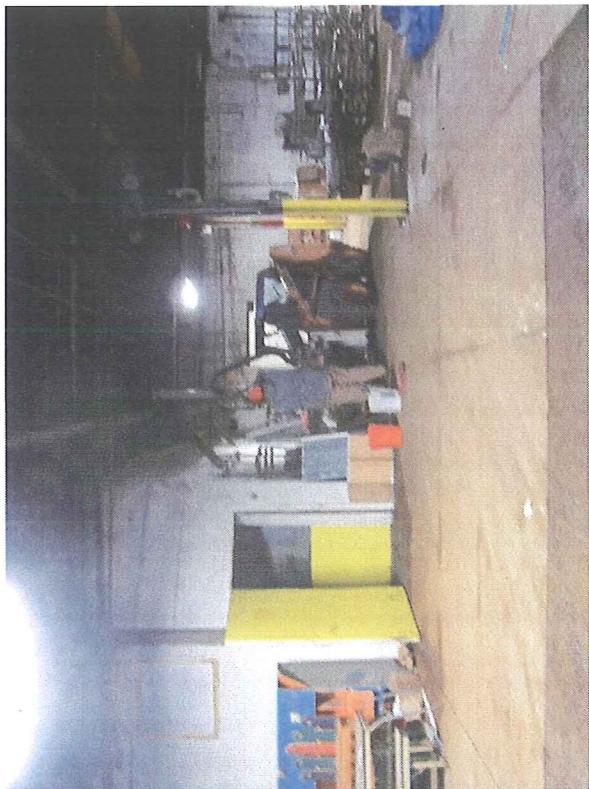
9. Location of C-3

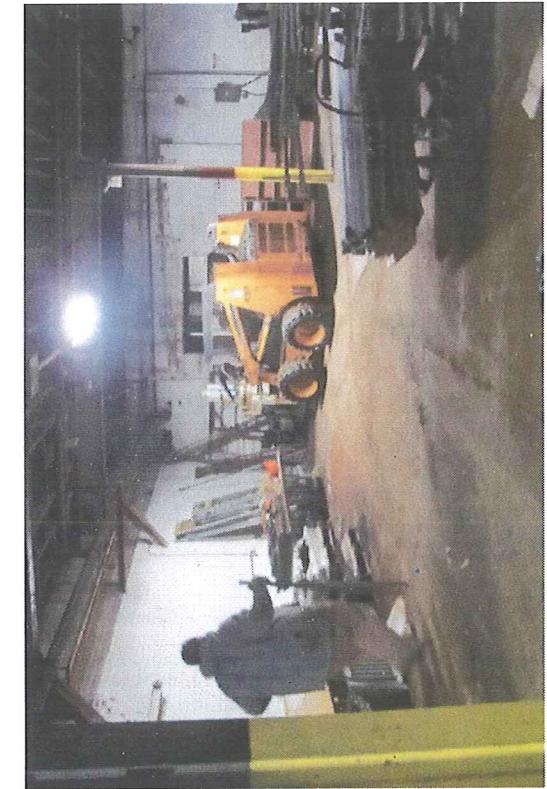
11. Attempted Lcore location with refusal

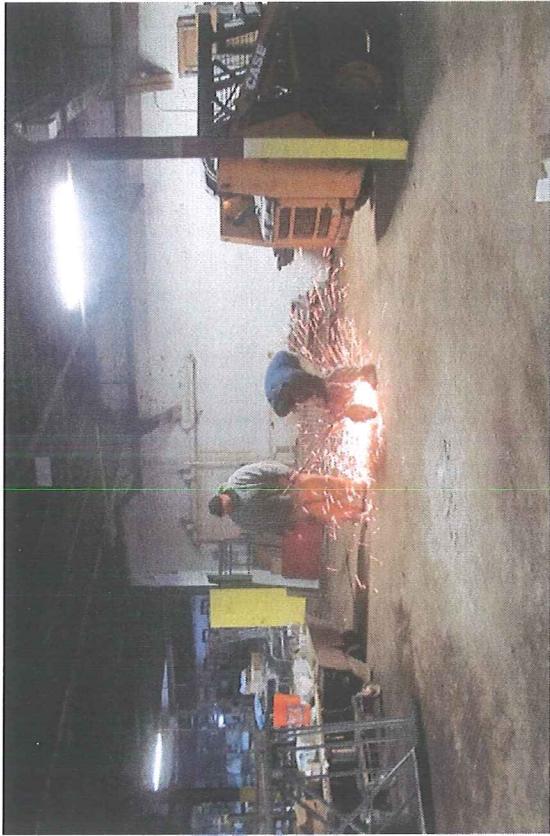
14. Cutting metal for core location C-4

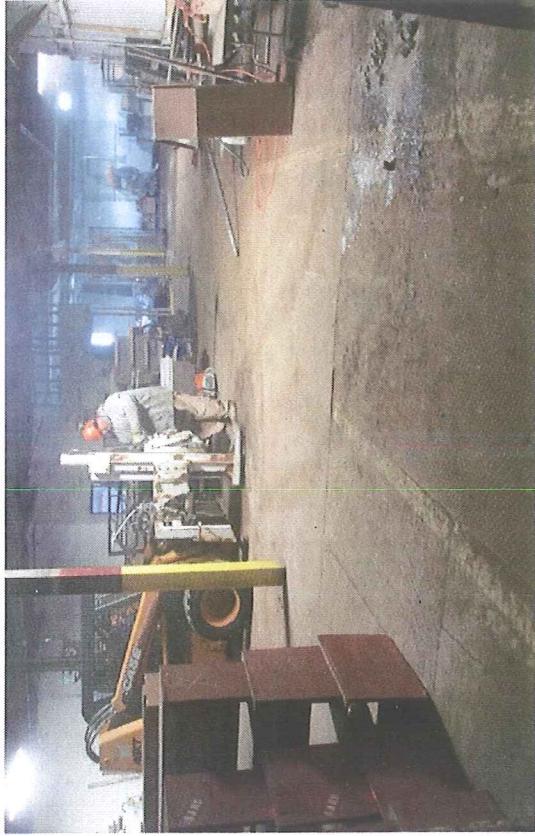
16. Location of C-4 facing south

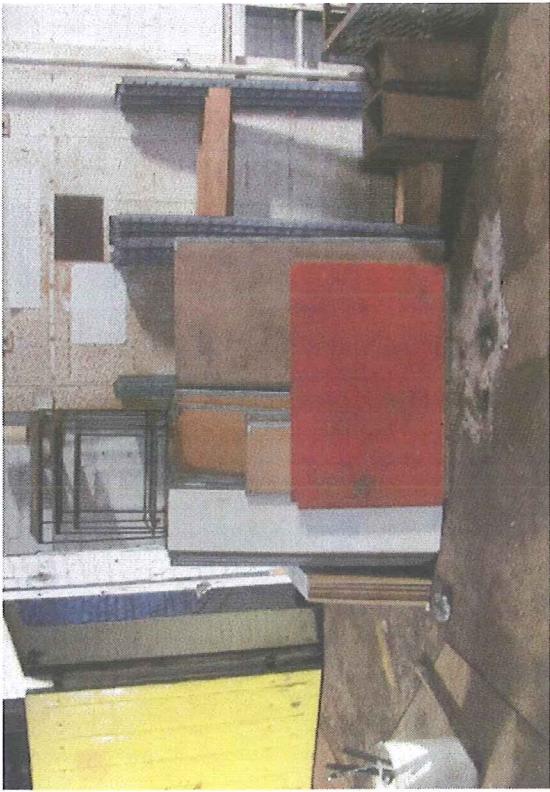
13. Core location C-3

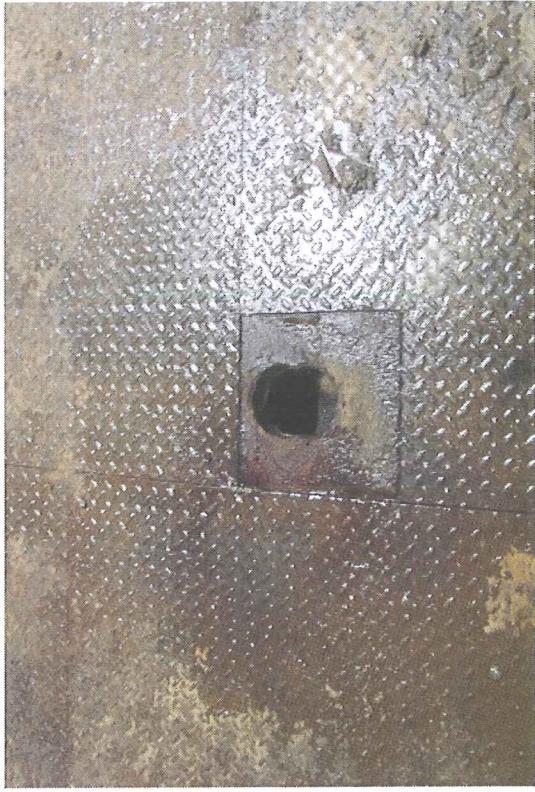
15. Core location C-4

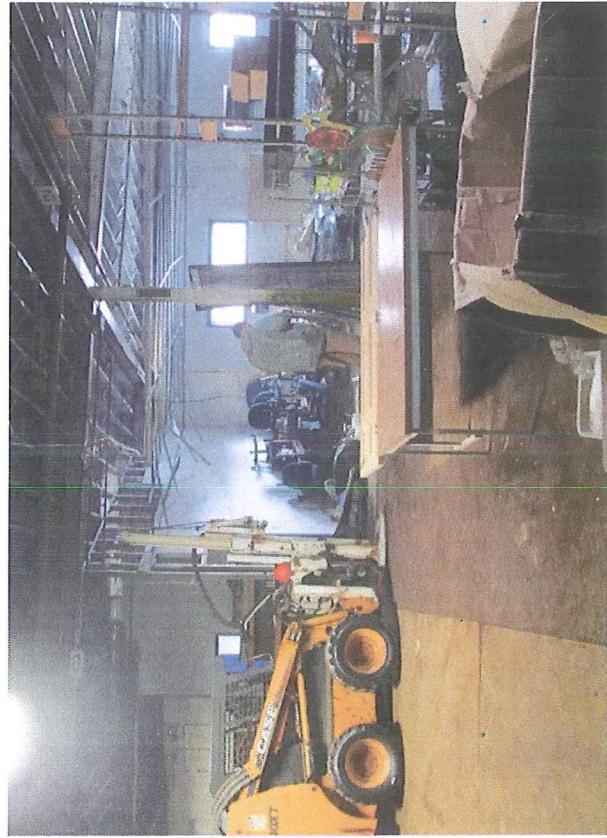
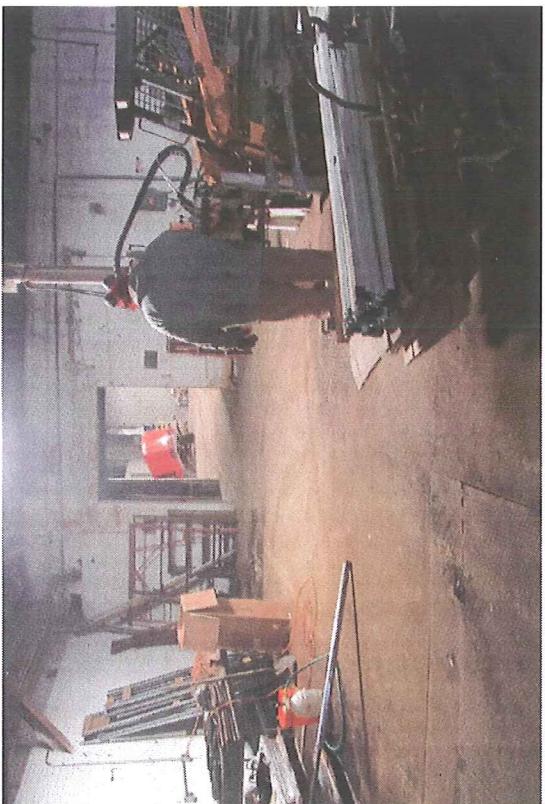
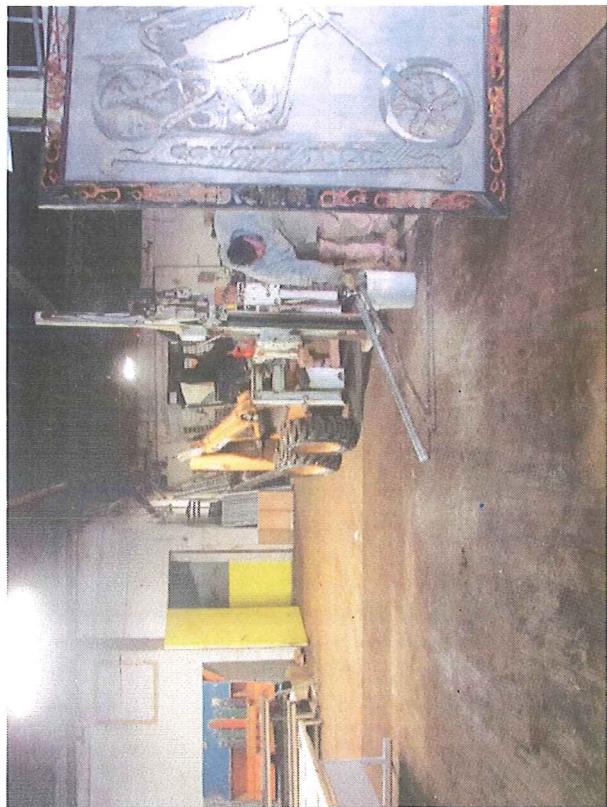
18. Soil Cores from C-4
19. Attempted core location that had refusal; south side facing east
20. Attempted core location that had refusal; south side facing east
