REMEDIAL INVESTIGATION/ALTERNATIVES ANALYSIS REPORT

31 TONAWANDA STREET SITE AND 150 TONAWANDA STREET/FORMER CSX VACANT RAIL PROPERTY BUFFALO, NEW YORK 14207 NYSDEC SITE # C915299

October 2019

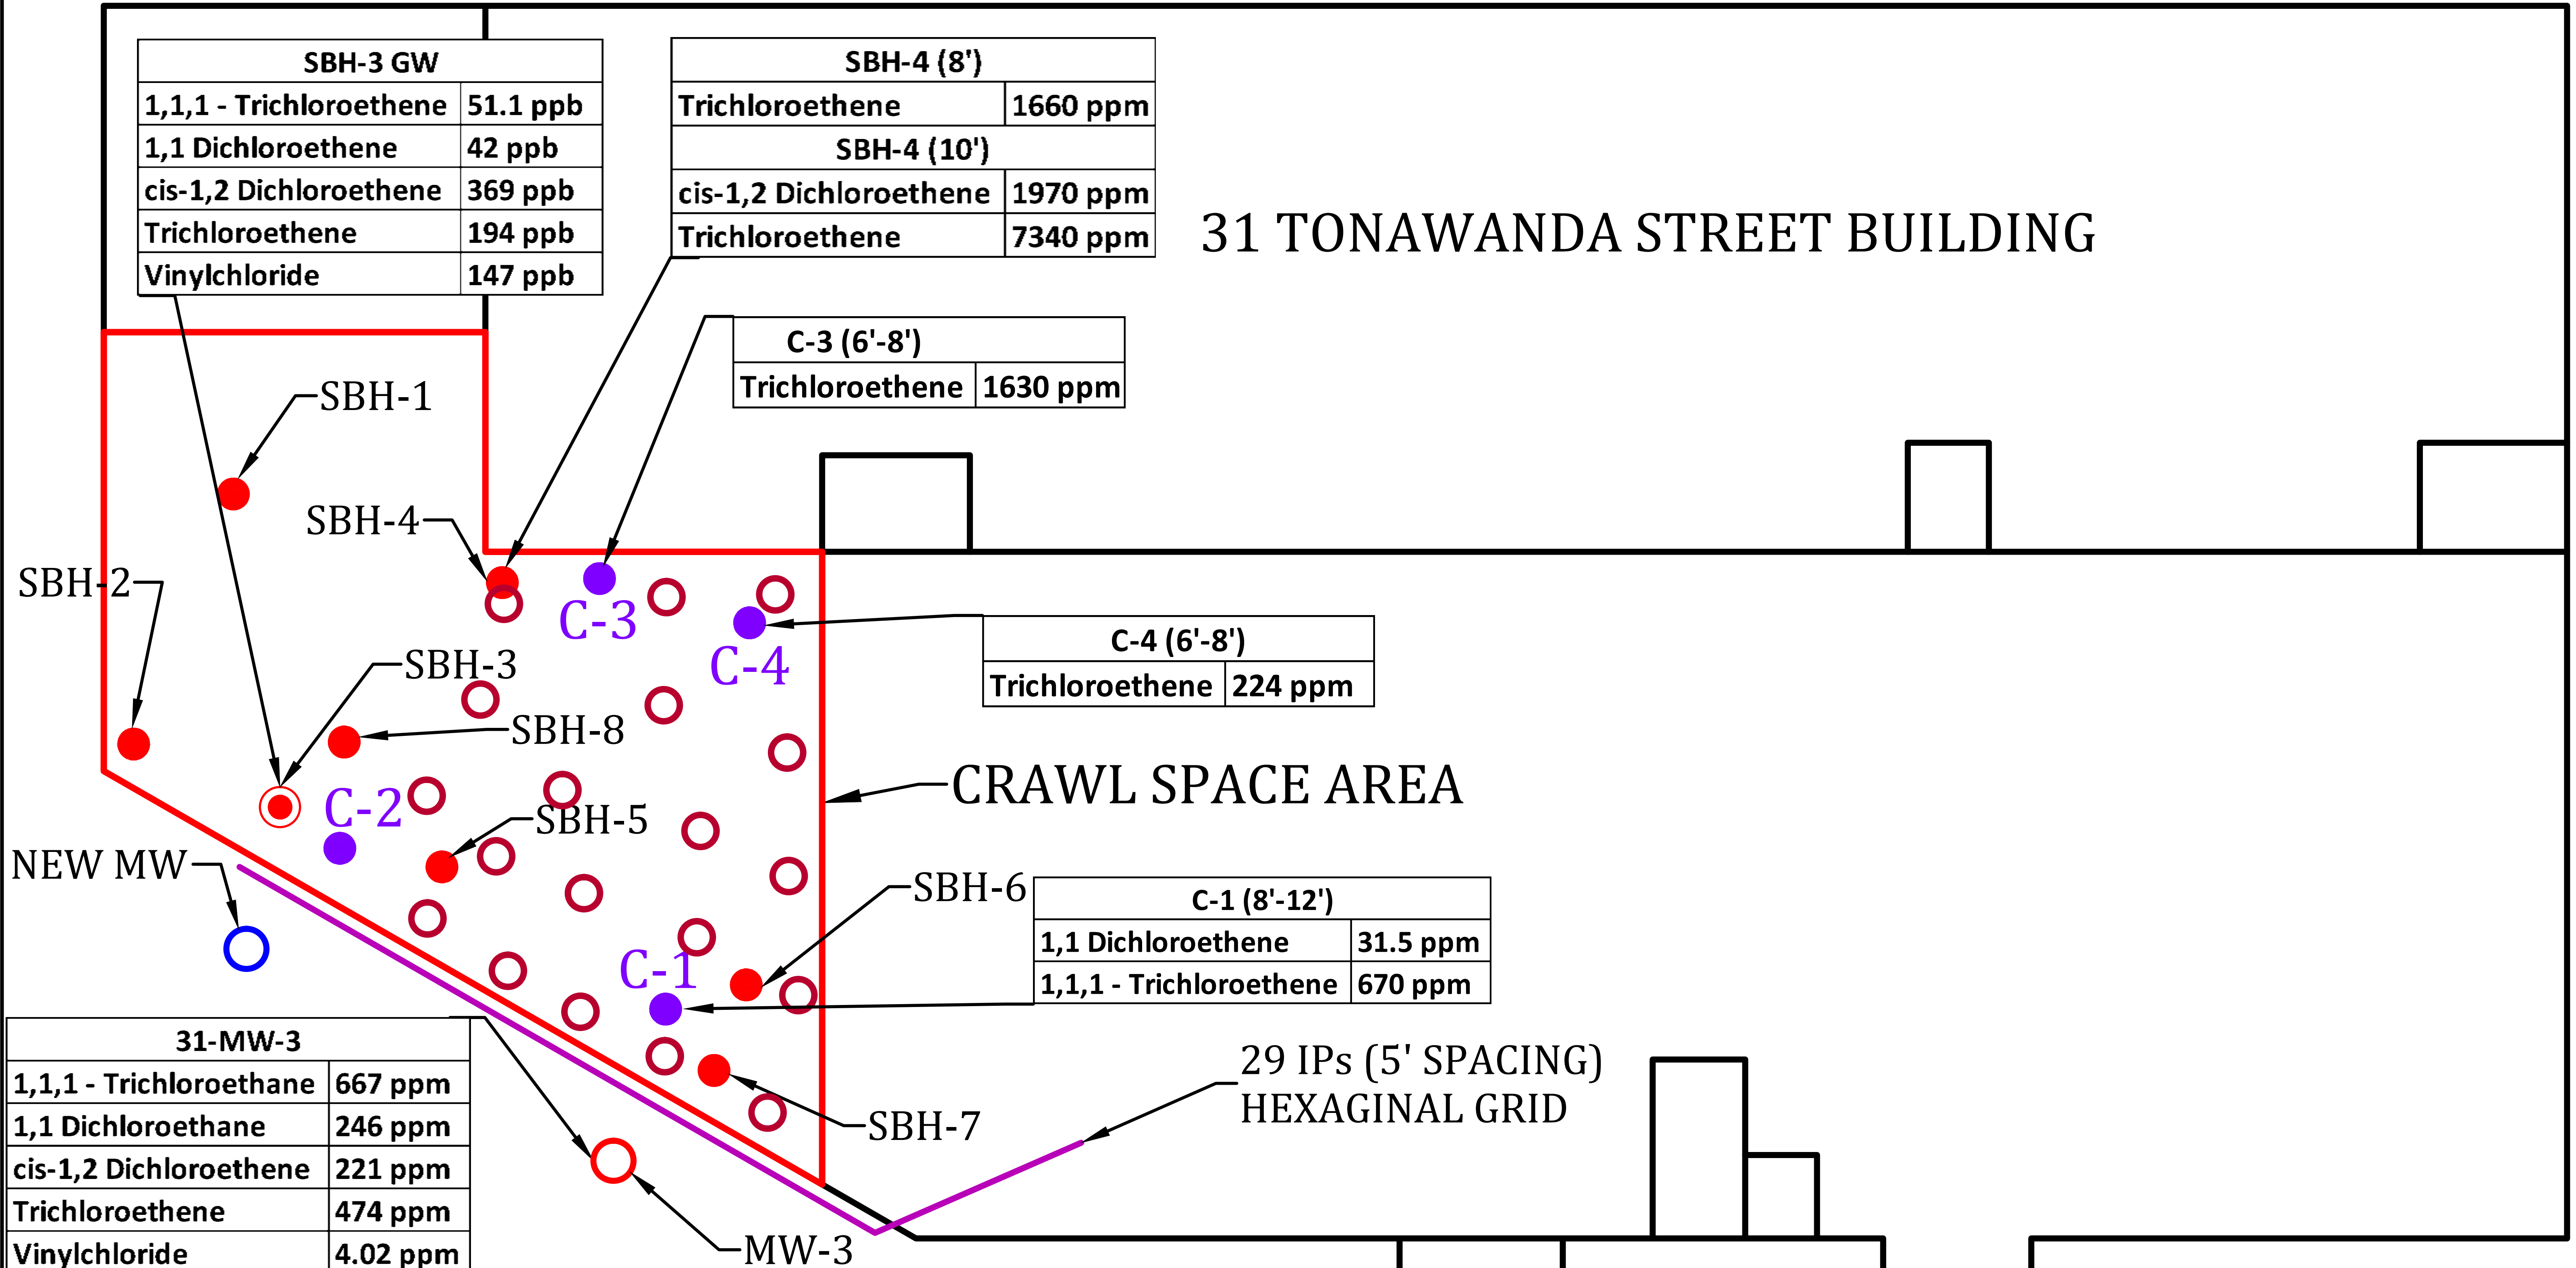
Figure 3A: 2019 Crawlspace Investigation

To assess soil conditions below the crawl space section of the building where historical chemical operations were indicated a total of eight (8) borings were installed in this area. (refer to **Figure 3A**). The crawl space area has a combination of metal/concrete/wooden floor with a three (3) to four (4) foot space beneath it to a soil floor. Four of the eight borings were not completed due to slag in one boring and concrete in the others resulting in the inability of completing the borings due to refusal. The remaining four (4) soil borings were advanced between eight (8) and 16 feet bgs. Continuous soil sampling was conducted using the Geoprobe® with a two-inch diameter sampler. The objective of the supplemental assessment within the crawl space section of the building was to assess contaminate levels in the vadose (non-water bearing) zone versus the depths that were moist or wet indicating contact with groundwater.

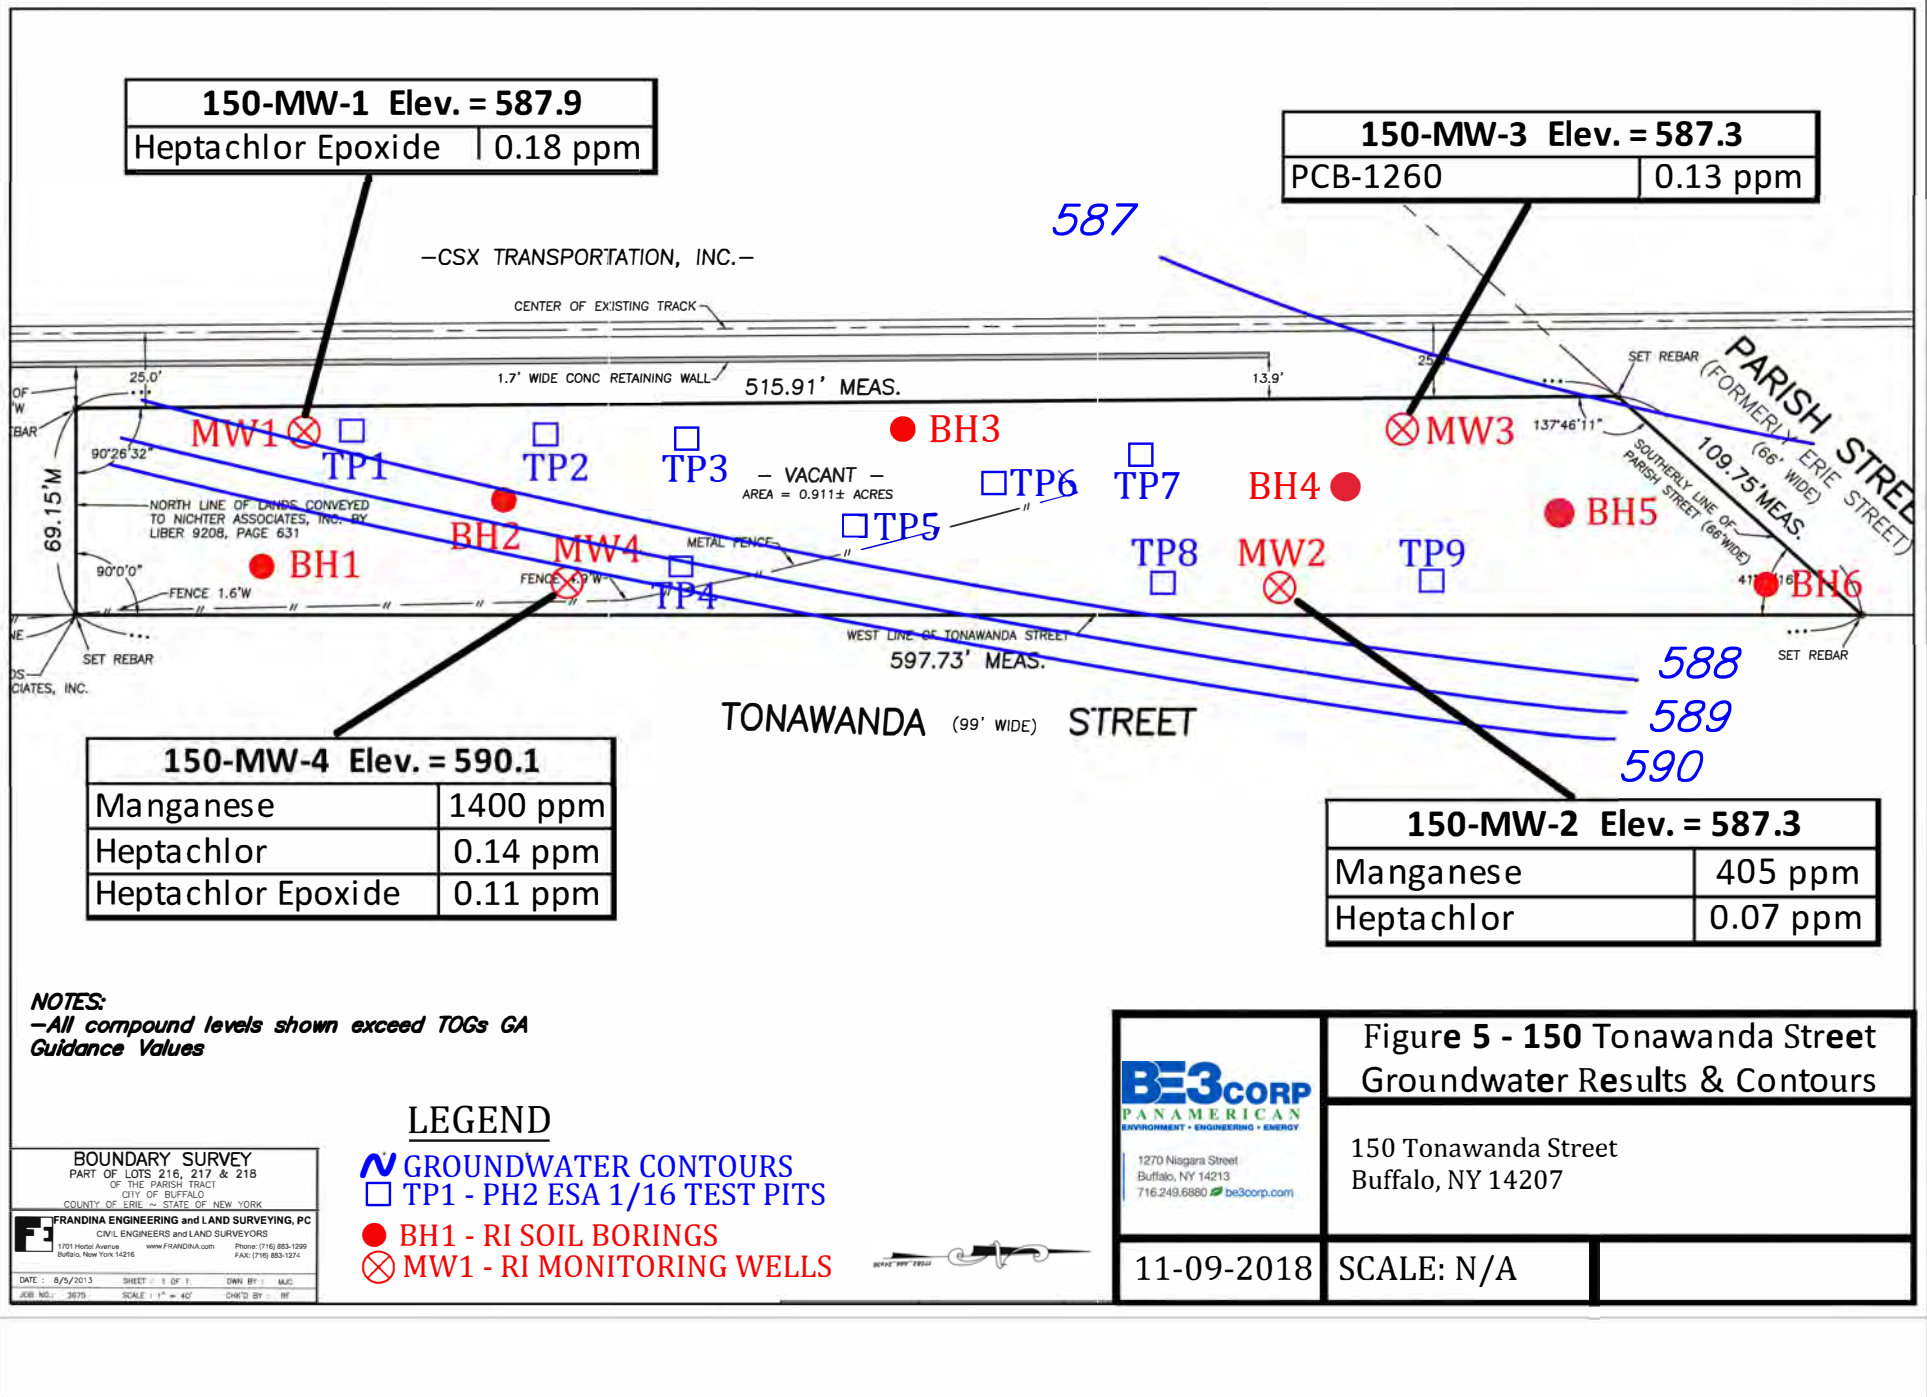
150-MW-1 Elev. = 587.9	
Heptachlor Epoxide	0.18 ppm

150-MW-3 Elev. = 587.3	
PCB-1260	0.13 ppm

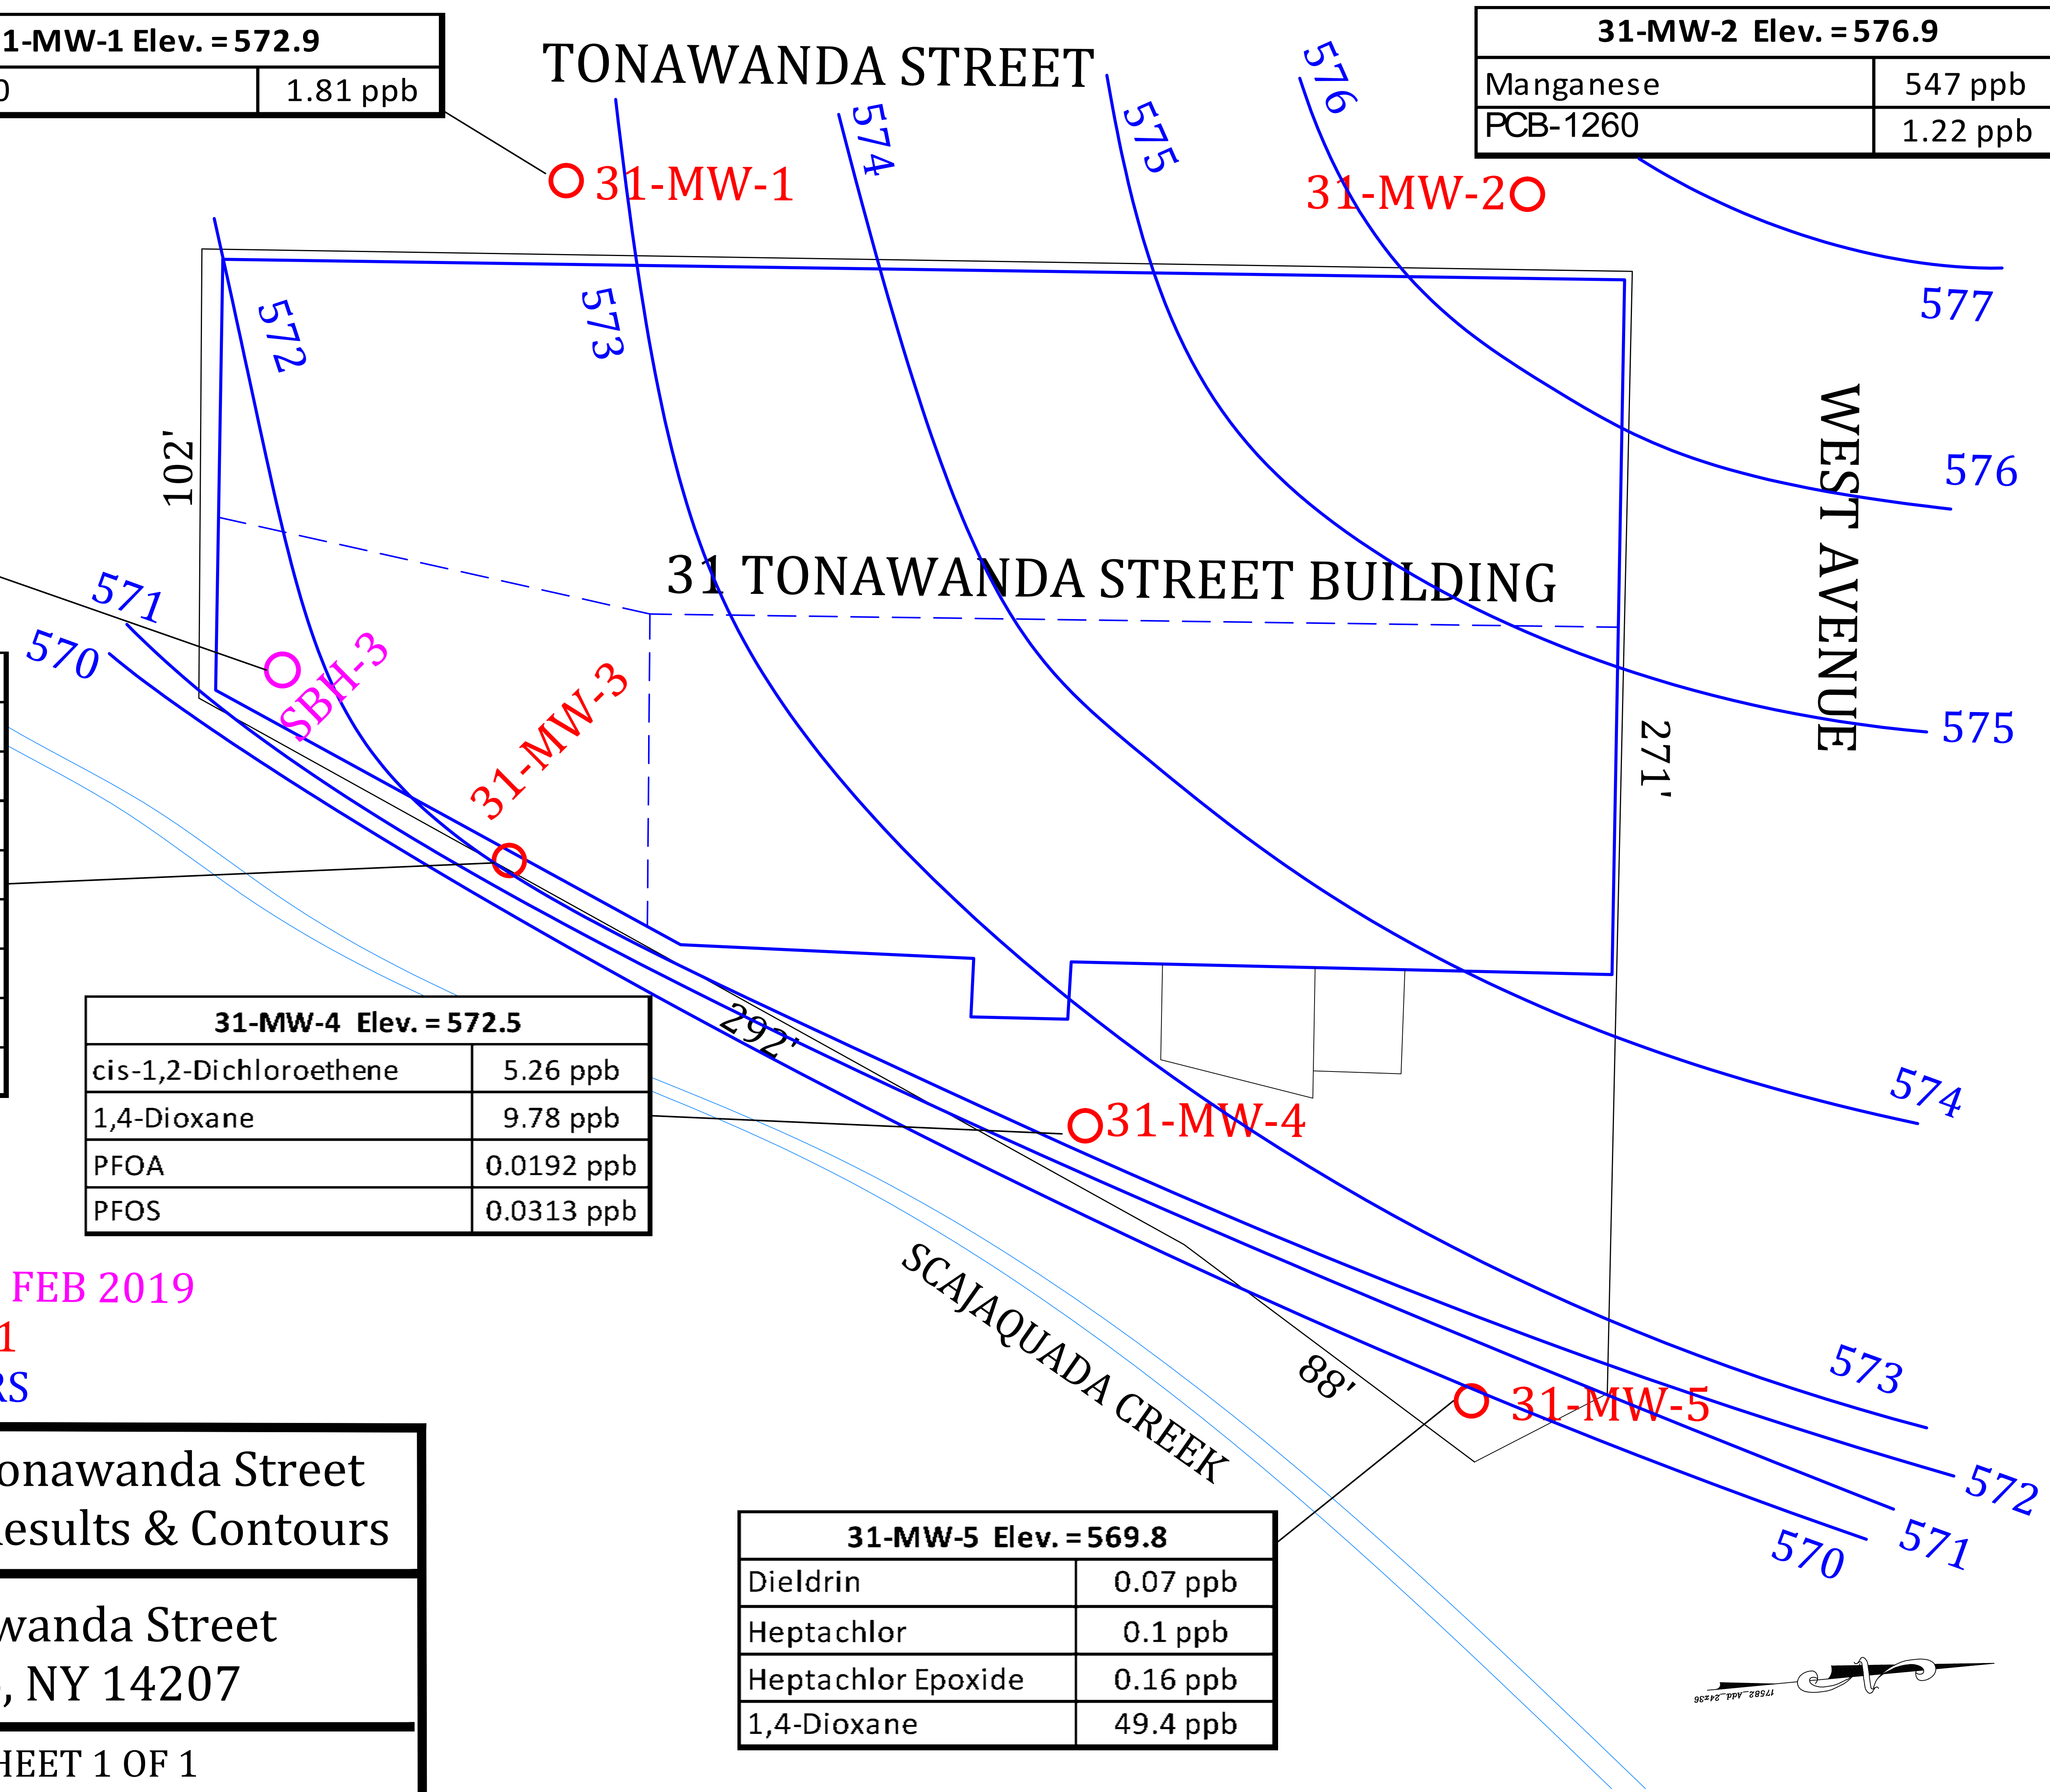
1270 Niagara Street Buffalo, NY 14213 716.249.6880 be3corp.com	Figure 6: 31 Tonawanda Street Groundwater Results & Contours	
	31 Tonawanda Street Buffalo, NY 14207	
08-06-2019	SCALE: N/A	SHEET 1 OF 1

31-MW-5 Elev. = 569.8	
Dieldrin	0.07 ppb
Heptachlor	0.1 ppb
Heptachlor Epoxide	0.16 ppb
1,4-Dioxane	49.4 ppb

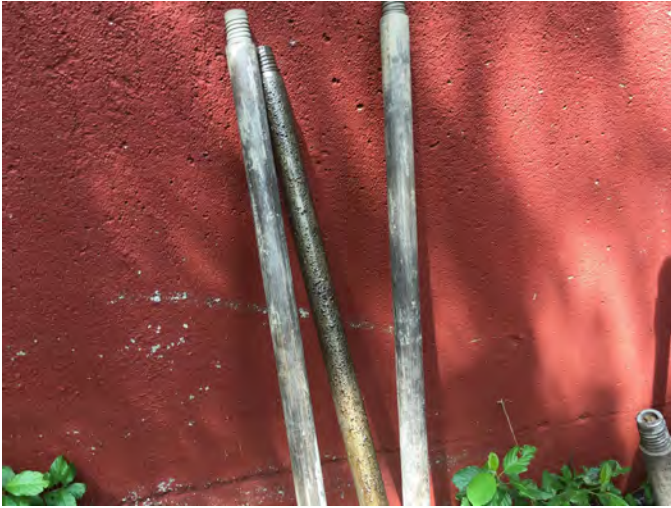
21. Product found on probe rods after BH-1 boring.

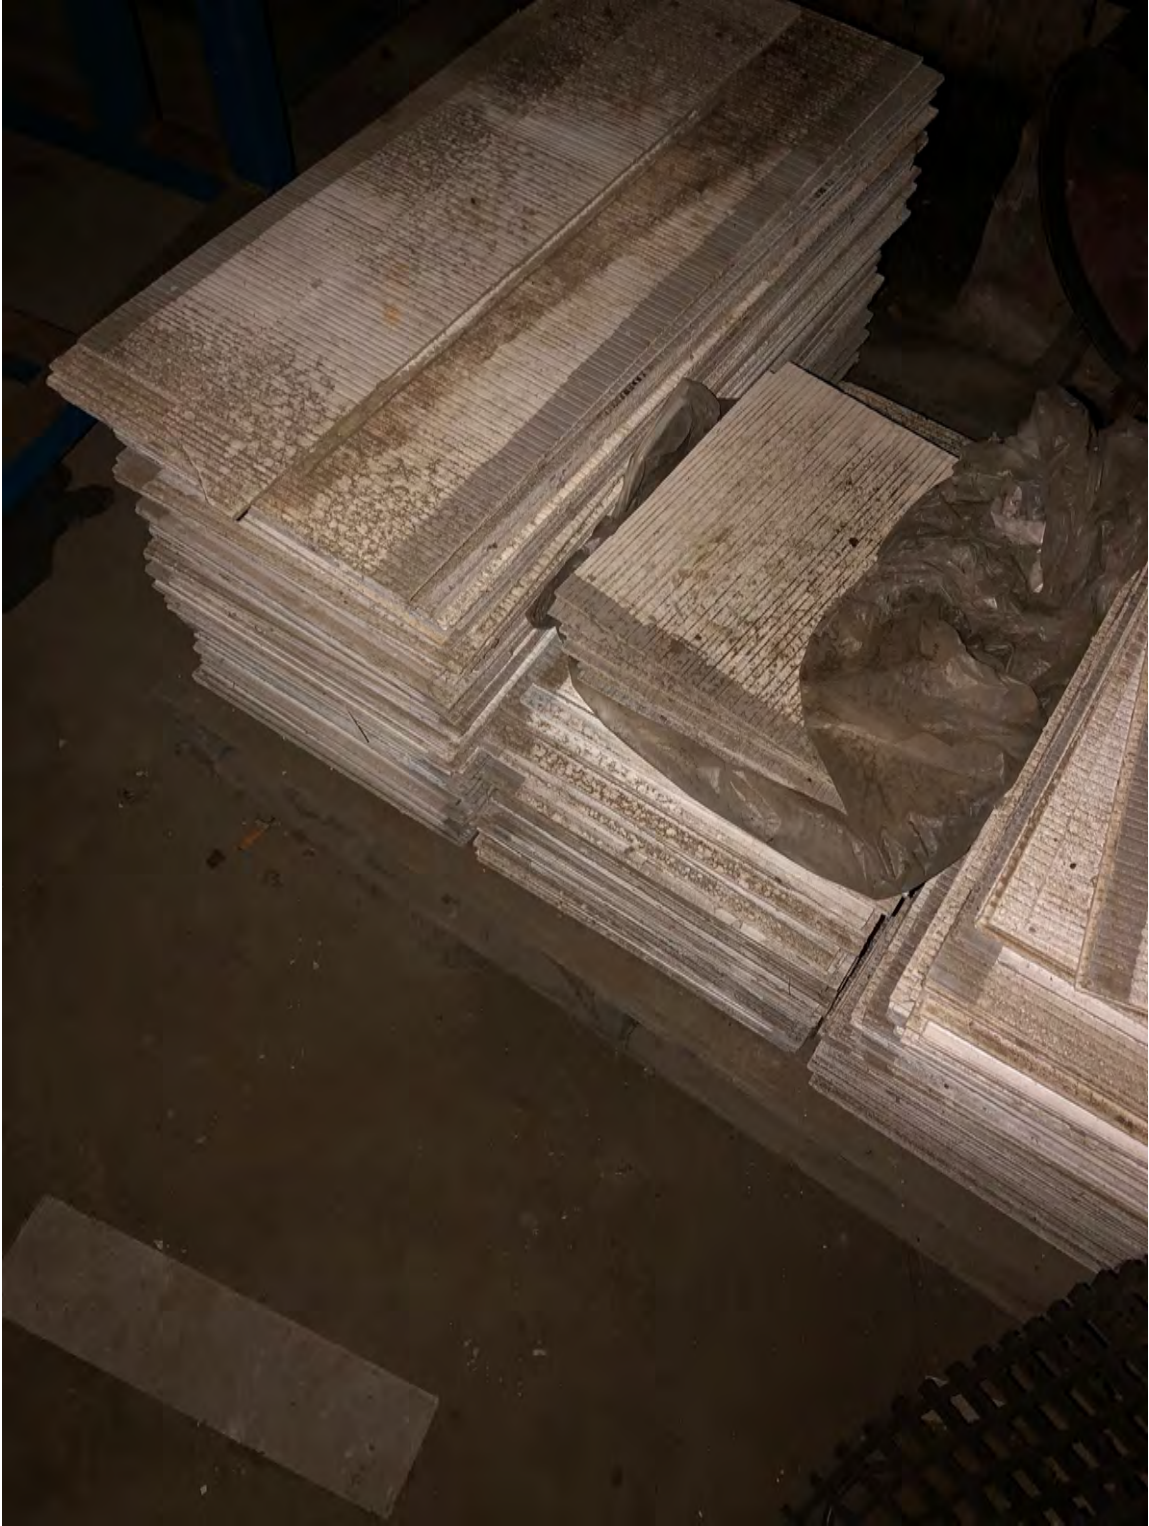
The results of the ACM survey indicated the presence of ACM in the building in a number of materials such as transite panels/siding, window glazing, wiring, etc. (see complete list in **Appendix F**). Sampling of window caulking for PCB content indicated that the material sampled was found to be below the 50-ppm threshold for PCB's by laboratory analysis. A review of the X-Ray florescence (XRF) instrument results indicates that LBP is present and shows deterioration on interior and exterior building components in the building. There are approximately 478 PCB containing light ballasts in the building that will have to be properly disposed of if remove during renovation.

Transite Siding Stacked on a Pallet

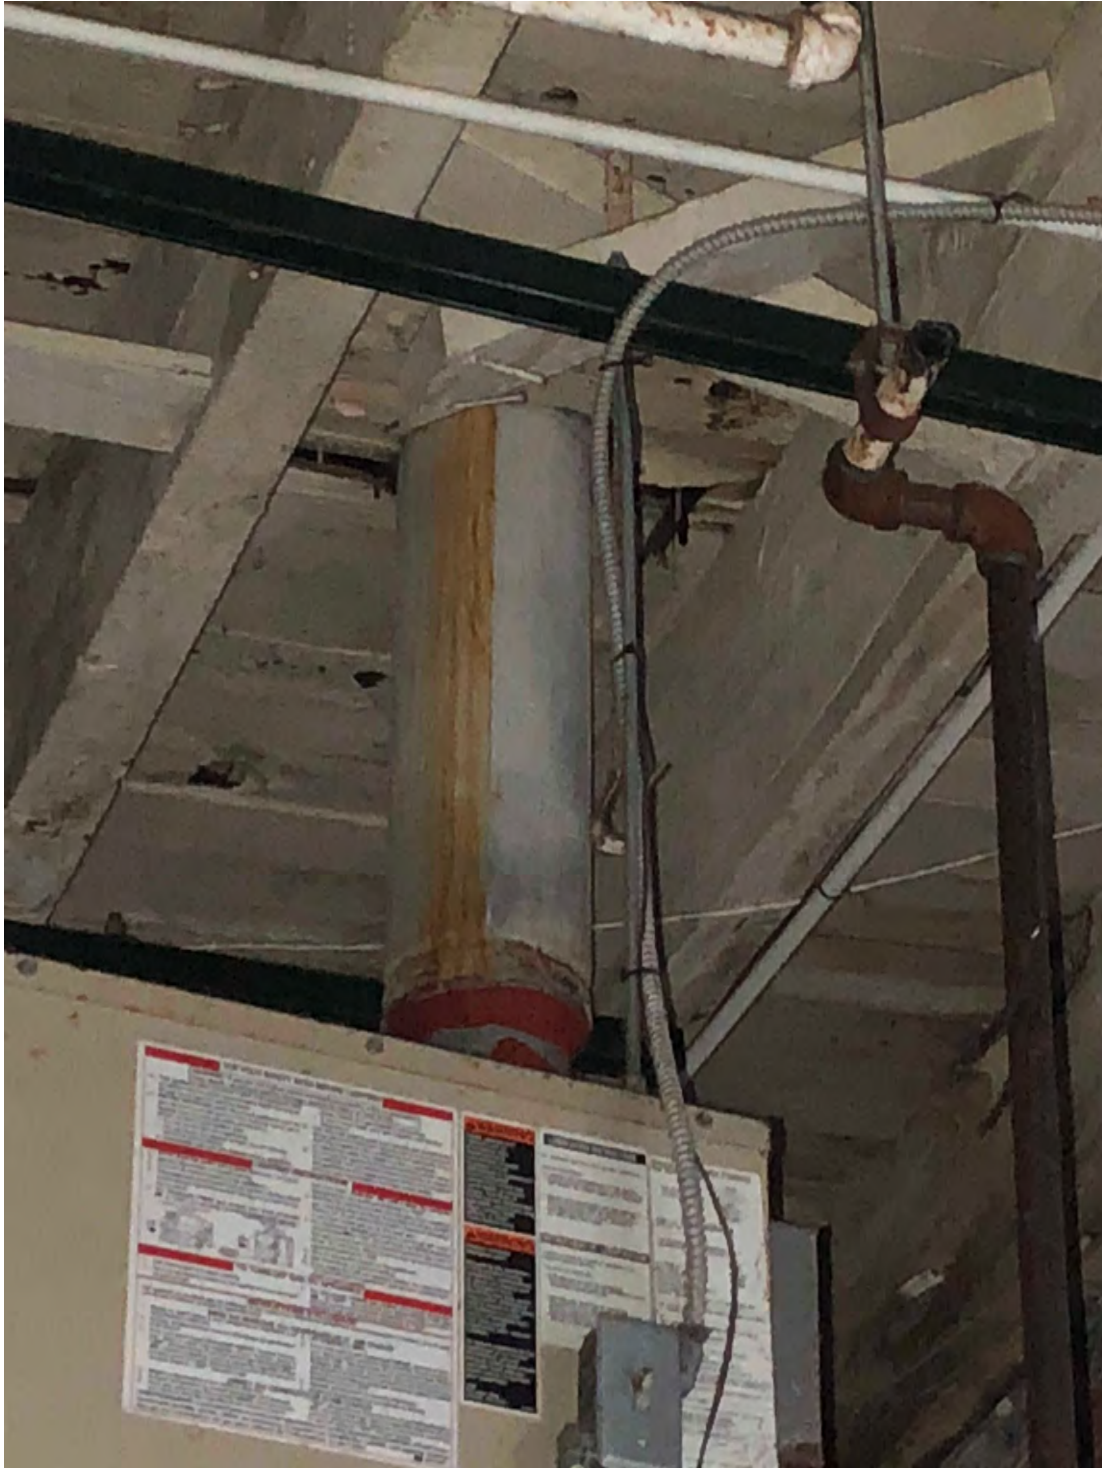
Transite Pipe

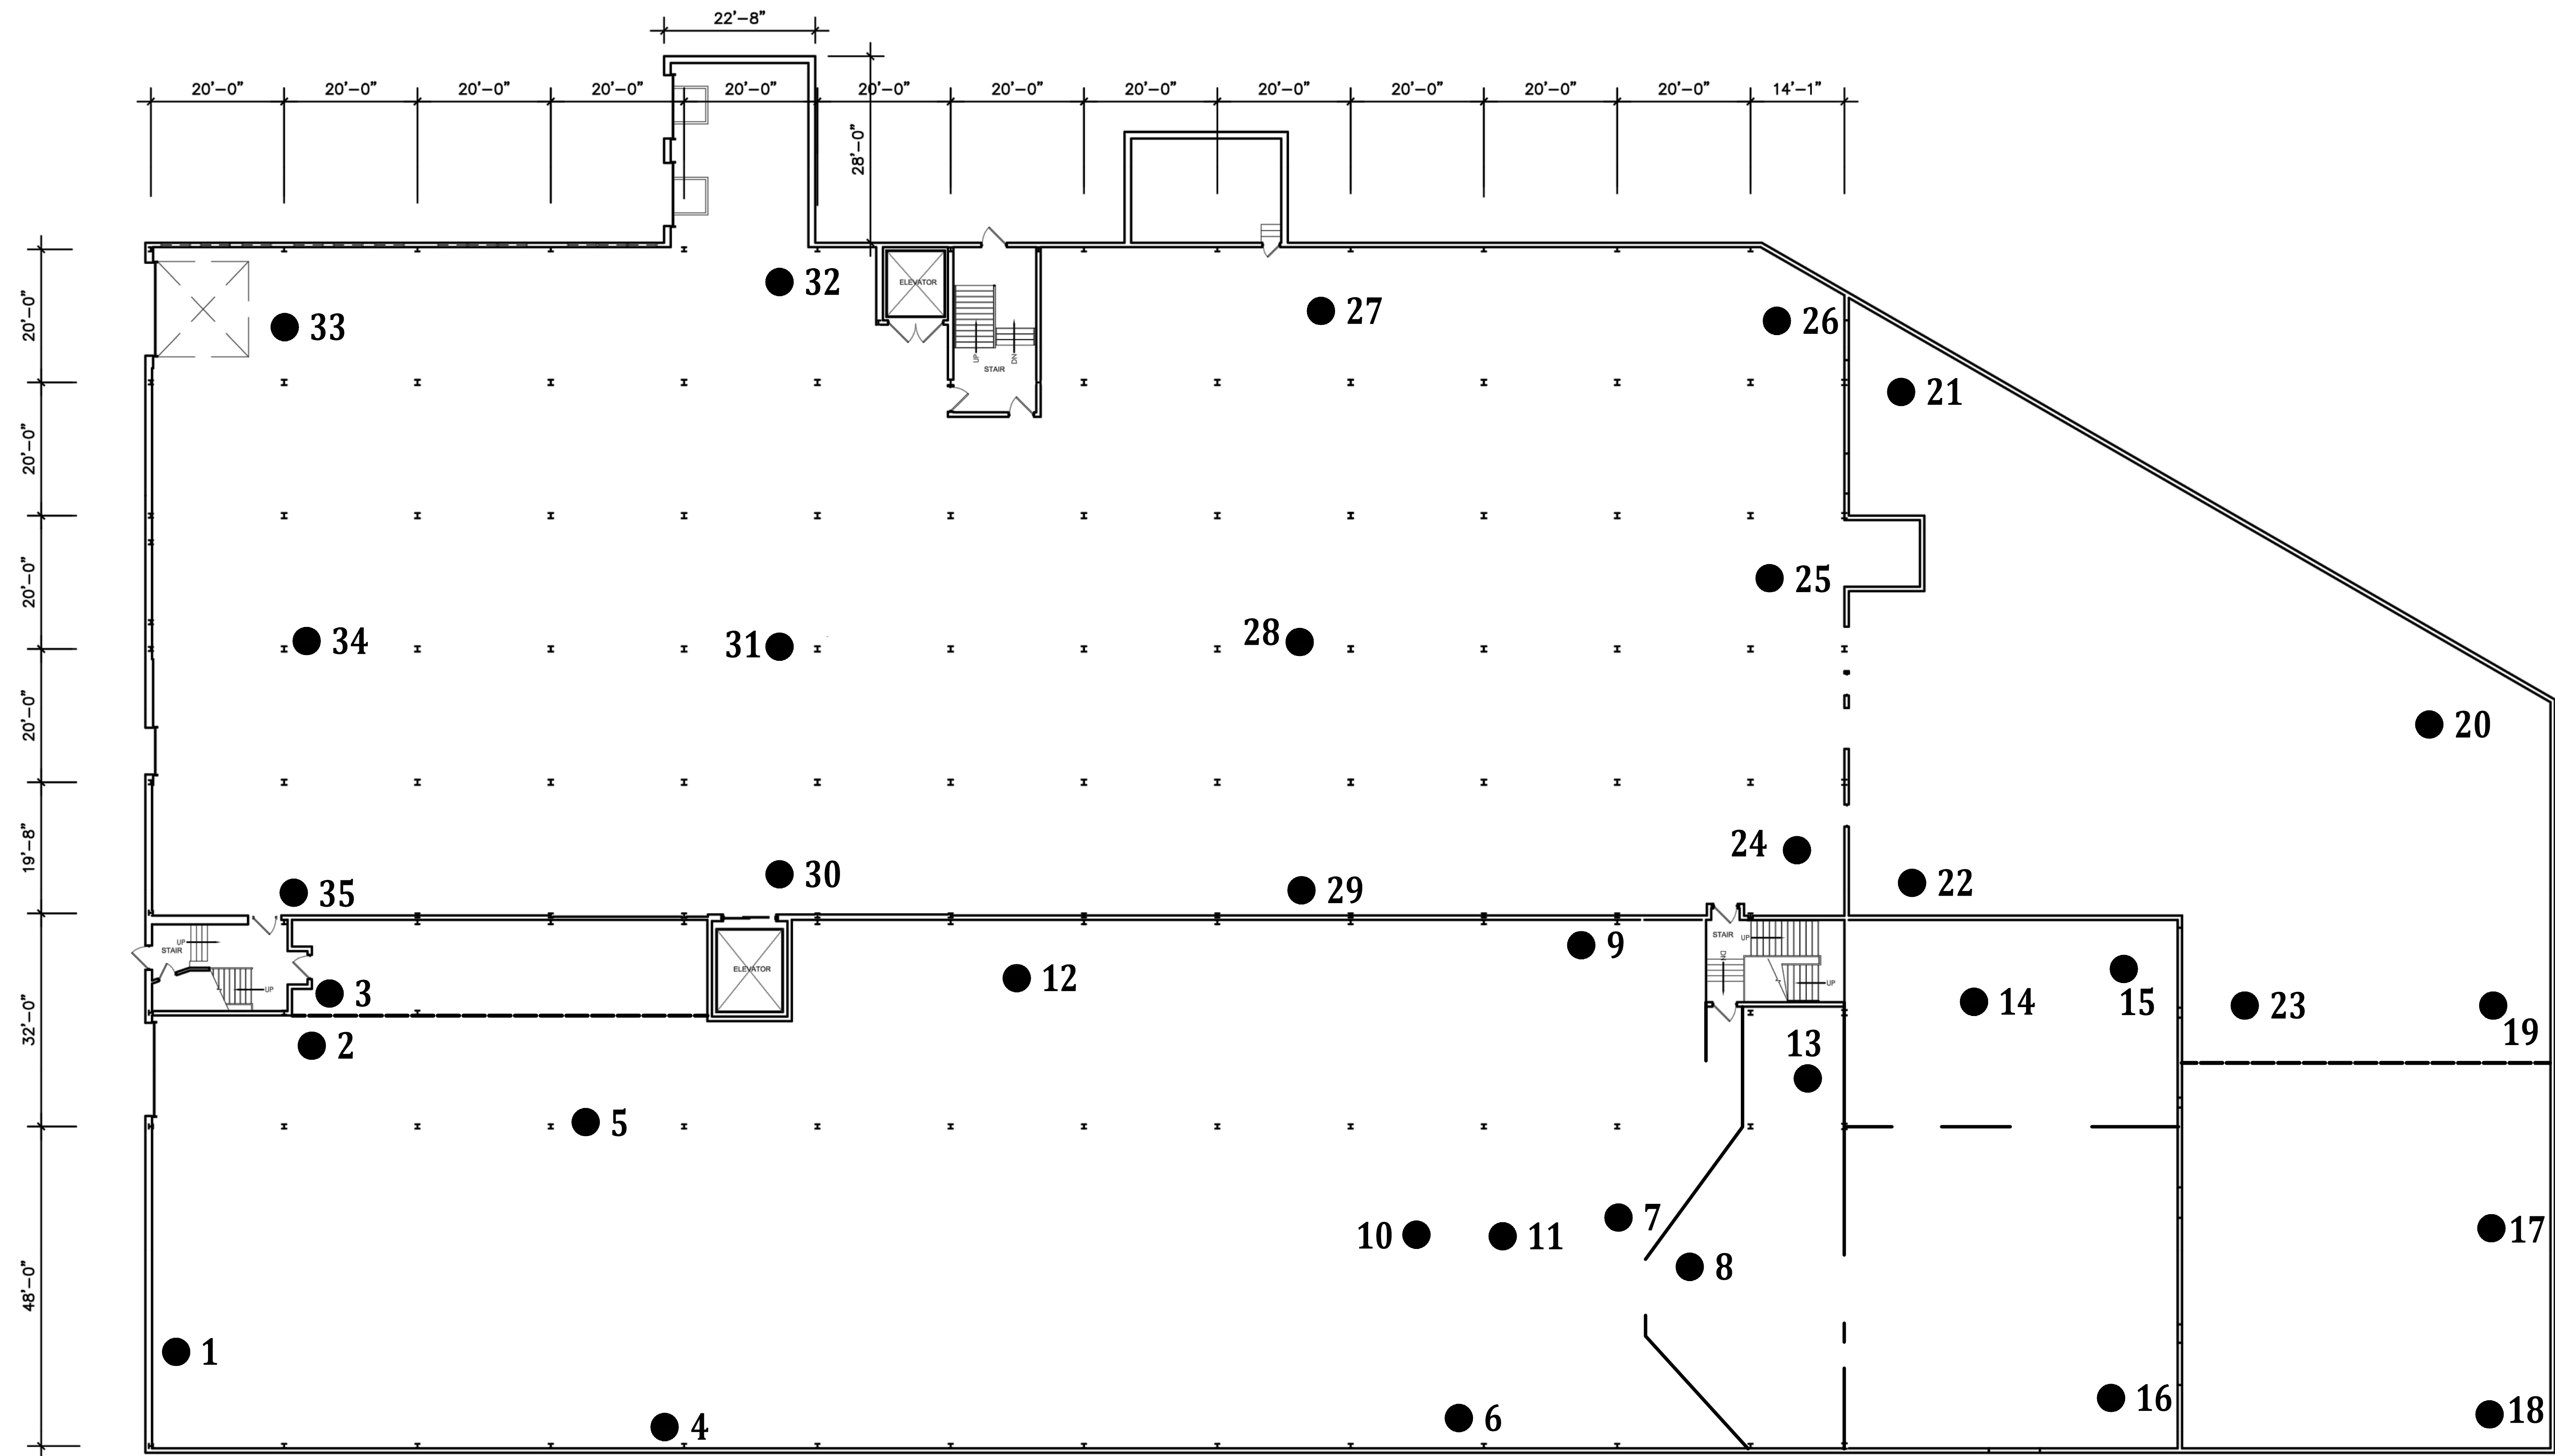
DIAGNOSTICS:
 BASEMENT: NO DATA DUE TO WATER BELOW SLAB

DIAGNOSTICS:
 HIGH BAY AREA:
 SP4 FESTA FORCE WC=2.48" SP5 FESTA FORCE WC=2.52"
 1: -0.167 6: -0.010
 2: -0.004 7: -0.010
 3: -0.004 8: 0.000
 4: -0.001 9: -0.009
 5: -0.004 10: -0.088
 11: -0.062
