**SOIL VAPOR INTRUSION
INVESTIGATION
INSPECTION REPORTS**

INSPECTION REPORT

Site Number: C915299A

Site Name: 31 Tonawanda Off-site

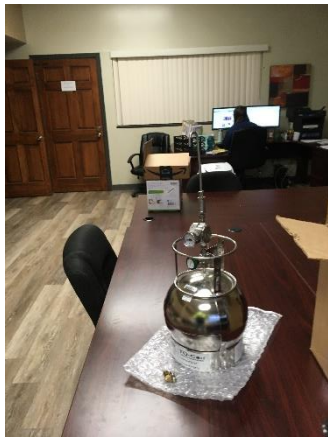
Image 2: Indoor Air Summa Canister
Sample Location: Room #2 (Office)

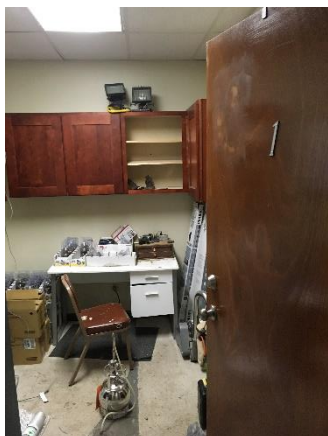
7:25 – The hole for the first sub-slab canister was drilled across the hall from the front office in Room #1. The room appears to be a storage room that is attached to the garage; the room is heated. The thickness of the concrete slab appears to be 6 to 8 inches as a longer drill bit was needed to drill through the slab.

Image 4: Sub-slab Summa Canisters
Sample Location: Room #1

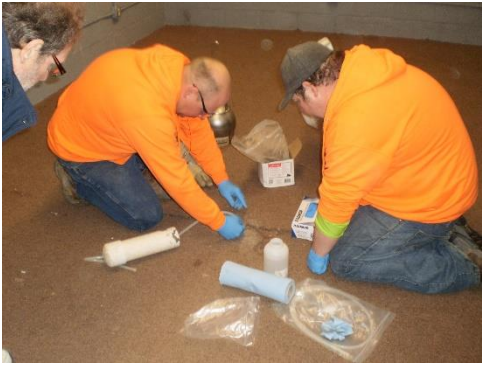
7:40 – A second sub-slab hole was drilled in Room #10. Room #10 is located in the middle of the building complex. Two (2) canisters were placed next to one another on the floor of Room #10; one acting as the duplicate. The thickness of the concrete slab was approximately 6 inches. The material below the slab appeared to be a silty clay.

Image 6: Installation of Sub-slab Summa Canisters
Sample Location: Room #10

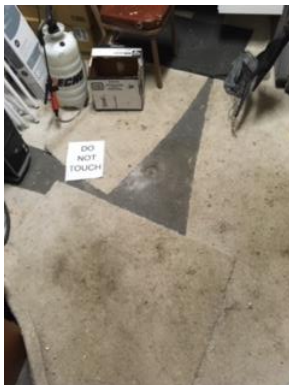
Image 10: Room #1

Images 10 -12: Repaired sub-slab holes

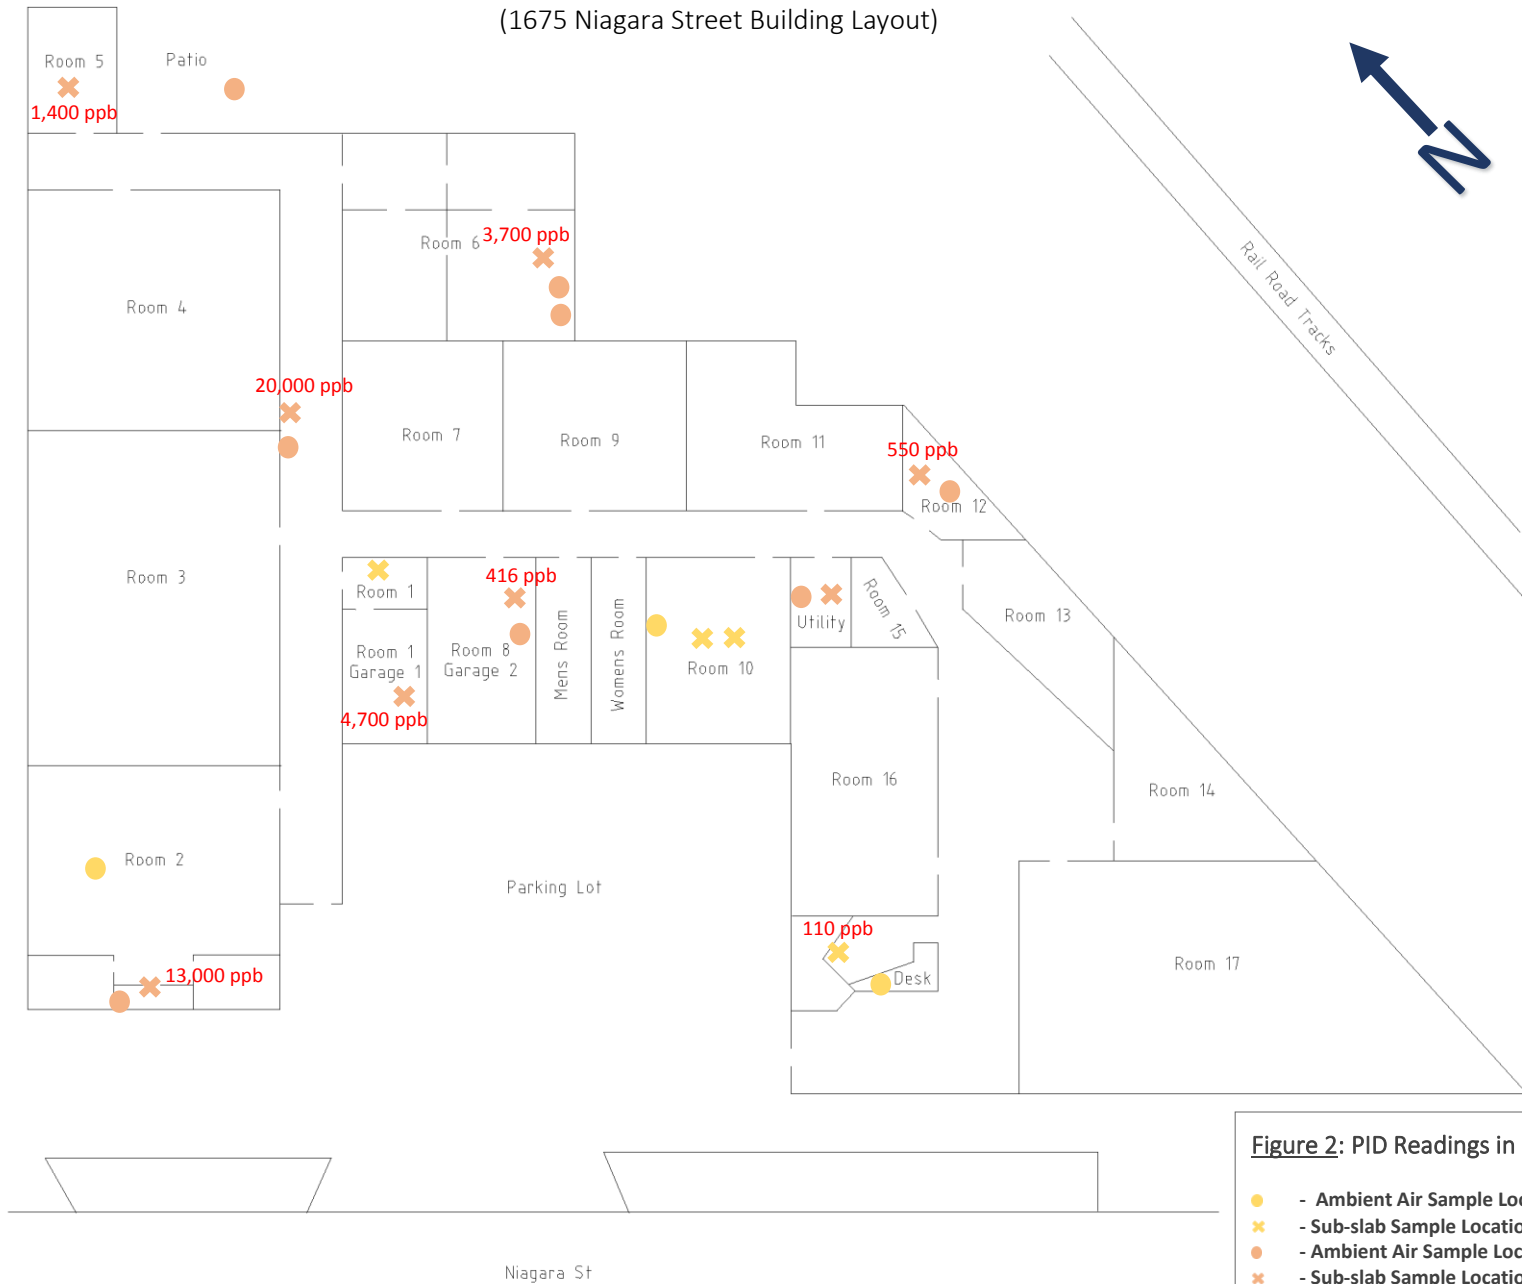
Figure 2: PID Readings in Sub-slab Holes

from both holes, the hole on the south side of the hallway displayed a reading of 1,500 ppb while the hole on the north side of the hallway displayed a reading of 20,000 ppb. Based on the elevated PID readings, a sub-slab canister was installed in the hole on the north side of the hallway. An ambient air canister was placed in the main hallway about 2' off the ground next to an air return.

PID Readings for Sub-slab Holes in RED

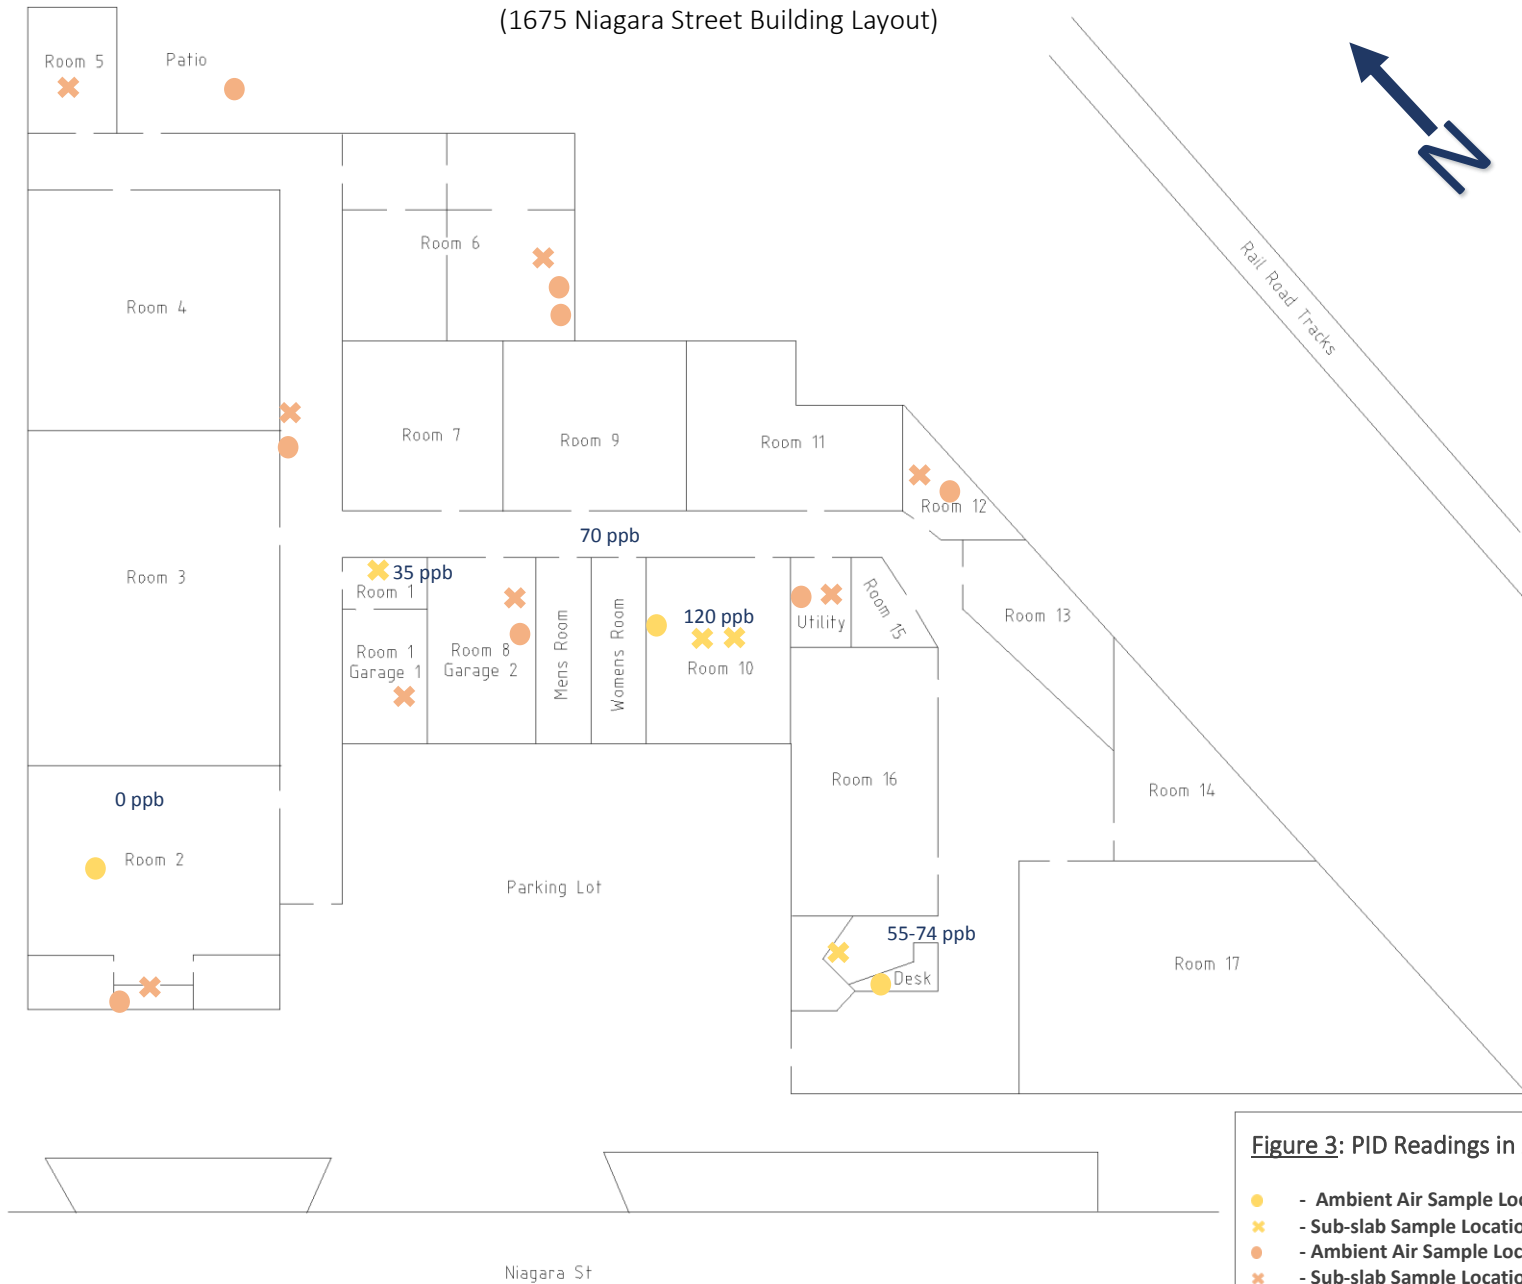
Figure 3: PID Readings in Ambient Air

- - Ambient Air Sample Location (March 2020)
 - ✕ - Sub-slab Sample Location (March 2020)
 - - Ambient Air Sample Location (April 2020)
 - ✕ - Sub-slab Sample Location (April 2020)
- PID Readings for Ambient Air in BLUE**

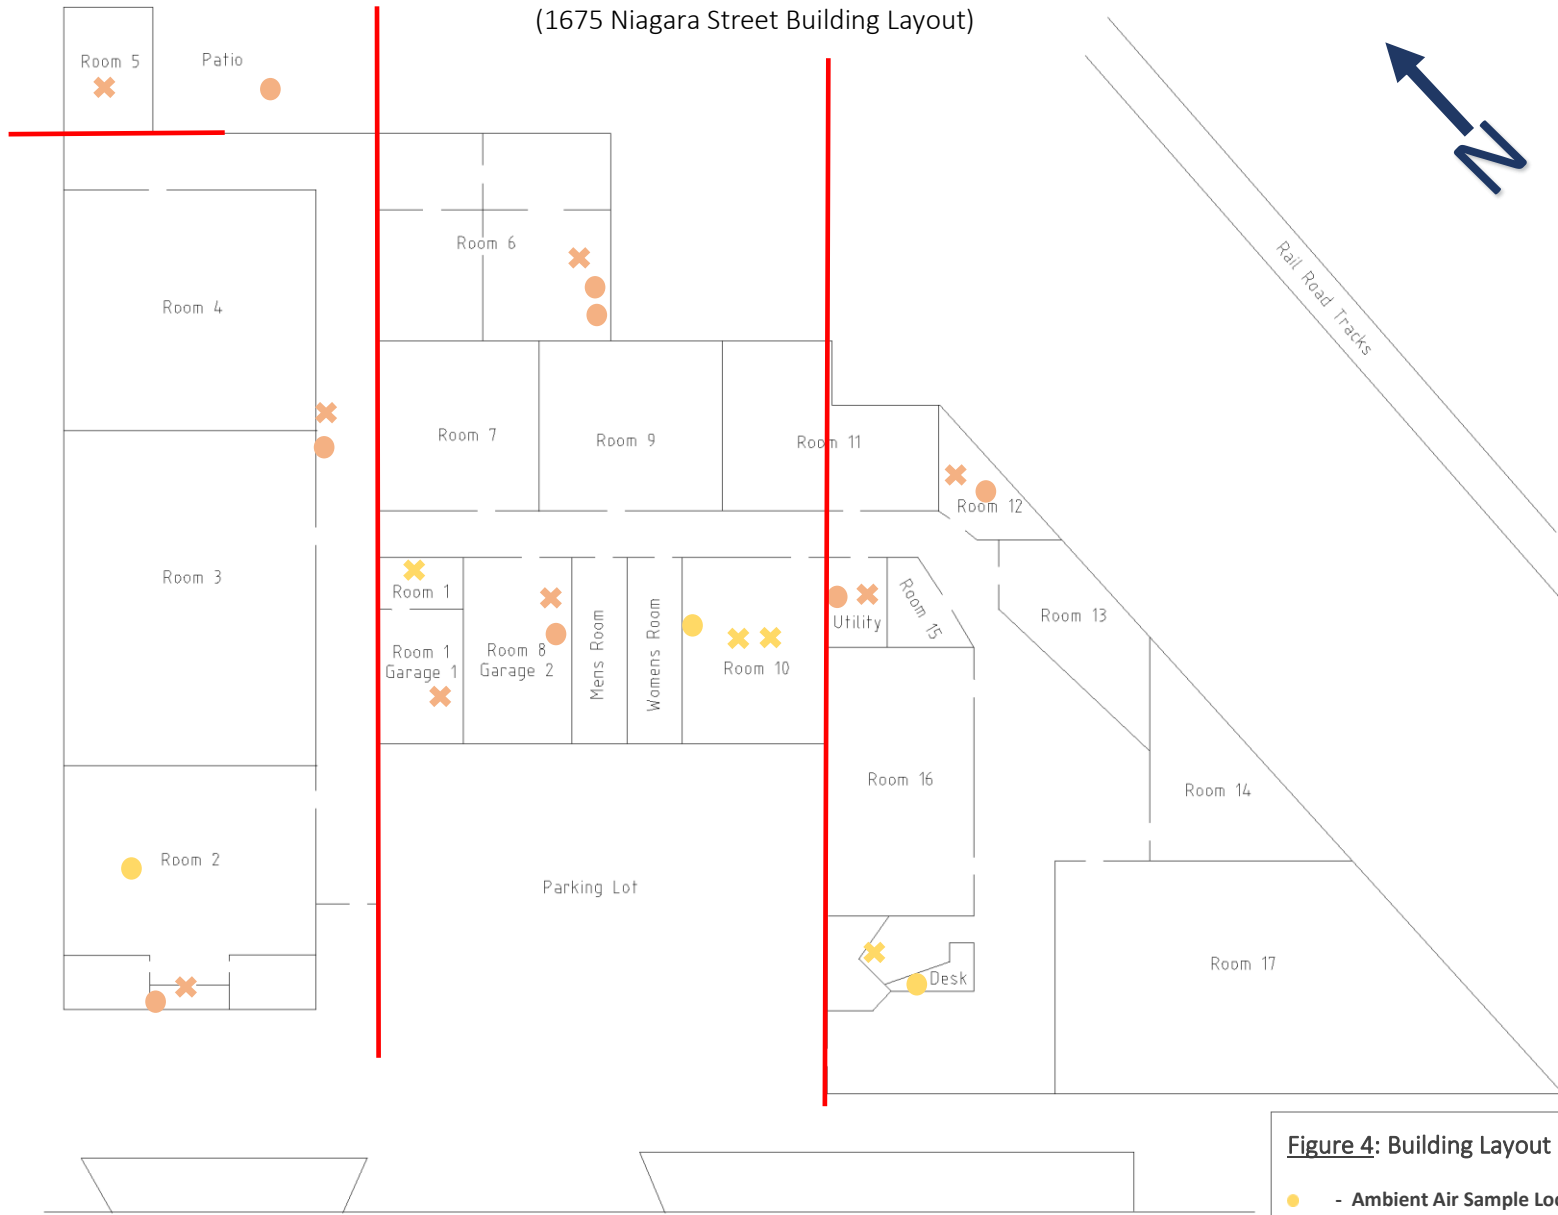
Figure 4: Building Layout

- All suction points for the sub-slab sample locations were inspected and tested for leaks.
- Apart from Garage 1, PID readings were not elevated outside the sub-slab holes; readings only spiked near the holes.
- Based on the layout of the building, the building complex appears to be composed of three separate buildings along with a shed (see Figure 4).

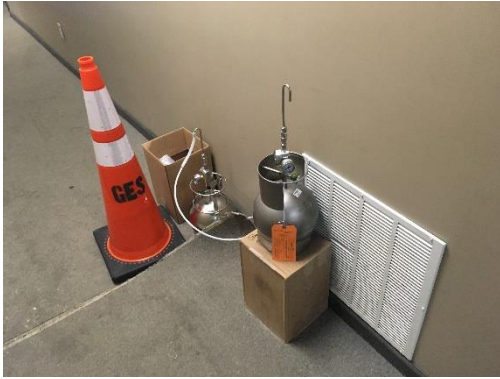
0730 – The second sub-slab sample location was in the main hallway between Room #3 and Room #7. Two holes were advanced for this sample location. The first hole was drilled on the south side of the hallway down to the furthest extent possible. The 12" drill bit did not break through the concrete pad. It was suspected that the drill bit may have gone through a footer, so another hole was advanced on the north side of the hall. On the north side the 12" bit did not break through the pad. PID readings were gathered

Image 6: Summa Canisters
Sample Location: Main Hallway

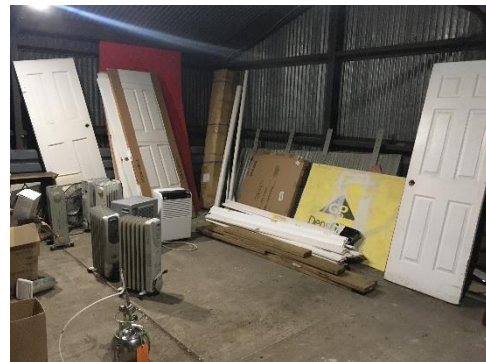
0830 –The door to Room #5 is on an outer wall. The door opened to a shed that must have been built sometime after the building. A significant step up (6") exists between the hallway and Room #5". The shed appeared to be used for storage of wheelbarrows, hand tools, and other outdoor equipment. The thickness of the slab in Room #5 was 6" and PID readings were 1,400 ppb in the hole. A sub-slab canister was installed.

Image 11: Shed structure
Sample Location: Room #5

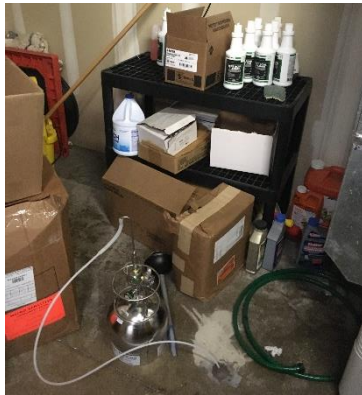
0910 – A sub-slab hole was advanced through the slab (6" thick) of the Utility Room across from Room #11. An ambient air canister was placed on a utility cart, about 4' above the ground surface. The Utility Room contained the furnace along with several cleaning supplies, insect repellants, and weed killers.

Image 14: Sub-slab Canister, Cleaning supplies
Sample Location: Utility Room

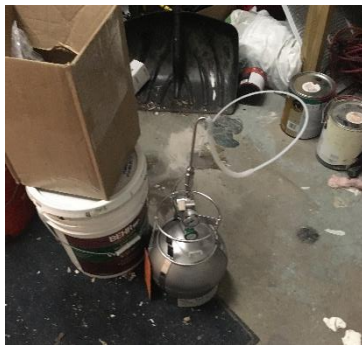
0930 – A sub-slab hole was advanced through the slab of the garage attached to Room #1. The slab was approximately 8" thick and the PID reading in the hole was 4,700 ppb. PID readings were observed in the room but not to the degree that was observed in the sub-slab hole. The garage attached to Room #1 contained several containers of paints, stains, and polyurethane. Garage 1 does have duct work vented in, but the garage did not appear to be heated. No indoor air canister was collected in Garage 1.

Image 16: Sub-slab Canister
Sample Location: Garage 1

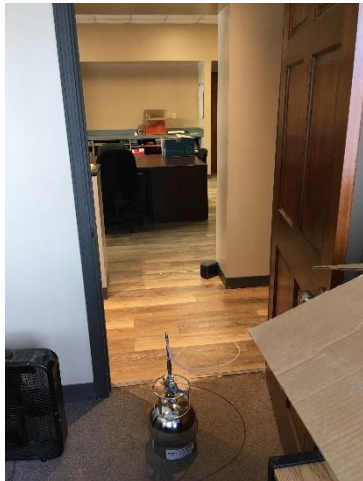
0945 – A sub-slab hole was advanced through the slab of the front office (Room #2), the slab was approximately 10" thick and the PID reading gathered from the hole was 13,000 ppb. An indoor air canister was installed on a desk, 3 ½' above the ground surface.

Image 20: Sub-slab Canister
Sample Location: Room #2 (Front Office)
