Remedial Investigation Report

**31 Tonawanda Street Off-Site Area
Buffalo, Erie County, New York
Site Number C915299A**

August 2023

New York State Department of Environmental Conservation
Region 9
700 Delaware Avenue
Buffalo, New York 14209

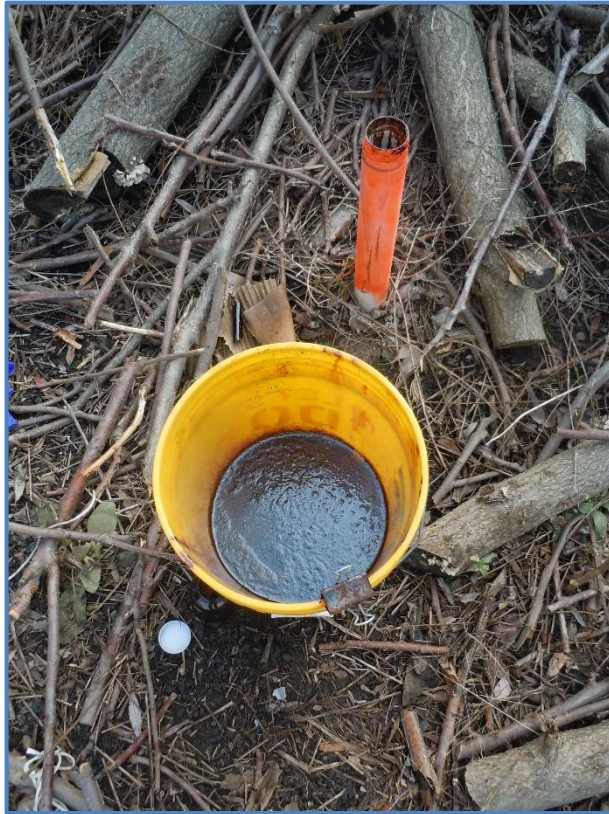
Figure 4-1. Photo showing the NAPL extracted from monitoring well 1660-MW-7 during sample collection. Photo taken by Glenn M. May on January 15, 2020.

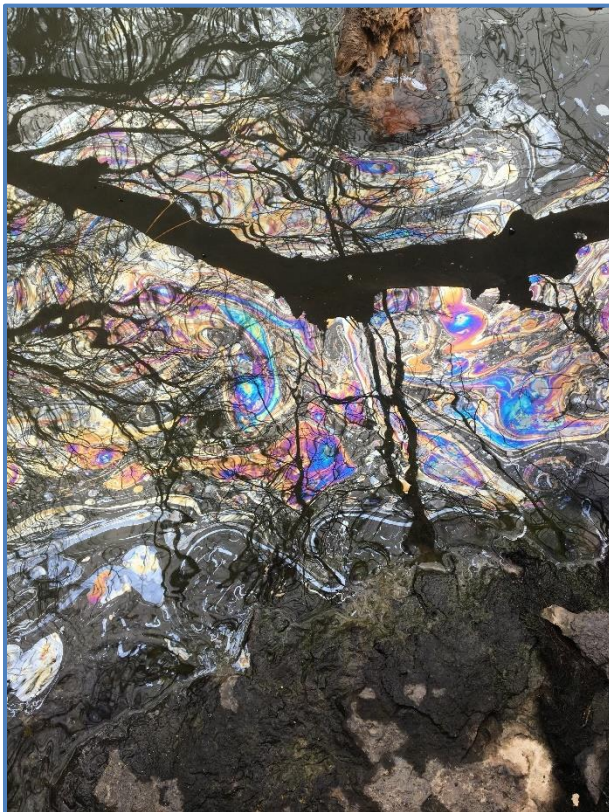
Figure 4-2. Photo showing the sheen that was generated on the Scajaquada Creek slip during the collection of sediment sample BSA-SED-1. View looking south. Photo taken by Glenn M. May on January 15, 2020.

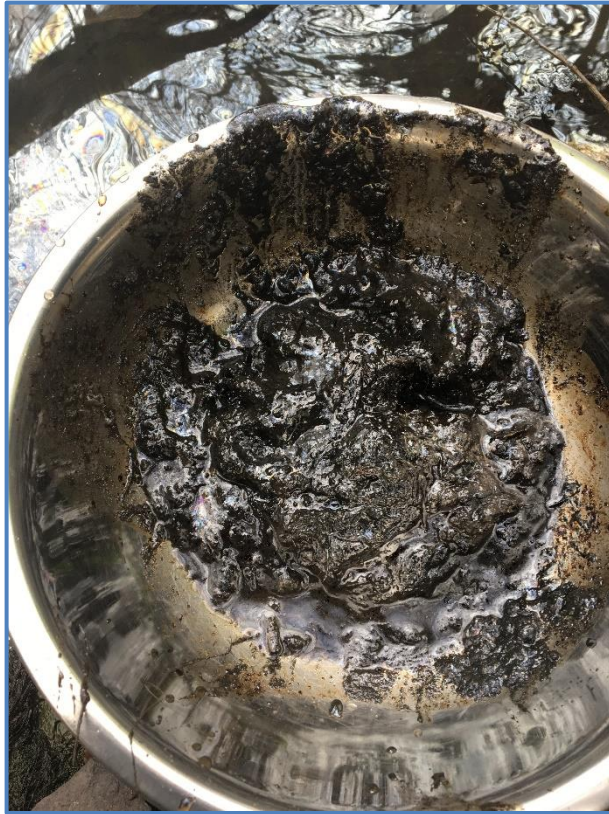
Figure 4-3. Photo showing sediment sample SED-1. Photo taken by Glenn M. May on January 15, 2020.

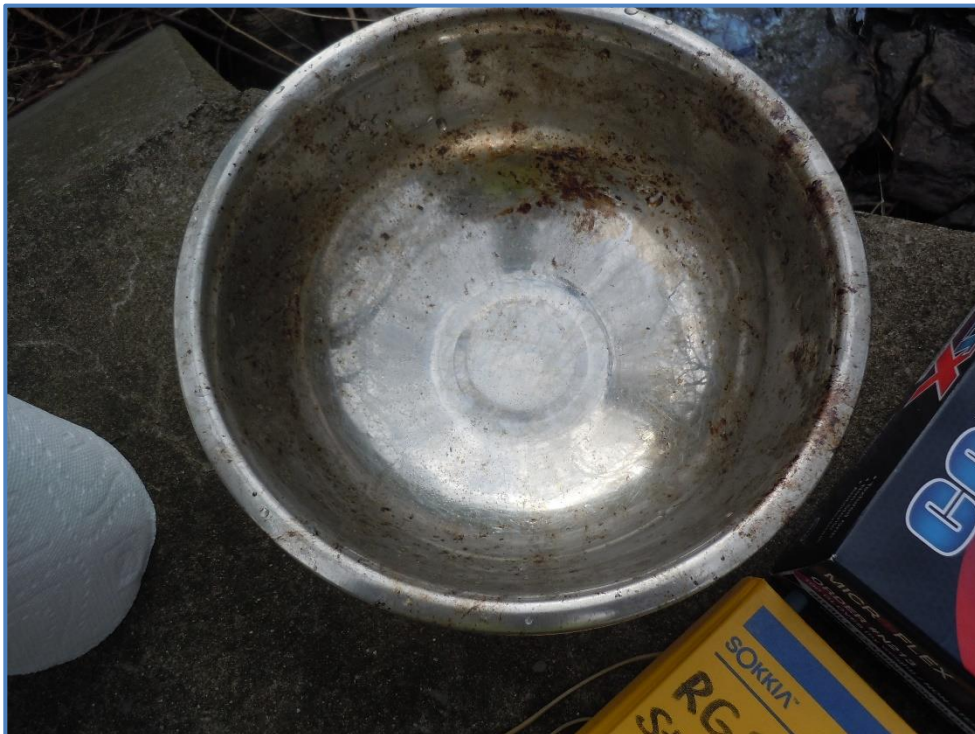
Figure 4-4. Photo showing the viscous, brownish black, sticky residue in the sampling bowl following the collection of sediment sample SED-1. Photo taken by Glenn M. May on January 15, 2020.

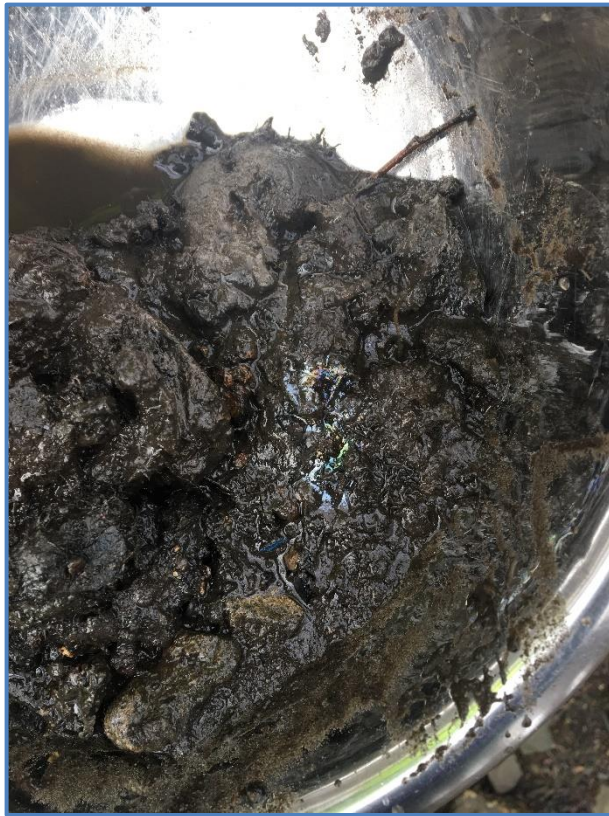
Figure 4-5. Photo showing the rainbow sheen on sediment sample SED-2. Photo taken by Glenn M. May on January 15, 2020.

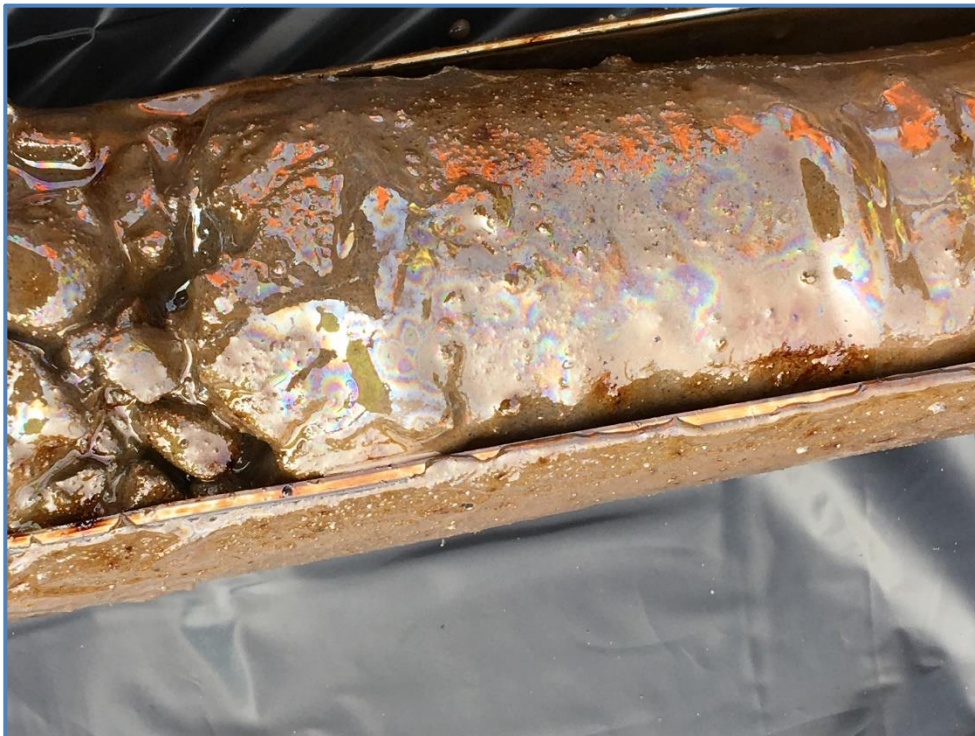
Figure 4-6. Photo showing NAPL and sheens in the gravelly sand deposit in soil boring 1660-MW-5R. Photo taken by Glenn M. May on September 14, 2020.

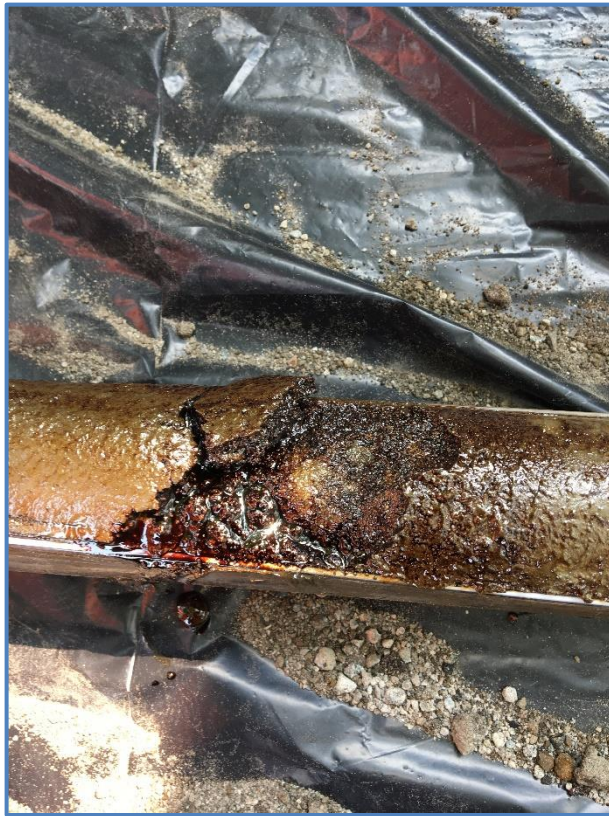
Figure 4-7. Photo showing NAPL in a sand seam in soil boring 1660-SB-1. Photo taken by Glenn M. May on September 16, 2020.

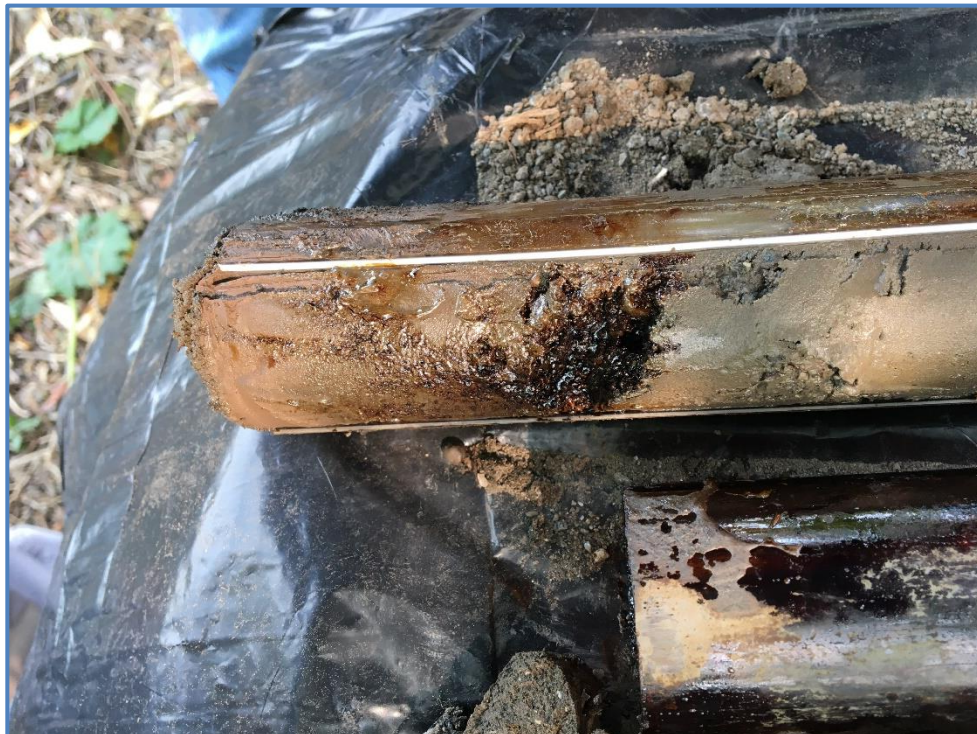
A thin seam of NAPL saturated sand with gravel was encountered at a depth of approximately 31.7 feet (Figure 4-8). Reddish-brown silty clay was observed below this seam at a depth of approximately 31.8 feet (Figure 4-8). A PID reading of 692.7 ppm was measured on the NAPL saturated sand and gravel seam from 31.7 to 31.8 feet depth.

Figure 4-8. Photo showing NAPL in a sand seam in soil boring 1660-MW-8. The underlying reddish-brown silty clay is also shown. Photo taken by Glenn M. May on September 16, 2020.

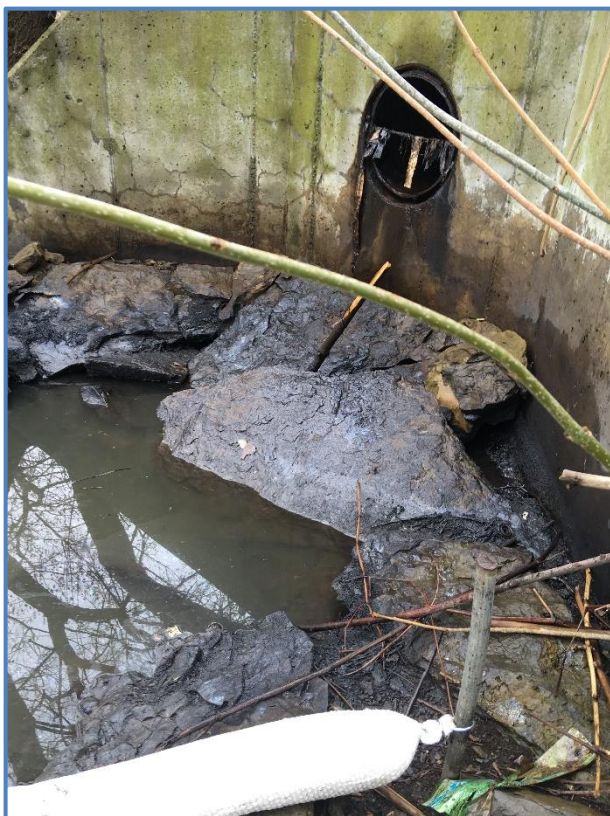
Figure 4-9. Photo showing the oily residue that coats the rocks at the Niagara Street pumphouse discharge area. Photo taken on May 3, 2019 by unknown.

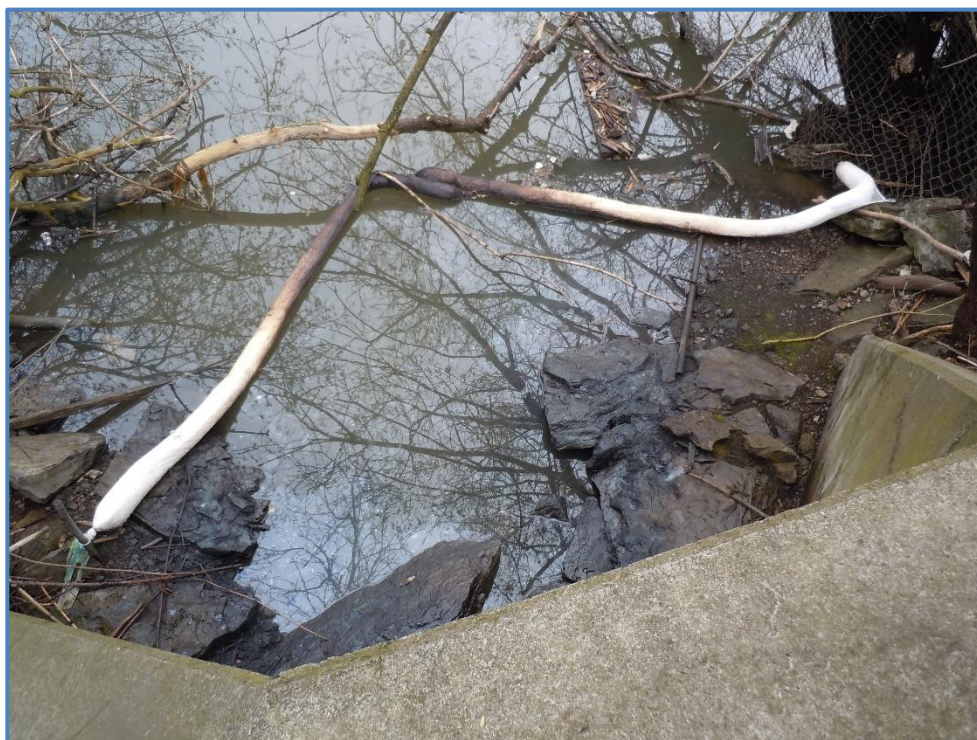
Figure 4-10. Photo showing the oil booms placed at the Niagara Street pumphouse discharge area to absorb any NAPL pumped into the creek. Photo taken on May 3, 2019 by unknown.

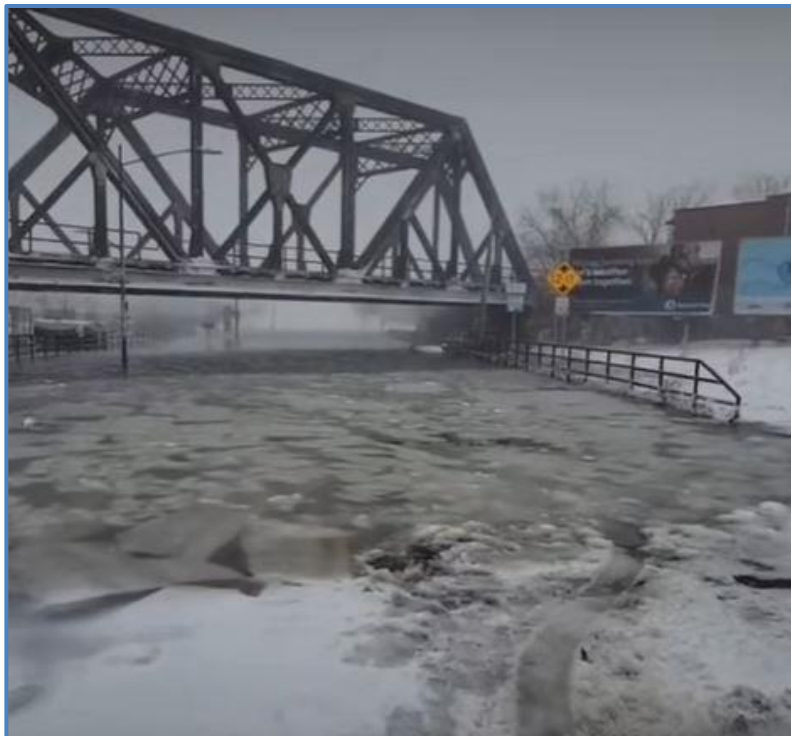
These seiche events can cause local flooding (Figure 5-15), rapid and intense erosion of the shoreline, and impede recreation on the lake. When ice is present, it can pile up and cause additional damage to the shoreline. During these seiche events, more wave energy is transferred to the lake bottom as larger waves reach the shoreline, resulting in greater movement of sediments (erosion) compared to calmer times of the year. This is a major concern when sediments in the area affected by the seiche are contaminated, as they are in the lower reaches of Scajaquada Creek.

Figure 5-15. Photo showing the flooding of Niagara Street during the December 2022 seiche event. Image captured from a Facebook video of the flood.
