PERIODIC REVIEW REPORT
for the
SILOS AT ELK STREET SITE
(SITE NO. C915309)

50 ELK STREET
BUFFALO, NEW YORK

May 2022

PERIODIC REVIEW REPORT

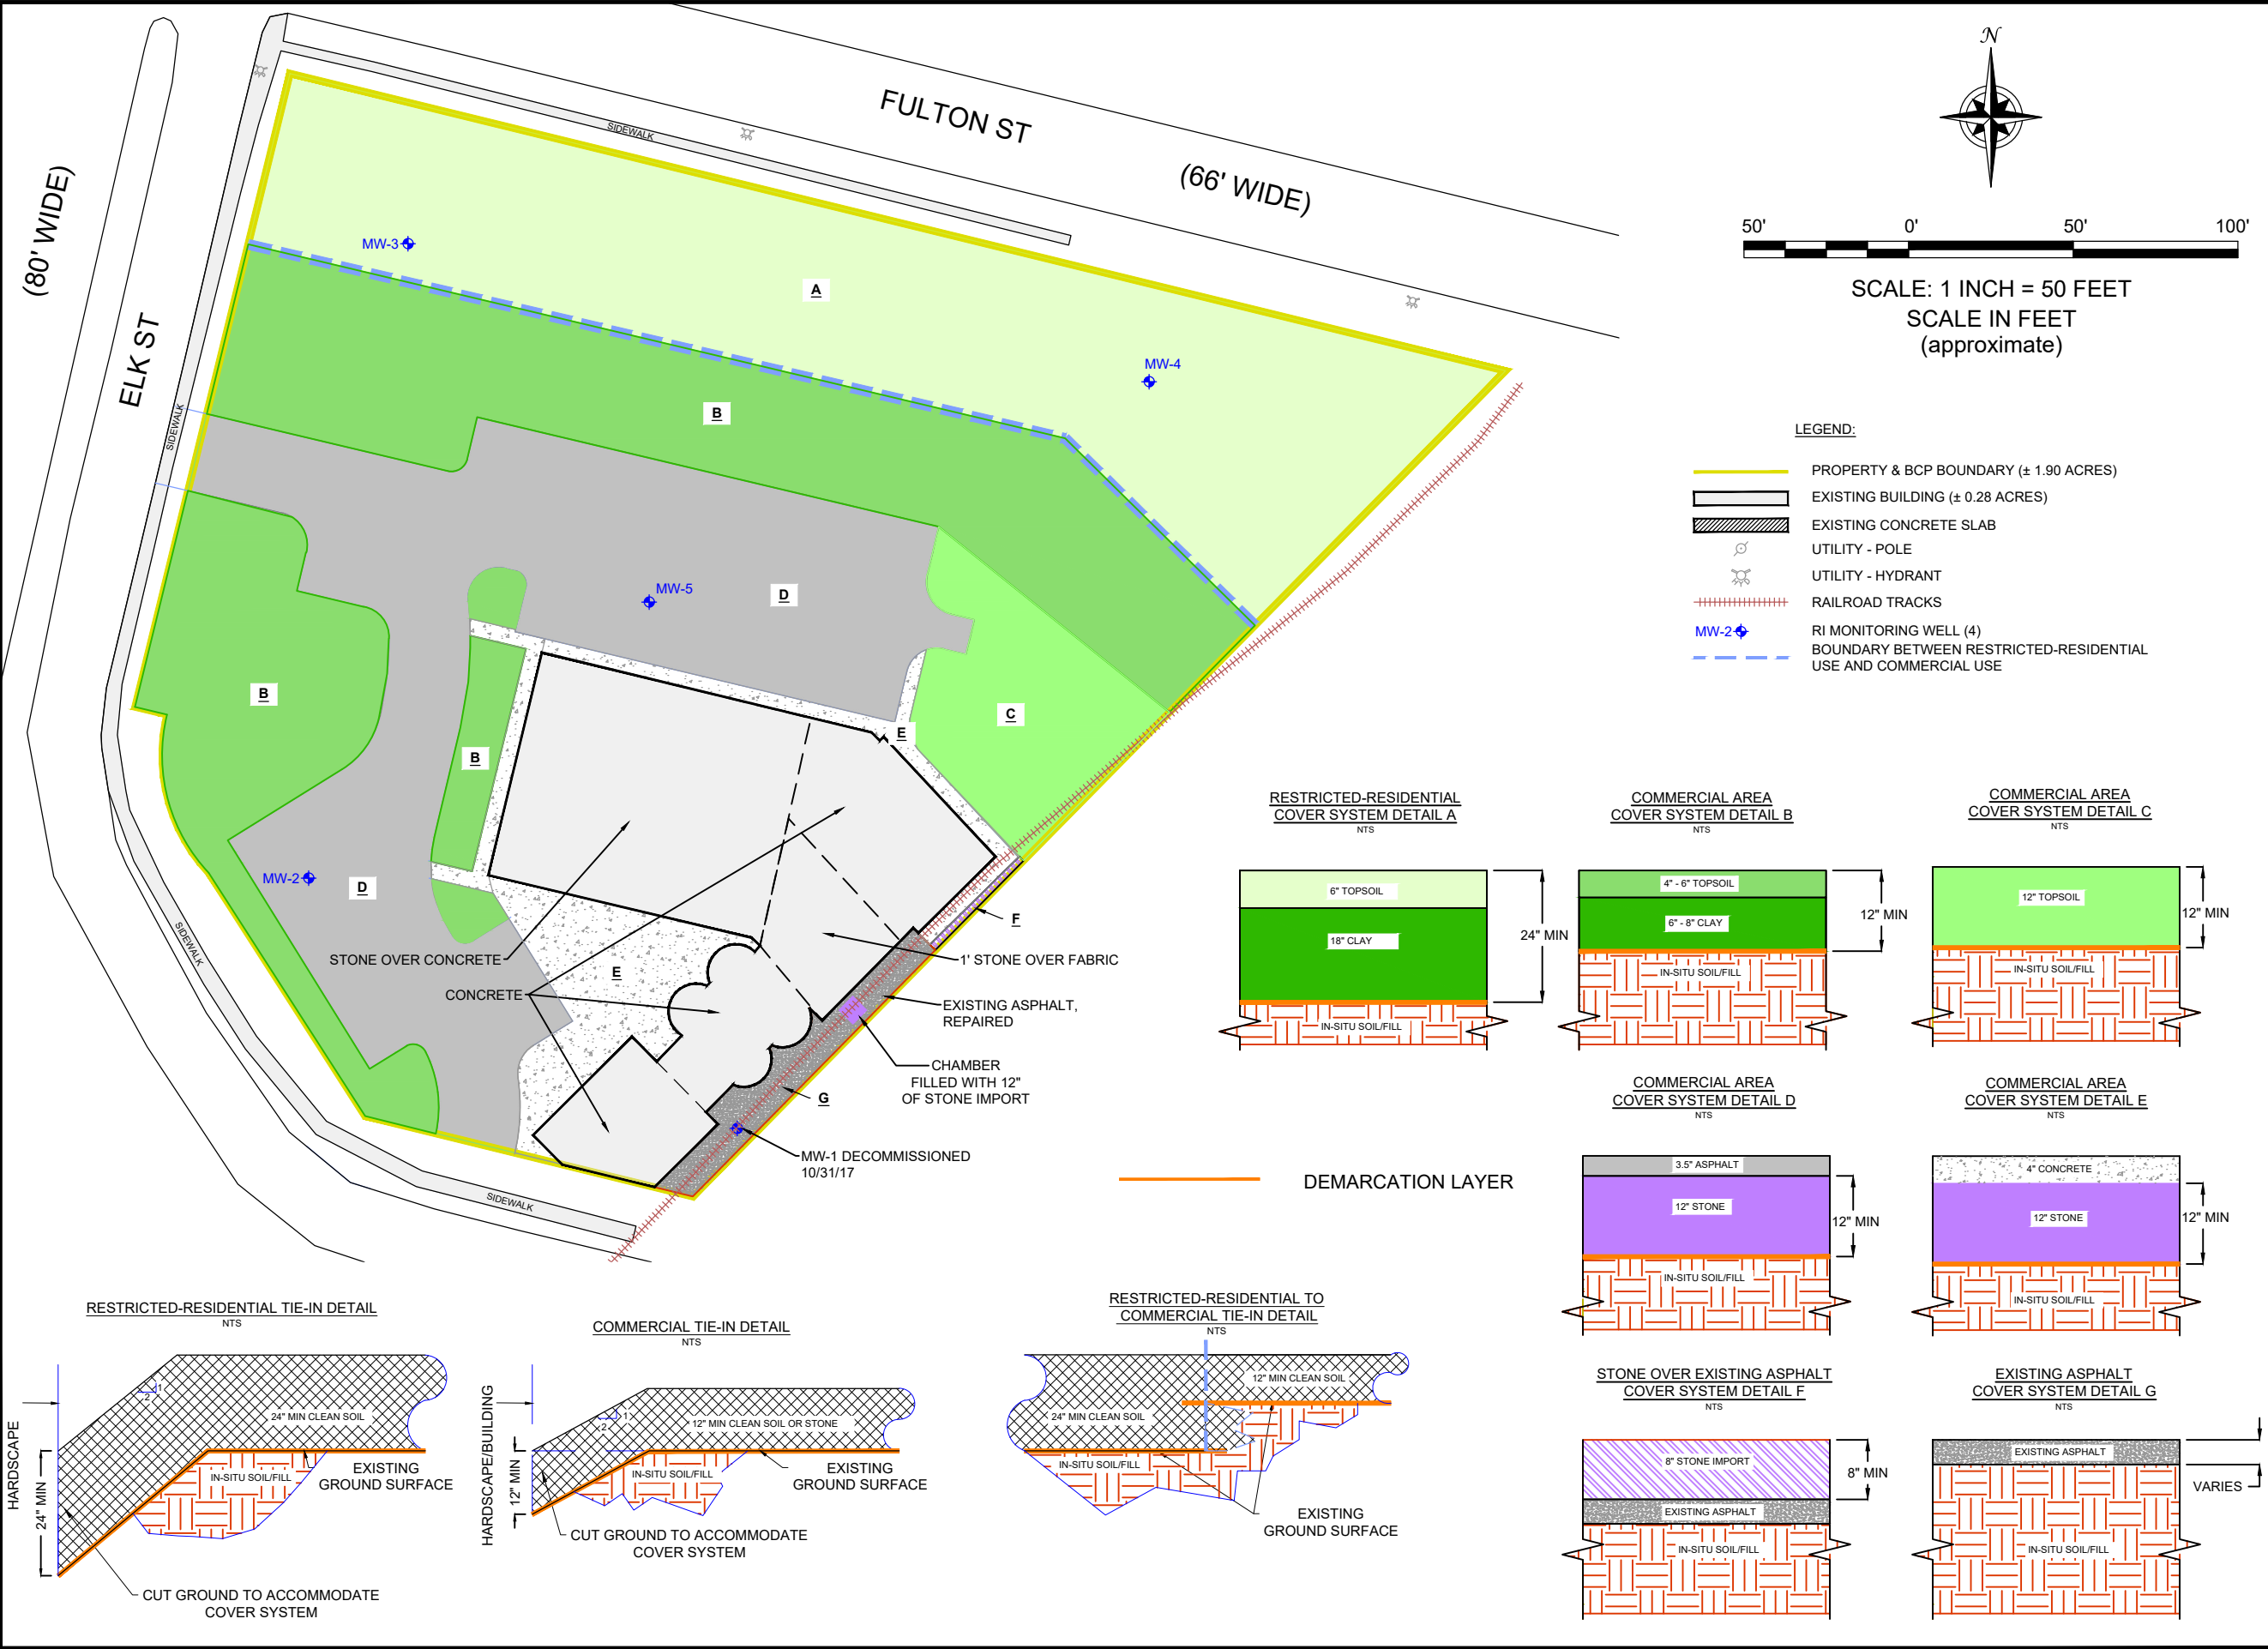
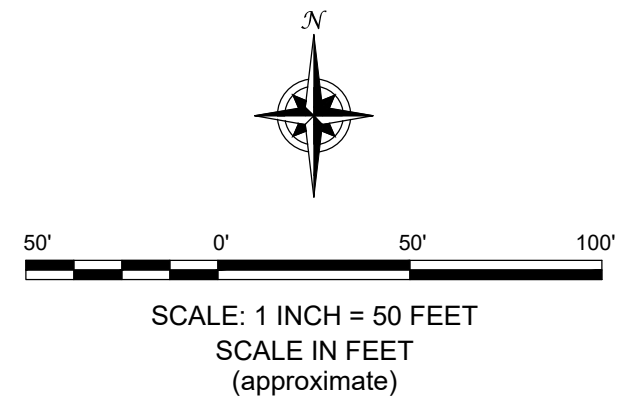
FIGURE 2

Final redevelopment of the Site included pouring concrete sidewalks along the northern, southern, and western sides of the building (previously 12-inches of stone cover). Figure 2 shows the current cover system layout and details.

COVER SYSTEM LAYOUT AND DETAILS
 PERIODIC REVIEW REPORT

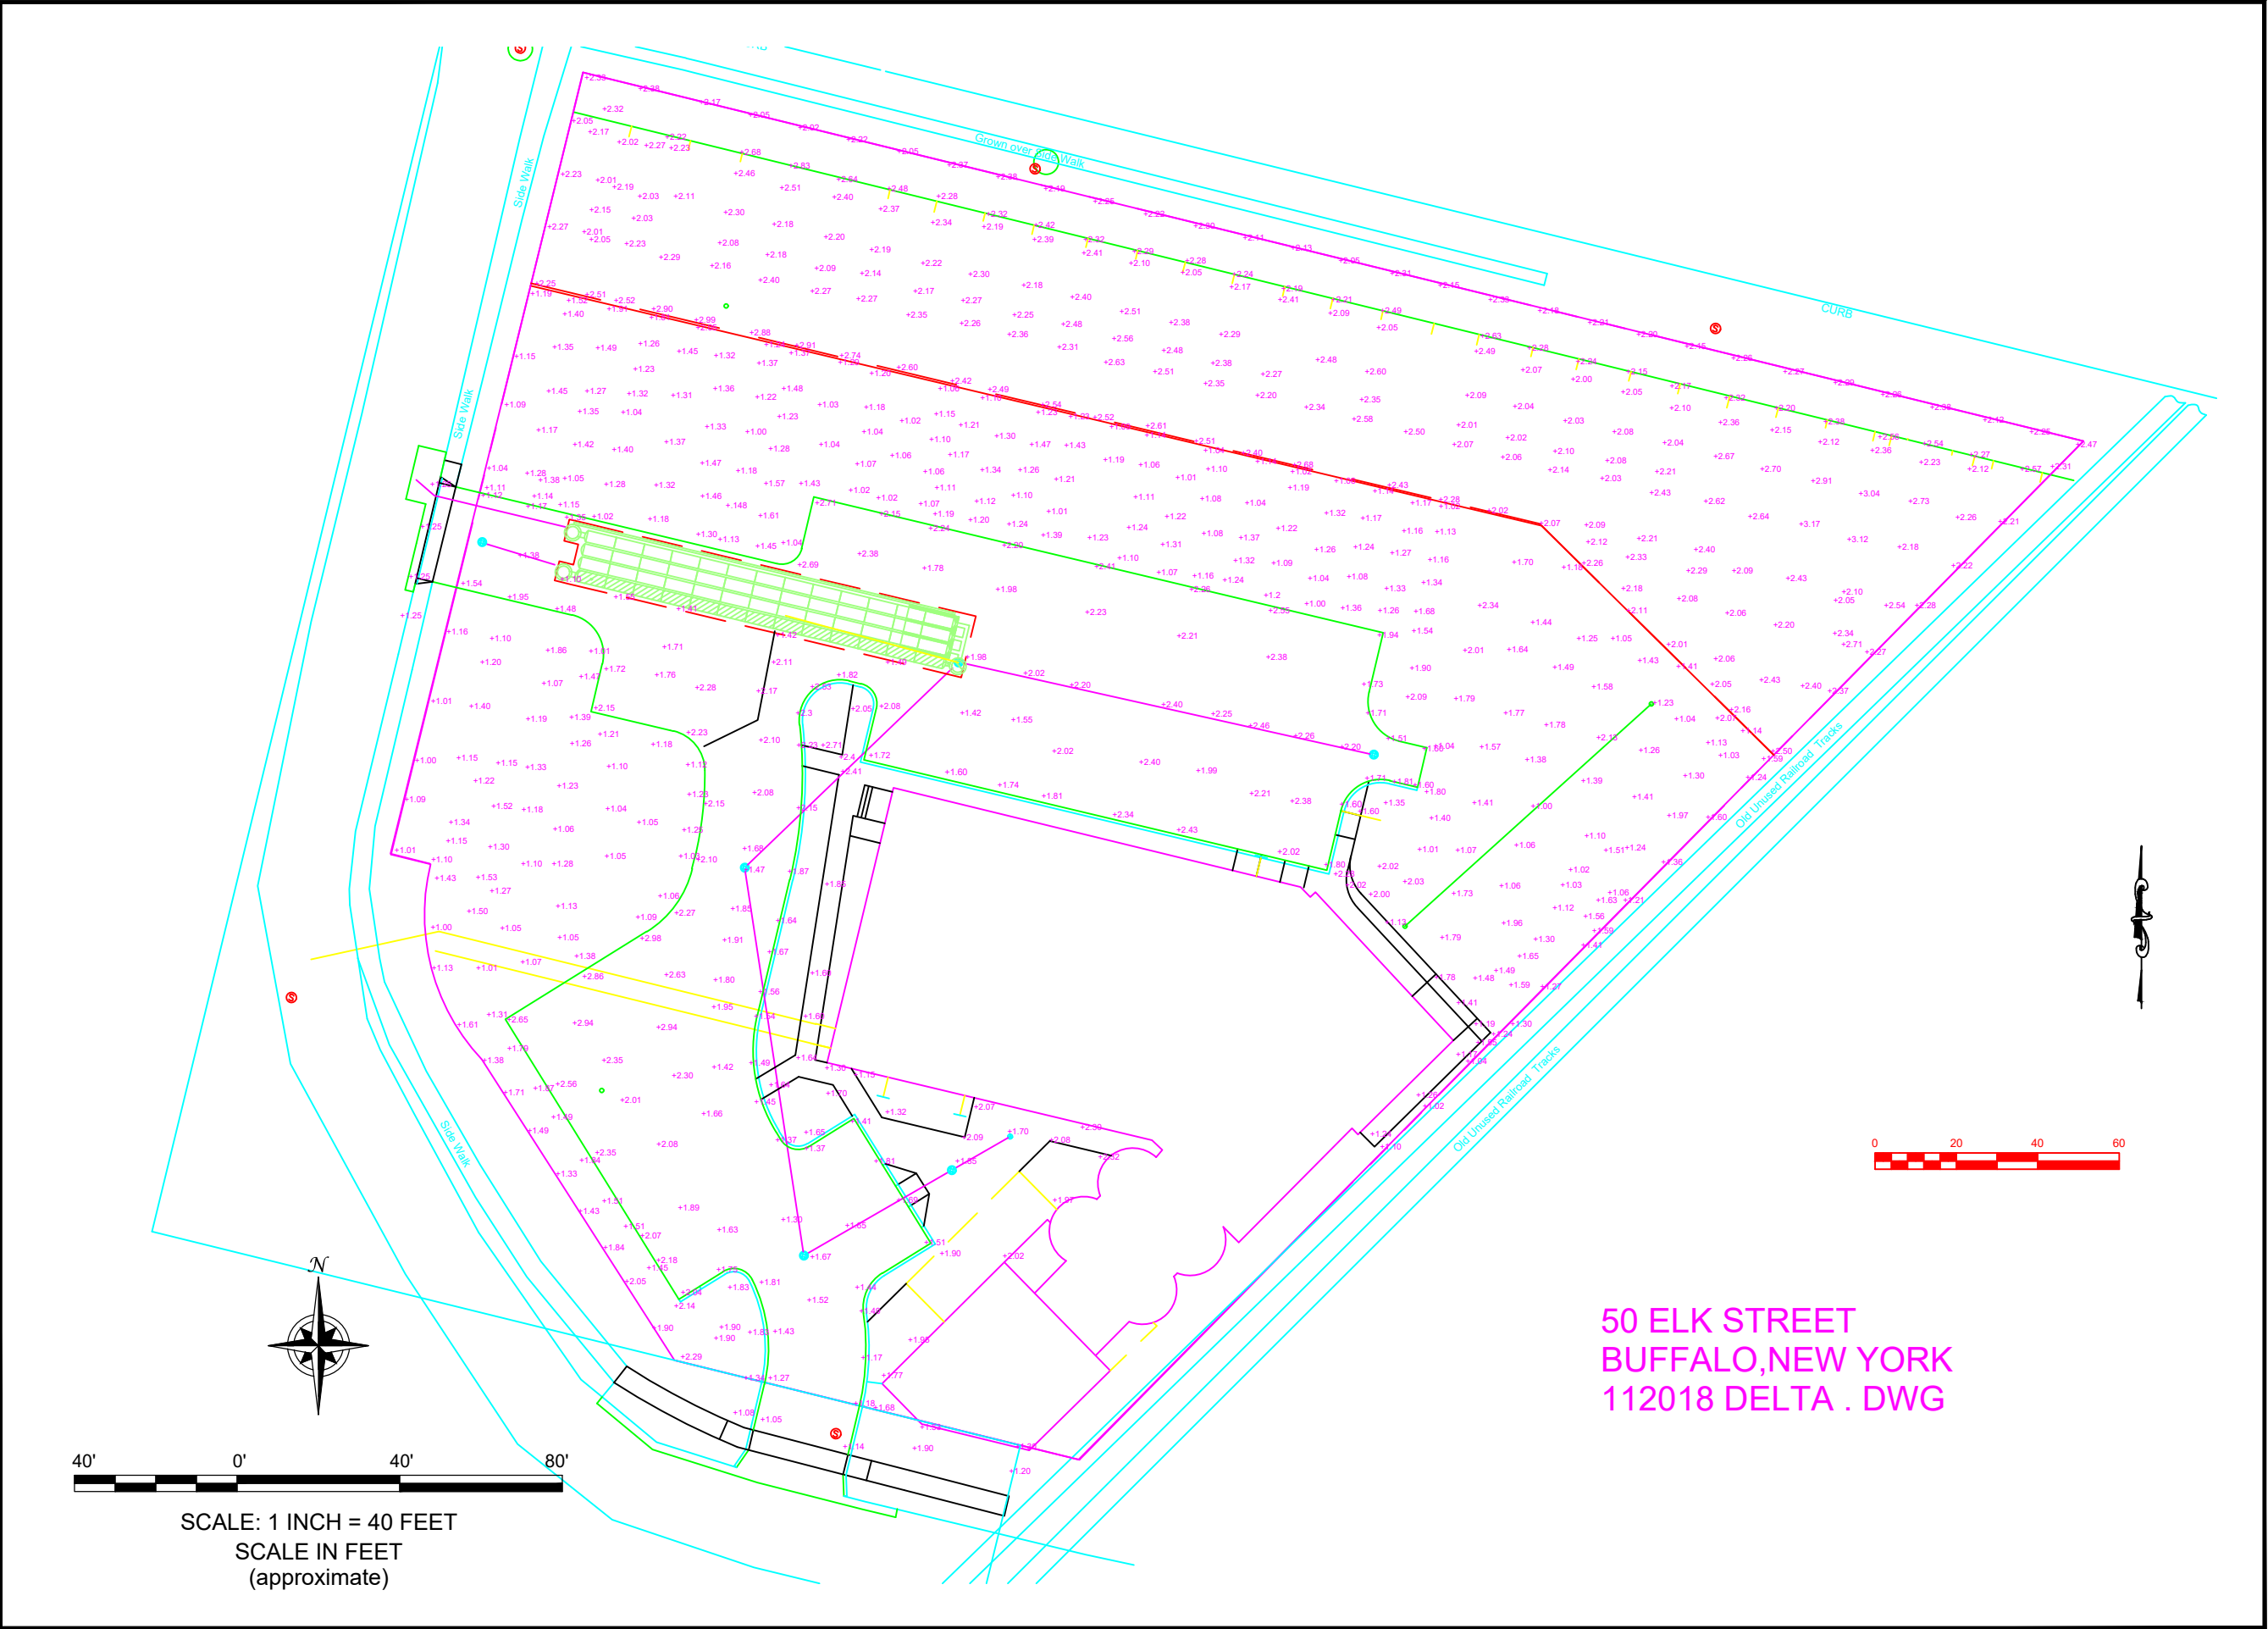
FIGURE 3

building and north of the parking lot. The May 2019 PRR includes photographs depicting the redevelopment work. Cover materials were cleared within the limits of the work areas of the prior to excavation. Demarcation fabric was pulled back in the work areas and spoils regraded beneath. New demarcation fabric was replaced in the work area and edges were tied into existing demarcation fabric. New subgrade and final grade elevation survey shots were taken by Greenauer's surveyor and revised cover thicknesses are included on Figure 3.

**NOVEMBER 2018 COVER REPAIR
THICKNESS VERIFICATION**

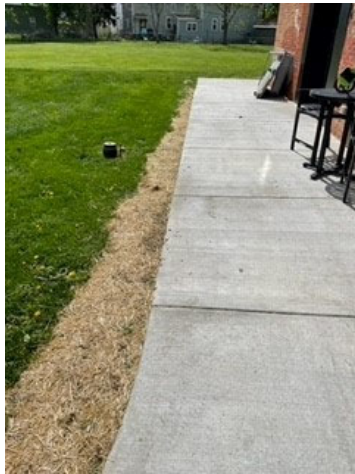
Based on the Site inspections performed on April 15, 2020, April 27, 2021, and April 5, 2022, the asphalt and vegetative soil cover systems at the Site were compliant with the IC/EC requirements. Several small bare areas located adjacent to Site sidewalks and asphalt cover northeast and west of the building were noted during the April 5, 2022, inspection. These areas were re-seeded in April 2022 (refer to photos 7, 9, 10, and 11 in Appendix B).

- Photo 5: Stone and hardscape cover along the eastern property boundary (looking southwest)
- Photo 6: Hardscape and vegetative cover along northeast side of the building (looking northwest)
- Photo 7: Re-seeded greenspace cover along northeast side of the building (looking southeast)
- Photo 8: Asphalt parking lot cover area north of building (looking west)

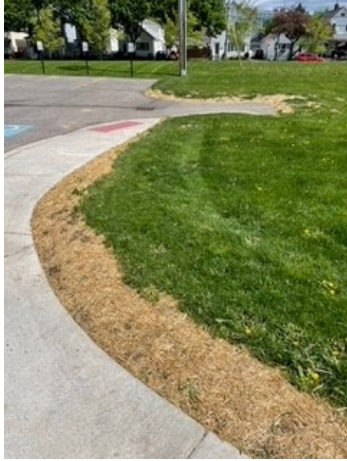
Photo 9: Re-seeded greenspace cover at east end of the asphalt parking lot area north of the building (looking north).
