**WESTERN NEW YORK WORKFORCE TRAINING CENTER  
ERIE COUNTY  
BUFFALO, NEW YORK**

# **PERIODIC REVIEW REPORT**

**April 27, 2022 – April 27, 2023**

**NYSDEC Site Number: C915310**

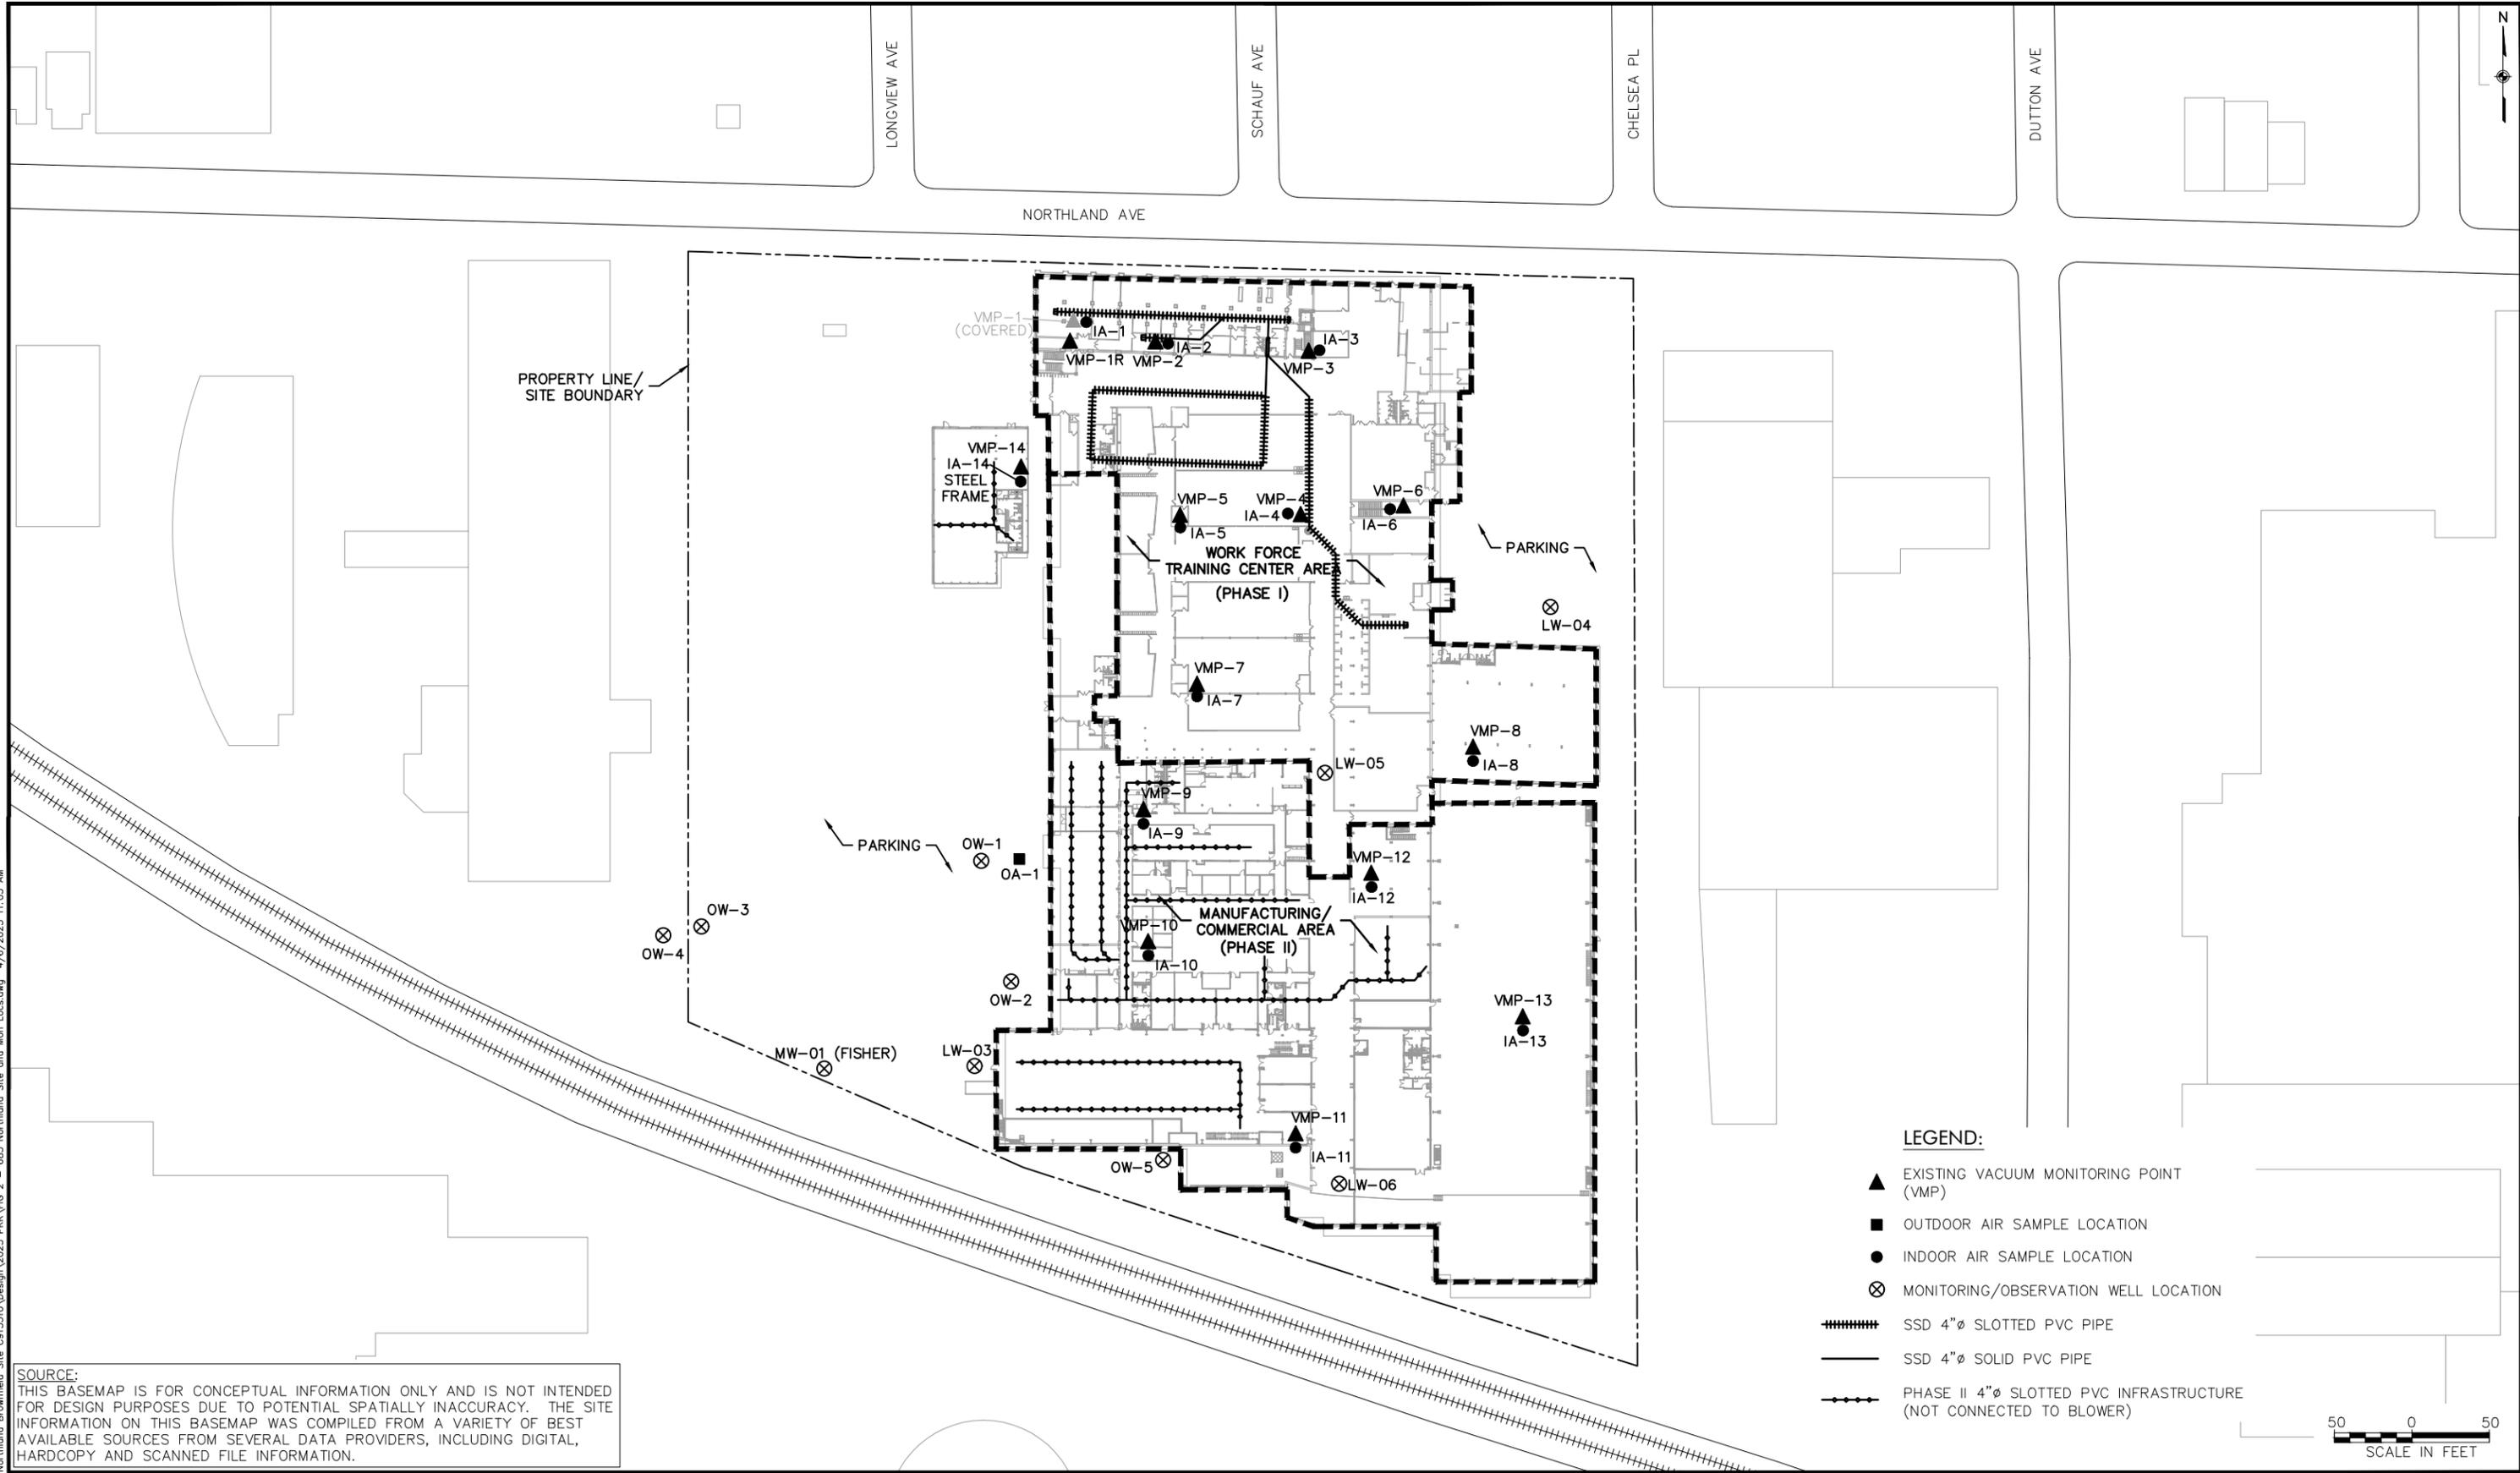
JOB TITLE AND LOCATION:	LIRO JOB NO.:
WESTERN NEW YORK WORKFORCE TRAINING CENTER FINAL ENGINEERING REPORT	20-131-2400
DRAWING TITLE:	SHEET OF
SITE PLAN AND MONITORING LOCATIONS	FIGURE NO.
	2

Monitoring well inspections were conducted in conjunction with the quarterly hydraulic and product monitoring events. Hydraulic monitoring report forms are provided in Appendix A. The locations of the groundwater monitoring wells and observation wells are shown on Figure 2.

One monitoring well, MW-01 was identified as being obstructed at a depth of approximately 6.8 feet below the top of the well casing (ft. BTOC). When the groundwater table elevation dropped below the obstruction, the water level could not be measured in the well.

A vacuum extraction system was used to remove the obstruction and rehabilitate the monitoring well. On April 20, 2023 the vacuum extraction system was used to remove approximately 5.5 feet of gravel, sand, and silt from within the well. The material may have collected in the well as result of bedrock formation collapse or it could have accidentally entered the well during parking lot subbase construction (however, LiRo did not observe any well condition such as a missing cover suggestive of a construction problem). Following the cleanout, the bottom of the well is approximately 12.5 feet BTOC and the water level in MW-01 was measured to be 6.3 feet BTOC. Static water level in the well has historically been in the range of approximately 6 feet to 8 feet BTOC at MW-1 so no additional well rehabilitation is required at this time.

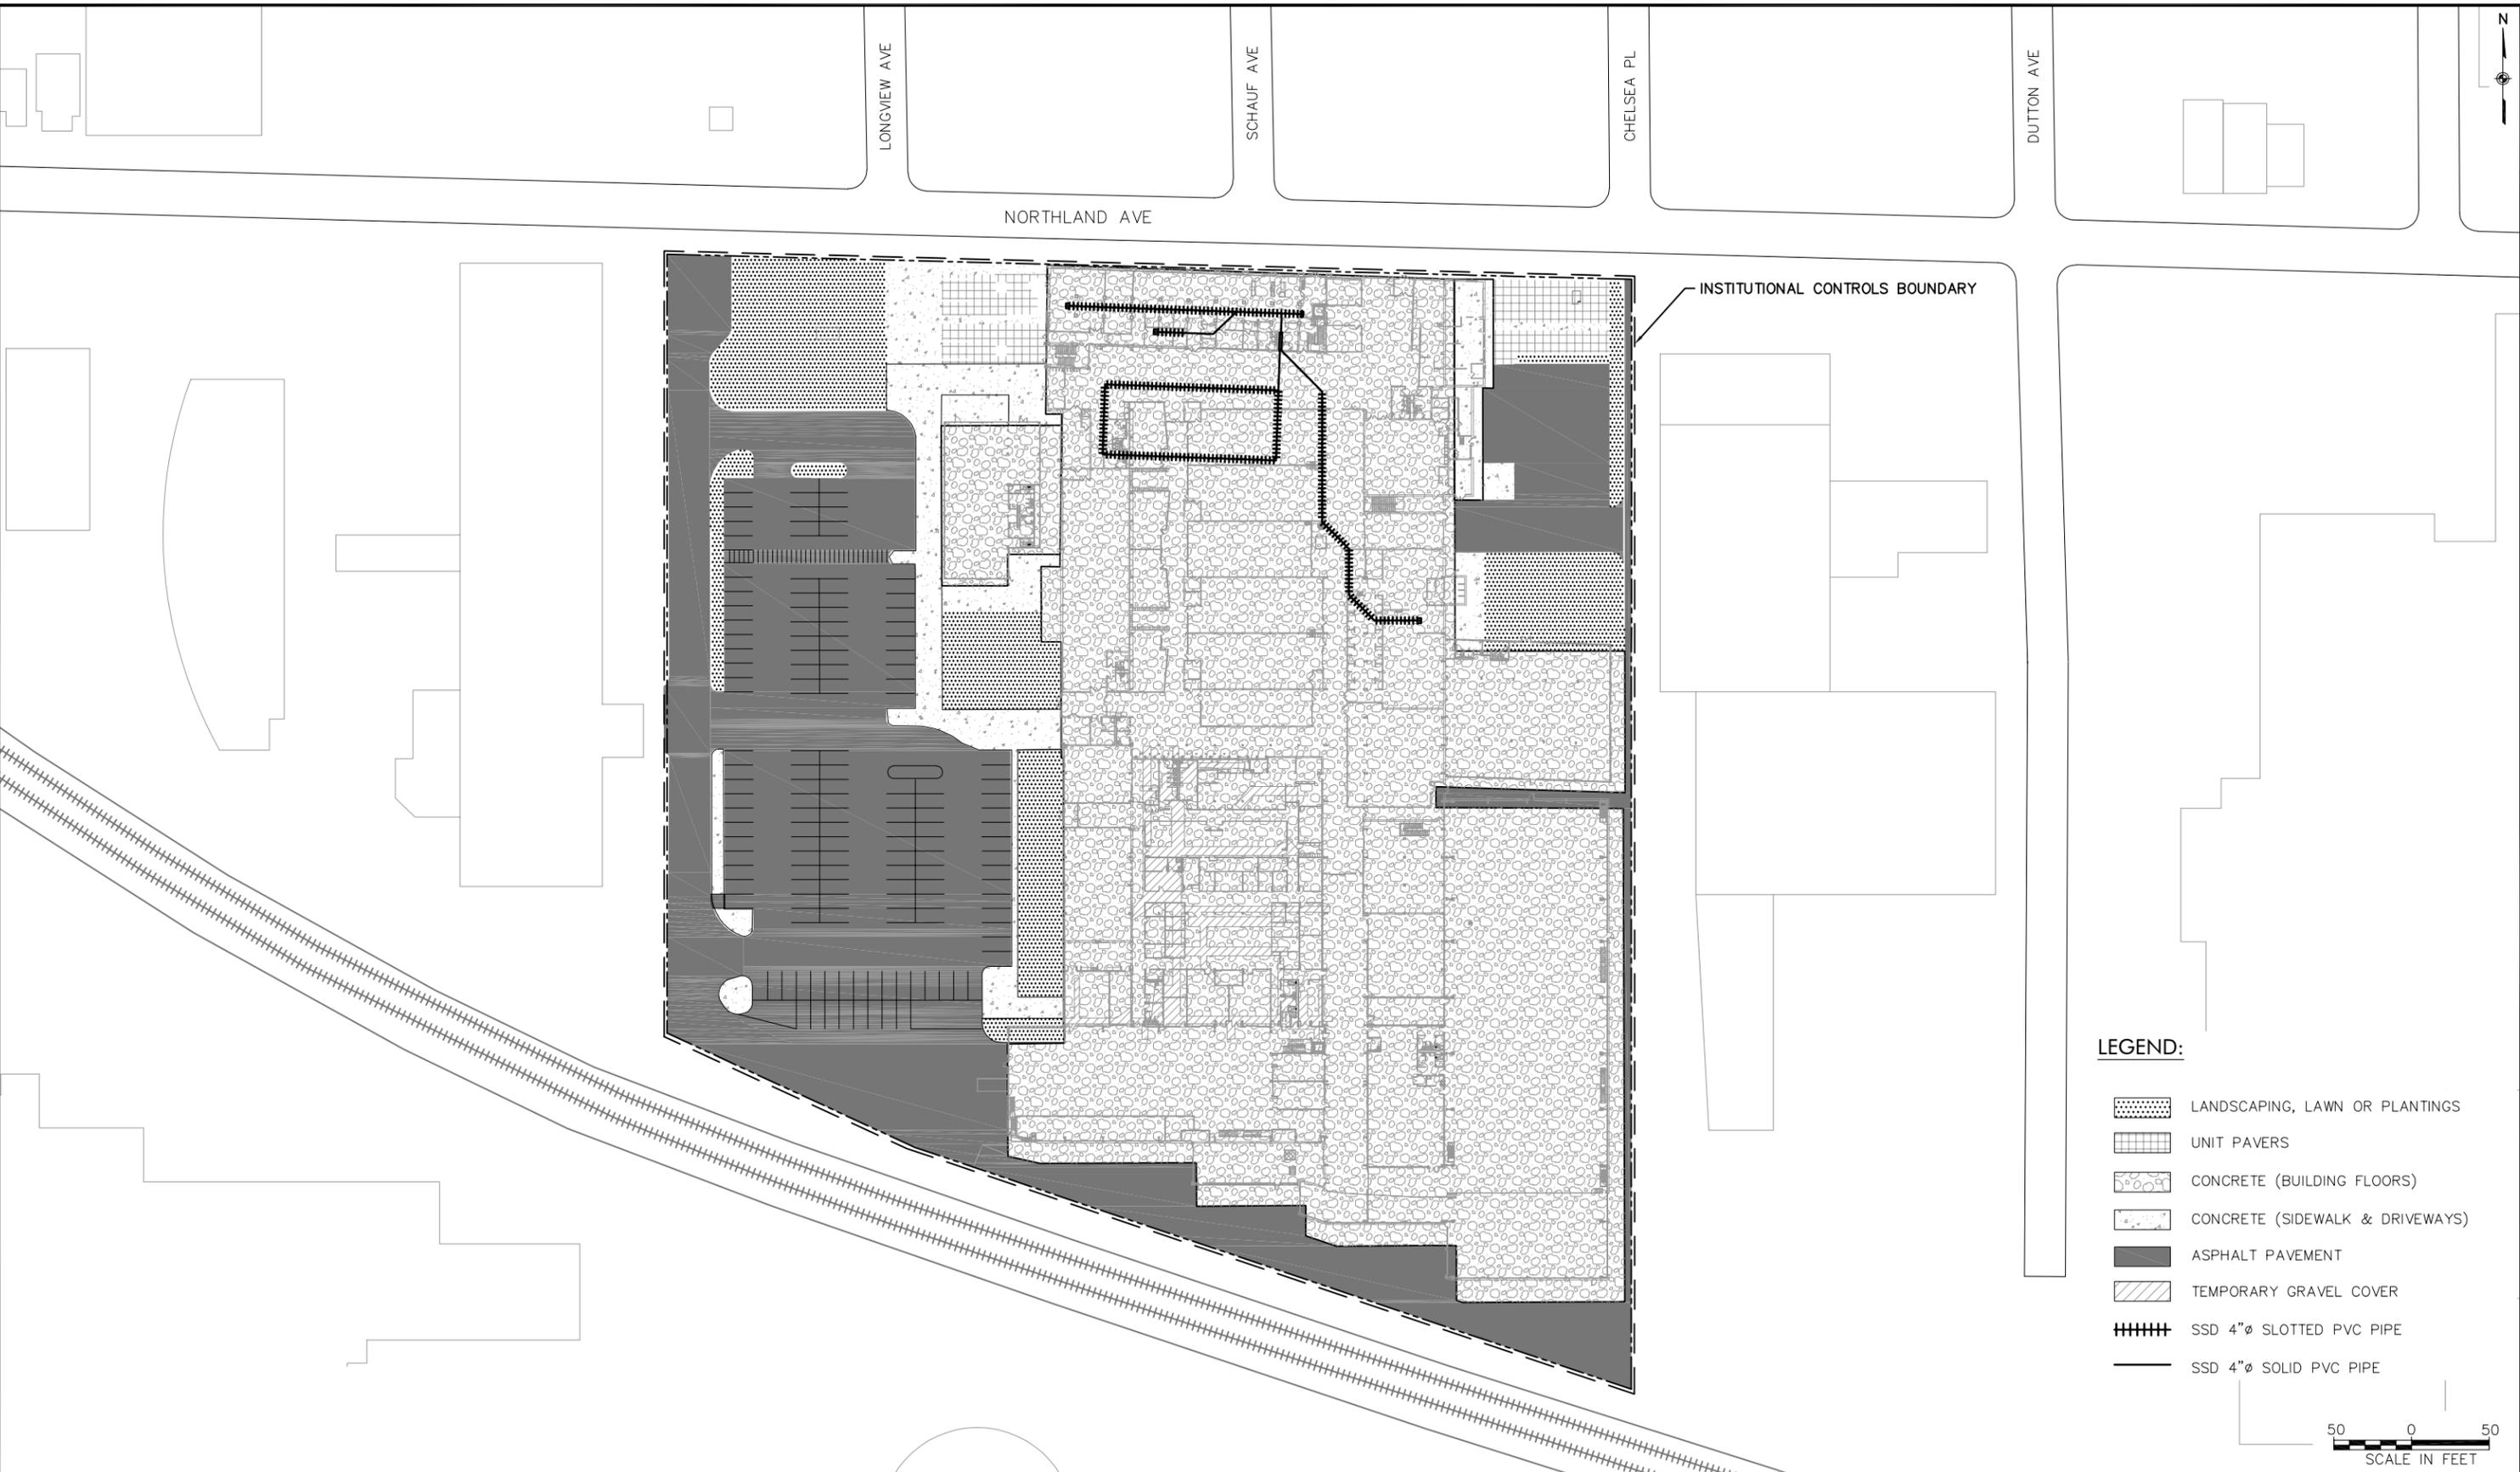
The cover systems to be maintained are shown on Figure 3. These areas were examined for damage, erosion, or deterioration. No deficiencies were observed in the Site cover systems.

No damage or deterioration was noted during the inspection. No corrective action is necessary for the cover systems at this time.
