CIMINELLI DEVELOPMENT COMPANY, INC.

**PHASE 1 ENVIRONMENTAL SITE ASSESSMENT
960 BUSTI AVENUE AND 990 NIAGARA STREET
BUFFALO, NY 14213**

NOVEMBER 1997

ACRES INTERNATIONAL CORPORATION

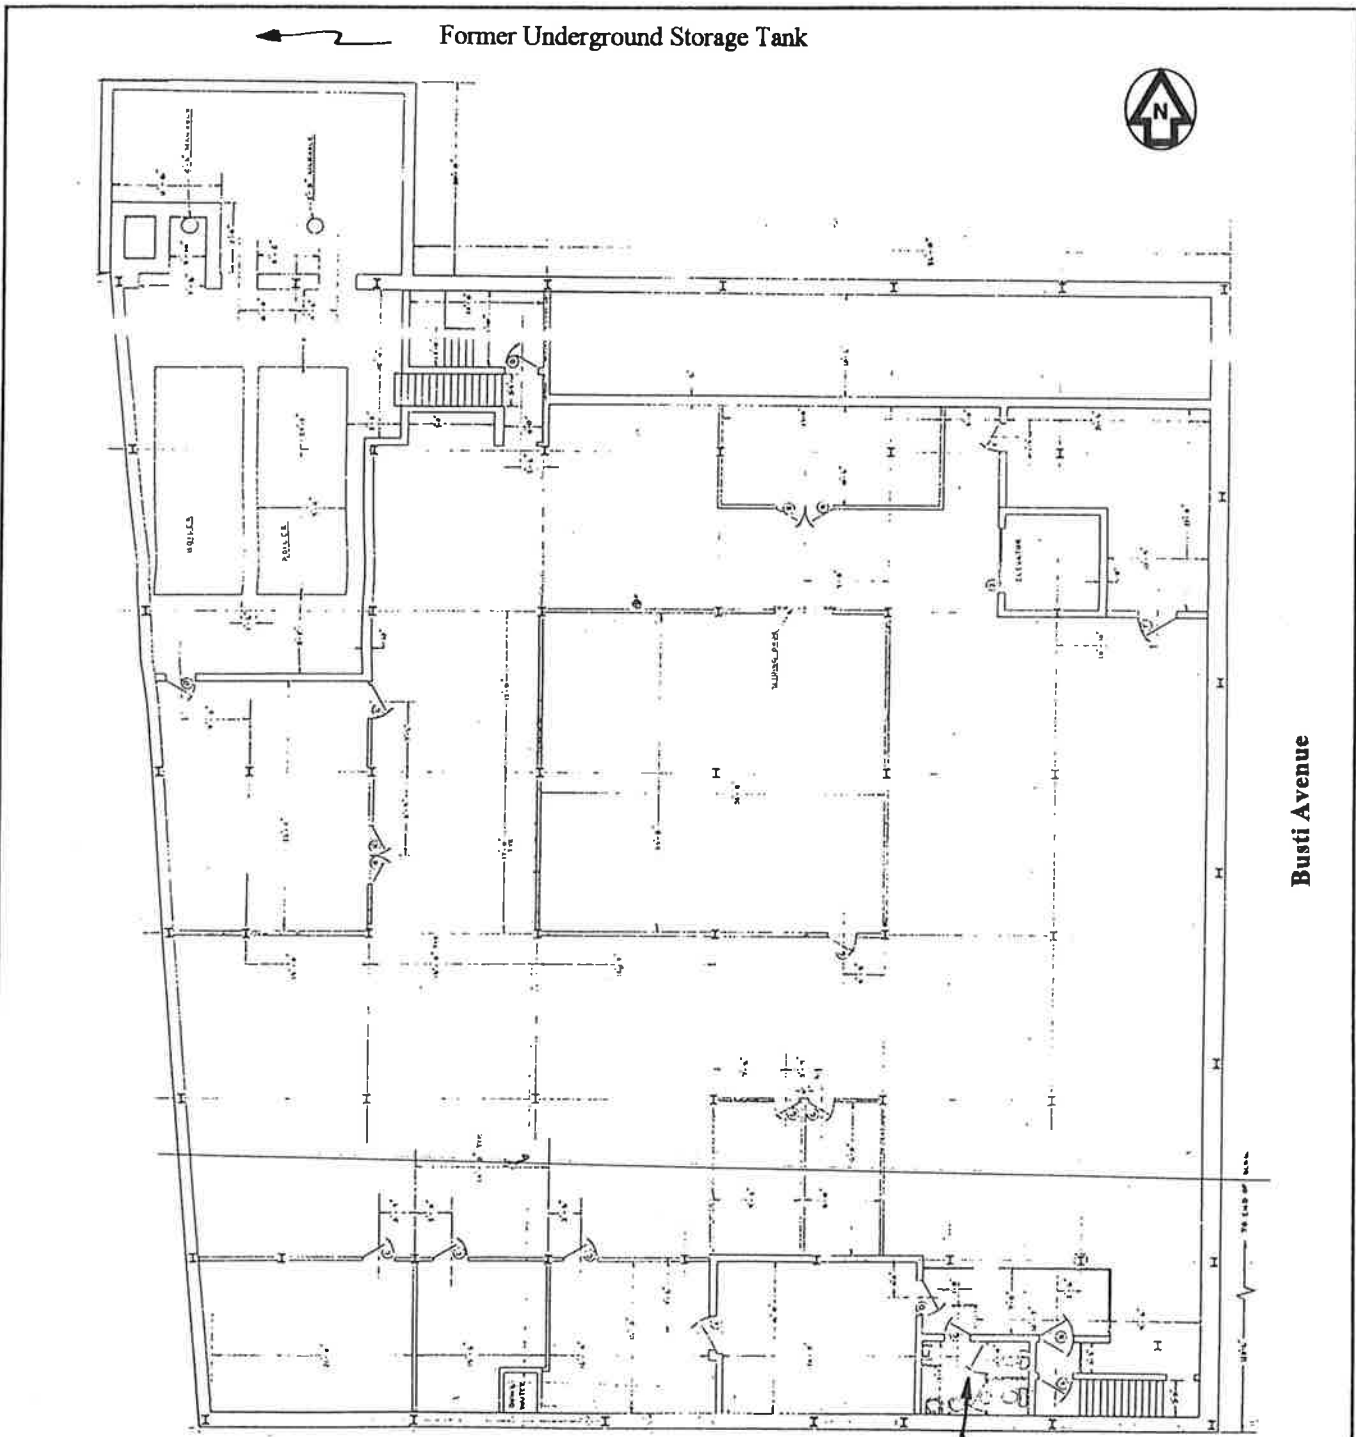
Figure 2
 Site Features - 960 Busti

Two small containers of reagent and/or waste were observed in a second floor laboratory in 960 Busti (see Figure 2). These include approximately 2 lbs. of lithium chloride powder in a glass container and 1 gallon of black liquid in a plastic container.

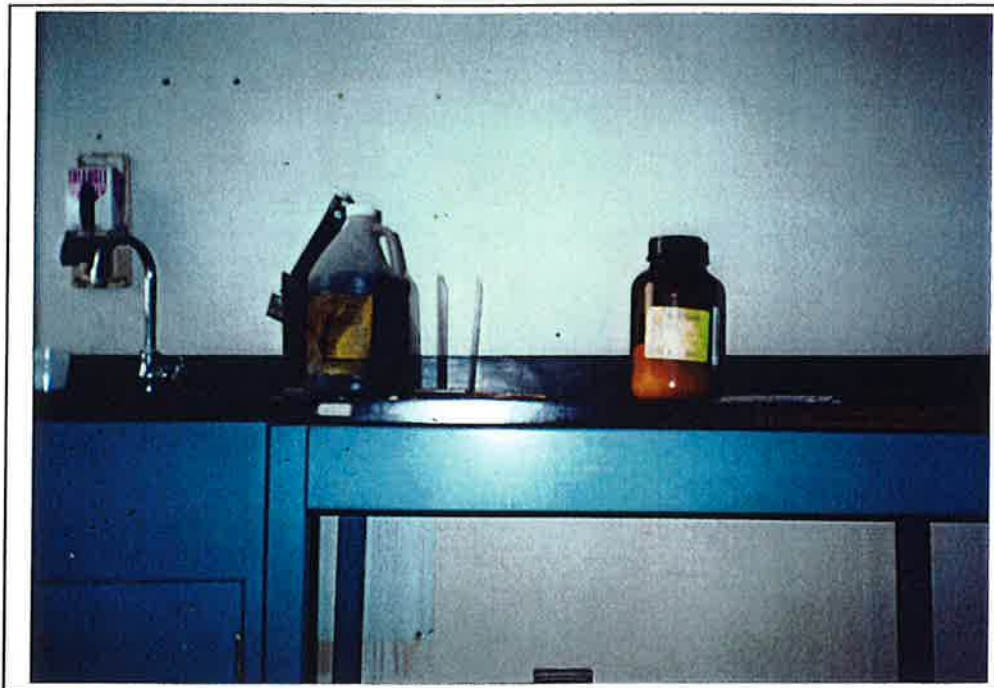
960 Busti Avenue

**Second floor - former lab, approximately 2 lbs. lithium chloride (powder)
and black liquid (plastic jug)**

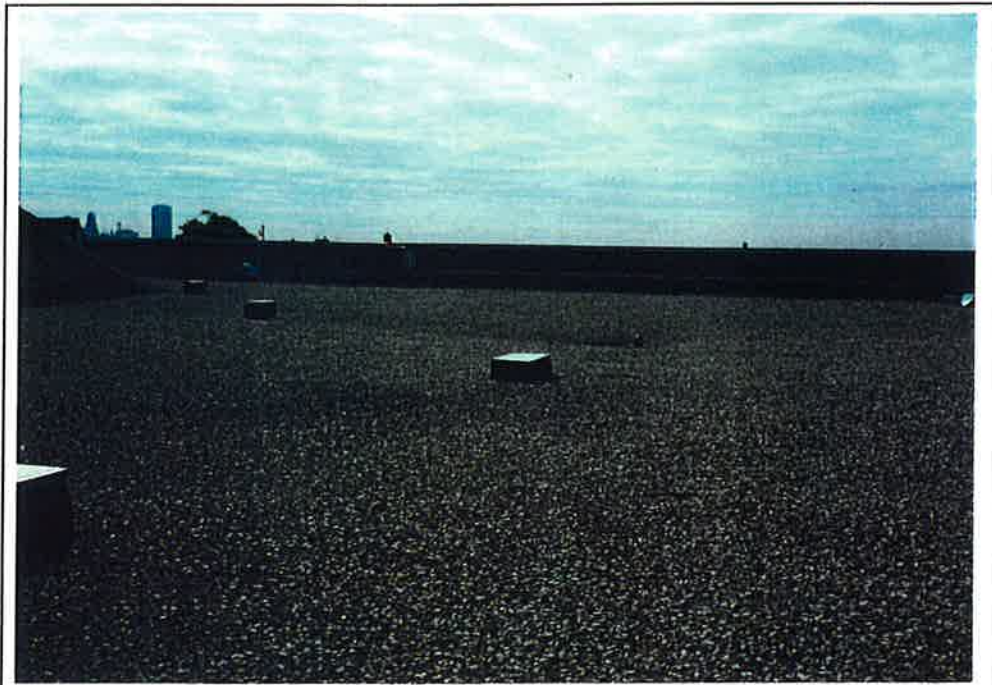
The building's roof was in excellent condition and appeared to have been recently resurfaced.

Roof 960 Busti Avenue

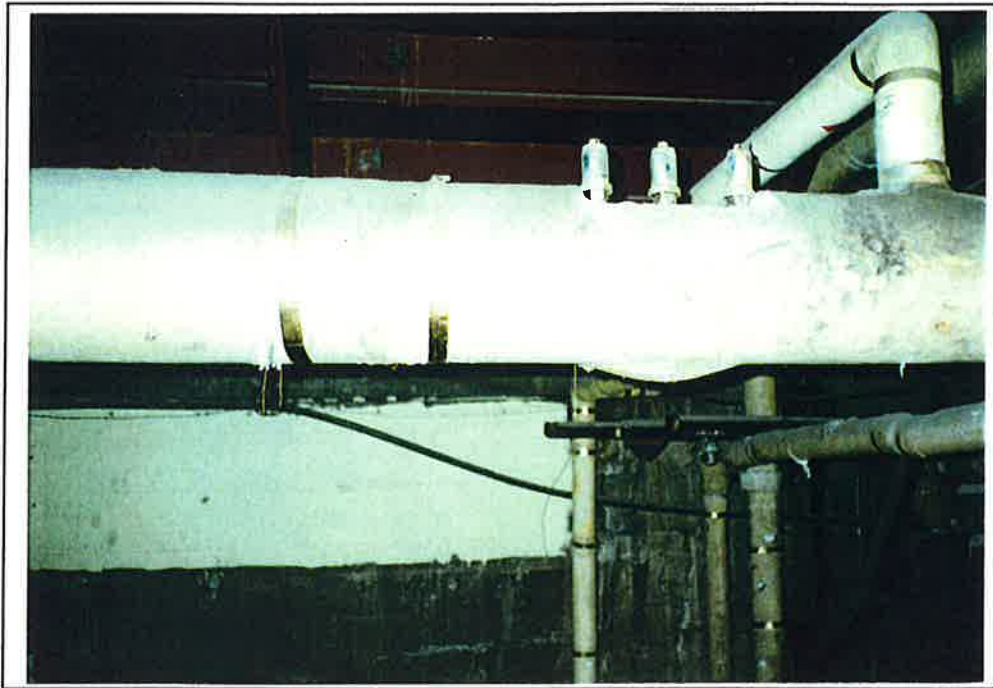
960 Busti Avenue

The piping insulation was generally in fair condition with some damaged areas. However, the piping at floor level was in very poor condition.

Basement, insulated pipes

- ▶ The sub-basement area pipe insulation has begun to deteriorate and should be removed.
- ▶ All condensate return piping insulation along outside walls and at some internal columns should be removed on all floors.
- ▶ Steam pipe insulation in the basement at floor level should be removed.
- ▶ Steam pipe insulation supported at ceiling level in the basement should be repaired in numerous places.

In general, the entire pipe insulation system should be examined in light of the possible future building use. The type of insulation currently in place will continue to deteriorate and can create an asbestos fiber release if it falls. In addition, the majority of the vinyl tile is in good condition. This material can be sealed with wax but will continue to be a potential source of asbestos fibers if cleaned routinely.

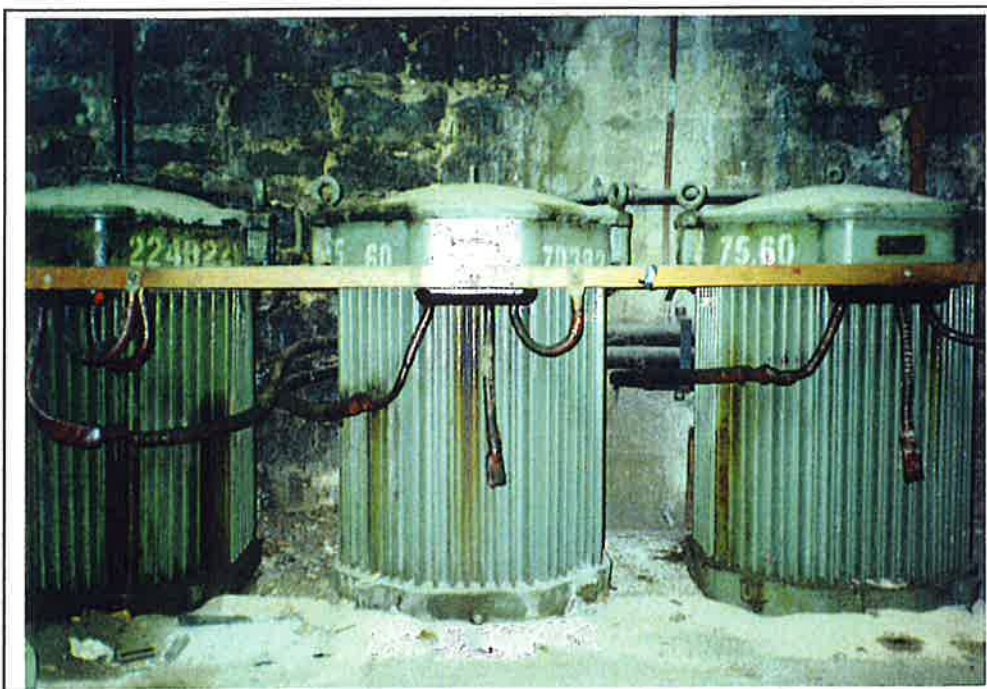
960 Busti Avenue

Basement, 75 kVA transformers

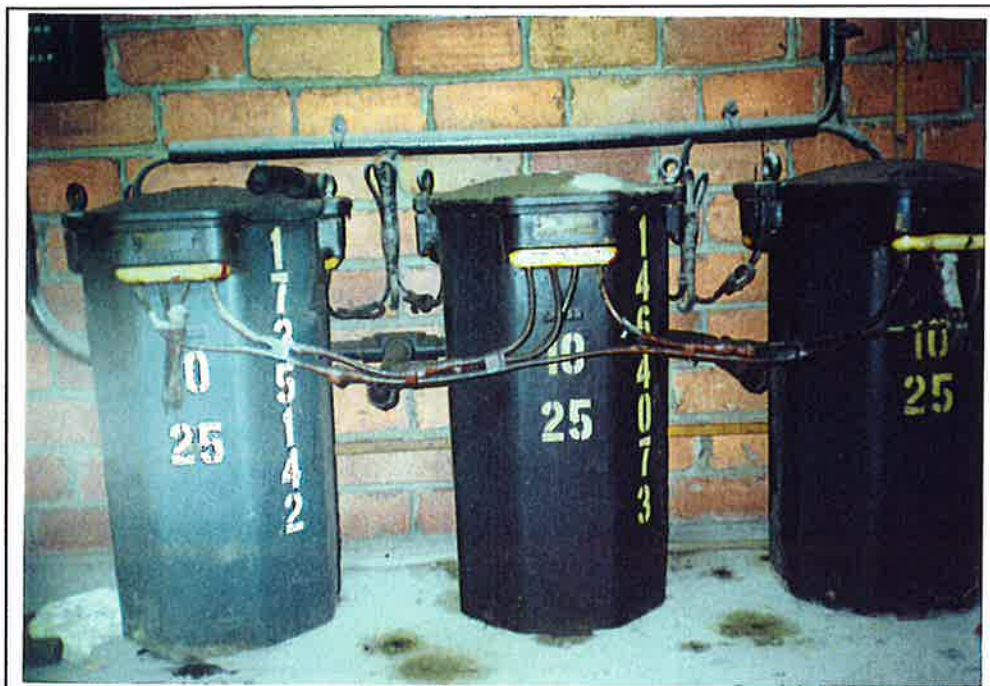
960 Busti Avenue

Basement, 10 kVA transformers

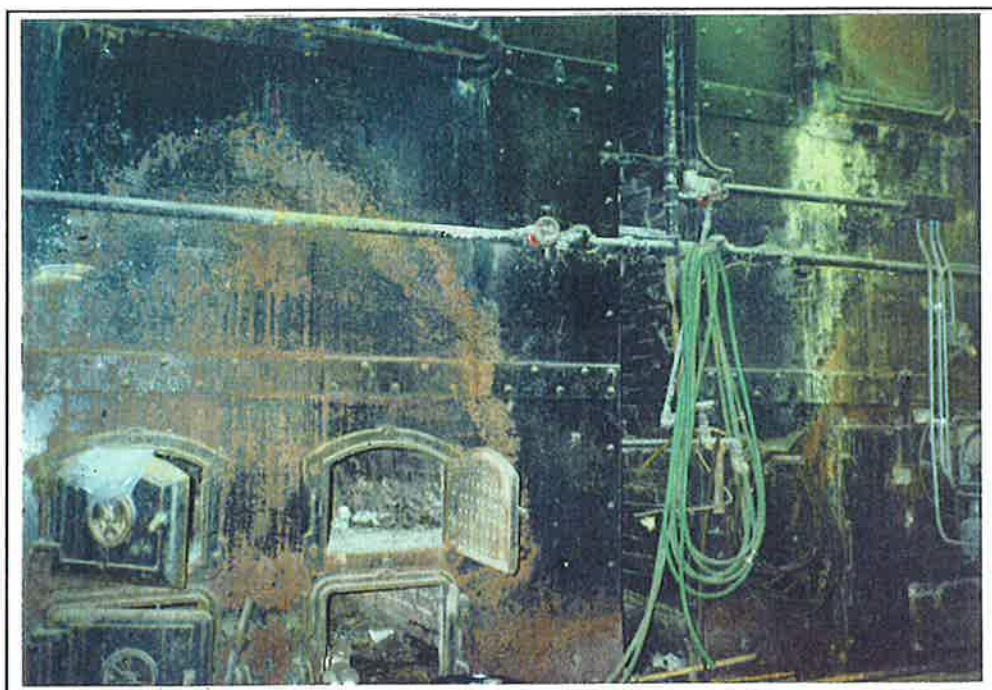
960 Busti Avenue

A sub-basement is located in the northeast corner of the building and is accessible from the basement. Three steam boilers in various conditions are in this area.

Sub-basement, boilers
