Re: Phase I Environmental Site Assessment  
Keystone Corporation, 2929 and 2939 Main Street, Buffalo, NY  
Project No. e1405

## PHASE I ENVIRONMENTAL SITE ASSESSMENT

**Keystone Corporation**  
2929 and 2939 Main Street  
Buffalo, NY 14214

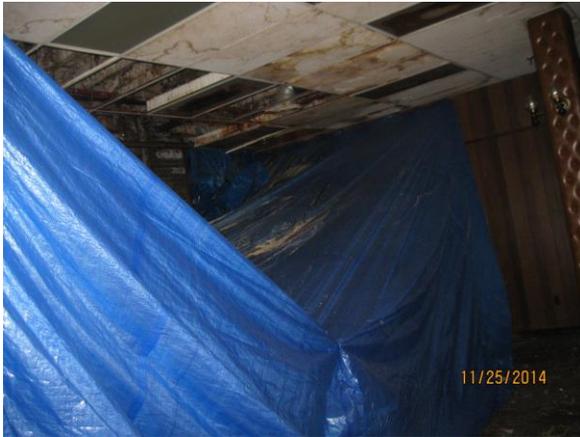
**Photo 5:**

Photo 5: Building 2: Water damage to ceiling and ceiling tiles.

- Water damaged ceilings were noted in Buildings 2 and 3 and pooled water was observed in certain areas. The water damage can promote mold growth. The roof and leaks should be appropriately repaired to prevent further water intrusion from occurring.

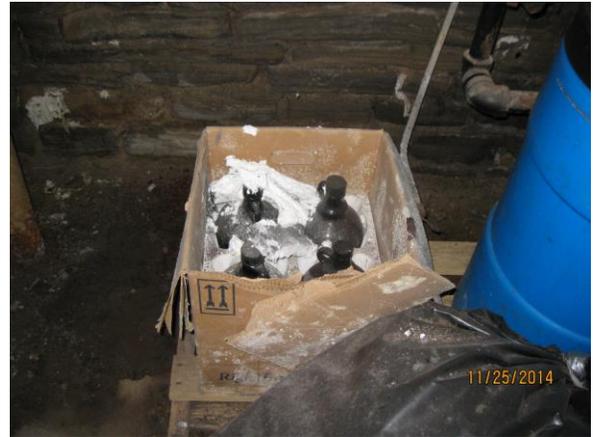
**Photo 6:**

Photo 6: Building 2: Unknown white powder (and drum to right) in basement.

- Various drums of unknown contents and gallon-size bottles covered in white residue, as well as several plastic bags labeled as “Danger – Contains Asbestos Fibers” were observed in the basement of Building 2. These materials should be properly classified and disposed.

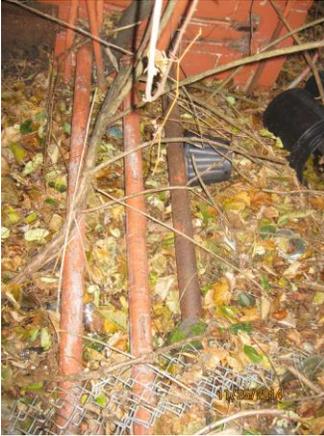
**Photo 13:**

- Several pipes, possibly vent or supply pipes, were observed protruding from the ground and building in the area of a former oil pump house. The purpose of the oil pump house and nature of these pipes is unknown. Previous Phase II investigation identified petroleum impacts in the surface soil collected near the pump house. Potential release from the pump house and/or pipes may have impacted soil profile and/or groundwater at the subject site.

Photo 13: Piping associated with oil pump house.

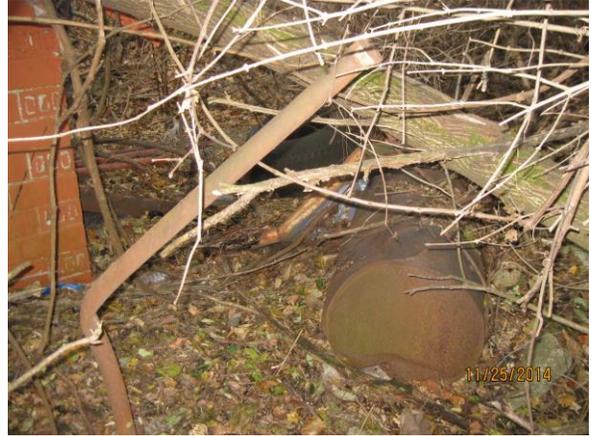
**Photo 14:**

Photo 14: Drum and piping near oil pump house.

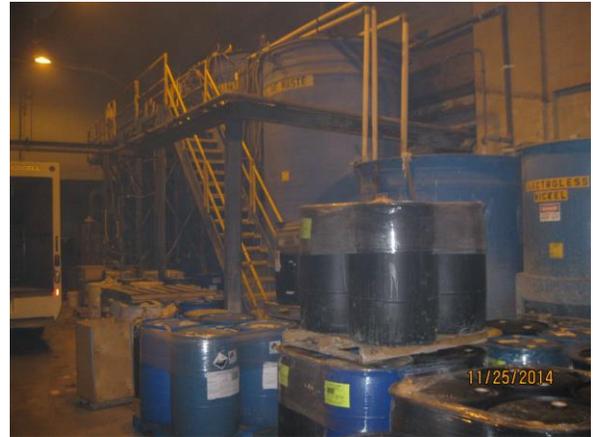
**Photo 18:**

Photo 18: Building 3: Wastewater treatment system and drum storage.

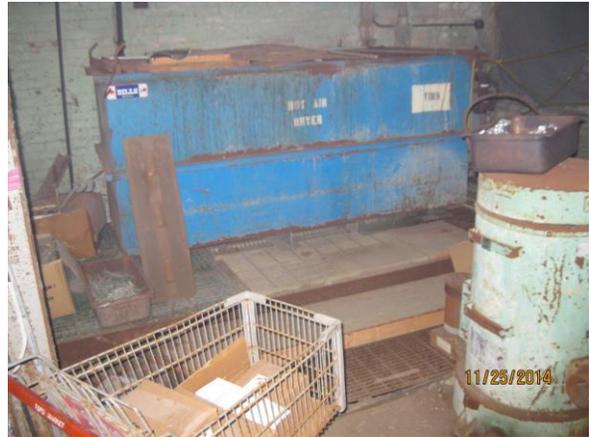
**Photo 22:**

- A pit/sump was observed in the southeast corner of Building 3. The pit was reportedly associated with a former vapor degreaser that utilized trichloroethene (TCE). Previous reports indicated the floor of the sump has signs of cracking. Potential releases to the sump may have results in soil, groundwater, or vapor intrusion impacts at the subject site.

Photo 22: Building 3: Pit for former vapor degreaser.

In this context, HEI recommends that a subfloor and subsurface investigation be completed on the subject site to assess if the soil profile and/or groundwater have been impacted by historical site operations. Additionally, due to the usage of various solvents and petroleum products at the subject site, a vapor intrusion survey should also be completed to assess possible vapors within the slab and indoor air.

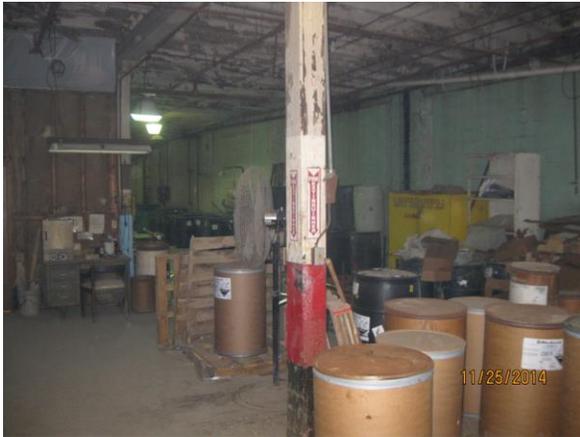
**Photo 25:**

- Hazardous waste drums of concentrated chromic acid were stored near the chromium plating line. This waste is mixed in a mixing tank with sodium metabisulphite to change the valence state of the chromium before it is processed in wastewater pretreatment system. Spillage was apparent in the area. The mixing tank should be retrofitted with secondary containment to control releases of this hazardous liquid.

Photo 25: Building 3: Hazardous waste drum storage (background) and powder additive storage (foreground).
