# ASBESTOS INSPECTION REPORT

# Limited Pre-Renovation Asbestos Inspection Report

**27 Chandler Street  
Buffalo, NY 14207**

Project ID: 19-0102DB-A

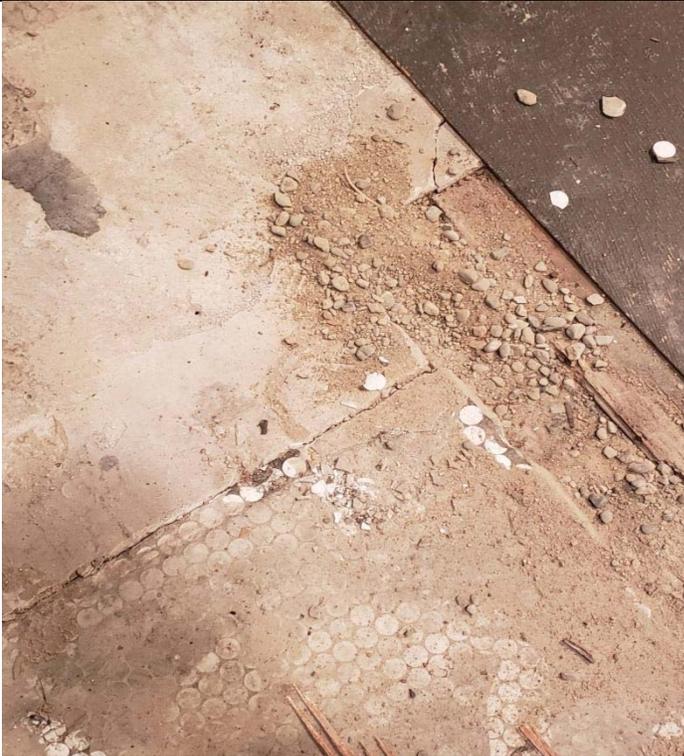
**Location:**  
1000

**Observation:**  
Ceramic tile grout/mudbed  
tested for asbestos.

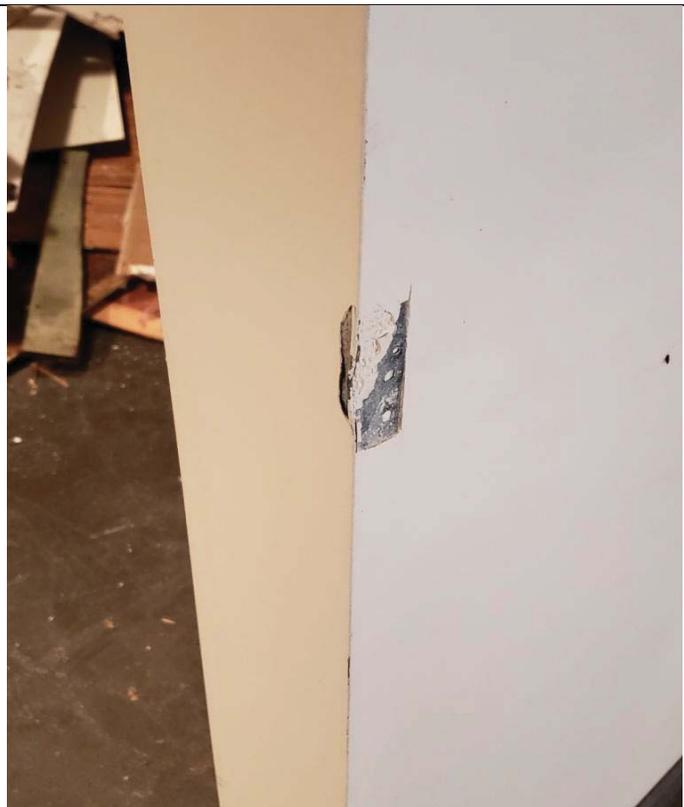
**Location:**  
Throughout Building

**Observation:**  
Drywall / Joint Compound  
tested for asbestos.

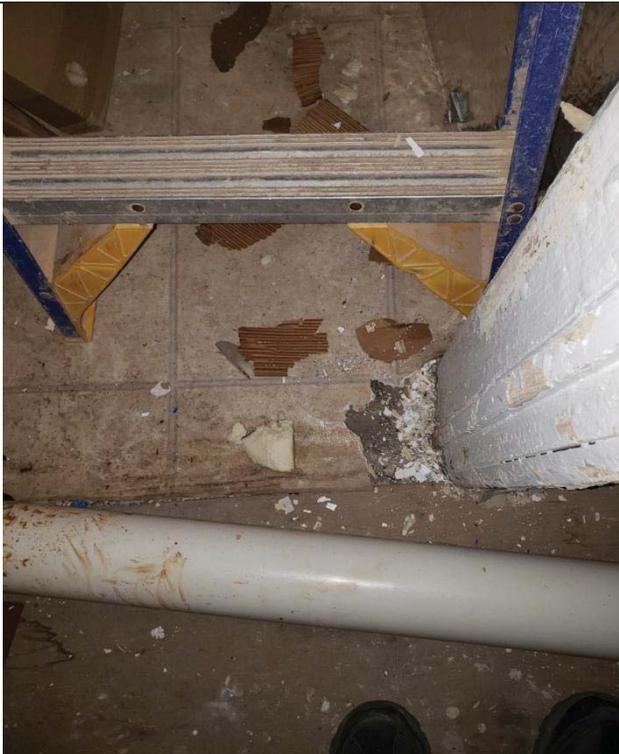
**Location:**  
2007

**Observation:**  
Beige linoleum tested for  
asbestos.

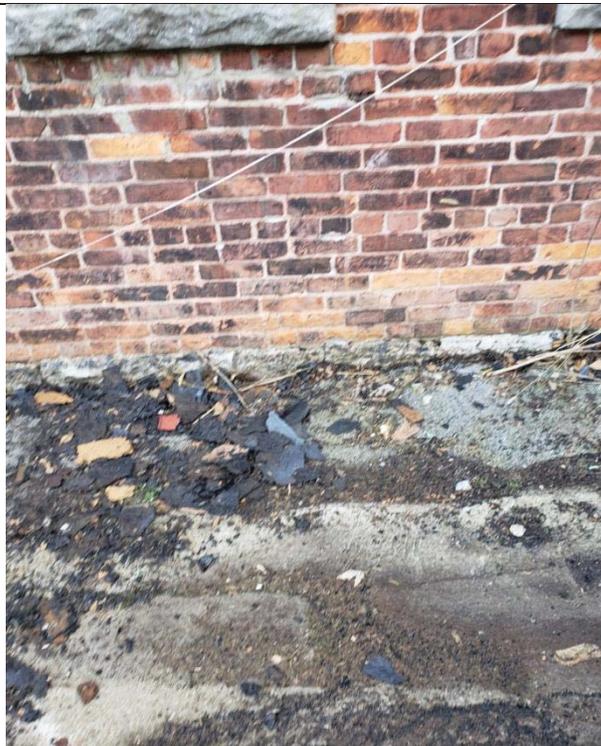
**Location:**  
Exterior

**Observation:**  
Roofing debris tested for  
asbestos.

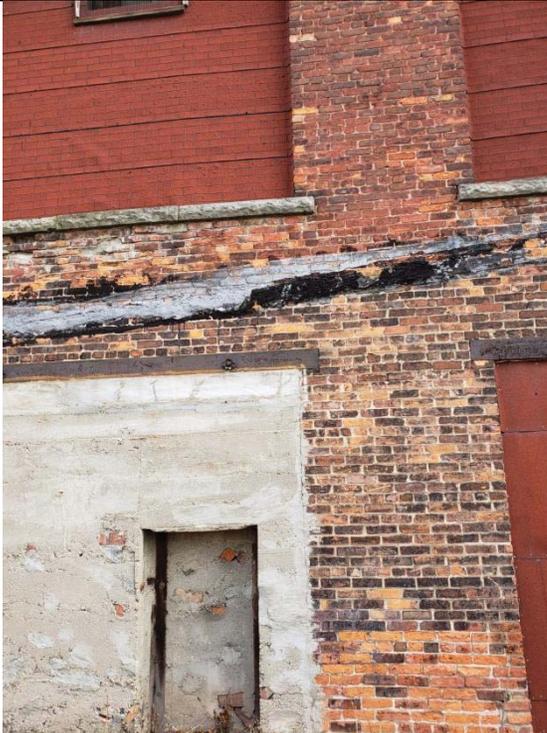
Exterior West Side of Building  
- On Brick

Repair Tar presumed to  
contain asbestos.

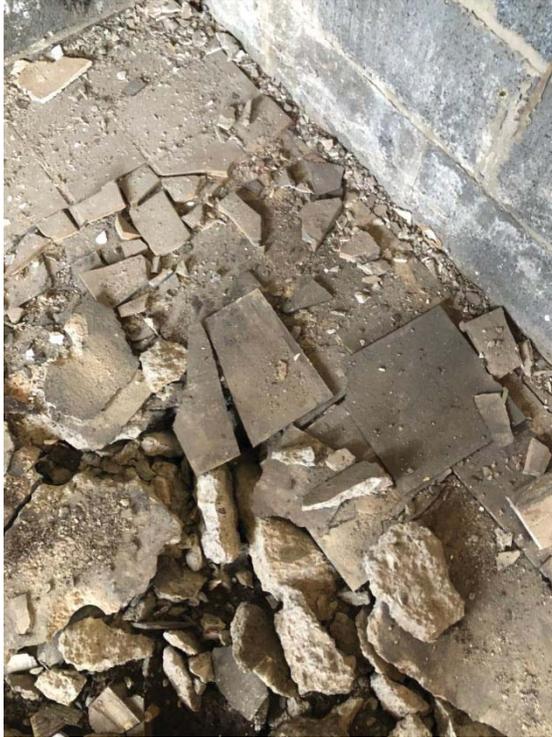
Interior

**NOTE 2=** 9" x 9" floor tile debris is found in the front section of SID 1000. The approximate area of the debris field is 2,500 sq. ft. Additionally, there is floor tile debris located on the exterior West side of the building, this debris field is approximately 600 sq. ft. Any areas with debris greater than 10 sq. ft. present will require a site specific variance from New York State Dept. of Labor.

Floor tile debris present in multiple locations found to contain asbestos.

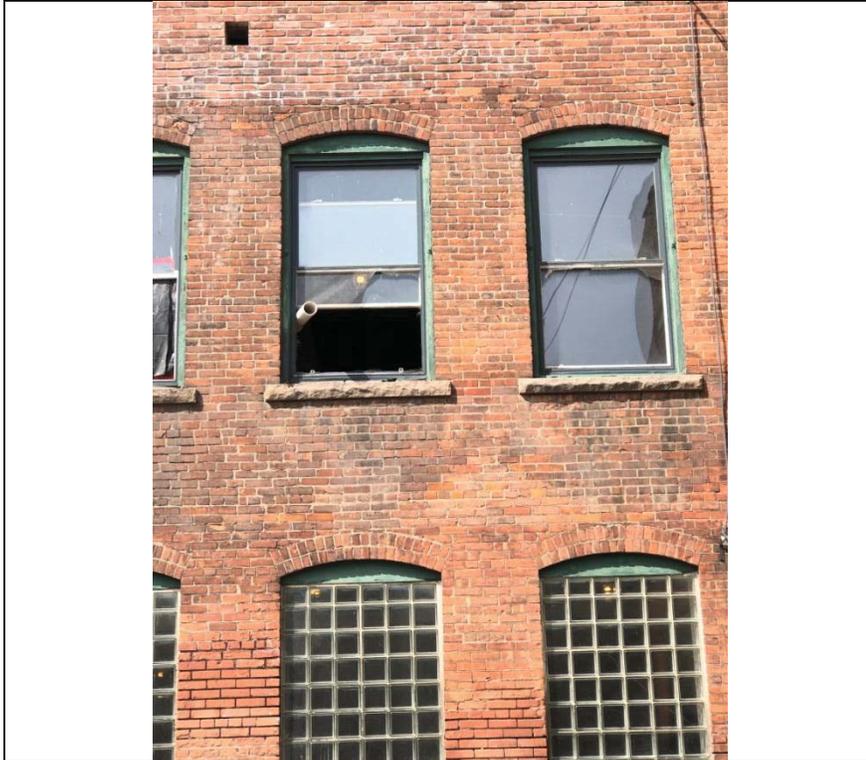
**Location:**  
Exterior 2<sup>nd</sup> Floor Level

**Observation:**  
Original double hung windows found to contain asbestos caulk and glaze.

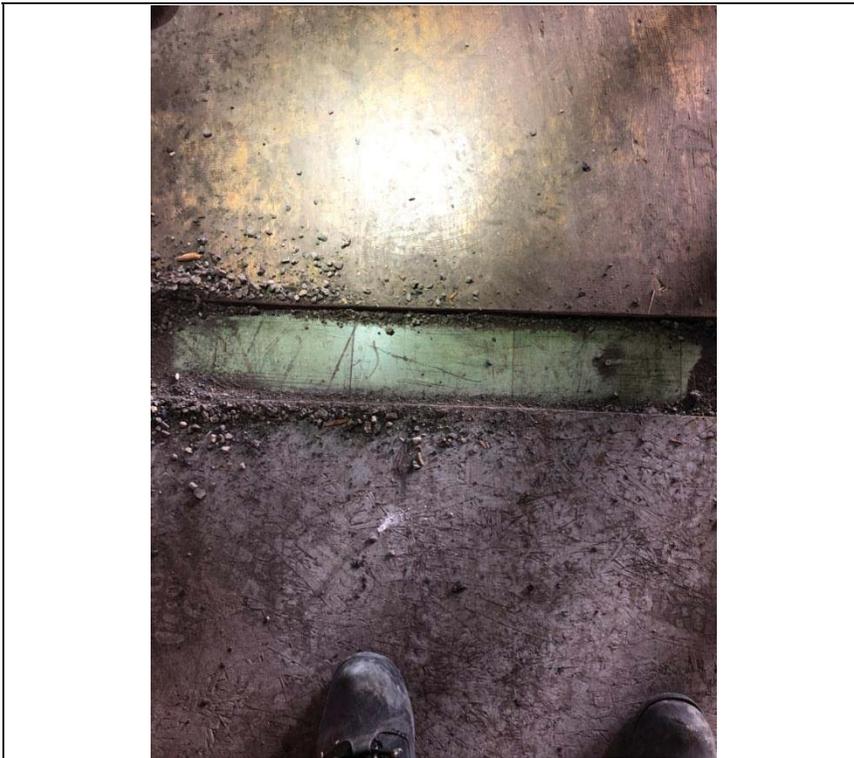
**Location:**  
Interior – SID 2000

**NOTE 1=** 9" x 9" floor tile is found in SID 2000 under the OSB subfloor, there is evidence of drilling into this material. Any further drilling/anchoring into the subfloor should be done by a licensed asbestos abatement contractor.

**Observation:**  
9"x9" Floor tile located under OSB board found to contain asbestos.
