Periodic Review Report

240 – 260 Lakefront Boulevard Site
NYSDEC Site #C915340
240 Lakefront Boulevard
City of Buffalo, Erie County, New York

February 2025

Reporting Period:
December 4, 2023 to December 4, 2024

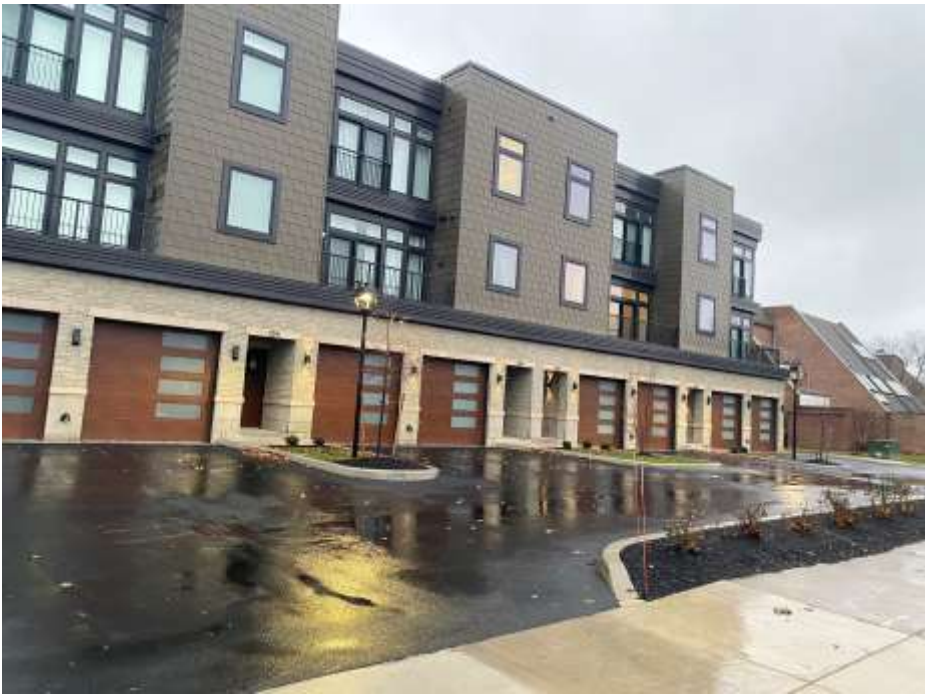
Building A -
hardscape (Soil Cover
Type A) and
landscape areas (Soil
Cover Type B).

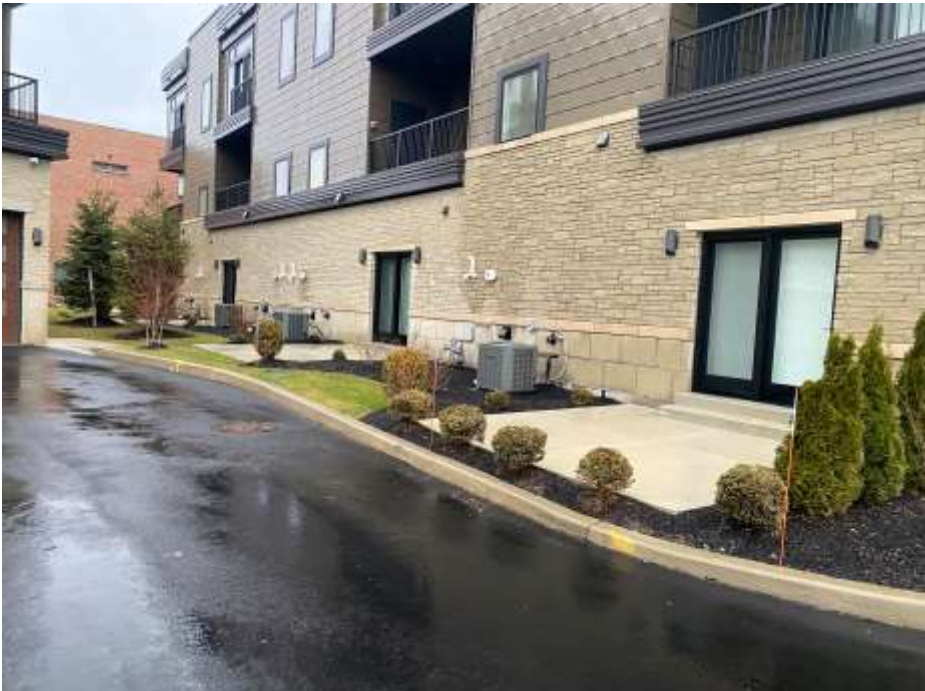
Exhibit:	Date:	240-260 Lakefront Boulevard Periodic Review
2	12/27/2024	Report

Track 4 cover system
behind Building A.
Soil Cover Type A
(building foundations
and concrete pad) and
landscaped areas.

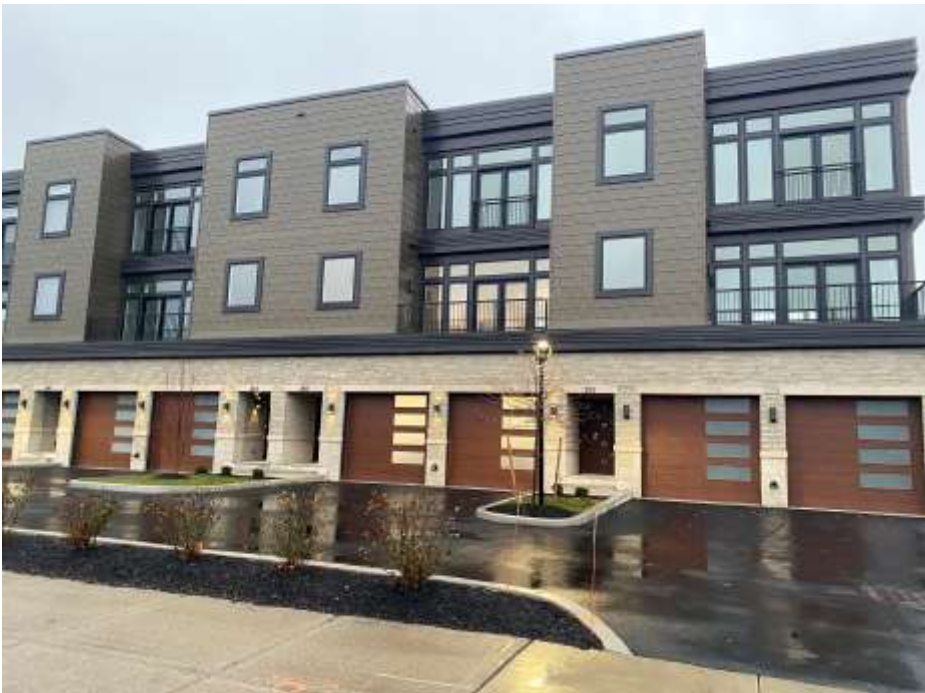
Exhibit:	Date:	240-260 Lakefront Boulevard Periodic Review
3	12/27/2024	Report

Building B - Track 4 cover system of the Site along Lakefront Boulevard (Soil Cover Type A and B).

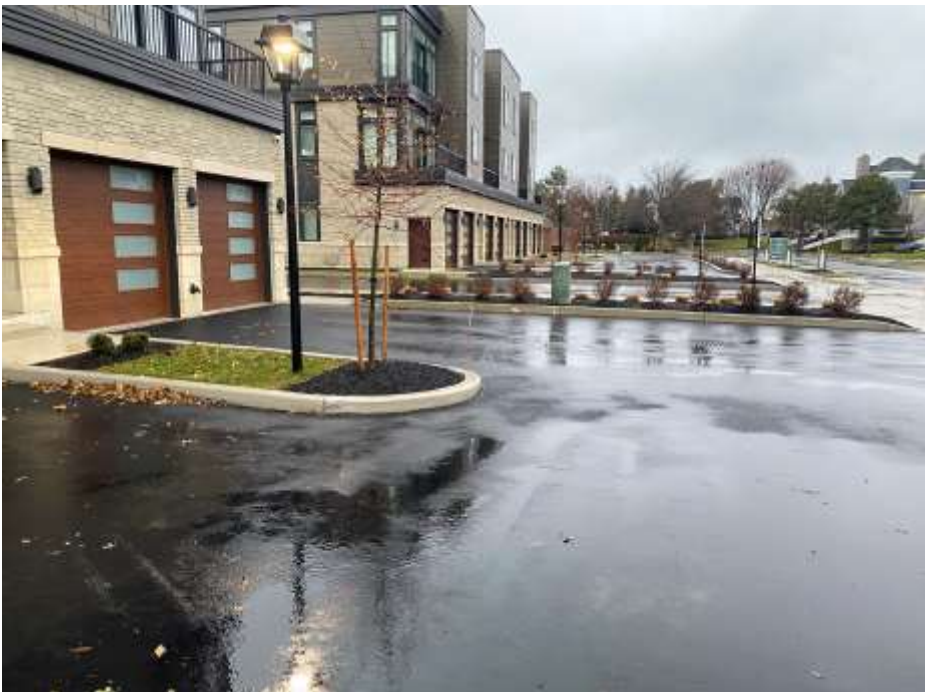
Exhibit:	Date:	240-260 Lakefront Boulevard Periodic Review
4	12/27/2024	Report

Building B - hardscape (Soil Cover Type A) and landscape areas (Soil Cover Type B).

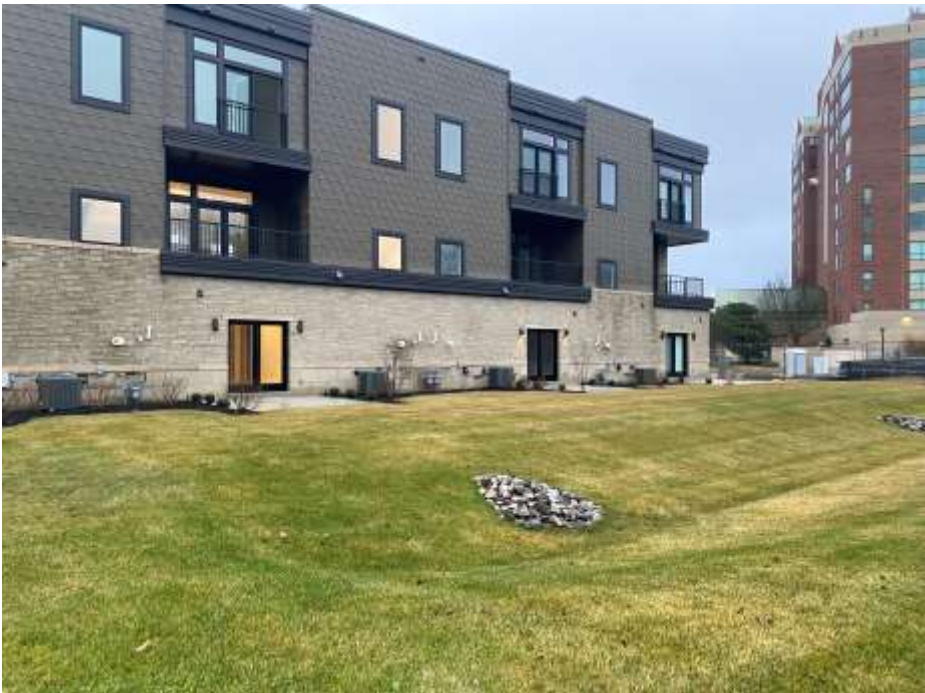
Exhibit:	Date:	240-260 Lakefront Boulevard Periodic Review
5	12/27/2024	Report

Track 4 cover system behind Building B.
Soil Cover Type A
(building foundation and concrete pad) and landscaped areas.

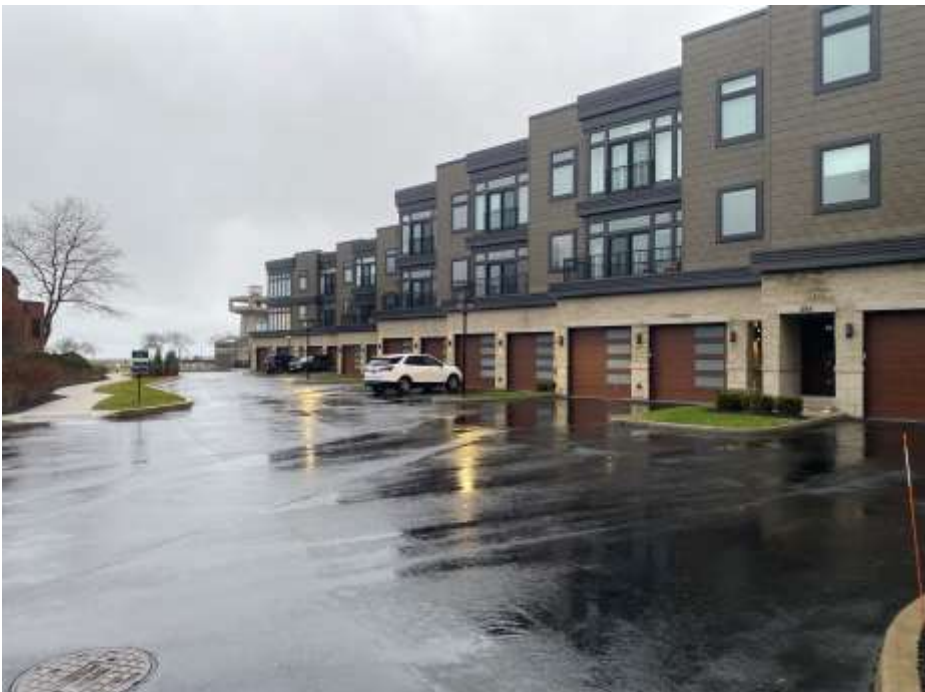
Exhibit:	Date:	240-260 Lakefront Boulevard Periodic Review
6	12/27/2024	Report

Track 4 cover consisting of eight townhomes (Soil Cover Type A) and landscape areas (Soil Cover Type B).

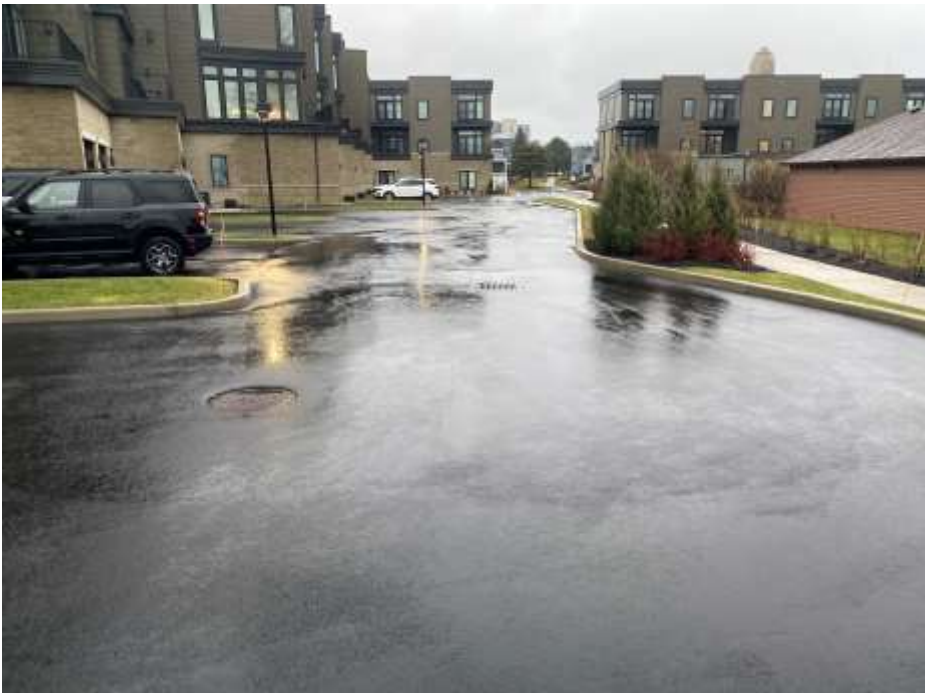
Exhibit:	Date:	240-260 Lakefront Boulevard Periodic Review
7	12/27/2024	Report

Track 4 cover system consisting of driveway (Soil Cover Type A) and landscape areas (Soil Cover Type B).

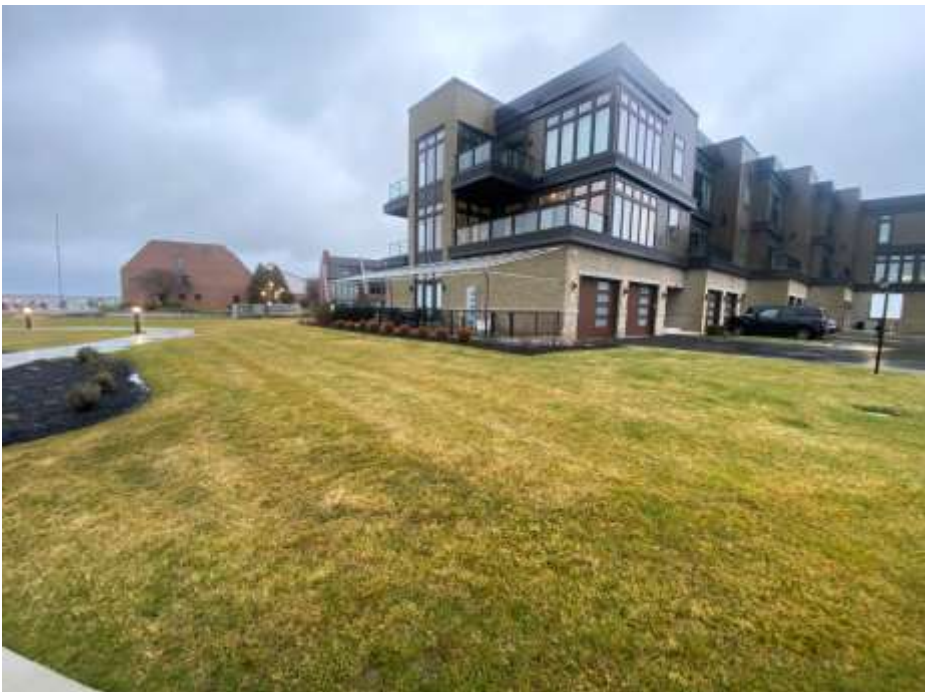
Exhibit:	Date:	240-260 Lakefront Boulevard Periodic Review
8	12/27/2024	Report

Track 4 cover consisting of eight townhomes (Soil Cover Type A) and landscape areas (Soil Cover Type B).

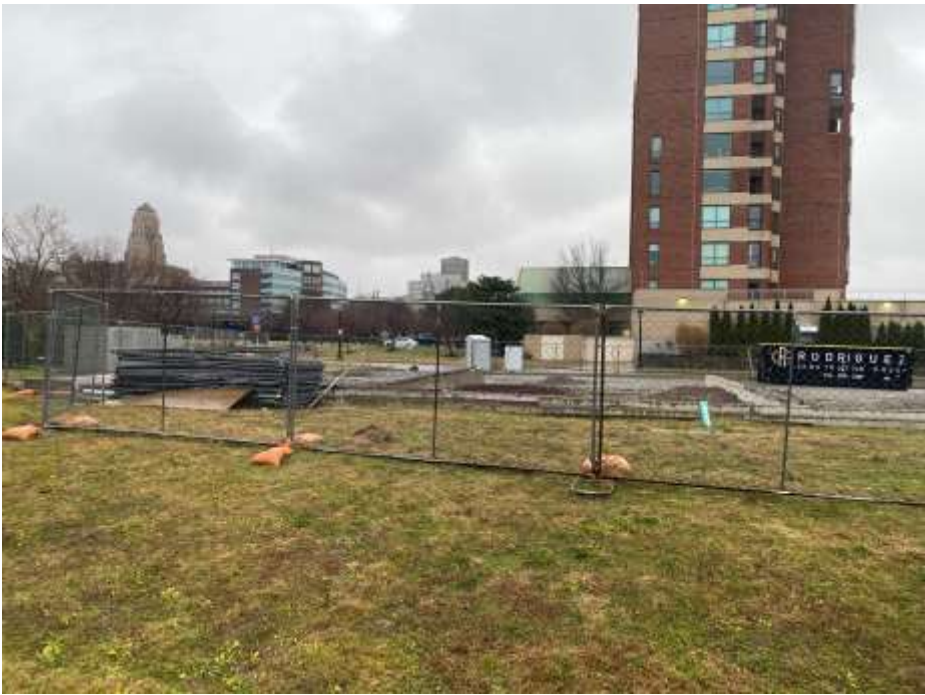
Exhibit:	Date:	240-260 Lakefront Boulevard Periodic Review
9	12/27/2024	Report

Track 4 cover system adjacent to Obijawa Circle. Soil Cover Type A (hardscape) and Soil Cover Type B (landscape).

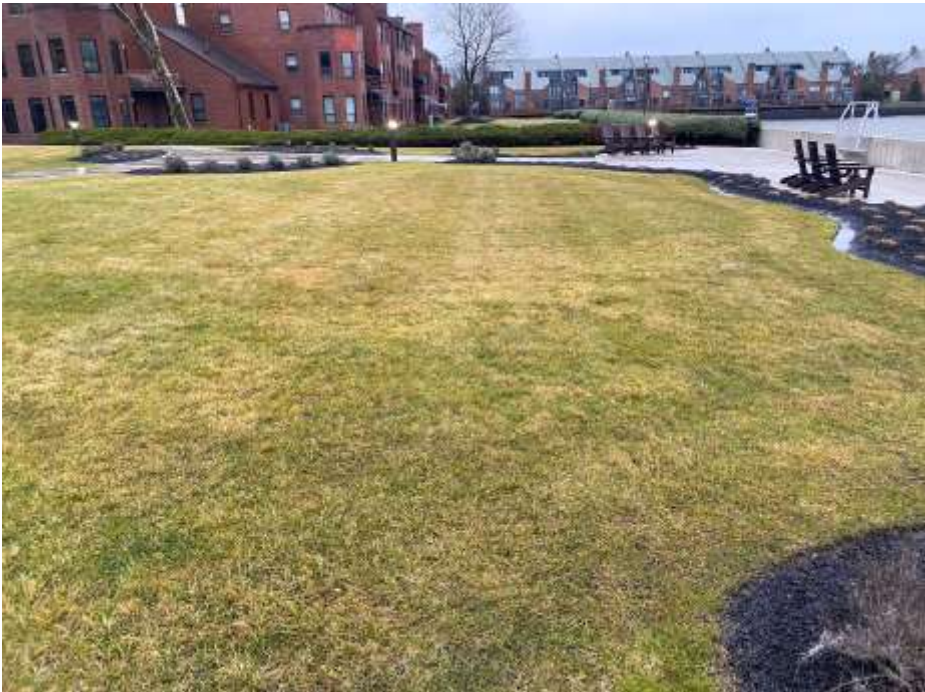
Exhibit:	Date:	240-260 Lakefront Boulevard Periodic Review
10	12/27/2024	Report

Track 4 cover landscape areas (Soil Cover Type B).

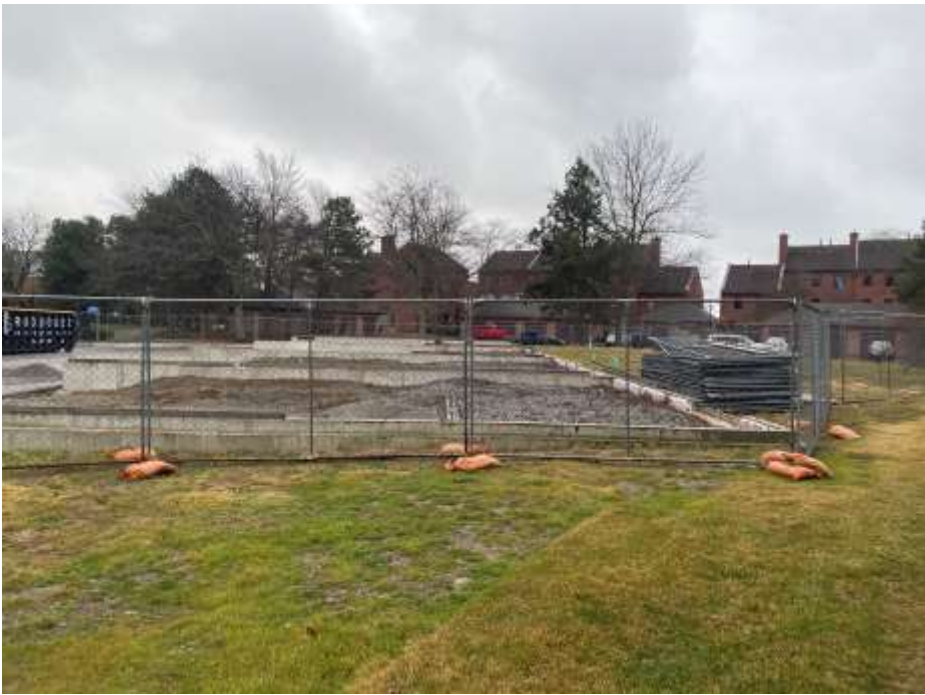
Exhibit:	Date:	240-260 Lakefront Boulevard Periodic Review
11	12/27/2024	Report

Track 4 cover system adjacent to Obijawa Circle. Soil Cover Type A (hardscape) and Soil Cover Type B (landscape).

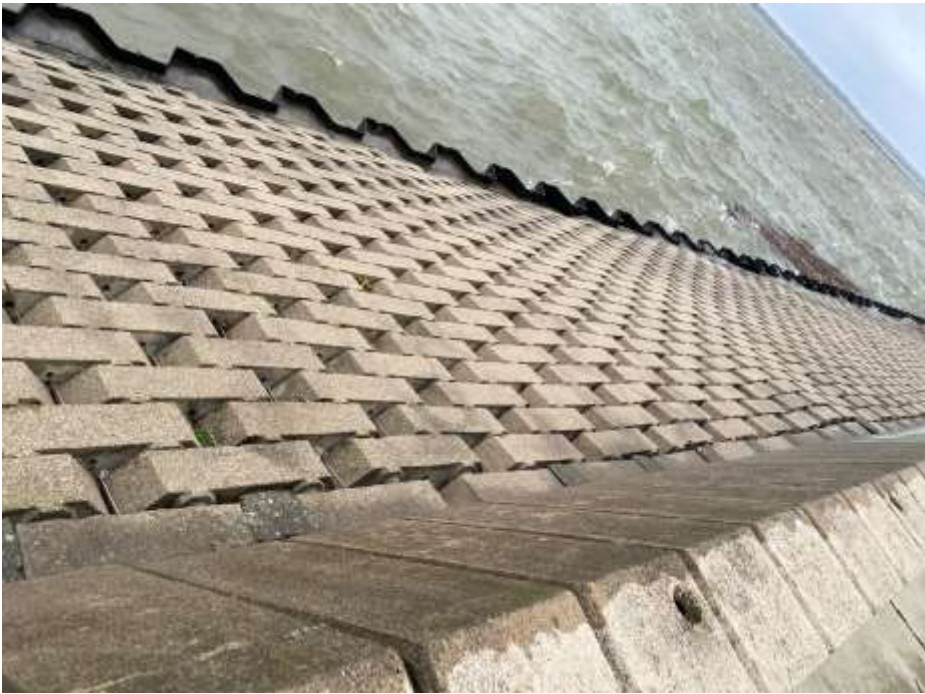
Exhibit:	Date:	240-260 Lakefront Boulevard Periodic Review
12	12/27/2024	Report

The shoring wall appeared to be in good condition with no evidence of physical damage, corrosion, signs of subsidence and structural failure.

Shoring wall.
