Phase I Environmental Site Assessment  
Tonawanda Coke and Related Parcels  
3874 River Road  
Tonawanda, NY

Date: 30 August 2020

Prepared by:  
New York State Professional Geological Services PLLC  
5586 Main St.  
Buffalo, NY 14221

Project No.: 20011

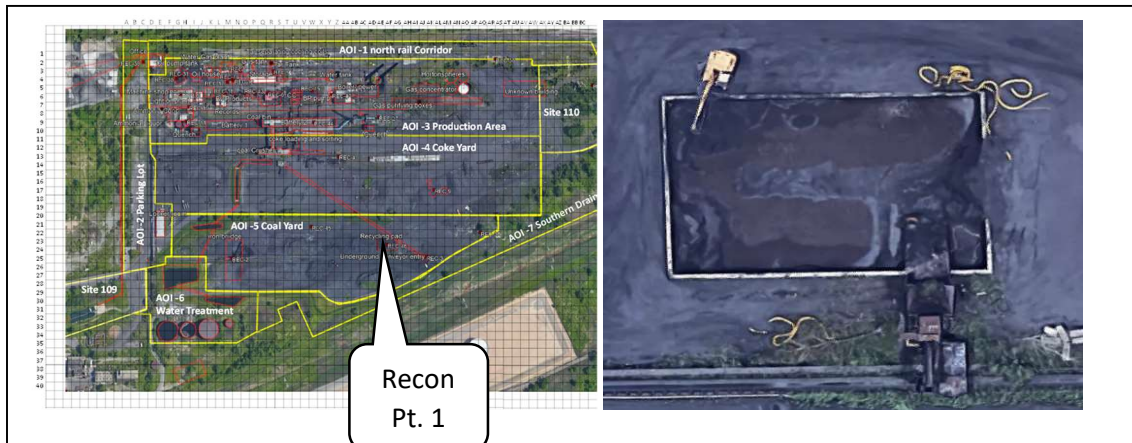
**Recon Pt. 1: Mixing Pad.** This picture shows the concrete mixing pad on the south side of the coal fields. This mixing pad, at grid location AE 24 & AF24, was used to combine sludge and tar with coal before it went to the battery.

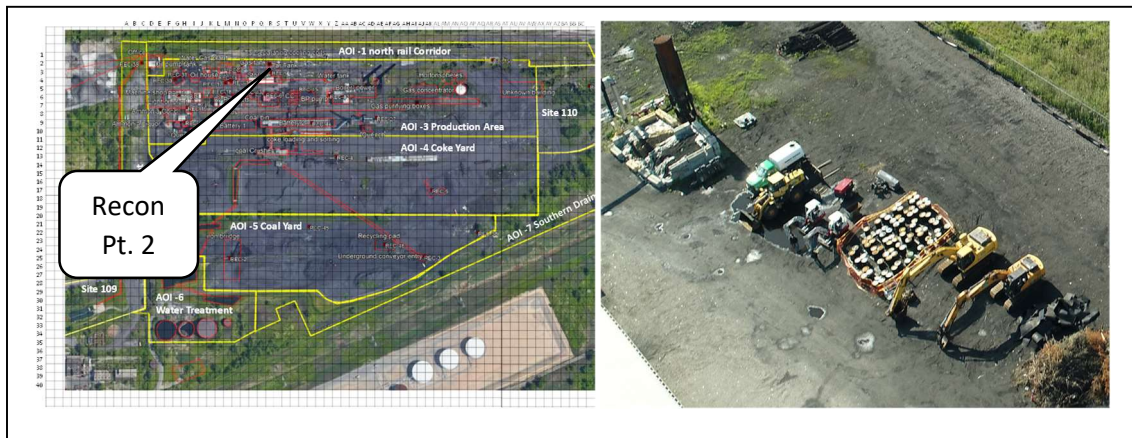
**Recon Pt. 2: Drum Field.** This picture shows the drum field at grid location Q3 on the BCP site. These drums are thought to contain both waste from the site and EPA investigation derived waste.

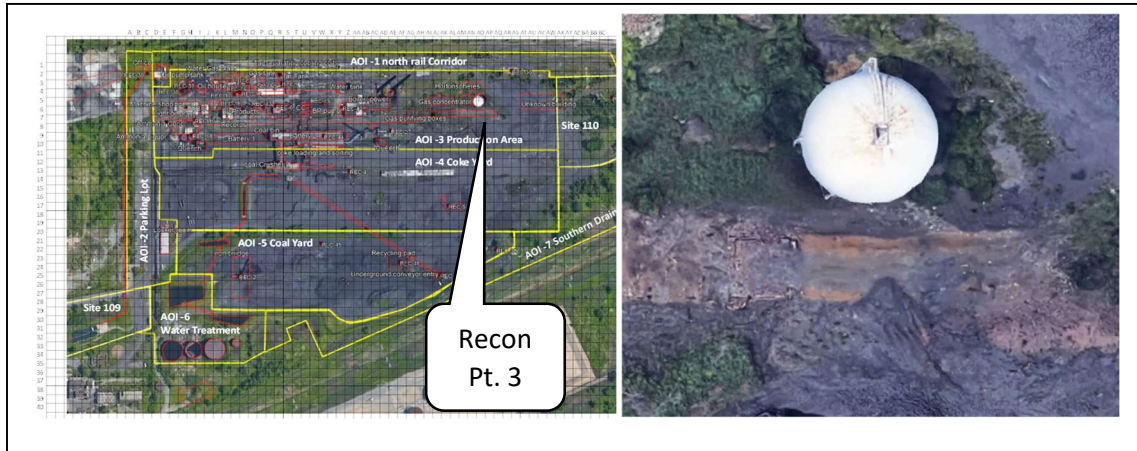
**Recon Pt. 3: Gas Purifying Boxes.** This picture shows the stained soil at the former site of the gas purifying boxes at grid location AL7 in the coke oven gas processing area.

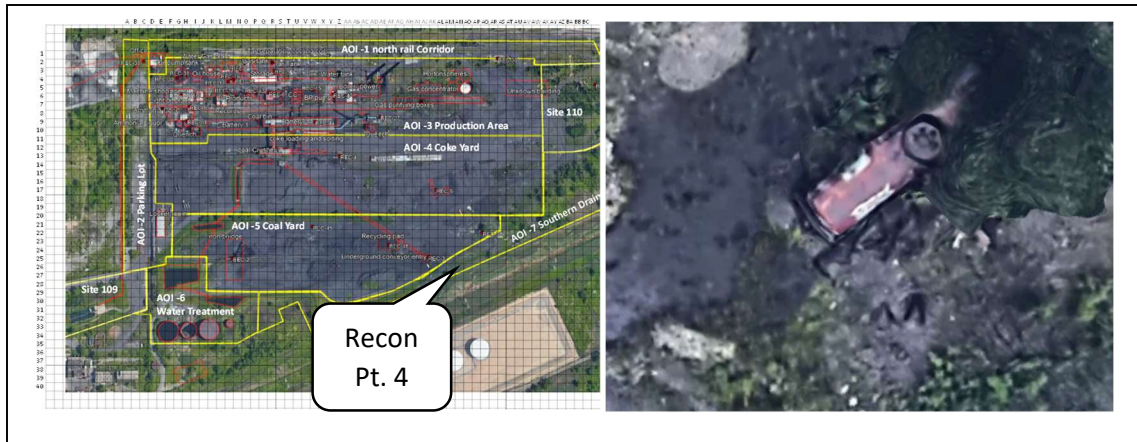
**Recon Pt. 4: Buried Rail Tanker car.** This picture shows the Buried tanker rail car at grid location AP22 on the south side of the BCP site. This rail car may contain or have leaked hazardous material.

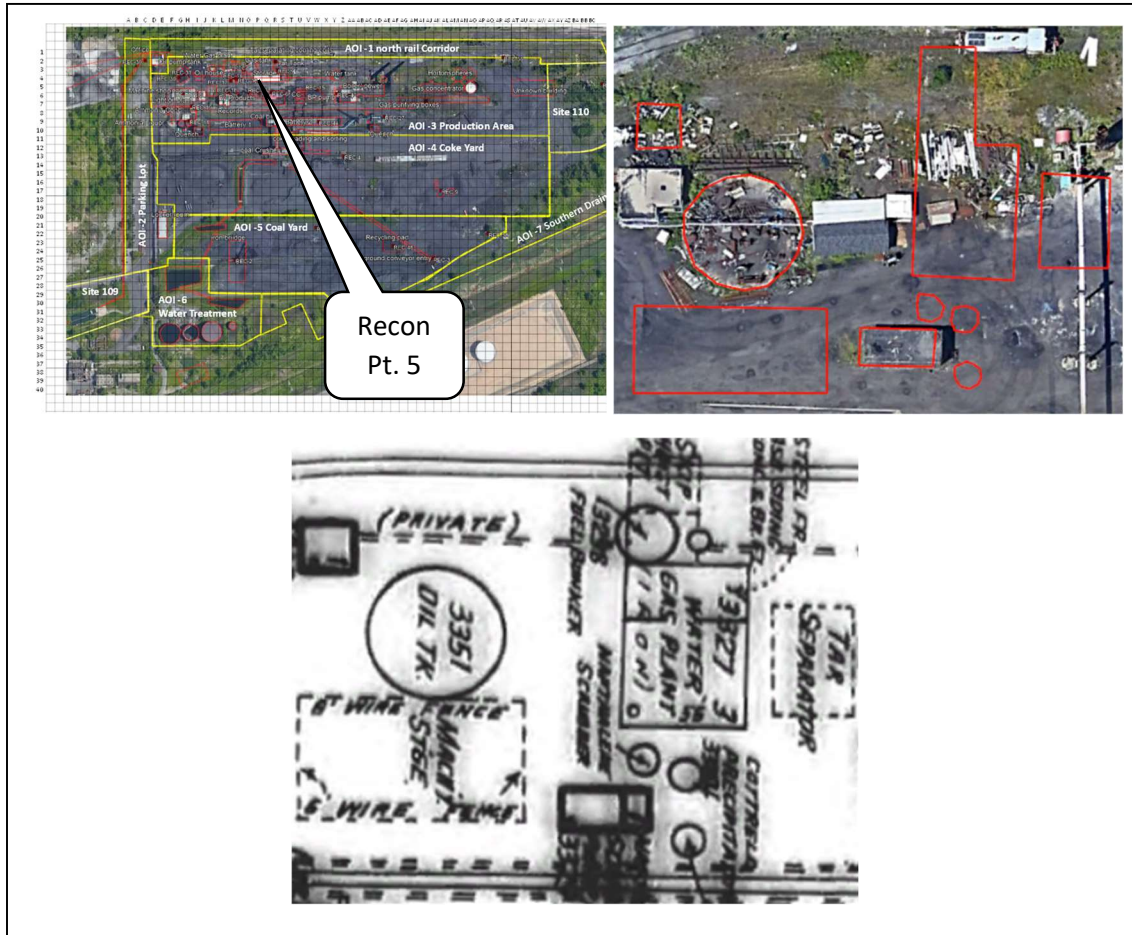
**Recon Pt. 5: Water Gas Plant** This picture shows the former location of the Water Gas plant and naphthalene processing area. This area, at grid location L3&4 and M3&4, may be contaminated with cyanide, naphthalene, tar, and light oil rich in benzene.

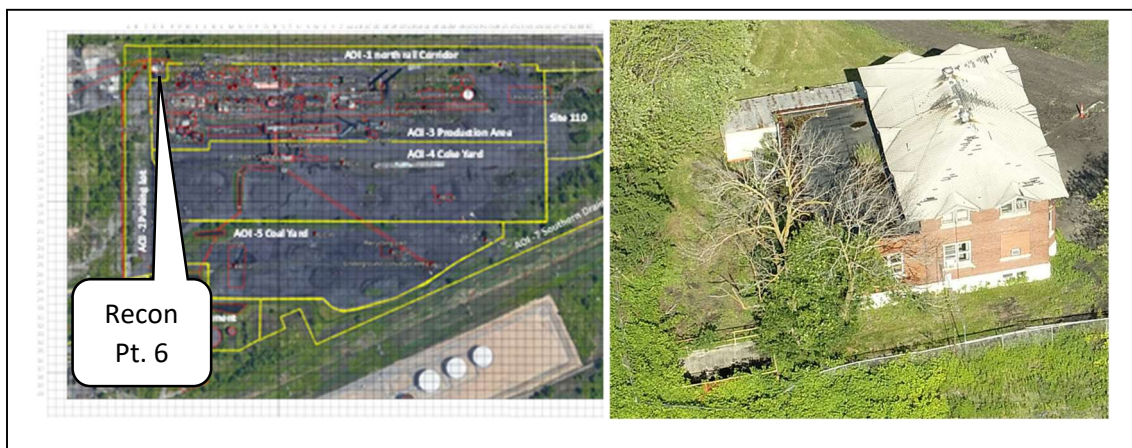
**Recon Pt. 6: Office Stormwater Sump:** This picture shows the open sump in the northwest corner of the office building. This sump at grid location C 3 is the central connection for the abandoned storm water drain with an outfall in the Niagara river (outfall 3).

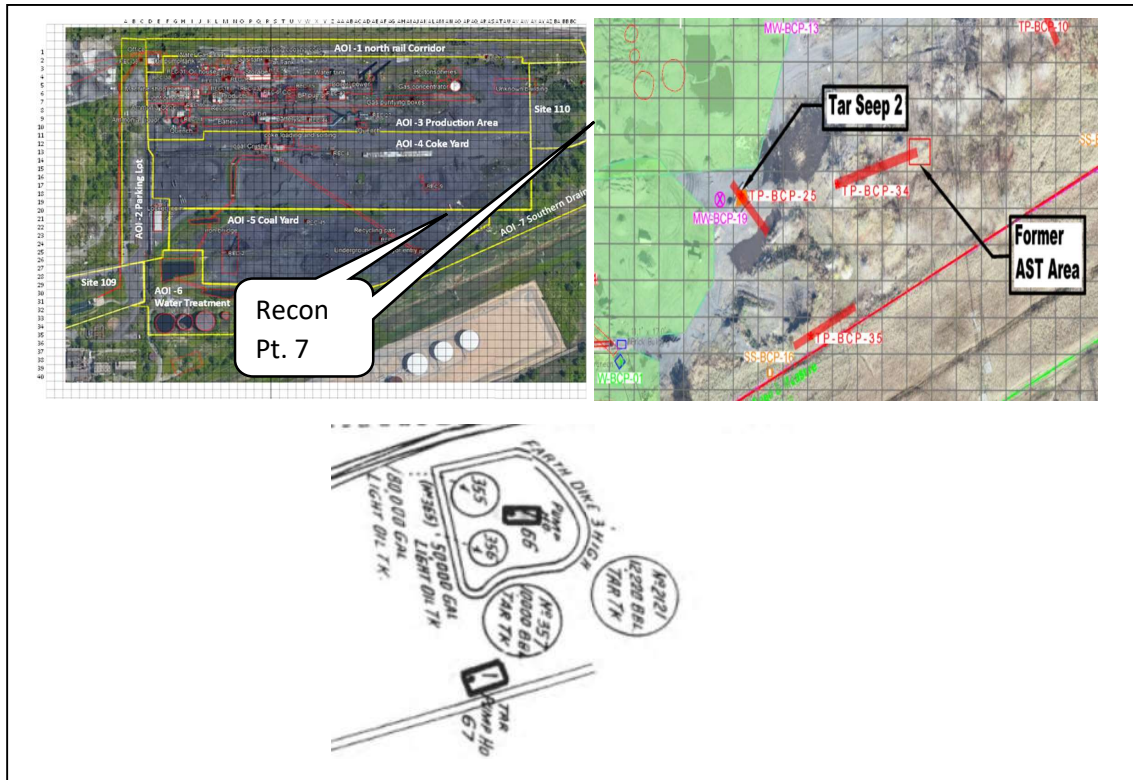
**Recon Pt. 7: Tar Storage Area.** This picture shows the tar and light oil storage area that is visible in aerial photos from 1959 to 1983 but is now completely invisible. The high benzene concentration of the light oil and the high likelihood of spills in an area where the tanks and their contents were removed before 1983 at grid location AL 29 is a continuing concern.

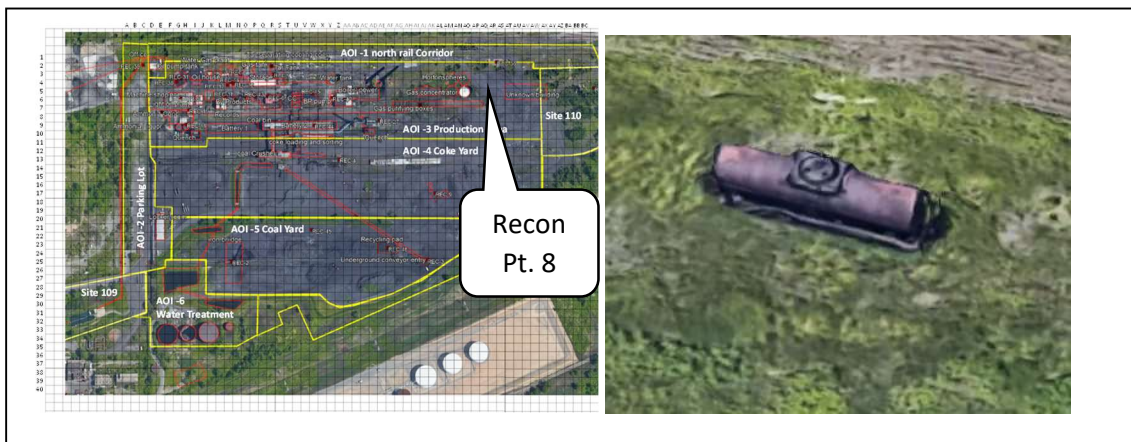
**Recon Pt. 8: Buried Rail Tanker Car.** This picture shows the Buried tanker rail car at grid location R1 to the north of the BCP site. This rail car may contain or have leaked hazardous material.

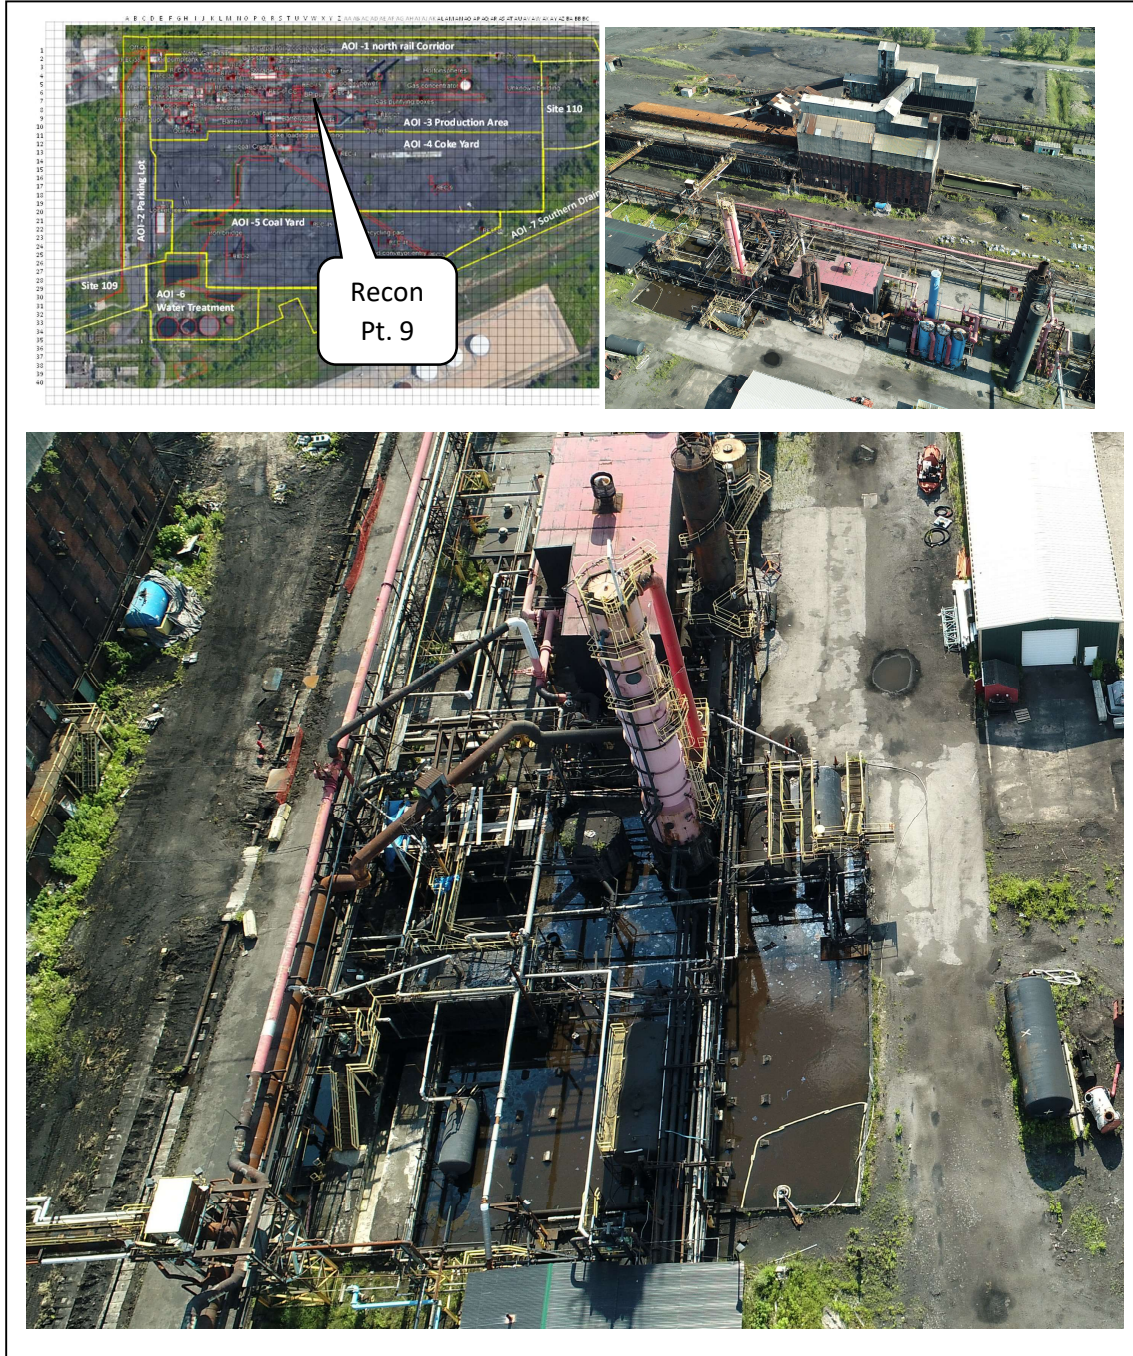
***Recon Pt. 9: Byproduct Building Rear Containment Area*** . This picture shows the containment area at grid location R5 behind the Byproduct Building. The surface of the water has what appears to be a chemical or petroleum sheen on its surface which may indicate the presence of contamination.

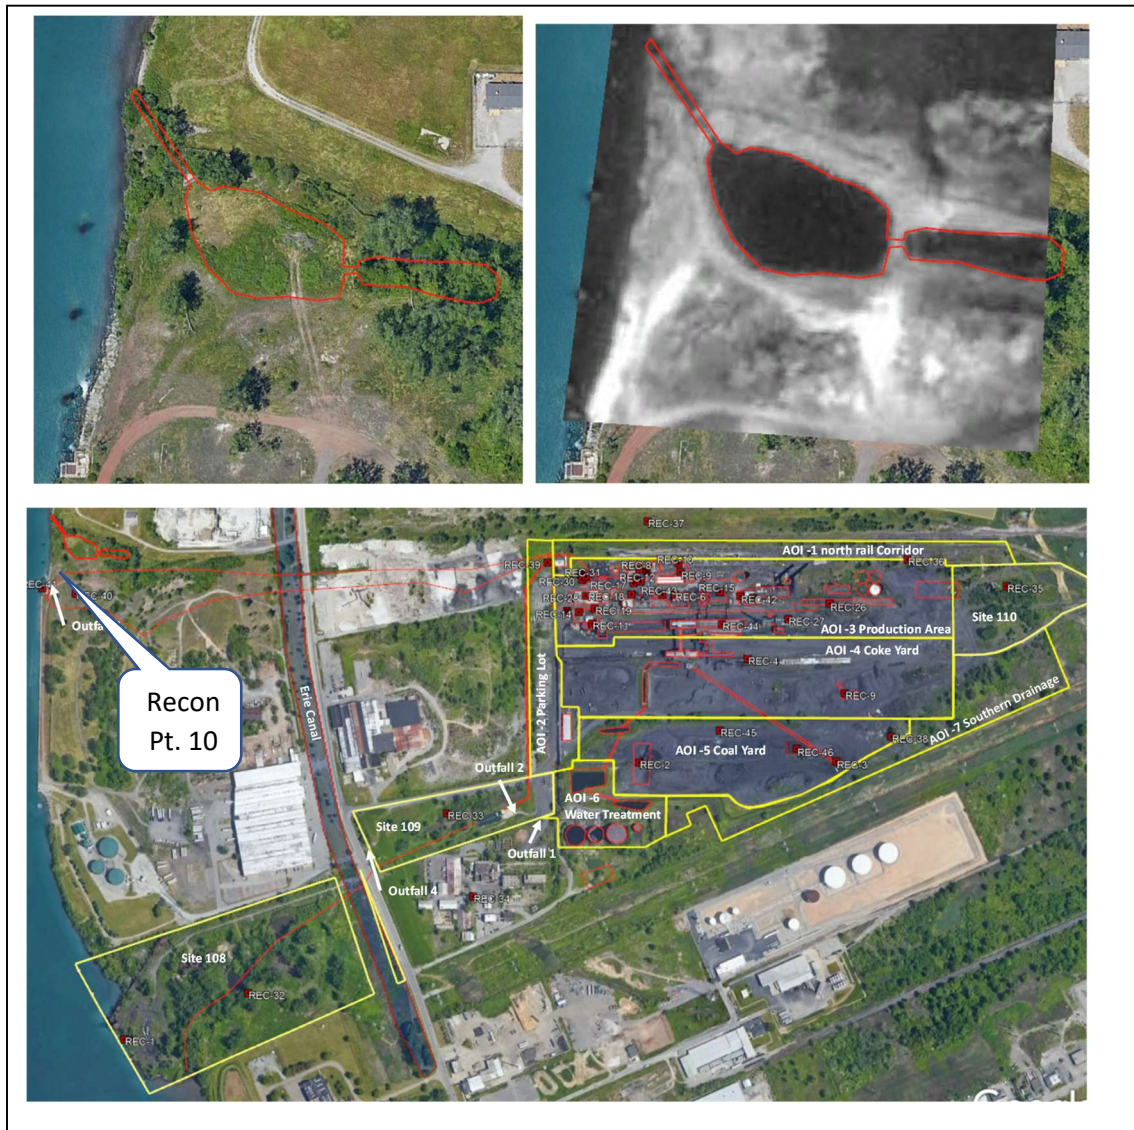
Recon Pt. 10: Outfall 3 and Former Settling Pond. This picture shows the northern outfall connected with the BCP site and the location of a former settling pond from the 1983 aerial photo. The outflow may be an active release point into the Niagara River and the sediment from the ponds may also contain residual contamination. The former Rattlesnake Island Channel sits to the east of the ponds.
