# **Tank Management and Closure Construction Completion Report Tank No. HW1**

Riverview Innovation & Technology Campus  
Brownfield Cleanup Program Site No. C915353

3875 River Road  
Tonawanda, New York 14150

August 19, 2025

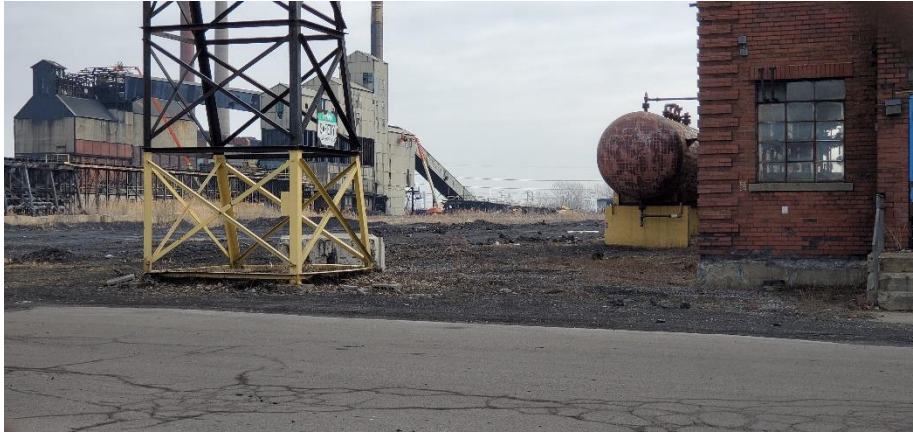
| <b>Photo No. 1</b><br><b>Direction Photo Taken:</b><br><br>View is east. | | |

| <b>Description:</b><br><br>HW1 was a hot water tank located north adjacent to the former Shower/Locker Building. | | |

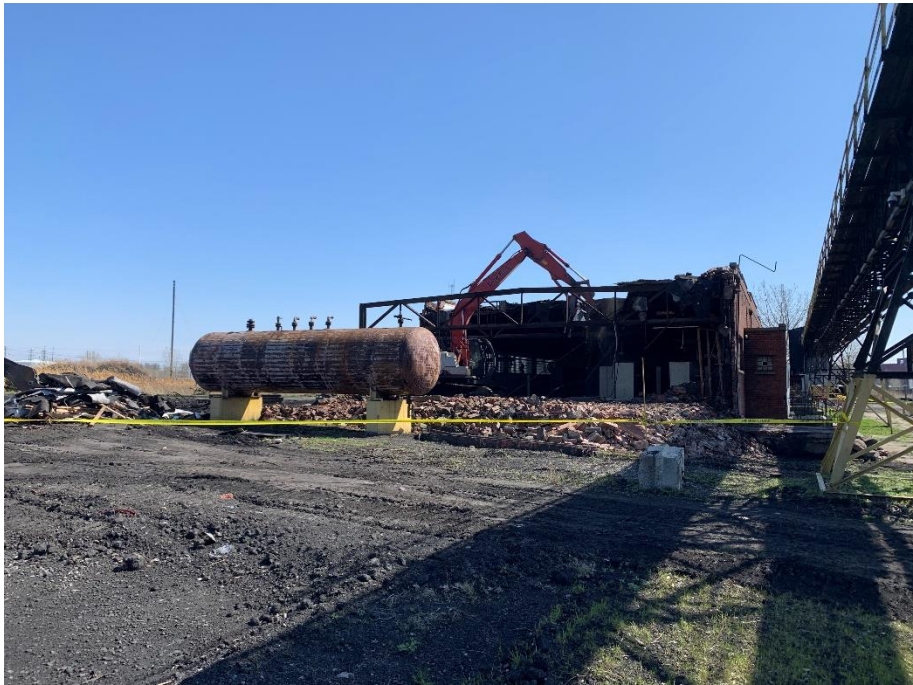
| <b>Photo No. 2</b><br><b>Direction Photo Taken:</b><br><br>View is south. | | |

| <b>Description:</b><br><br>HW1 was a hot water tank located north adjacent to the former Shower/Locker Building (being demolished in this photograph). | | |

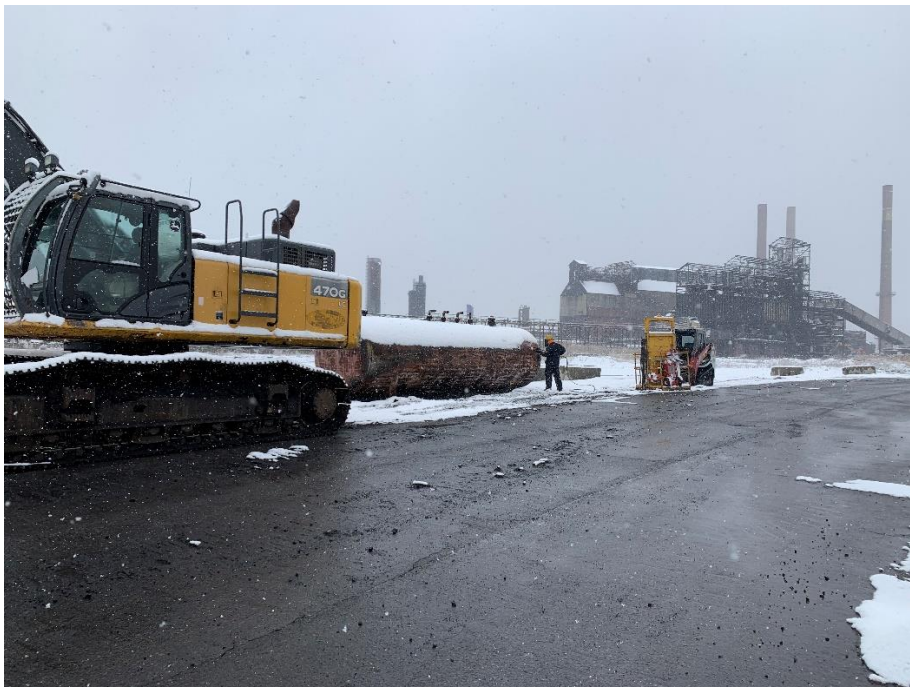
| <b>Photo No. 3</b> | | |

| <b>Description:</b><br><br>HW1 steel is torch cut to size in preparation for recycling. | | |

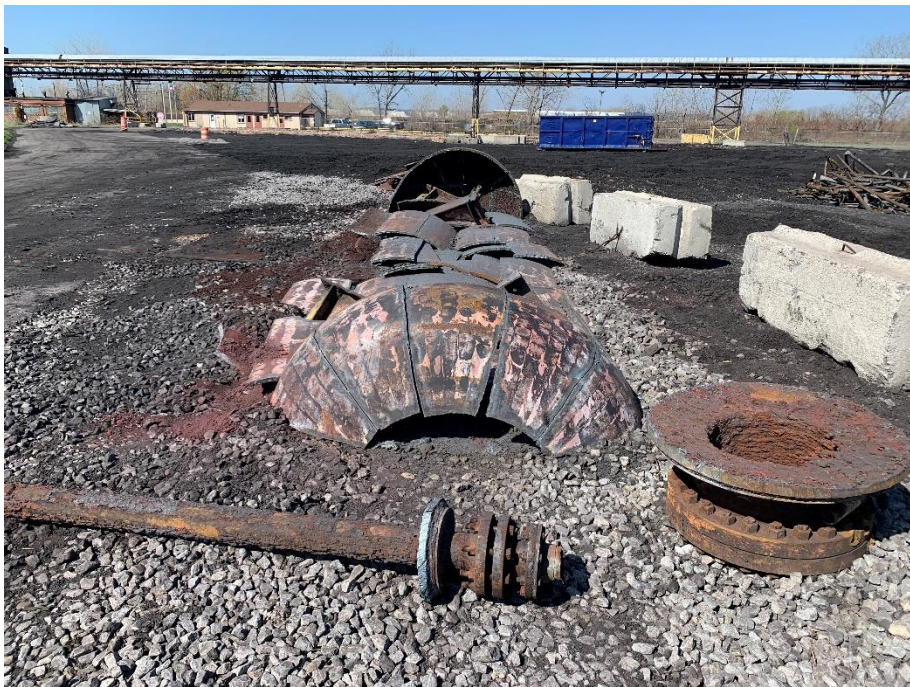
| <b>Photo No. 4</b> | | |

| <b>Description:</b><br><br>The shell of HW1 has been sheared for recycling. | | |
