April 22, 2021

To: Benjamin McPherson (NYSDEC)

From: Todd Waldrop (Inventum)

RE: Surface Water System - Next Steps
Riverview Innovation & Technology Campus, Inc.
Brownfield Cleanup Program Site No. C915353
Town of Tonawanda, New York

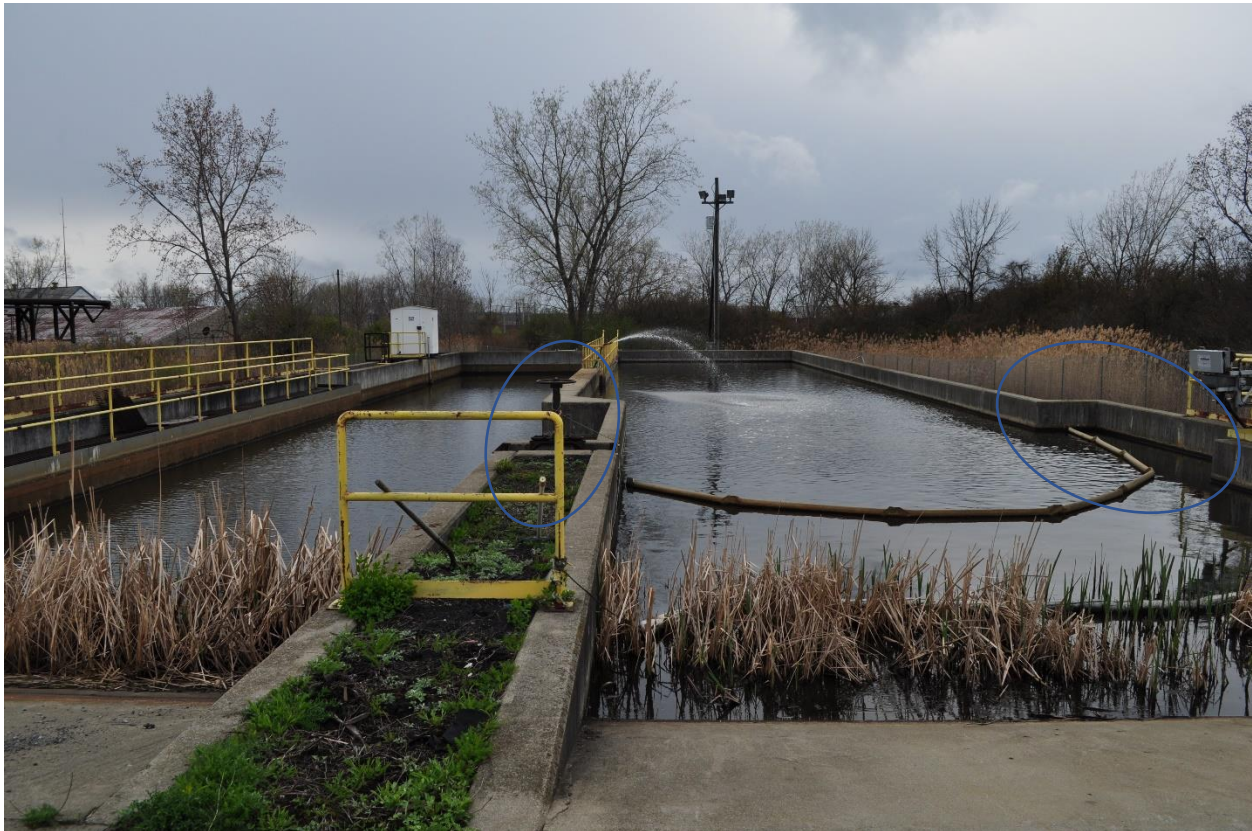
Sediment Traps in Settling Ponds

- Seepage into the Box Culvert between the Battery and the junction with the North South Section of the Box Culvert (Figure 2, Between Grids Q8 and D7);
- Flow from the North Storm Sewer containing sediment and seepage from the north side of the process area;
- Mobilization of sediment or portioning of compounds from the sediment in the North Pond (The silt traps at the primary outfall is full, see trap locations outlined in the photo below).

3. Clean out the Concrete-lined Settling Ponds;
 - a. Draft, revise and obtain approval for a Settling Pond IRM Work Plan, including;
 - i. Sequentially Open and Close each set of Valves:

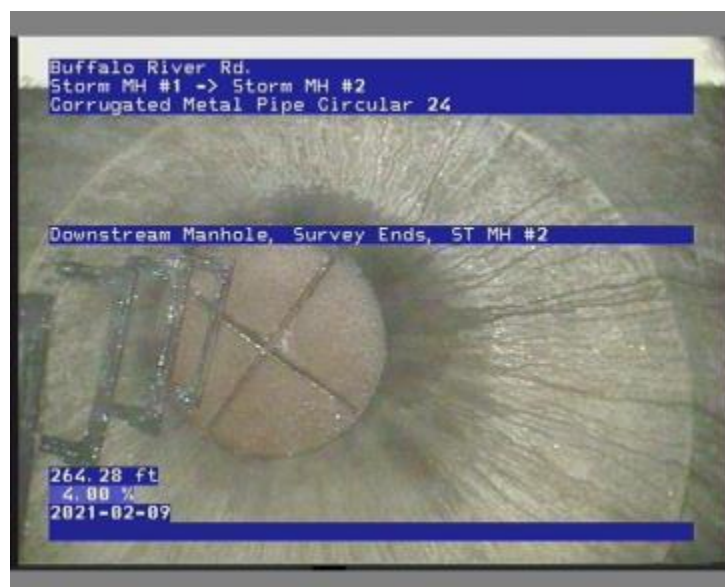
MH #1 to MH #2 (264.2-foot-long section, traveling south, February 9, 2021)

- Clean Corrugated Metal Pipe
 - First 36 Feet (0 – 36 feet)
 - There is little flow or sediment evident in video, water appears to be clear.
 - Little more sediment at 36 feet (joint?)
 - 36- to 180 feet
 - Water still appears to be clear.
 - Water gets deeper, max at 60- to 85-feet (uneven pipe slope?)
 - Water shallow is by 180 feet
 - 180- to 264.2 feet
 - Water gets deep quickly after 180 feet
 - Deeper water after 190 feet
 - Pipe $\frac{1}{4}$ full of water by 230 feet
 - Water very clear at MH#2 \approx 260 feet, some fine sediment stirred up as robot stopped.
 - Some wood (possible root material) debris in manhole sump.

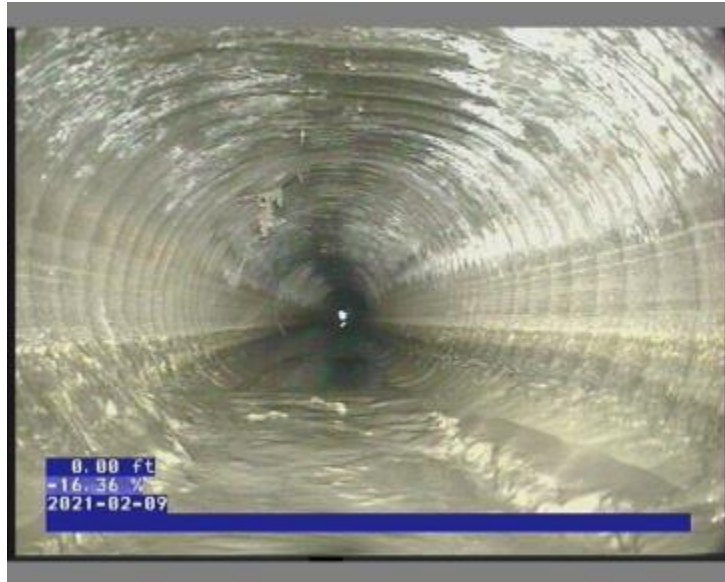
MHA to MH #1 (218.2-foot-long section, traveling northeast to Mansion Sump [MH #A], February 9, 2021)

- Clean Corrugated Metal Pipe
 - First 0- to 25 feet
 - Some brown/tan sediment on bottom of pipe.

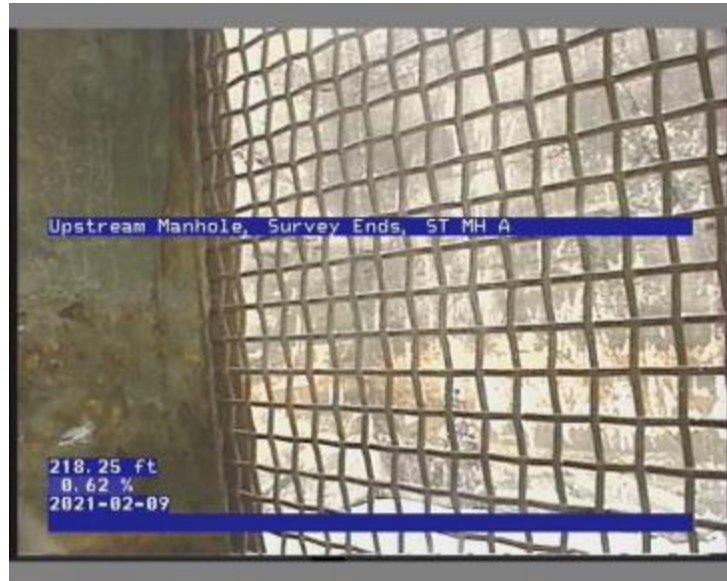
- 25- 80-feet
 - Root across bottom at joint 56 feet
 - Some sediment at roots, water cloudy to 70-feet.
 - Little water at 80 feet
- 80- to 190-feet
 - The depth of water increases from 80- to 90-feet
 - Gray and tan sediment at 90 feet
 - Roots (minor) at ~118 feet
 - Standing water $\frac{1}{4}$ to $\frac{1}{3}$ after \approx 125 feet
 - Less apparent water depth after at 170 feet
- 190- to 218.2 feet
 - Deeper as approach MHA
 - Roots at 190 feet (minor)
 - MHA at grate (mansion sump)
 - No flow from Mansion Sump so only a small amount of water is standing in pipe. (No flow observation is possible as there is a layer of snow at grate)
 - Pipe not level or backed up from ponds

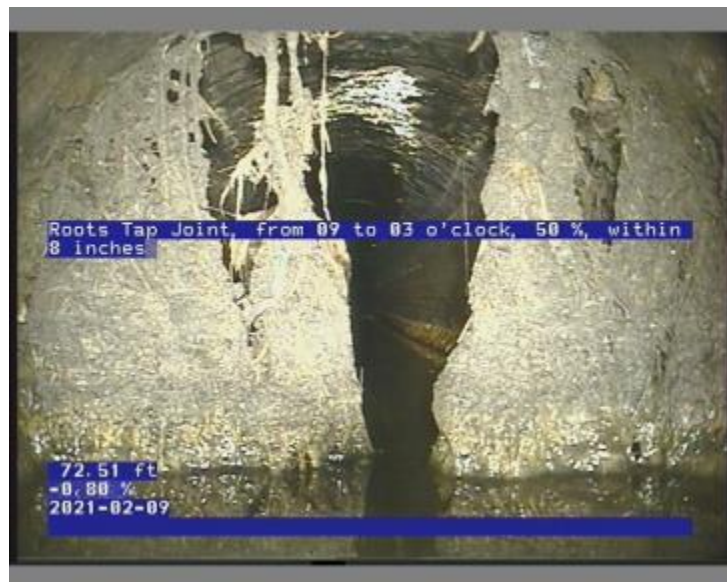
MH #2 to MH #3 (568.1 .2-foot-long section, traveling south from Manhole #2 to Manhole #3, February 9, 2021)

- 0- to 280 feet
 - Water \approx $\frac{1}{4}$ full along this segment
 - Hanging root mat at 73 feet; broke through

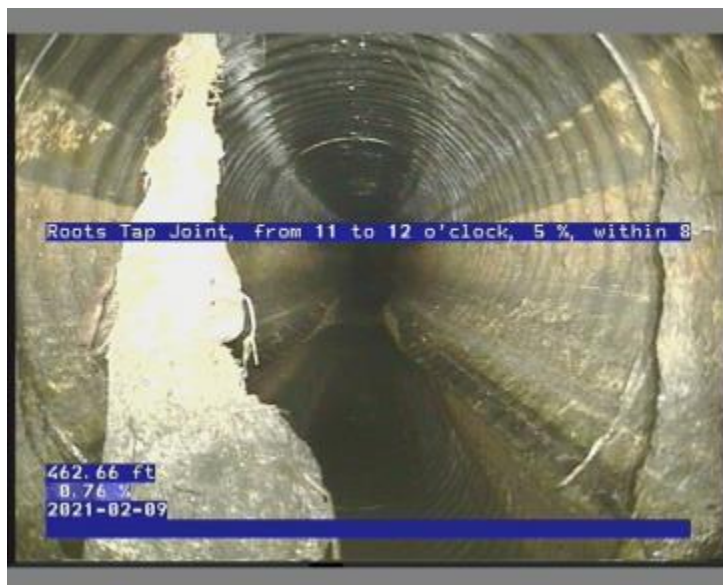
- Water with much more floating detritus after 73 feet, brownish yellow. Some black floating material similar to the organic material that forms on ponds periodically.– Water is backed up?
- Water clearer after 280 feet.
- 280- to 568.1-feet
 - Water appears clear by 350-feet.
 - Roots, heavy at 462-feet; Robot passed

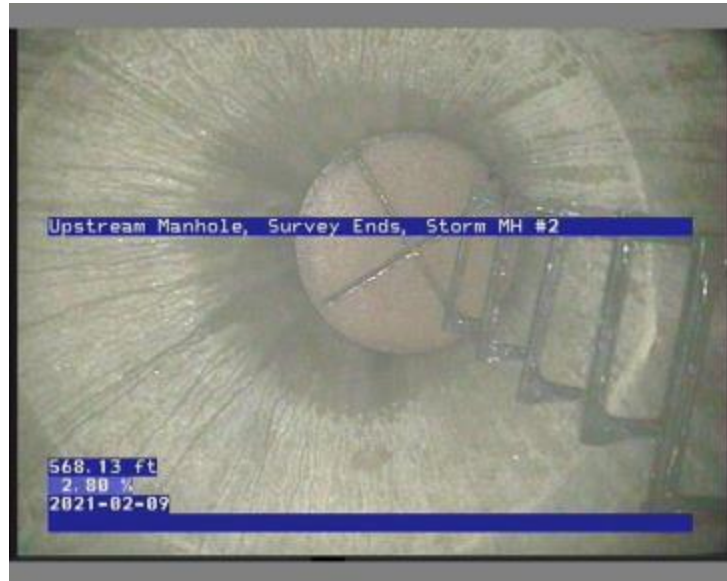
- Water noticeably clearer after roots passed.
- Water depth almost zero at 520 feet.
- There is a sudden change and water becomes deeper after 520 feet, notable depth of water by 530 feet.
- Water with dark sediment at approach to MH #2.
- MH#2 sump appears to be full of black sediment and a piece of wood (root material?).

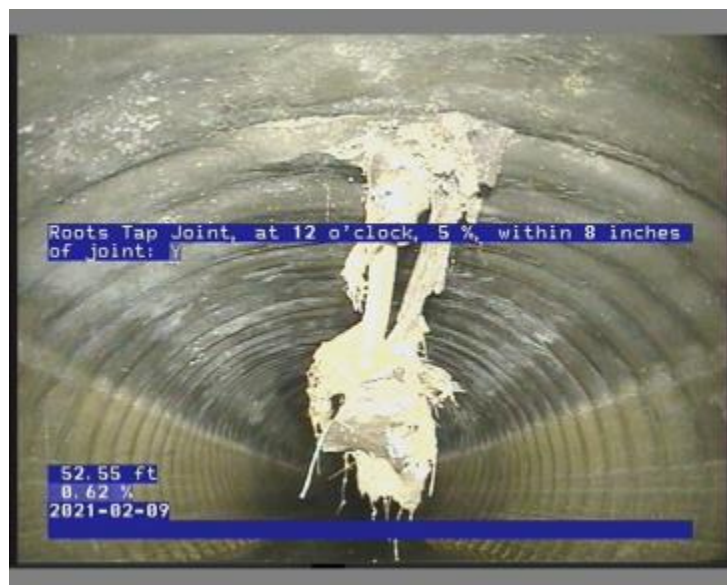
MH #3 to MH #4 (383.1-foot-long section, traveling south from MH #3 to MH#4, February 9, 2021)

- 0- to 95-feet
 - Water, dark with sediment from start (0 feet)
 - Roots at 52 feet
 - Water at $\frac{1}{4}$ depth at 52 feet
 - Note the pipe high water mark appears to have been $>3/4$ full.

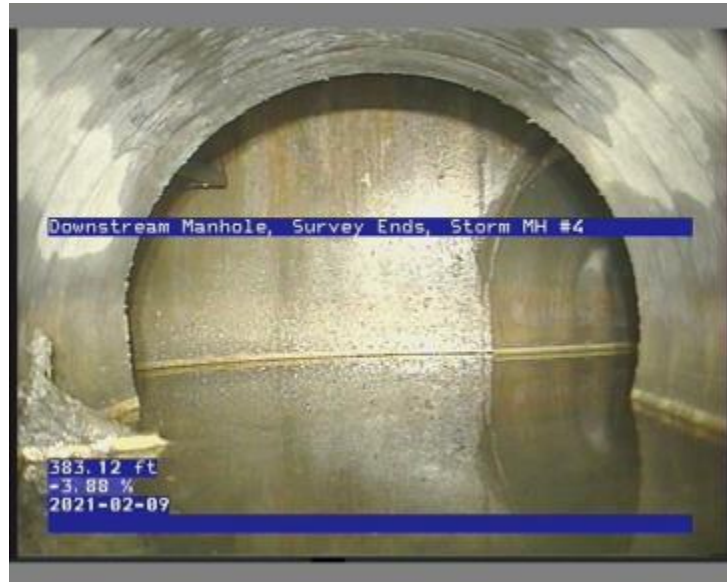
- 95- to 383.1 Feet
 - Water cloudy at 200 feet.
 - Water depth is 1/3 of the pipe by 260 feet.
 - The robot stirred up brown sediment at ~285 feet.
 - Water depth is nearly ½ by 340 feet.
 - Water at ¼ depth at MH #4, some sediment apparent (383 feet).

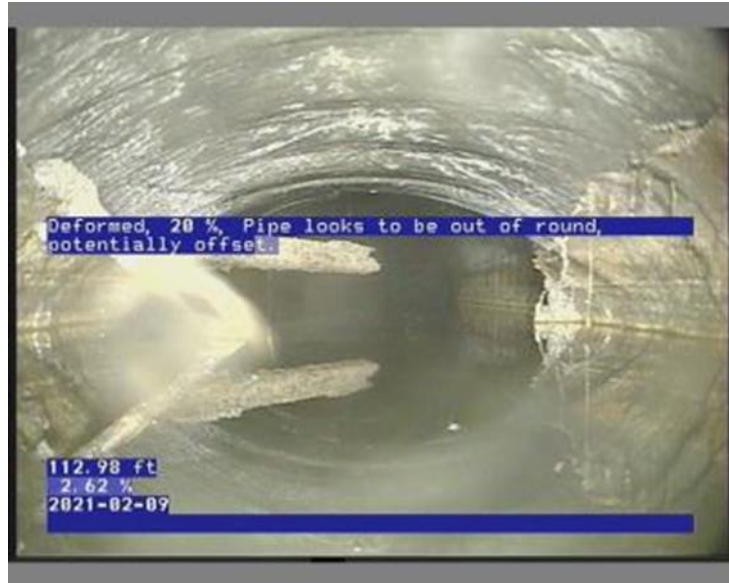
MH #4 to Ponds (113-foot-long section, traveling west-southwest from MH #4 to Settling Pond, February 9, 2021)

- 0- to 113 feet
 - Water ≈ 1/3 full, but appears to be standing (Backup from pond)
 - Water has clear appearance, some floating detritus.
 - Roots visible ~ 65 feet.
 - Roots at 111'; Large roots and water ½ to ¾ full. Standing water based on video
 - Pipe deformed at 112.98 feet, wood, or metal debris?
 - Robot could not pass deformed section of pipe.

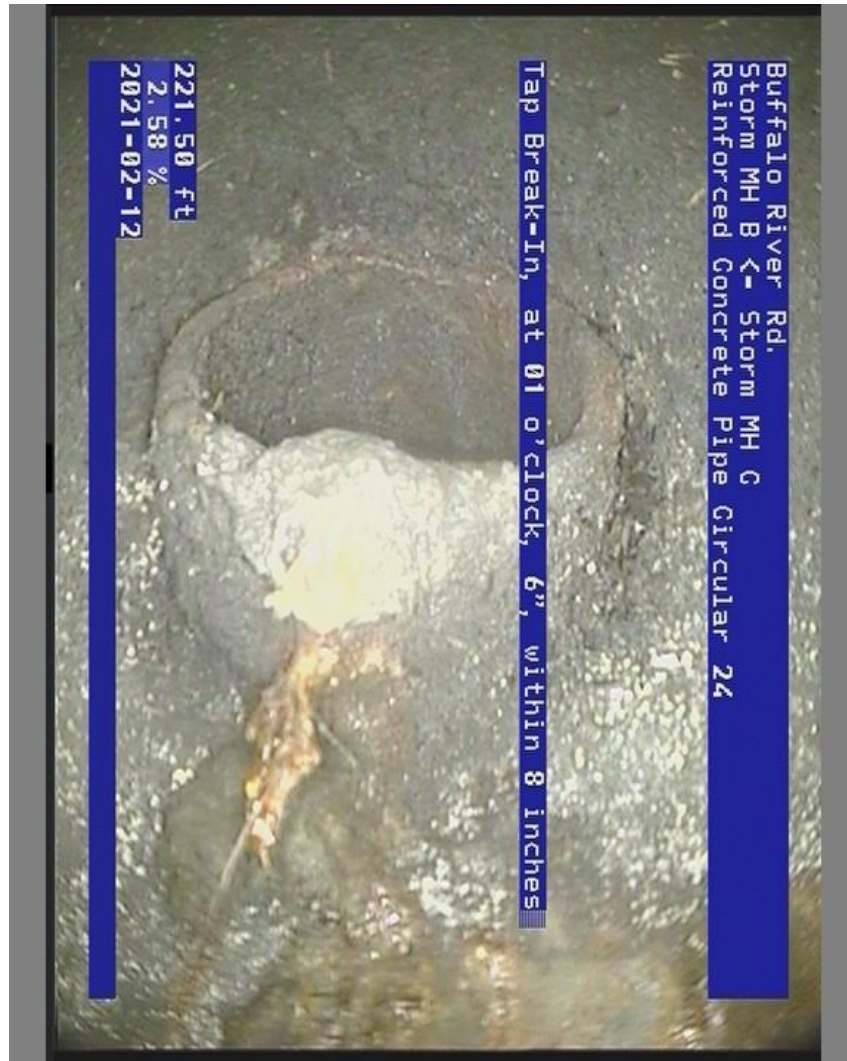
MH#C to MH#B (223-foot section traveling northwest from MH #C to Manhole B (Toward Mansion Sump), February 12, 2021)

- Smooth concrete 24" diameter concrete pipe
 - 0- to 90-feet
 - Much more coating and sludge than the North-South Storm Sewer.
 - Backup of liquid that is largely full of sludge and sediment. No visible movement.
 - Sludge/sediment appears to be dark gray to yellow.
 - Sludge sediment is dense enough that the robot is riding on (v moving through) the materials.
 - Around 90 feet the coating on the walls is less apparent.
 - 90- to 223- feet
 - Joints have seepage of "sludge" ≈ 100- to 130 feet, more from 130- to 180-feet.
 - Heavy sludge seepage at 200- to 210 feet.
 - Lateral at 220' (8-inch diameter)
 - At 223 feet, manhole construction set too high, causes backup of liquid. Water at manhole base appears to be only 1-inch.

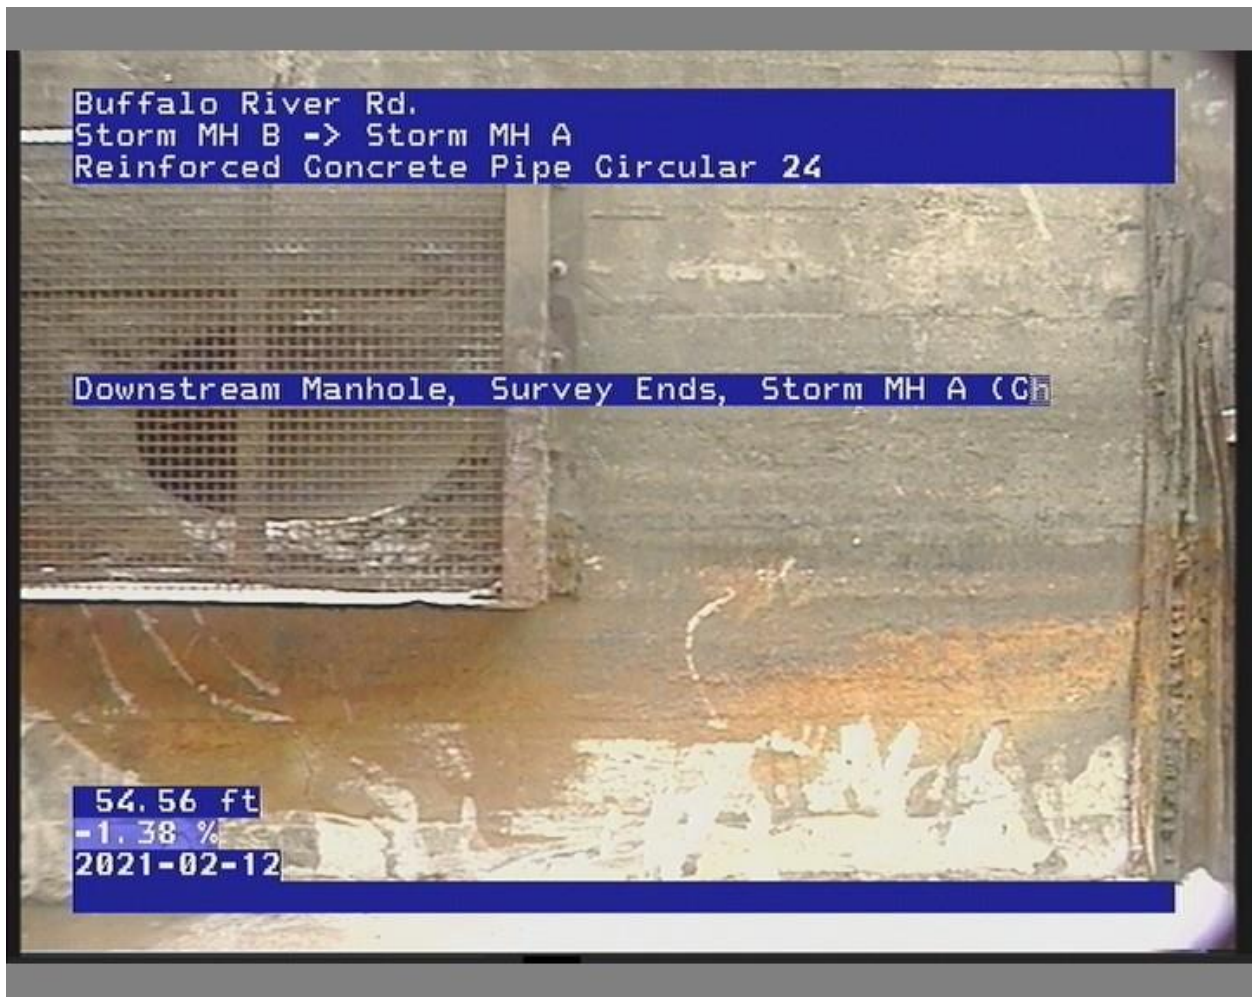
MH #B to MH #A (traveling west from MH #B to Manhole A (Mansion Sump), February 12, 2021)

- Smooth concrete 24" diameter concrete pipe
 - Coating around entire circumference.
 - Heavy sludge at bottom $\approx 4"$ thick. Materials are in piles v loose material with a level surface.
 - Thick sludge buildup to Mansion Sump
 - Notable that there is little water flow/depth at Mansion Sump (shows how irregular the slope of the North Storm Sewer is).

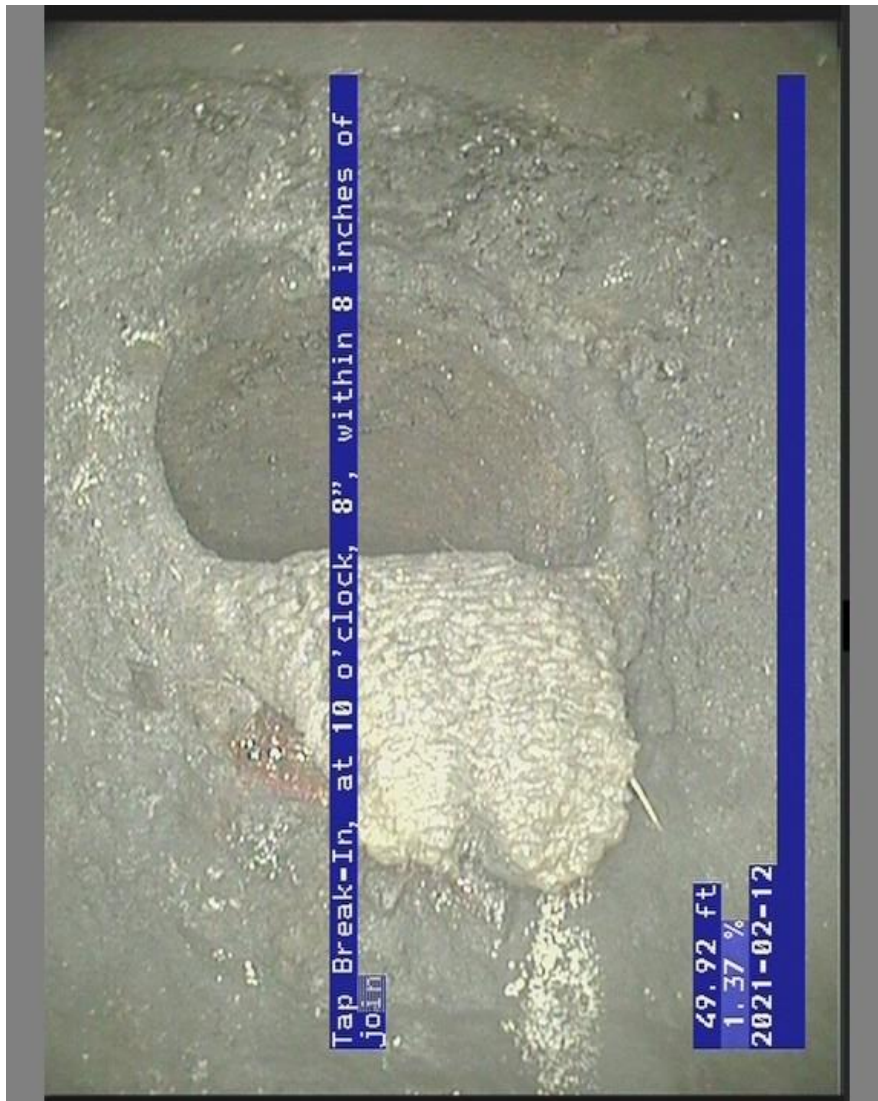
MH #D to MH #C (traveling west from MH #D to Manhole #C (Sample Location)),
February 12, 2021)

- Smooth concrete 24" diameter concrete pipe
 - Pipe clear at 0- to 20 feet. Little visible coating or sediment.
 - Some sediment leakage through joints 20 feet. (Video misty)
 - 8-inch diameter pipe lateral at 50 feet (See picture, sediment load from lateral)

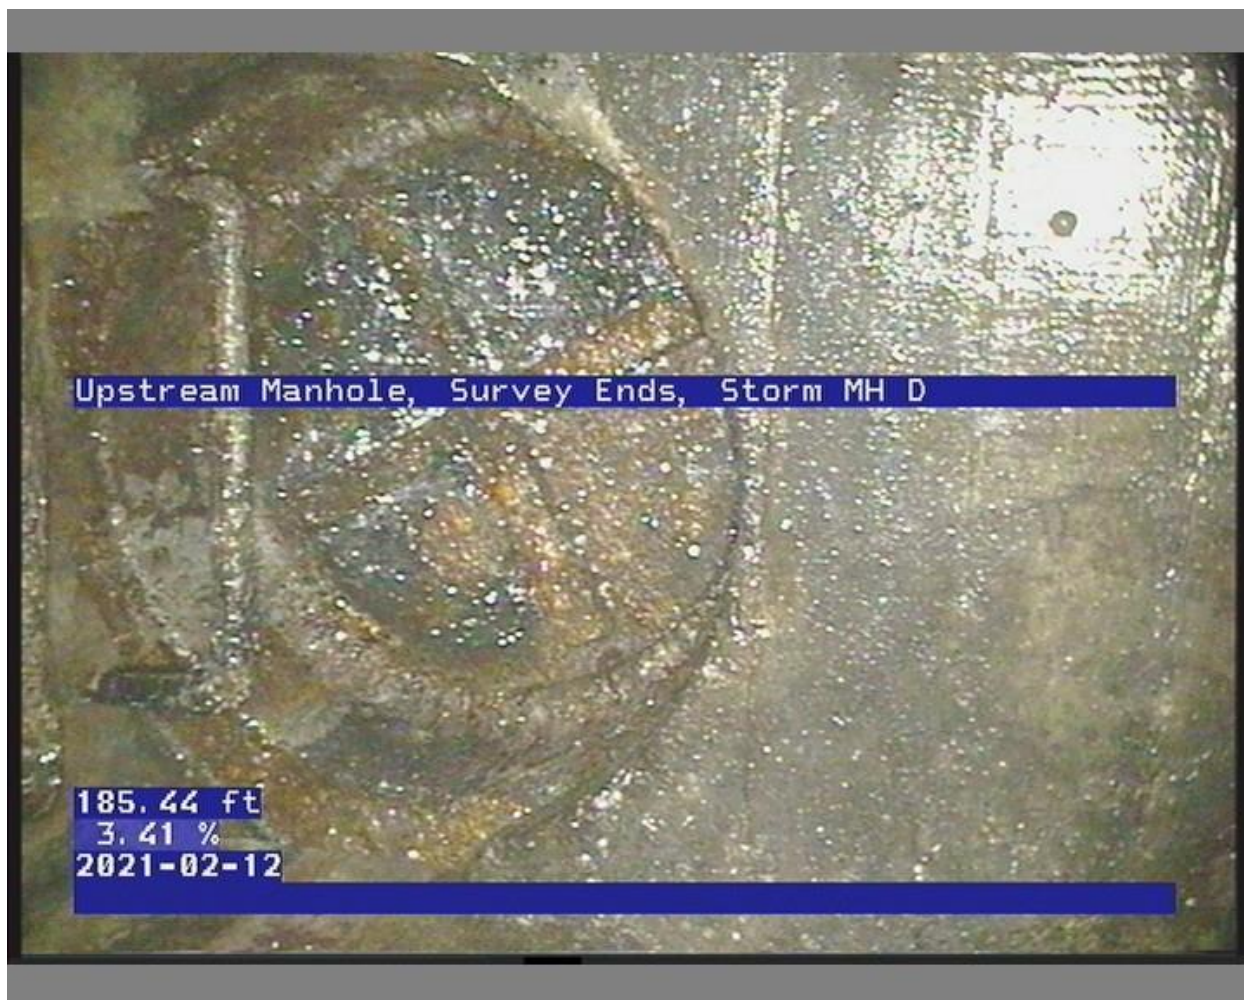
- Some form of penetration (root or pipe?) at ~167 feet, top ¼ of pipe.

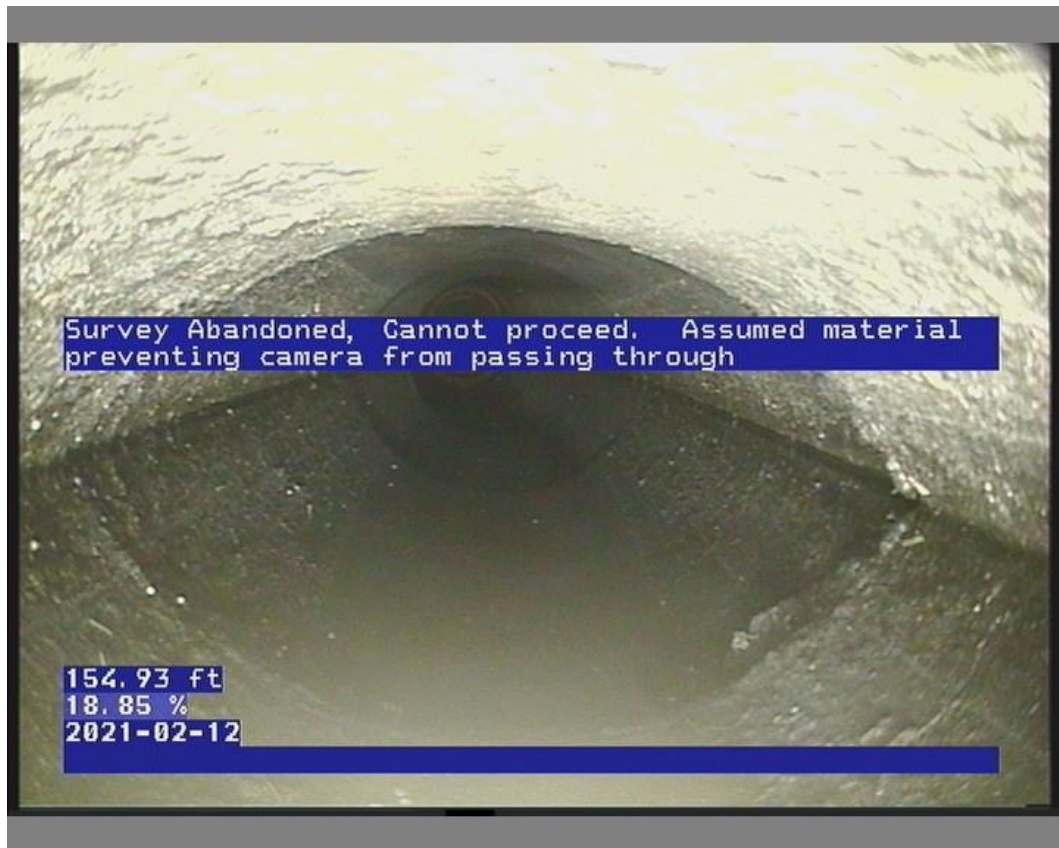
MH #E to MH#D (traveling west from MH #E to Manhole #D1, February 12, 2021)

- Some joints with yellow buildup.
- At 2" by 120' flow \approx 2" deep.
- Possible lateral at \sim 150 feet, top $\frac{1}{4}$ of circumference but crusted over, no flow.
- Box manhole, pipes not directly opposite/offset. Significant sediment in base.
- After manhole, water \approx 2" deep, pipe clean
- Water $> \frac{1}{2}$ by 130' clear
- Coating on pipe, after 130 feet. Sufficient coating to obscure joints. Appears to be light colored in video, possible organic sludge.
- Obstruction at 154.93 feet.
