PRE-RENOVATION SURVEY
FOR
LEAD-BASED PAINT
AT
SILO CITY – AMERICAN BUILDING
85 SILO CITY ROW
BUFFALO, NEW YORK

FEBRUARY 2020

Watts Architecture & Engineering (Watts) was retained by Generation Development Group to perform a pre-renovation survey for lead-based paint (LBP) as part of the renovations to the American Building located at 85 Silo City Row, Buffalo, NY.

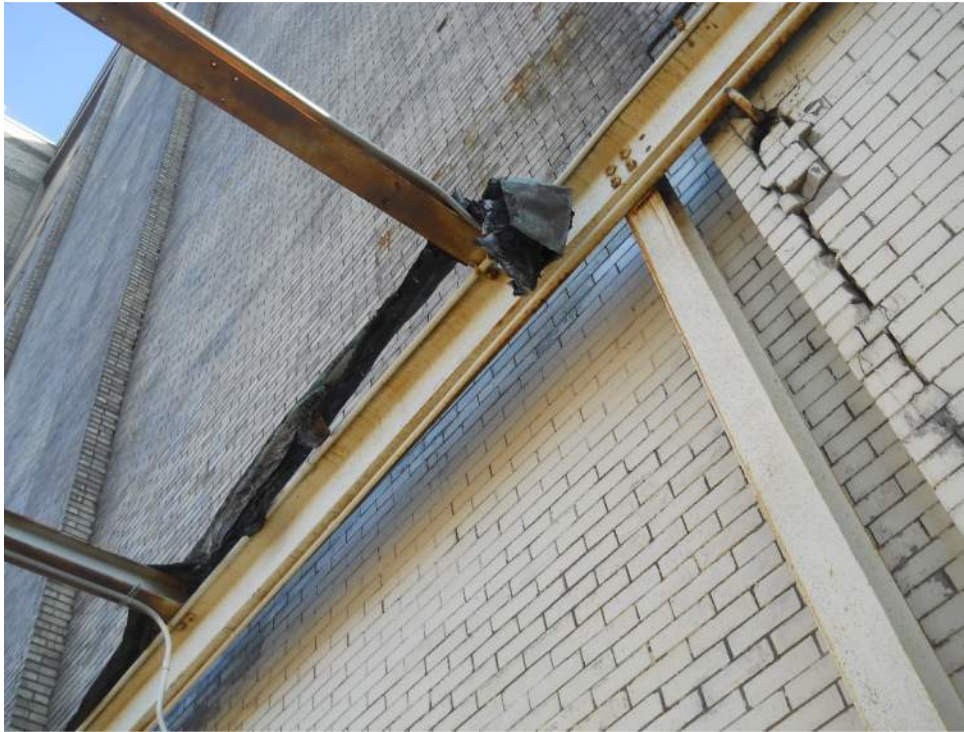
Photo 1 – View of lead-based paint coated exterior structural steel at Building 1.

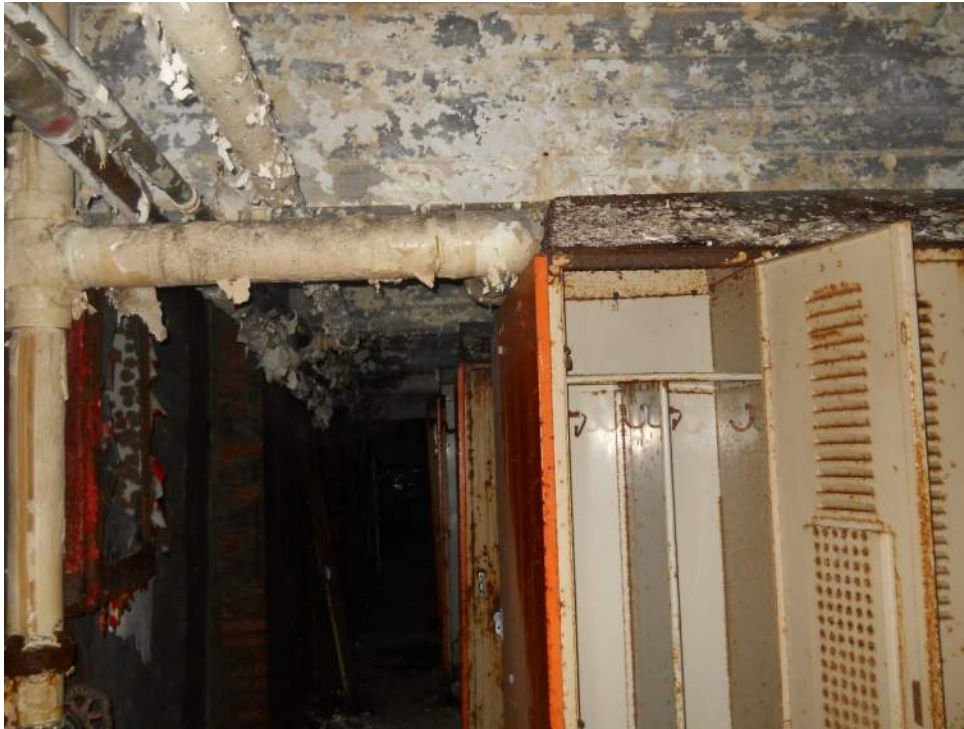
Photo 2 – View of lead-based paint coated lockers on the second floor of Building 2.

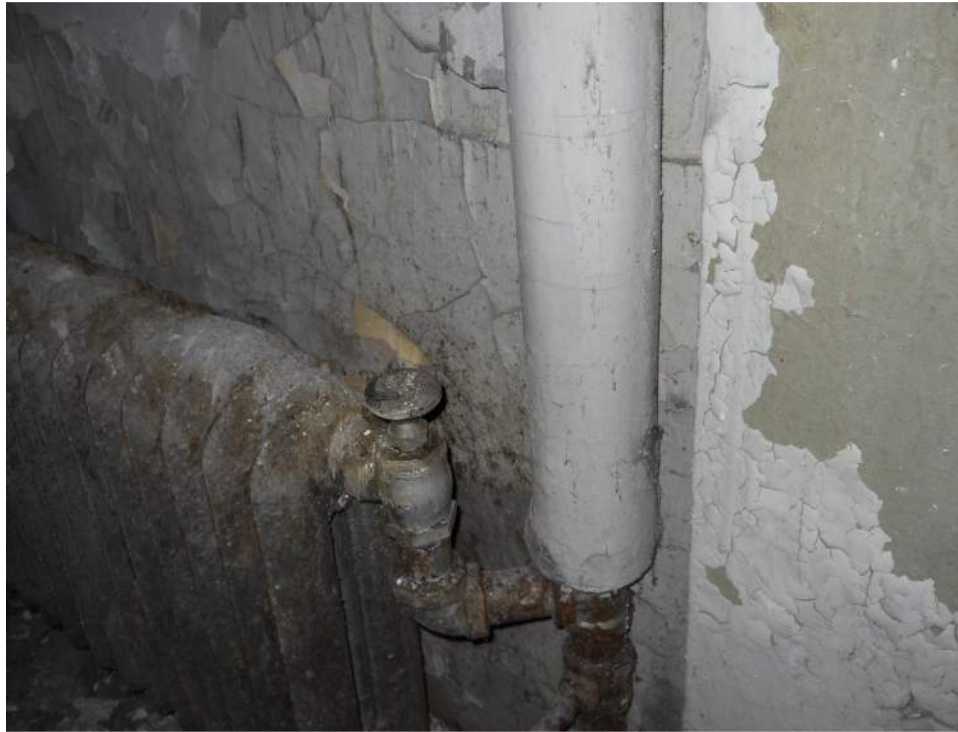
Photo 3 – View of a lead-based paint coated radiator in Building 2.

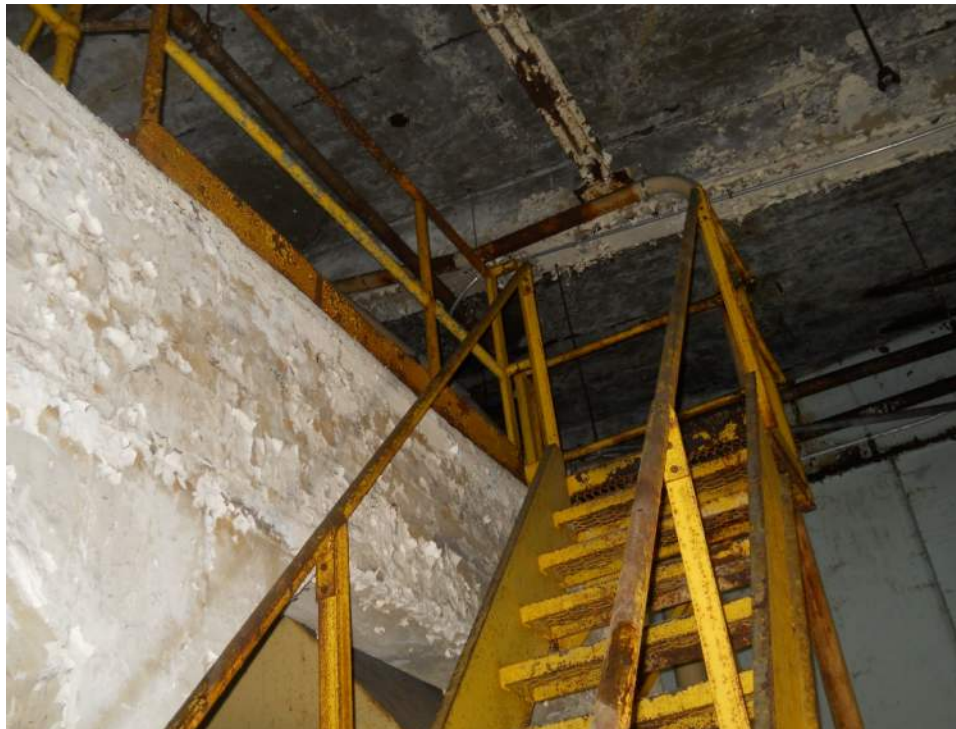
Photo 3 – View of lead-based paint coated staircase on the eighth floor of Building 2.

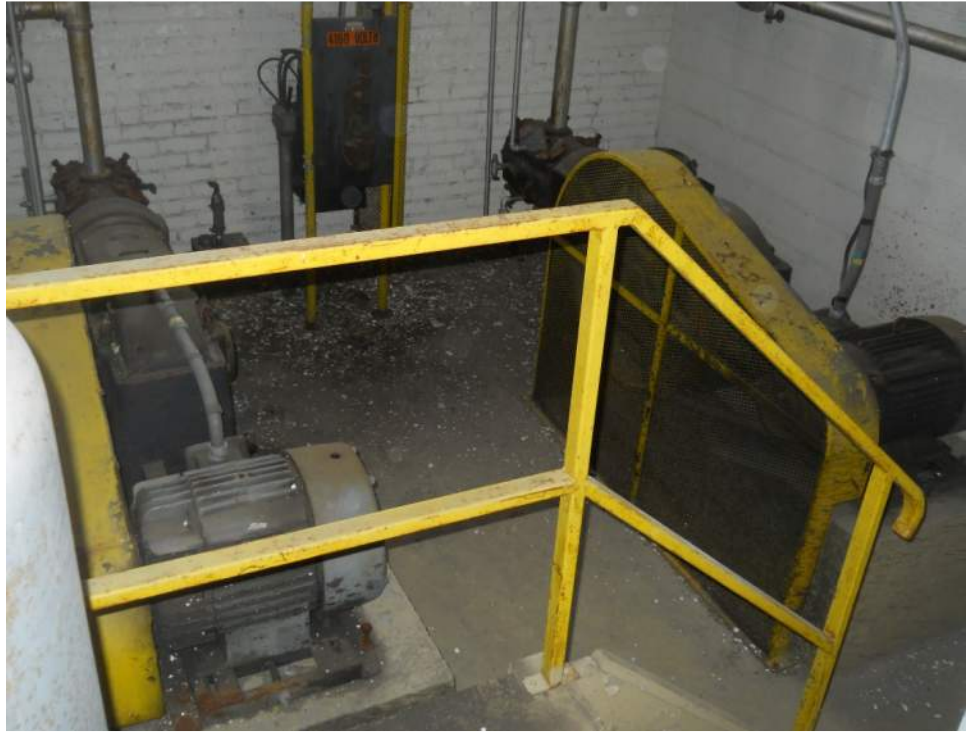
Photo 5 – View of a lead-based paint coated hand rail on the second floor of Building 1.

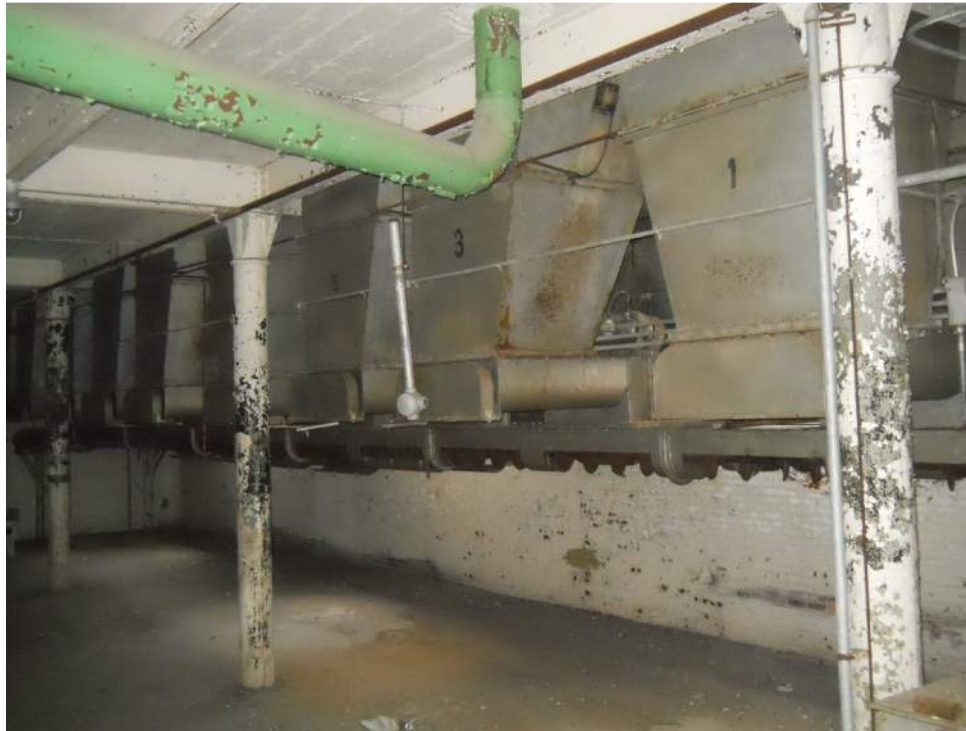
Photo 6 – View of lead-based paint coated columns in Building 1.

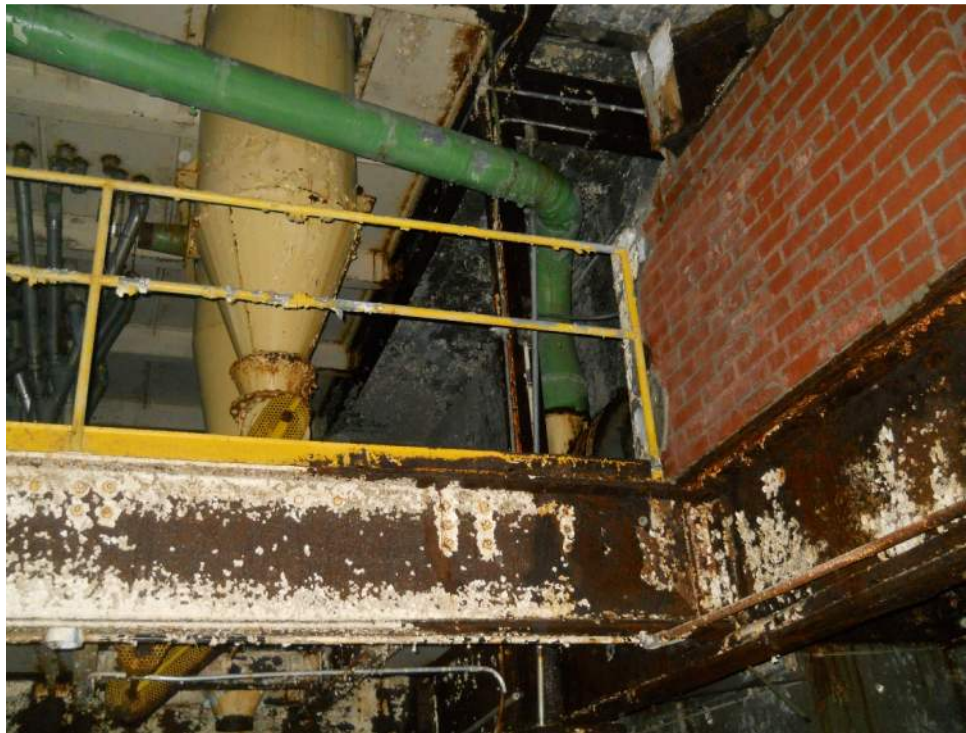
Photo 7 – View of lead-based paint coated hand rails and structural beams in Building 1.

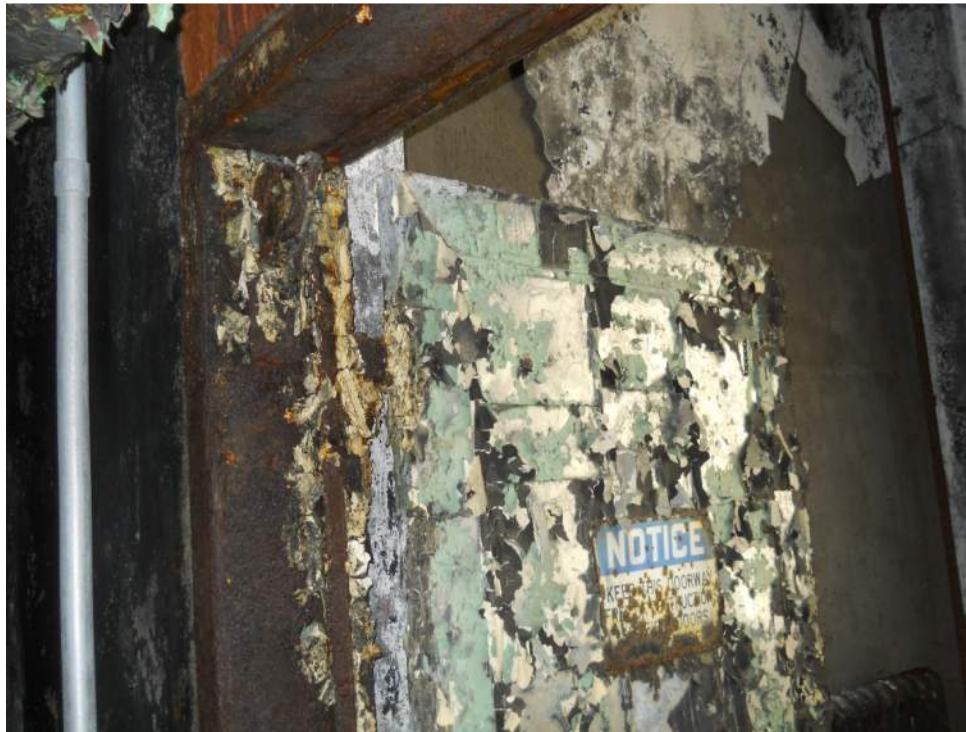
Photo 8 – View of lead-based paint coated blast door and frame in Building 2.
