Periodic Review Report

293 Grote Street Site
NYSDEC BCP #C915368
Buffalo, New York

May 5, 2025

**Roux Environmental Engineering
and Geology, D.P.C.**
2558 Hamburg Turnpike, Suite 300
Buffalo, New York 14218

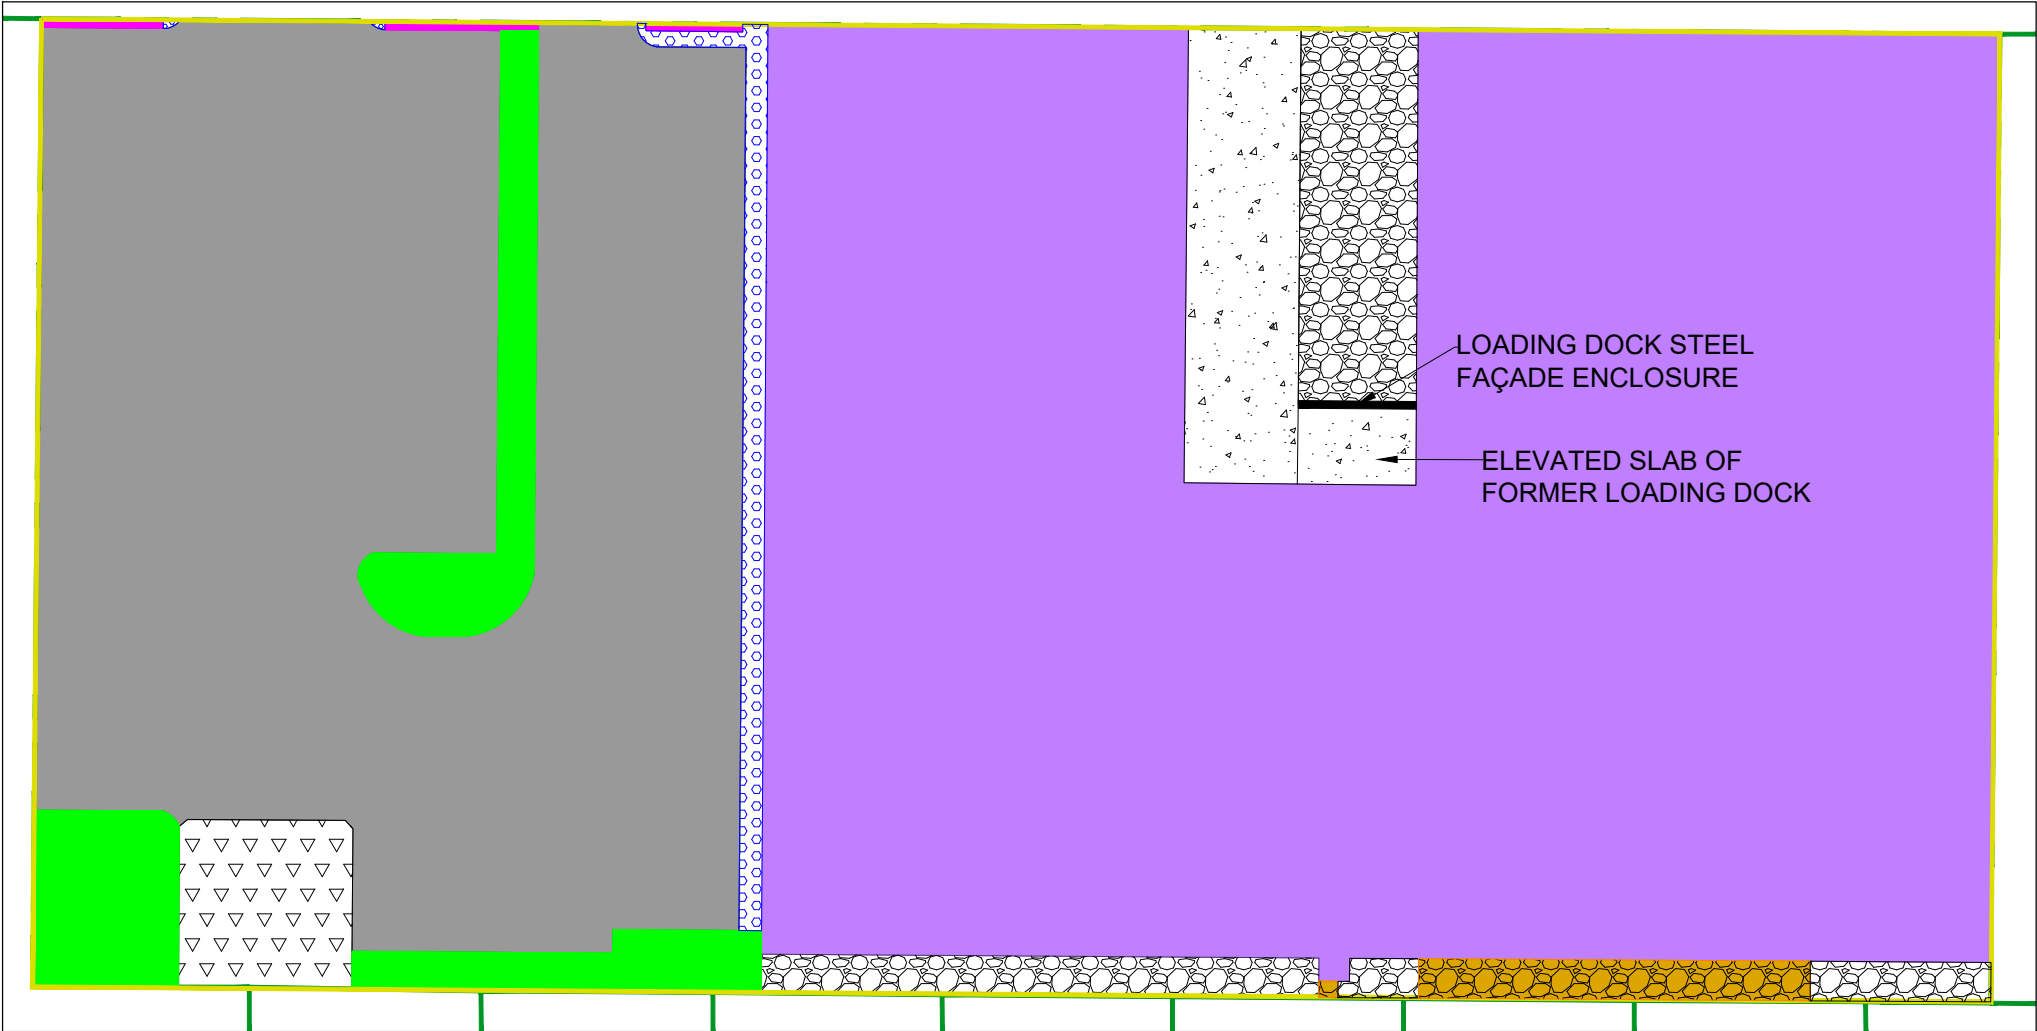
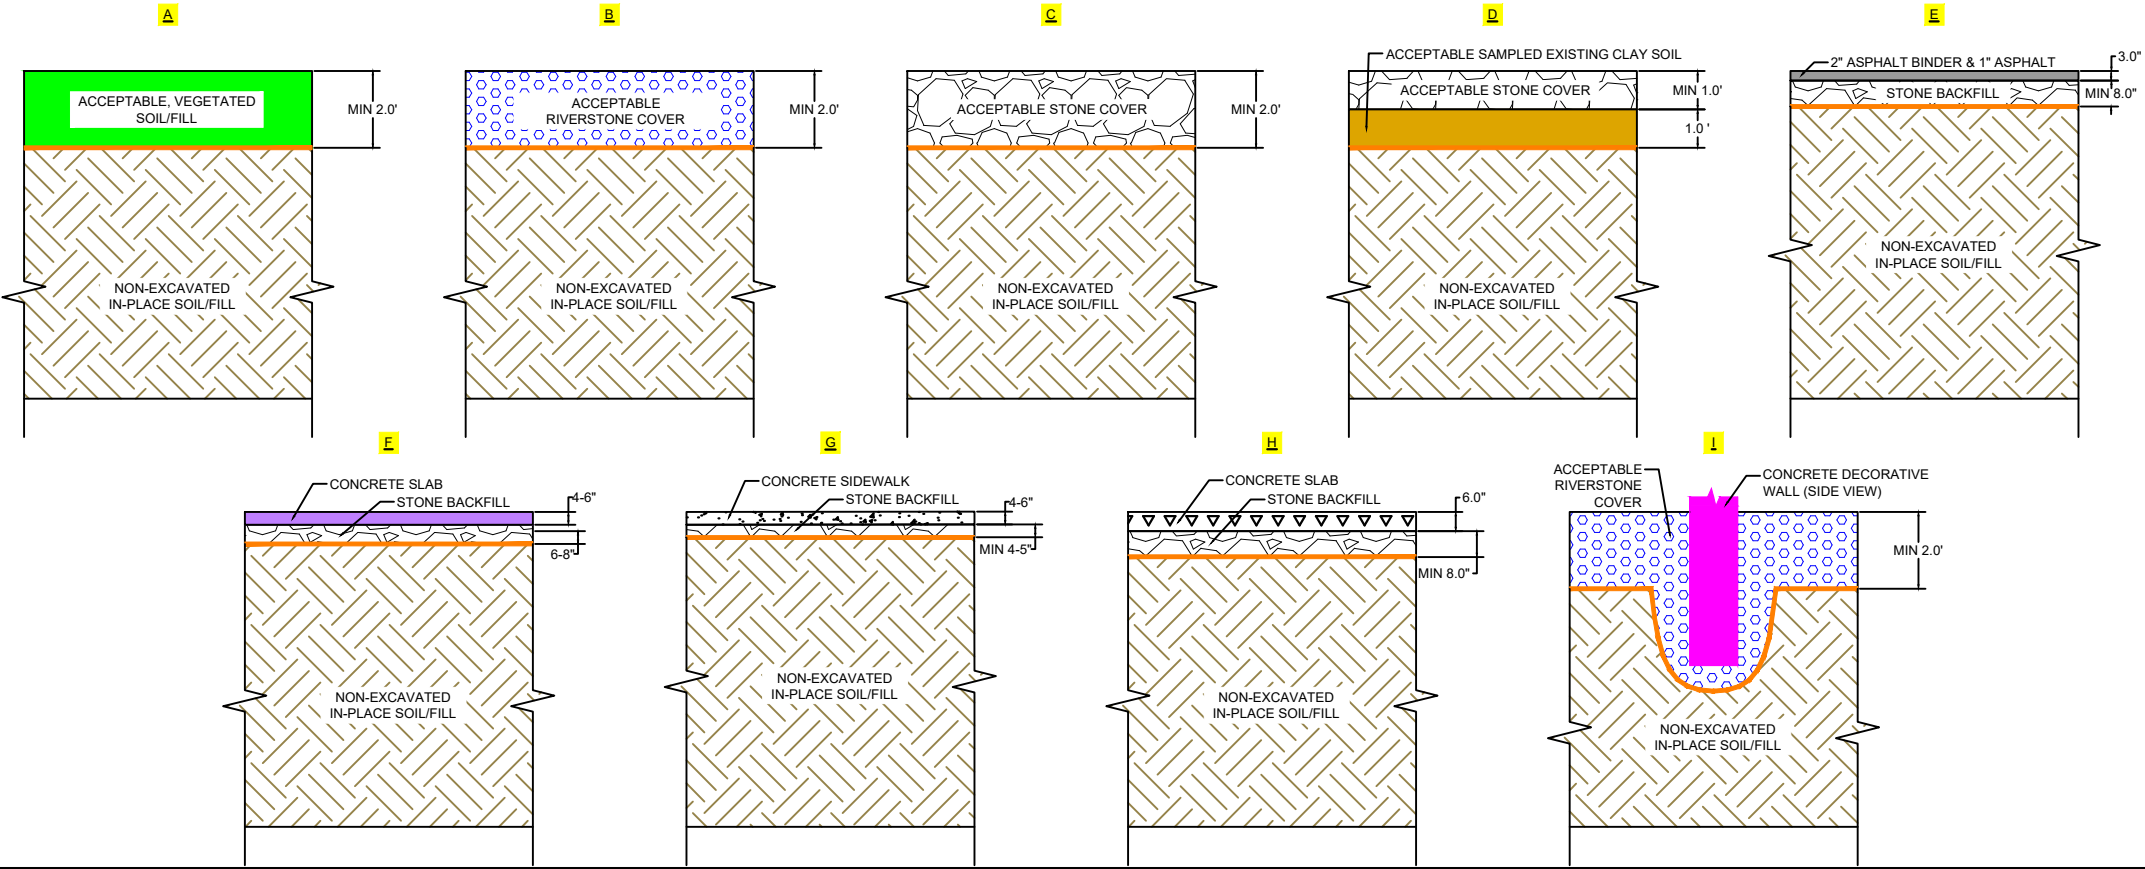
The 293 Grote Street Site is in compliance with the SMP, as the cover system and courtyard loading dock enclosure are in place (see Figure 3).

Inspection of the Site was conducted by Mr. Christopher Boron, P.G. on March 19, 2025, a Qualified Environmental Professional (QEP) per 6NYCRR Part 375.12. At the time of the inspection, the existing cover systems (see Figure 3) are performing as intended.

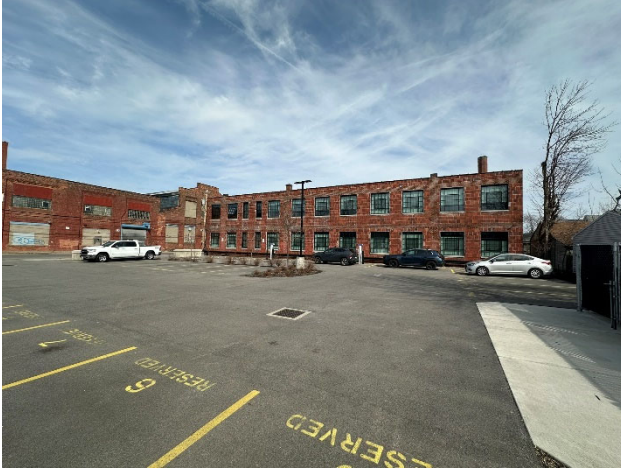
Photo 1: Cover system west of building, looking northeast.

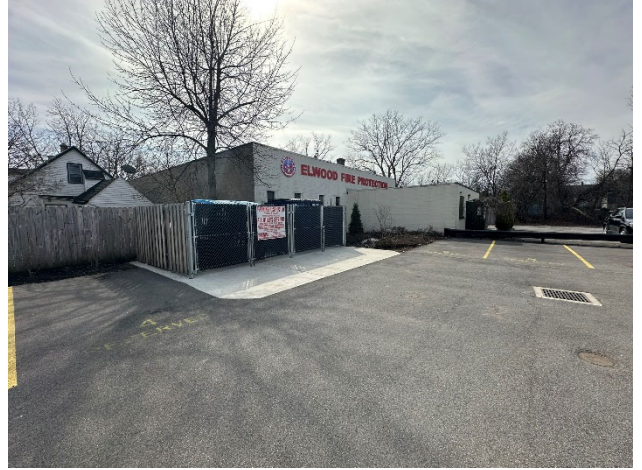
Photo 2: Cover system, west of building, looking southwest.

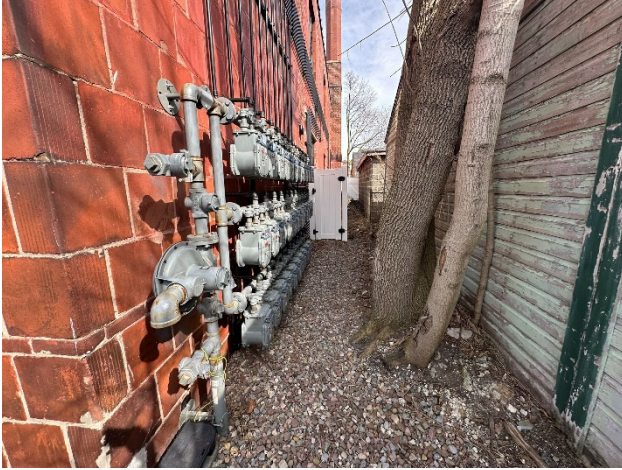
Photo 5: Cover system in rear alley, south of building, looking east.

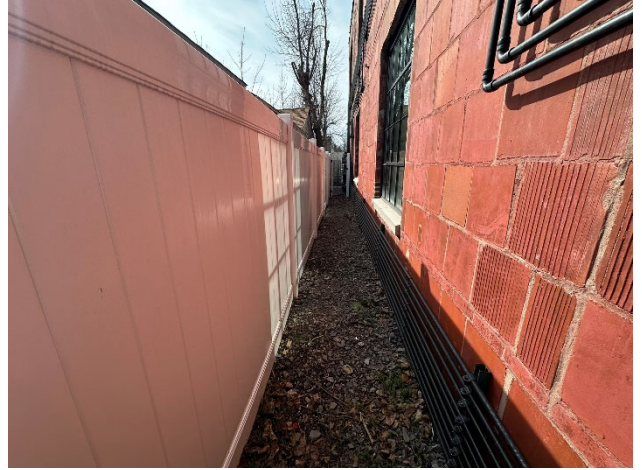
Photo 6: Cover system in rear alley, south of building, looking west.
