June 9, 2017

RE:               Mixed-Use Property  
                    1984 Elmwood Avenue, 15, 19, 35, 107, and 125 Norris Street, and 742 Hertel Avenue  
                    Buffalo, New York 14207  
                    LCS Project No. 17B280.39

At your request, Lender Consulting Services, Inc. (LCS) completed an ASTM E1527-13 Phase I Environmental Site Assessment of the subject property, identified as a mixed-use property located at 1984 Elmwood Avenue, 15, 19, 35, 107, and 125 Norris Street, and 742 Hertel Avenue, City of Buffalo, Erie County, New York. The subject property tax map shows the subject property to measure approximately 9.73 acres. The subject property is developed with the following:

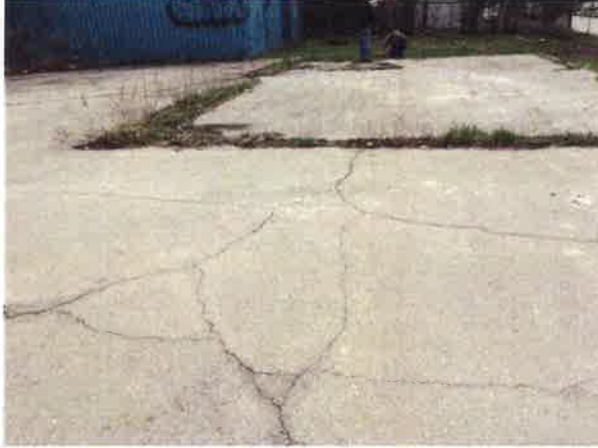
Exterior portions of the subject property included one garage (associated with residence), asphalt-paved parking, grassy areas, trees, and concrete sidewalks. An area of concrete was noted on the western portion (suspected former building location).

Photo 1: View of the former building pad on the exterior of building #1.

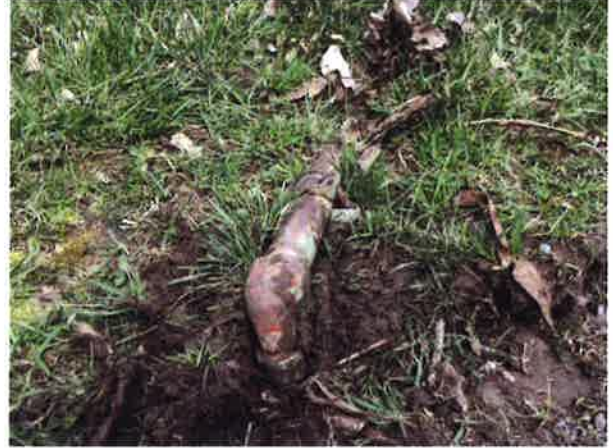
Photo 2: View of the suspect natural gas line in the vicinity of building #1.

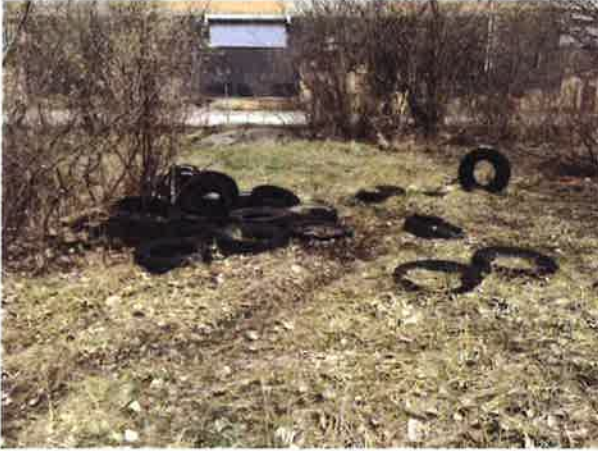
- LCS noted areas of dumping on-site (north of Building 2 and on the northeastern portion of the property), including tires, drums and grinding wheels, asphalt shingles, general refuse, paint cans, and additional rusted drums and buckets.

Photo 3: View of the dumping in the vicinity of building #1.

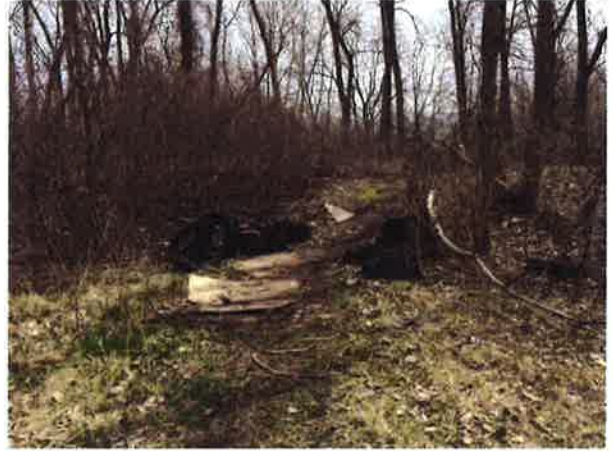
Photo 4: View of the dumping in the vicinity of building #1.

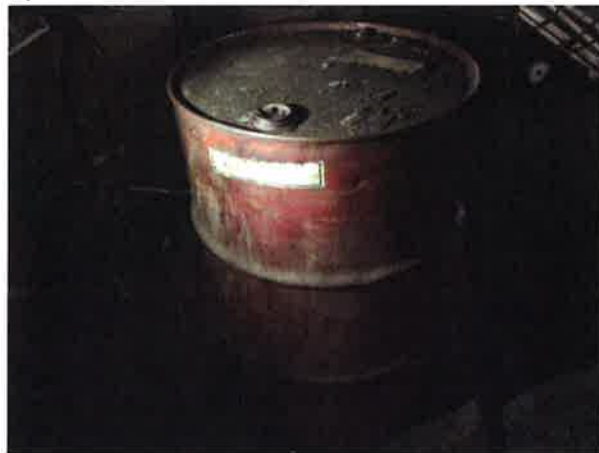
Photo 2: View of the stored 55-gallon drum on the interior of building #2.

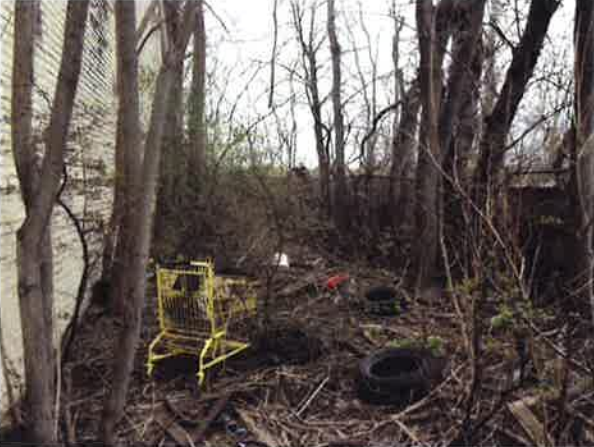
- Photo 1: View of the interior of building #2.
- Photo 2: View of the interior of building #2.
- Photo 3: View of the dumping south of building #2.
- Photo 4: View of the abandoned drums north of building #2.

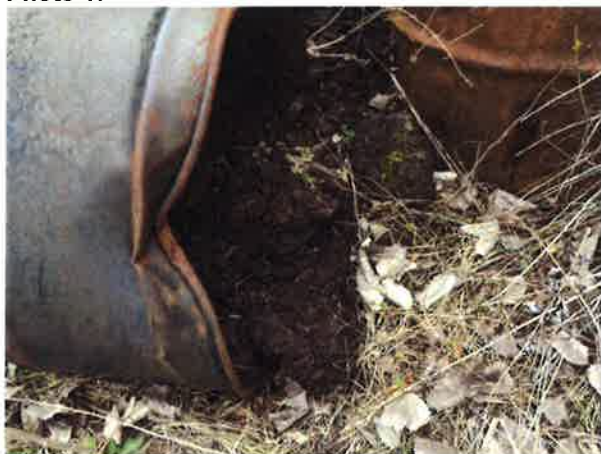
Photo 1: View of the slag like material within abandoned drums north of building #2.

| Known or Suspect RECs | Rationale/Opinion | Recommendation(s) |
|---|---|---|
| <p>Dark staining was noted to the floor in the area of three of the oil buckets in Building 1. Several unlabeled drums were noted north of Building 2; some of the drums appeared to be empty. The contents of the remaining drums could not be confirmed. Three empty drums were noted in Building 2 and were labelled anti rust and cutting fluid concentrate.</p> <p>LCS noted areas of dumping on-site (north of Building 2 and on the northeastern portion of the property), including tires, drums and grinding wheels, asphalt shingles, general refuse, paint cans, and additional rusted drums and buckets.</p> | <p>The potential exists for impact in the area of the dumping and staining.</p> | <p>As part of the above subsurface investigation, the staining should be properly cleaned and any impacted soils/materials removed and the debris on-site (and any associated impact) properly removed.</p> |

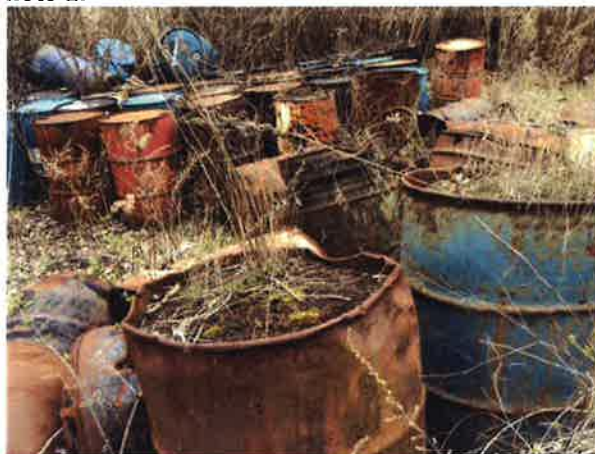
Photo 2: View of the abandoned drums north of building #2.

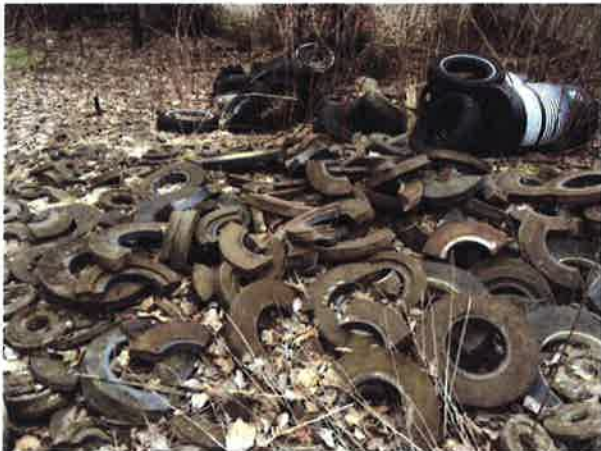
Photo 3: View of the dumped grinding wheels north of building #2.

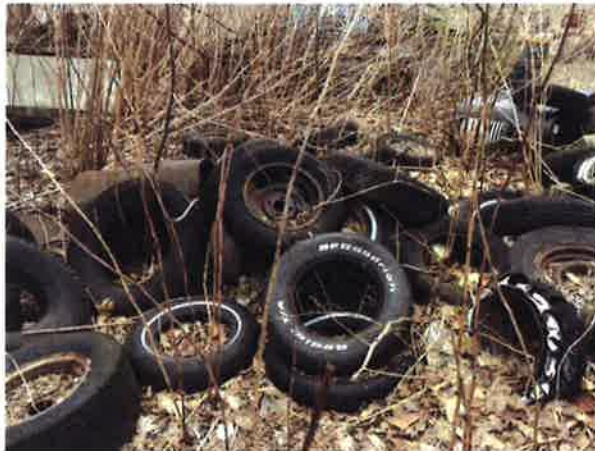
Photo 4: View of the dumped tires north of building #2.

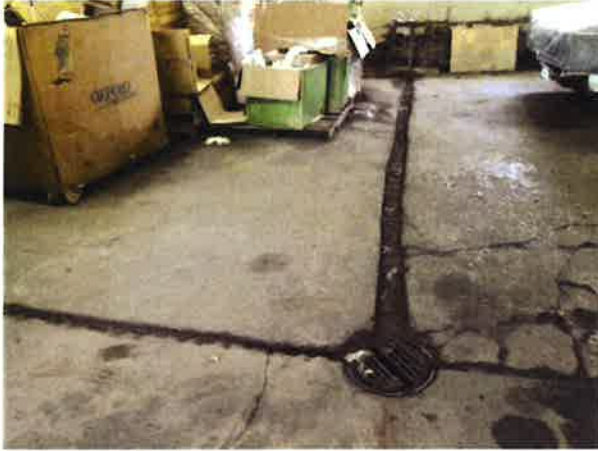
- On-site operations at 742 Hertel Avenue have included automotive repair and/or welding since at least 1931; operations currently include collision work (no engine repair). Floor drains noted within the collision shop presumably discharge to the municipal sewer system; no evidence of an oil-water separator was identified on-site.

Photo 1: View of the floor drain on the interior of building #3.

| Known or Suspect RECs | Rationale/Opinion | Recommendation(s) |
|---|---|---|
| <p>On-site operations at 742 Hertel Avenue have included automotive repair and/or welding since at least 1931; operations currently include collision work (no engine repair). Floor drains noted within the collision shop presumably discharge to the municipal sewer system; no evidence of an oil-water separator was identified on-site.</p> <p>The subject property included a foundry from at least 1912 through 1986; two small transformer rooms were noted within the foundry building from at least 1950 through at least 1986.</p> <p>According to city directories, on-site operations included printing in Building 1 in at least 1998.</p> | <p>The potential exists for on-site impact from such former operations.</p> | <p>Unless sufficient documentation is provided, a subsurface investigation is warranted to assess the environmental conditions on-site. If such identifies a concern, additional work may be required.</p> |

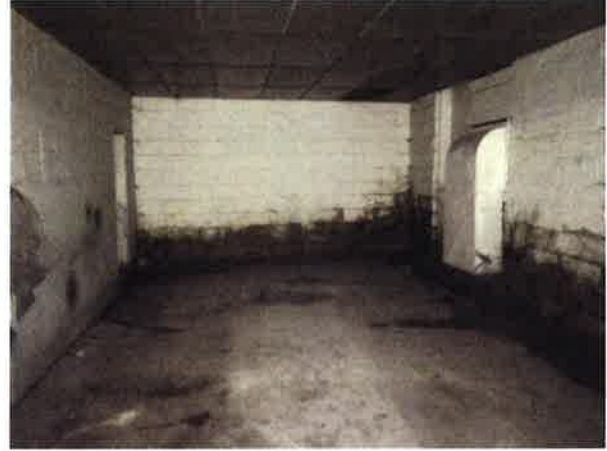
Photo 2: View of the paint booth on the interior of building #3.

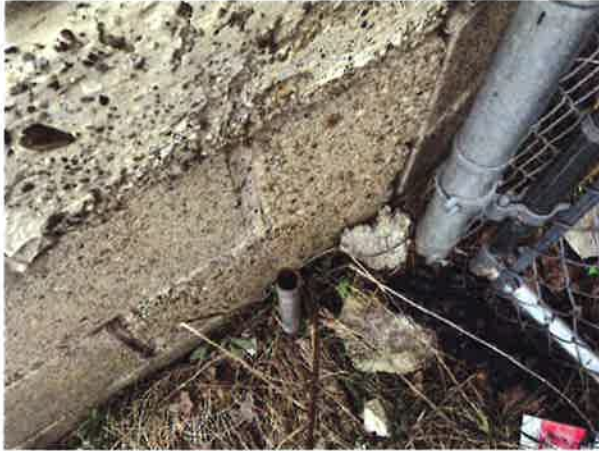
**Photo 1:**

- LCS noted a cut off pipe protruding from the ground along the eastern exterior of the collision shop building; the nature of such could not be confirmed.

Photo 1: View of the unknown pipe on the eastern exterior of building #3.

| Known or Suspect RECs | Rationale/Opinion | Recommendation(s) |
|---|---|---|
| <p>A building with two fuel tanks was noted on the eastern portion of the property from at least 1916 through at least 1986.</p> <p>According to Sanborn maps, a suspected gasoline tank was noted east of a former office building on the western portion of the property from at least 1950 through at least 1986.</p> <p>According to a previous study reviewed by LCS and City of Buffalo Permit records, a permit was filed in 1931 to install one 550-gallon gasoline storage tank and was in addition to a 275-gallon tank already on-site; records do not indicate whether such were above or underground.</p> | <p>The status of the tanks is unknown. LCS noted one cut pipe protruding from the ground along the eastern exterior of the collision shop building, which may be associated a former UST.</p> | <p>The above subsurface investigation should include a geophysical survey to assess whether any USTs remain on-site and an assessment of the environmental conditions on-site in the area of the USTs. The nature of all of the piping noted on-site by LCS should be confirmed.</p> |

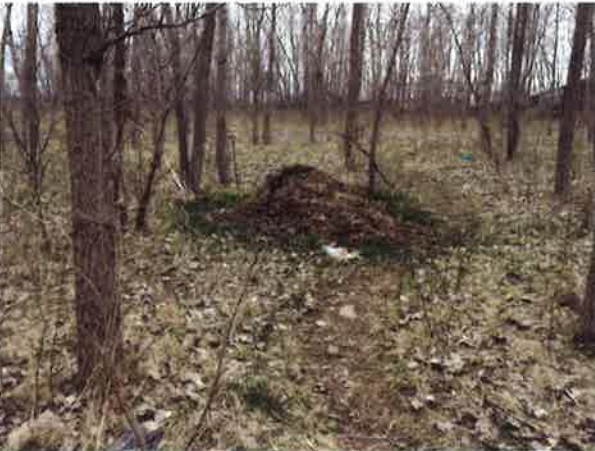
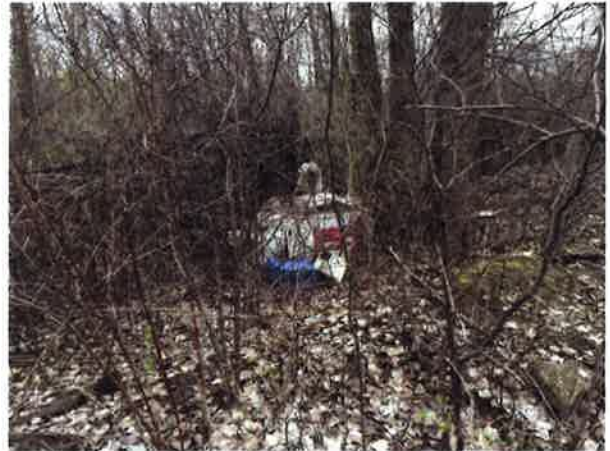
- Photo 1: View of the western exterior of building #4.
- Photo 2: View of the dumping on the vacant portion of the subject property.
- Photo 3: View of the dumping on the vacant portion of the subject property.
- Photo 4: View of the dumping on the vacant portion of the subject property.

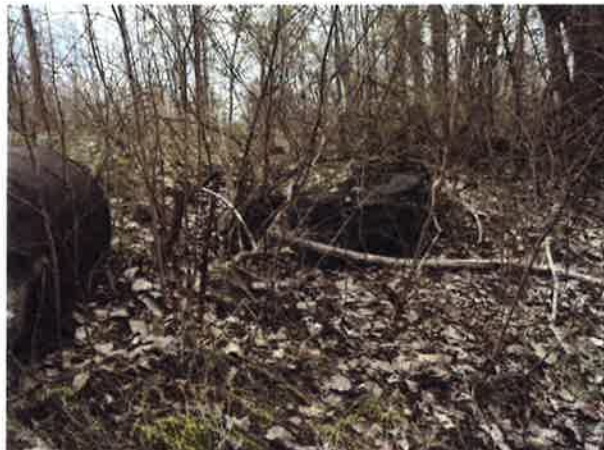
Photo 1: View of the dumping on the vacant portion of the subject property.
