RE: Mixed-Use Property
 1984 Elmwood Avenue, 15, 19, 35, 107, and 125 Norris Street, and 742 Hertel Avenue
 Buffalo, New York 14207
 LCS Project No. 17B280.39

At your request, Lender Consulting Services, Inc. (LCS) completed an ASTM E1527-13 Phase I Environmental Site Assessment of the subject property, identified as a mixed-use property located at 1984 Elmwood Avenue, 15, 19, 35, 107, and 125 Norris Street, and 742 Hertel Avenue, City of Buffalo, Erie County, New York. The subject property tax map shows the subject property to measure approximately 9.73 acres. The subject property is developed with the following:

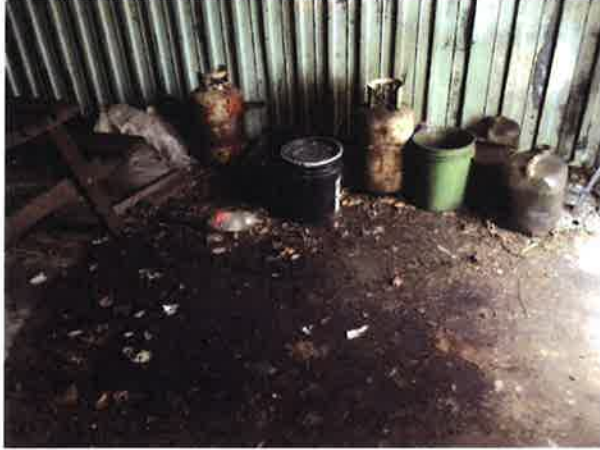
- According to city directories, on-site operations included printing in Building 1 in at least 1998.
- Dark staining was noted to the floor in the area of three of the oil buckets in Building 1. Several unlabeled drums were noted north of Building 2; some of the drums appeared to be empty. The contents of the remaining drums could not be confirmed. Three empty drums were noted in Building 2 and were labelled anti rust and cutting fluid concentrate.

Photo 1: View of the stored oils and staining on the interior of building #1.

<p>Dark staining was noted to the floor in the area of three of the oil buckets in Building 1. Several unlabeled drums were noted north of Building 2; some of the drums appeared to be empty. The contents of the remaining drums could not be confirmed. Three empty drums were noted in Building 2 and were labelled anti rust and cutting fluid concentrate.</p> <p>LCS noted areas of dumping on-site (north of Building 2 and on the northeastern portion of the property), including tires, drums and grinding wheels, asphalt shingles, general refuse, paint cans, and additional rusted drums and buckets.</p>	<p>The potential exists for impact in the area of the dumping and staining.</p>	<p>As part of the above subsurface investigation, the staining should be properly cleaned and any impacted soils/materials removed and the debris on-site (and any associated impact) properly removed.</p>

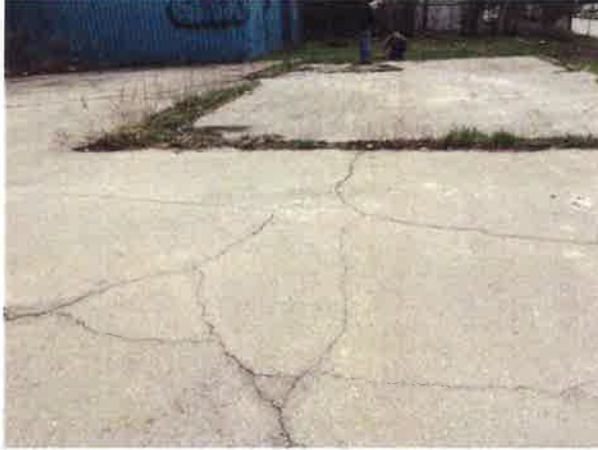
Photo 1: View of the former building pad on the exterior of building #1.

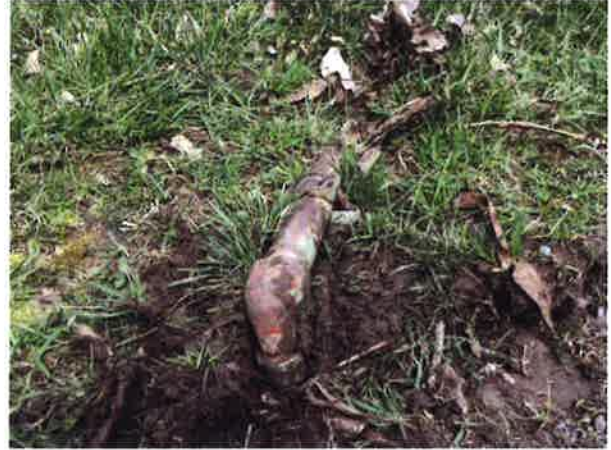
Photo 2: View of the suspect natural gas line in the vicinity of building #1.

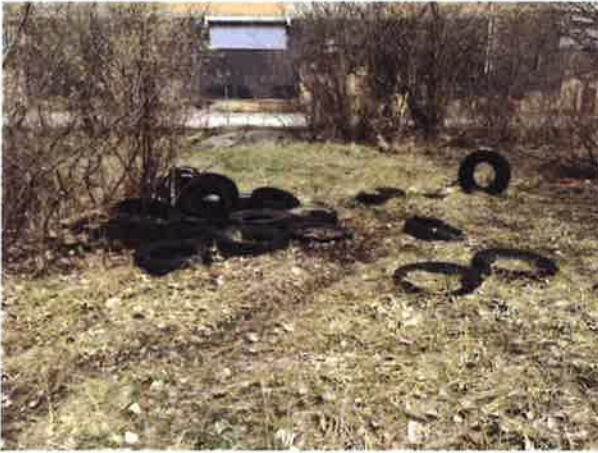
- LCS noted areas of dumping on-site (north of Building 2 and on the northeastern portion of the property), including tires, drums and grinding wheels, asphalt shingles, general refuse, paint cans, and additional rusted drums and buckets.

Photo 3: View of the dumping in the vicinity of building #1.

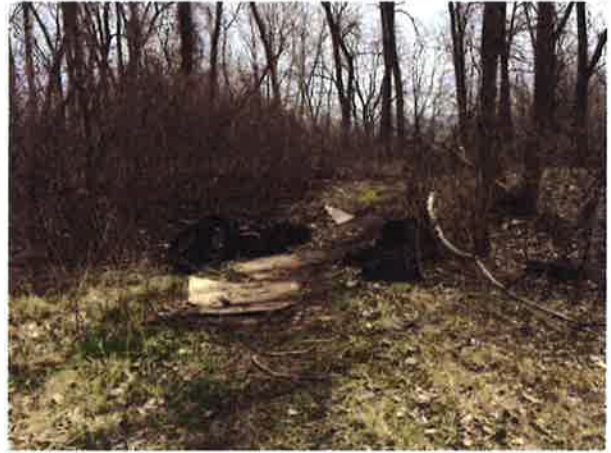
Photo 4: View of the dumping in the vicinity of building #1.

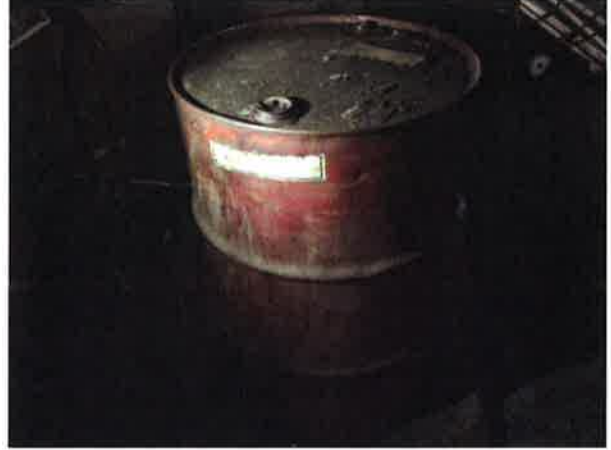
Photo 2: View of the stored 55-gallon drum on the interior of building #2.

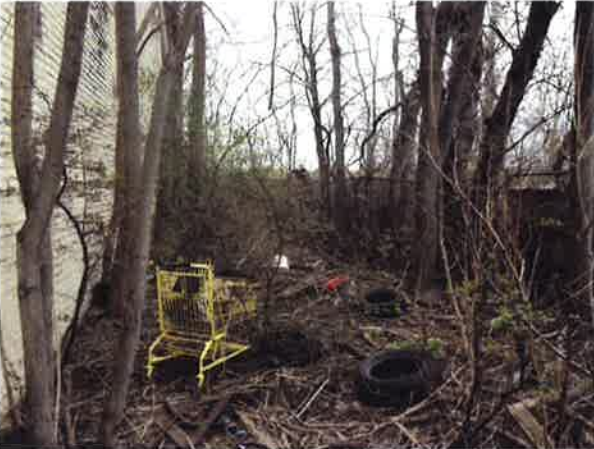
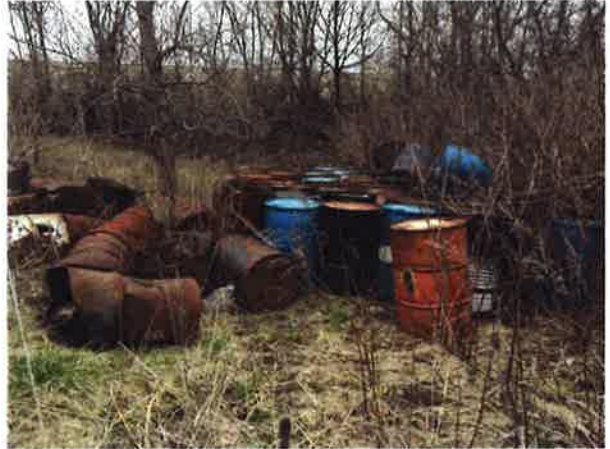
- Photo 1: View of the interior of building #2.
- Photo 2: View of the interior of building #2.
- Photo 3: View of the dumping south of building #2.
- Photo 4: View of the abandoned drums north of building #2.

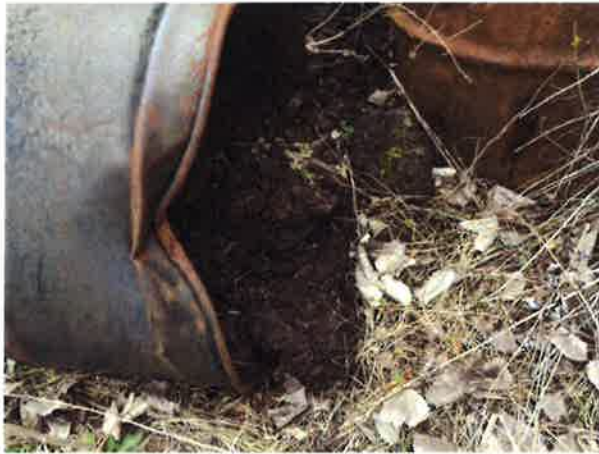
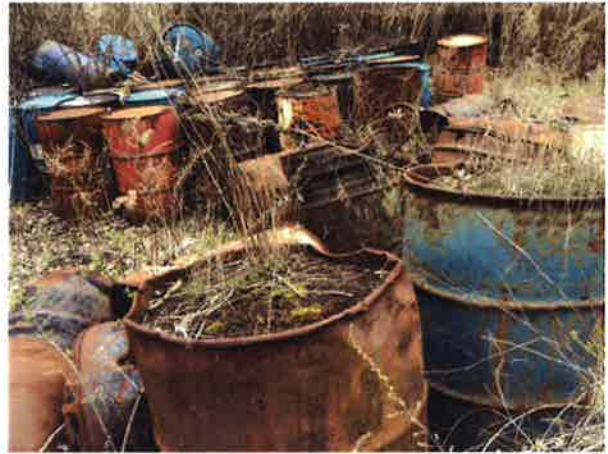
Photo 1: View of the slag like material within abandoned drums north of building #2.

Photo 2: View of the abandoned drums north of building #2.

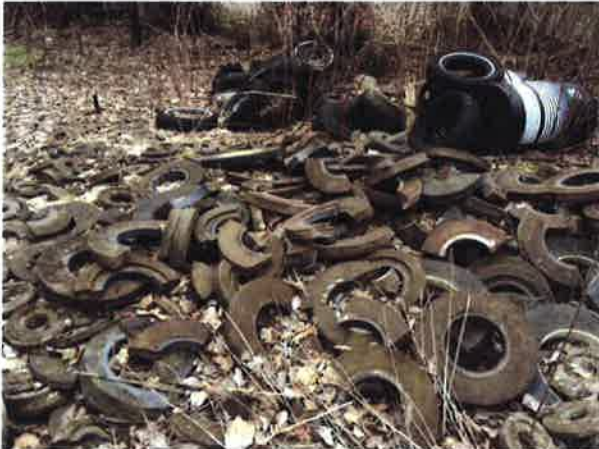
Photo 3: View of the dumped grinding wheels north of building #2.

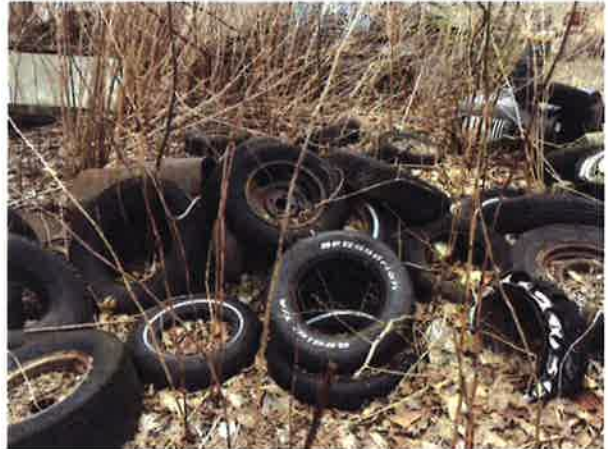
Photo 4: View of the dumped tires north of building #2.

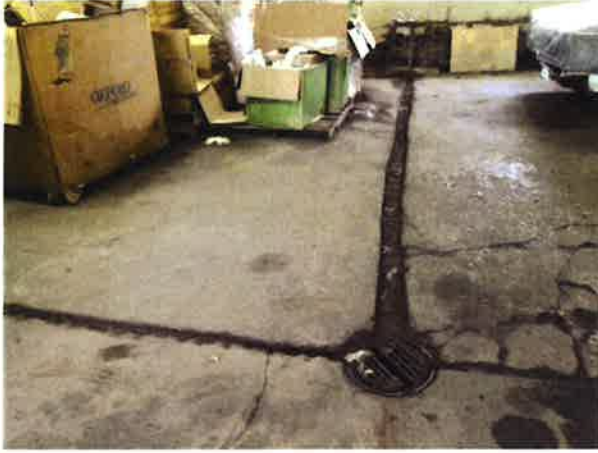
- On-site operations at 742 Hertel Avenue have included automotive repair and/or welding since at least 1931; operations currently include collision work (no engine repair). Floor drains noted within the collision shop presumably discharge to the municipal sewer system; no evidence of an oil-water separator was identified on-site.

Photo 1: View of the floor drain on the interior of building #3.

Known or Suspect RECs	Rationale/Opinion	Recommendation(s)
<p>On-site operations at 742 Hertel Avenue have included automotive repair and/or welding since at least 1931; operations currently include collision work (no engine repair). Floor drains noted within the collision shop presumably discharge to the municipal sewer system; no evidence of an oil-water separator was identified on-site.</p> <p>The subject property included a foundry from at least 1912 through 1986; two small transformer rooms were noted within the foundry building from at least 1950 through at least 1986.</p> <p>According to city directories, on-site operations included printing in Building 1 in at least 1998.</p>	<p>The potential exists for on-site impact from such former operations.</p>	<p>Unless sufficient documentation is provided, a subsurface investigation is warranted to assess the environmental conditions on-site. If such identifies a concern, additional work may be required.</p>

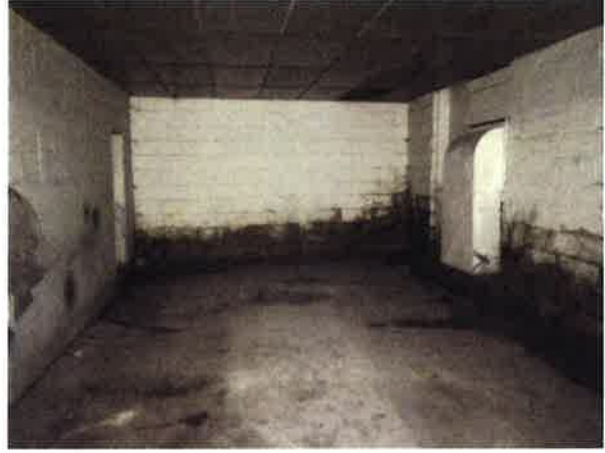
Photo 2: View of the paint booth on the interior of building #3.

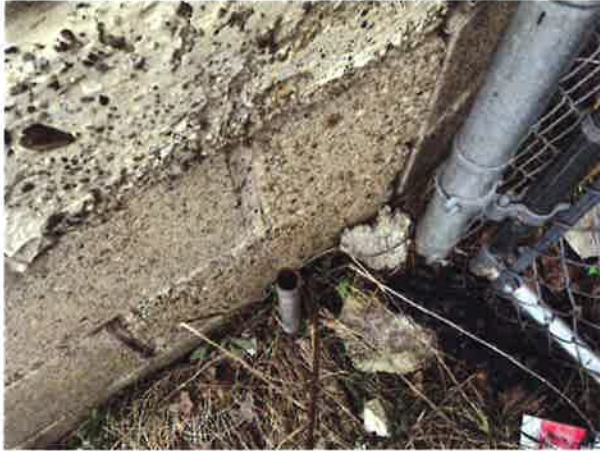
- LCS noted a cut off pipe protruding from the ground along the eastern exterior of the collision shop building; the nature of such could not be confirmed.

Photo 1: View of the unknown pipe on the eastern exterior of building #3.

Known or Suspect RECs	Rationale/Opinion	Recommendation(s)
<p>A building with two fuel tanks was noted on the eastern portion of the property from at least 1916 through at least 1986.</p> <p>According to Sanborn maps, a suspected gasoline tank was noted east of a former office building on the western portion of the property from at least 1950 through at least 1986.</p> <p>According to a previous study reviewed by LCS and City of Buffalo Permit records, a permit was filed in 1931 to install one 550-gallon gasoline storage tank and was in addition to a 275-gallon tank already on-site; records do not indicate whether such were above or underground.</p>	<p>The status of the tanks is unknown. LCS noted one cut pipe protruding from the ground along the eastern exterior of the collision shop building, which may be associated a former UST.</p>	<p>The above subsurface investigation should include a geophysical survey to assess whether any USTs remain on-site and an assessment of the environmental conditions on-site in the area of the USTs. The nature of all of the piping noted on-site by LCS should be confirmed.</p>

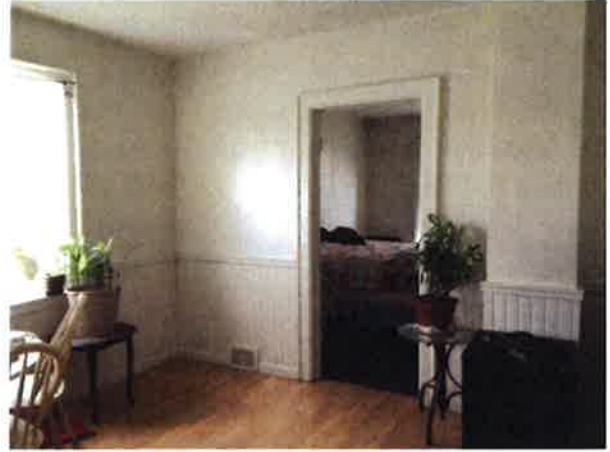
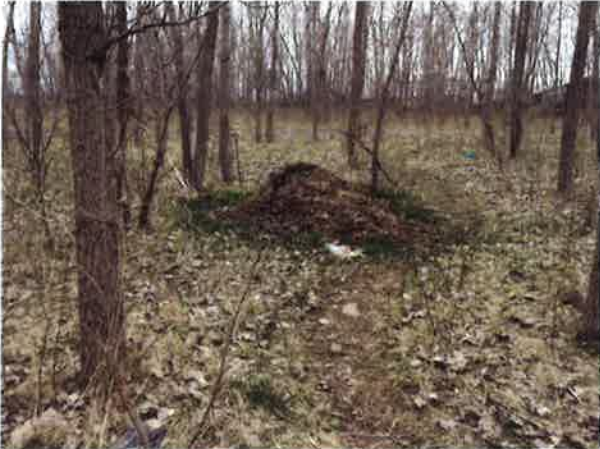
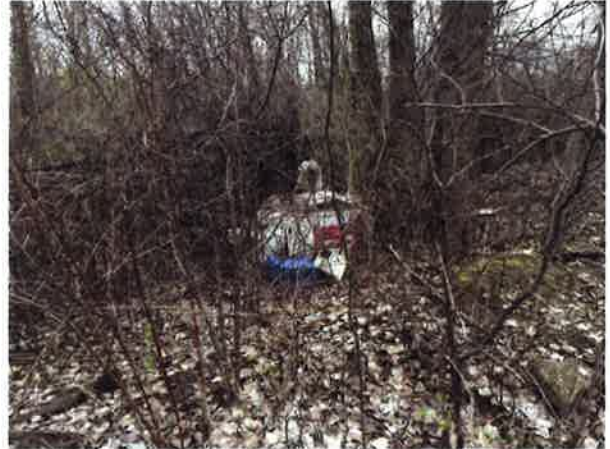
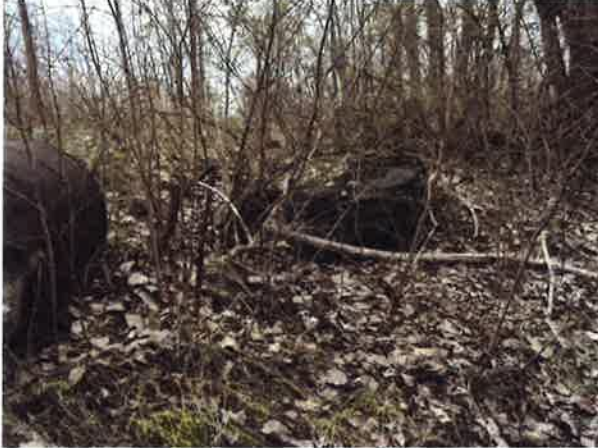
Photo 2: View of the dumping on the vacant portion of the subject property.

Photo 3: View of the dumping on the vacant portion of the subject property.

Photo 4: View of the dumping on the vacant portion of the subject property.

Photo 1: View of the dumping on the vacant portion of the subject property.
