Periodic Review Report

**Reporting Period June 14, 2020 to
June 14, 2025**

2250 Factory Outlet Boulevard Site
BCP Site No. C932127
Niagara Falls, New York

June 2025

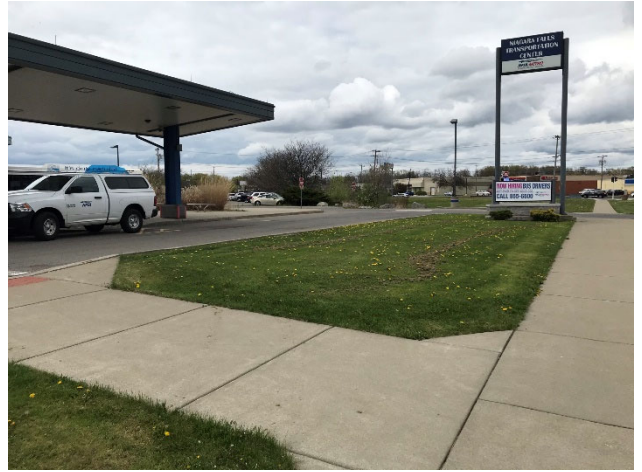
Photo 2: Exterior Site conditions from front walkway (looking northeast)

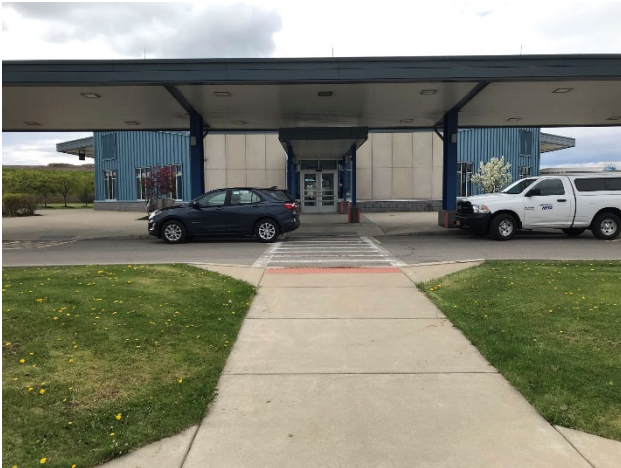
Photo 3: Exterior Site conditions from front walkway - asphalt and concrete surfaces (looking northwest)

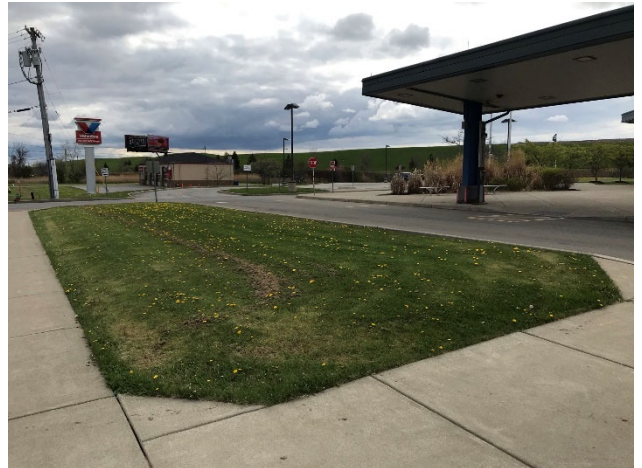
Photo 4: Exterior Site conditions from front walkway - asphalt, concrete, and landscaped areas (looking southwest)

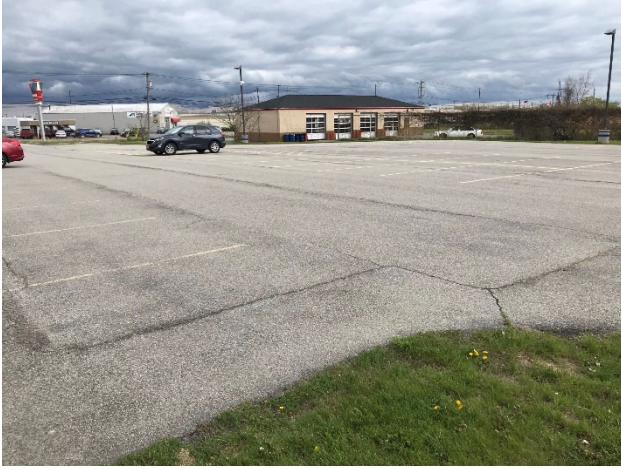
Photo 5: Exterior Site conditions – asphalt parking lot (looking southeast)

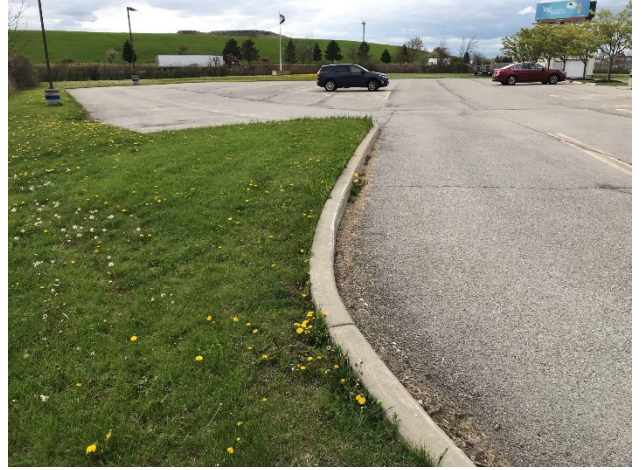
Photo 6: Exterior Site conditions – asphalt parking lot and vegetated area (looking northwest)

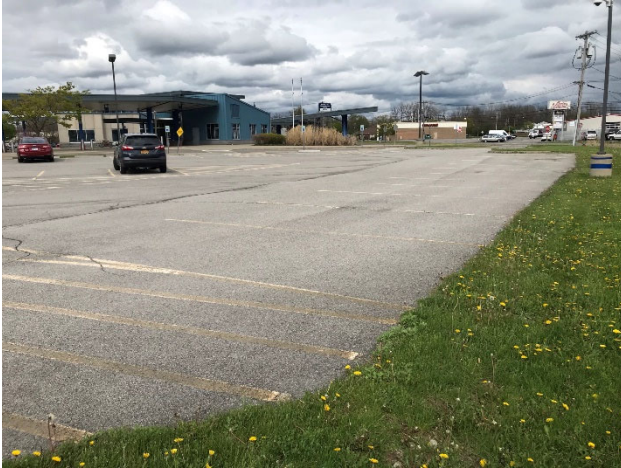
Photo 7: Exterior Site conditions – asphalt parking lot (looking northeast)

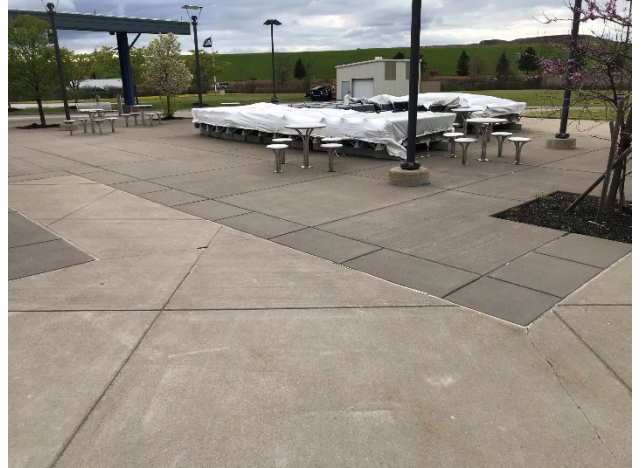
Photo 8: Exterior Site conditions – concrete surfaces from rear of building (looking west)

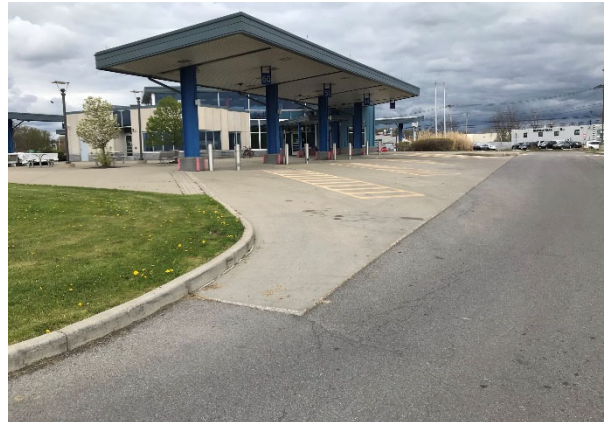
Photo 12: Exterior Site conditions from western side of building showing asphalt, concrete and landscaped areas (looking east)

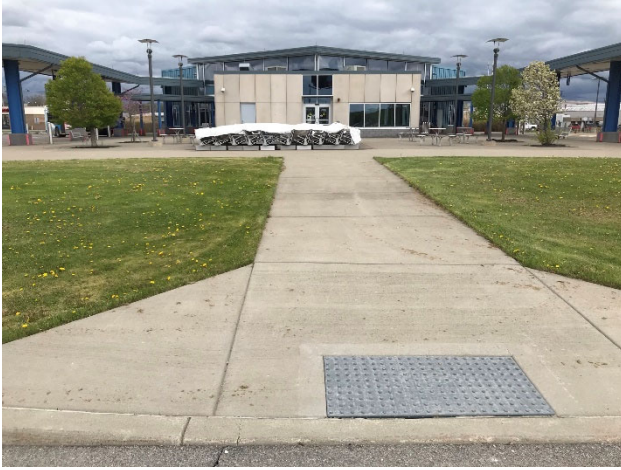
Photo 13: Exterior Site condition – rear of building (looking southeast)

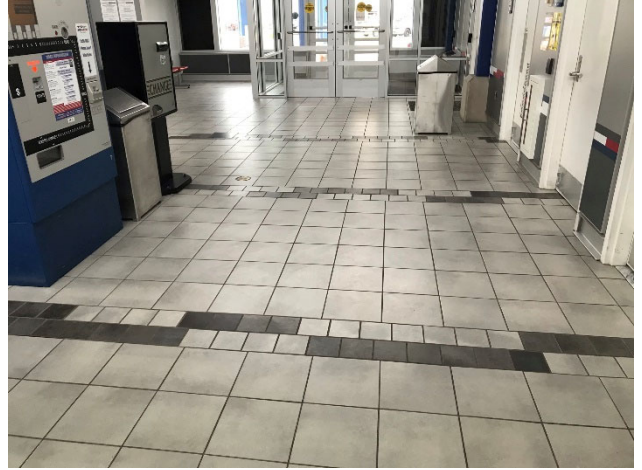
Photo 14: Interior Site conditions

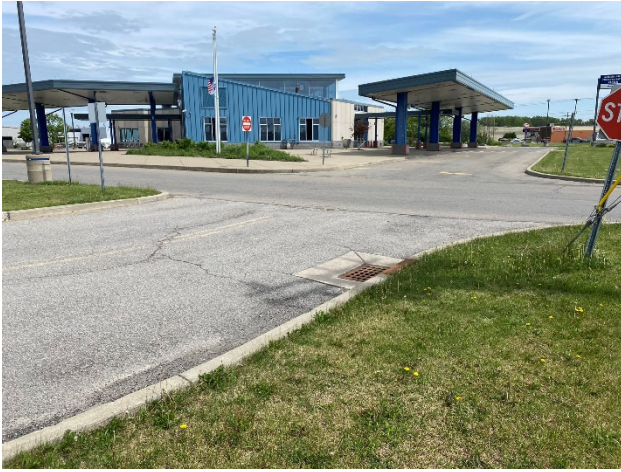
Photo 1: Exterior Site condition (looking north)

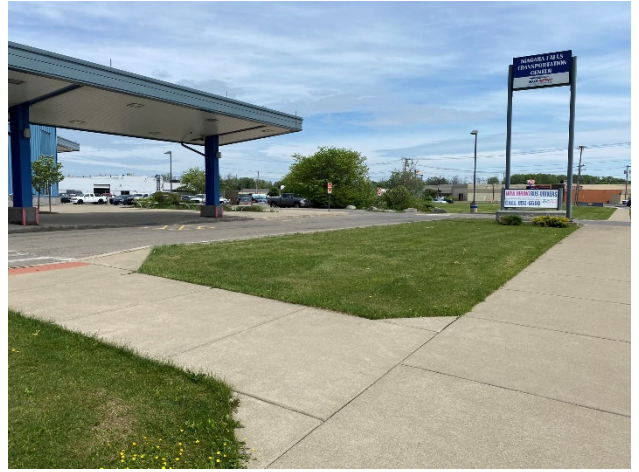
Photo 2: Exterior Site conditions from front walkway (looking northeast)

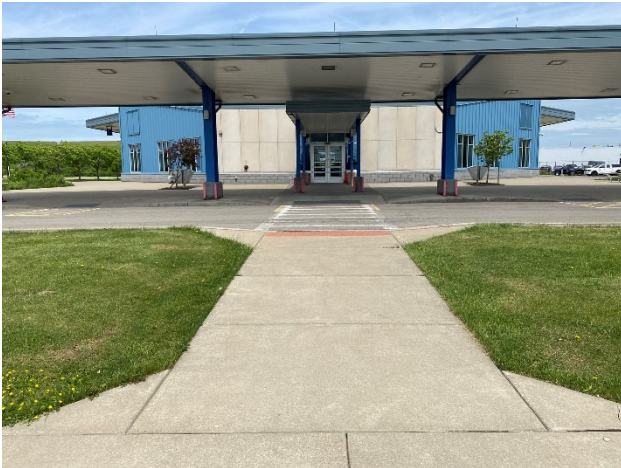
Photo 3: Exterior Site conditions from front walkway - asphalt and concrete surfaces (looking northwest)

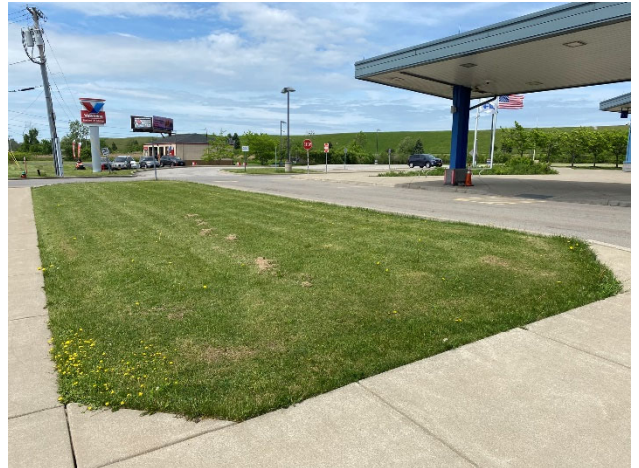
Photo 4: Exterior Site conditions from front walkway - asphalt, concrete, and landscaped areas (looking southwest)

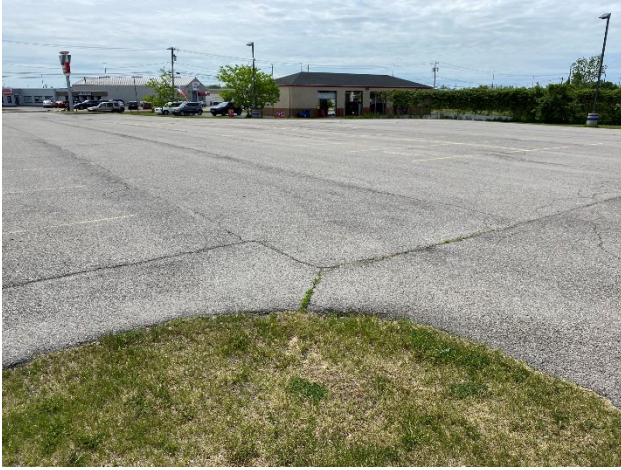
Photo 5: Exterior Site conditions – asphalt parking lot (looking south)

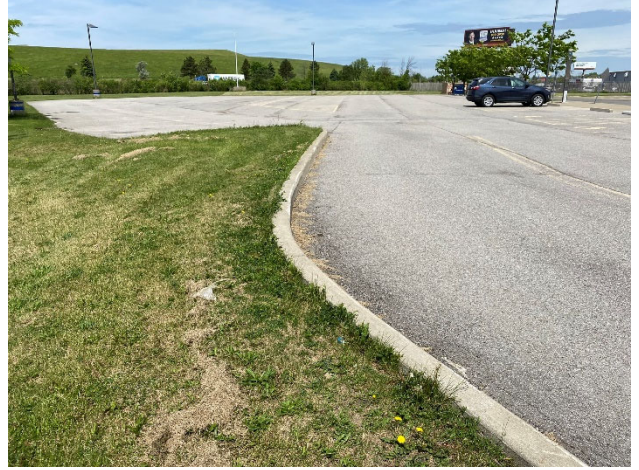
Photo 6: Exterior Site conditions – asphalt parking lot and vegetated area (looking northwest)

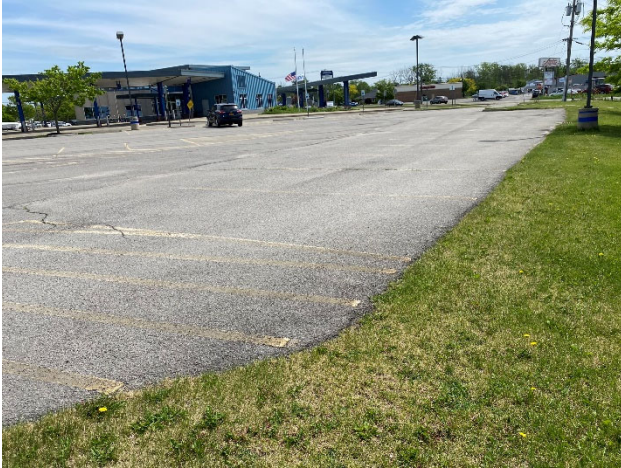
Photo 7: Exterior Site conditions – asphalt parking lot (looking northeast)

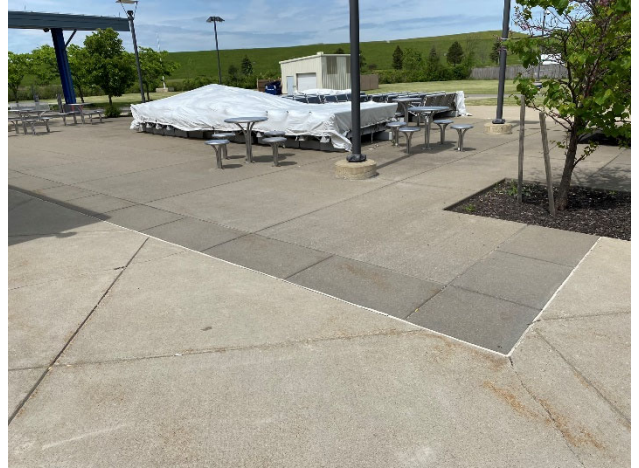
Photo 8: Exterior Site conditions – concrete surfaces from rear of building (looking west)

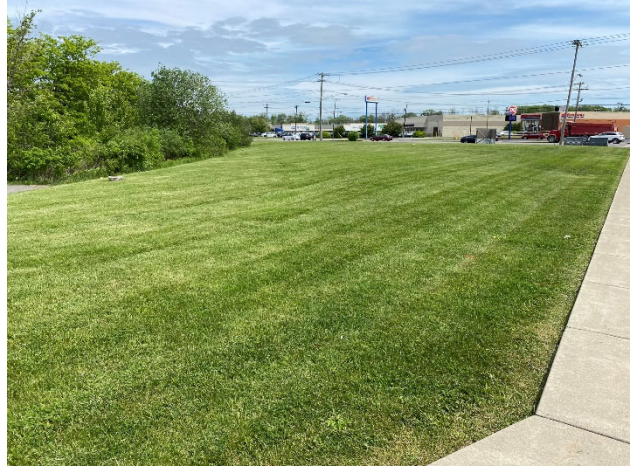
Photo 10: Exterior Site conditions from eastern Site entrance showing landscaping (looking north)

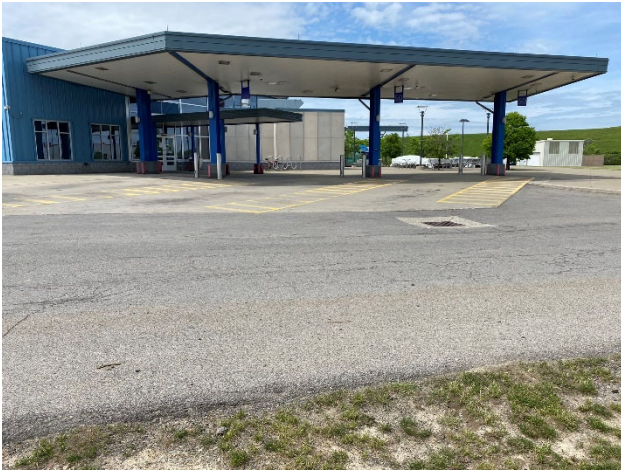
Photo 11: Exterior Site conditions from eastern side of building showing asphalt and concrete surfaces (looking southwest)

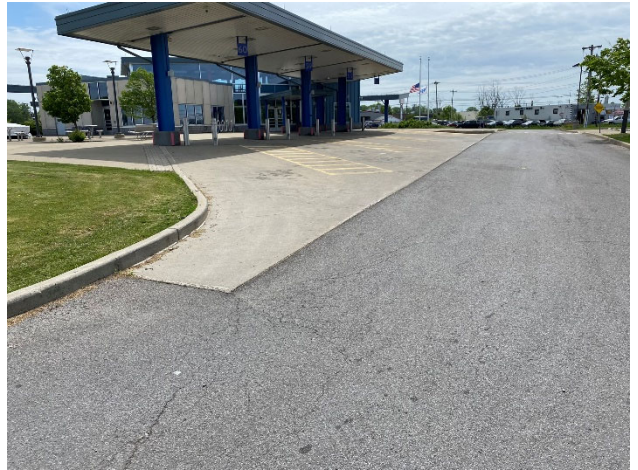
Photo 12: Exterior Site conditions from western side of building showing asphalt, concrete and landscaped areas (looking east)

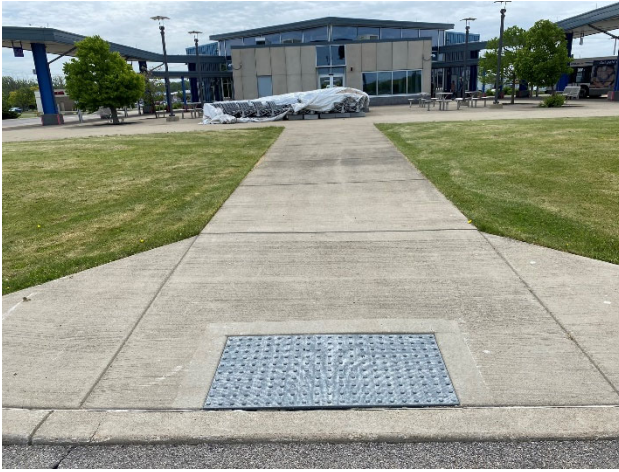
Photo 13: Exterior Site condition – rear of building (looking southeast)

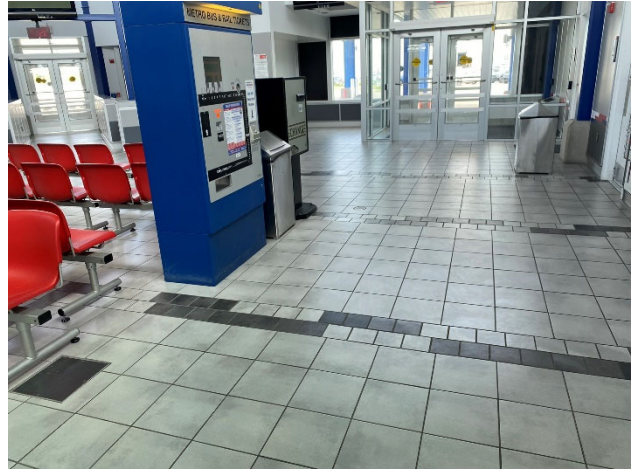
Photo 14: Interior Site conditions

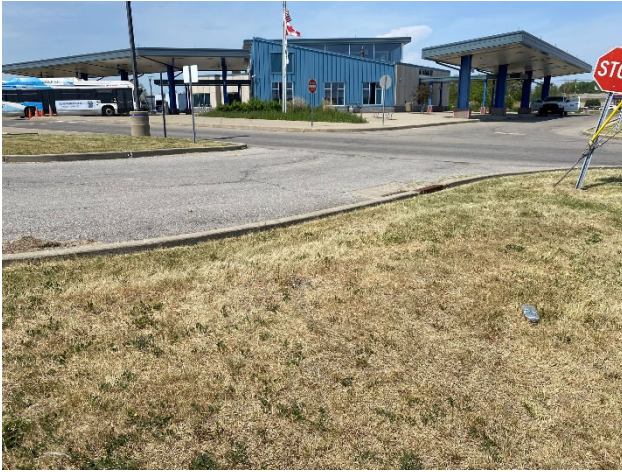
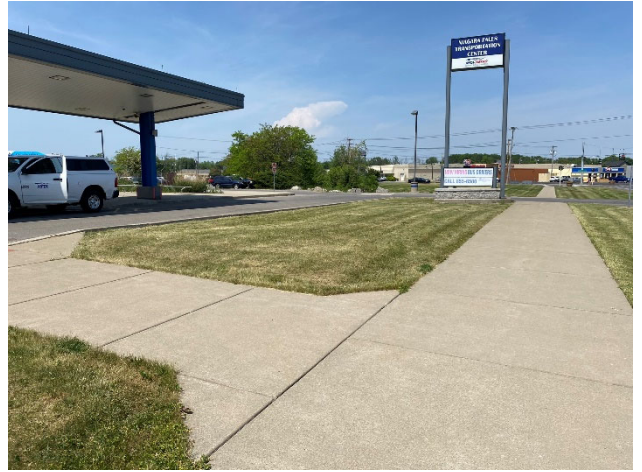
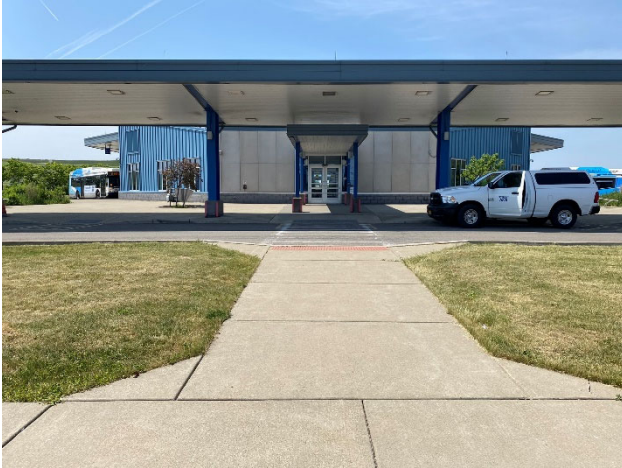
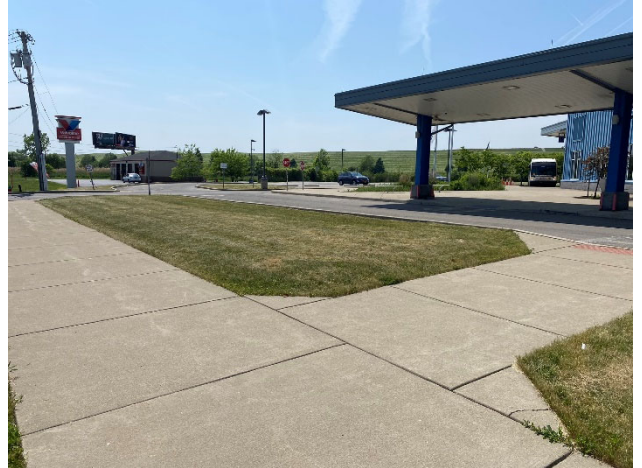
- Photo 1: Exterior Site condition (looking north)
- Photo 2: Exterior Site conditions from front walkway (looking northeast)
- Photo 3: Exterior Site conditions from front walkway - asphalt and concrete surfaces (looking northwest)
- Photo 4: Exterior Site conditions from front walkway - asphalt, concrete, and landscaped areas (looking southwest)

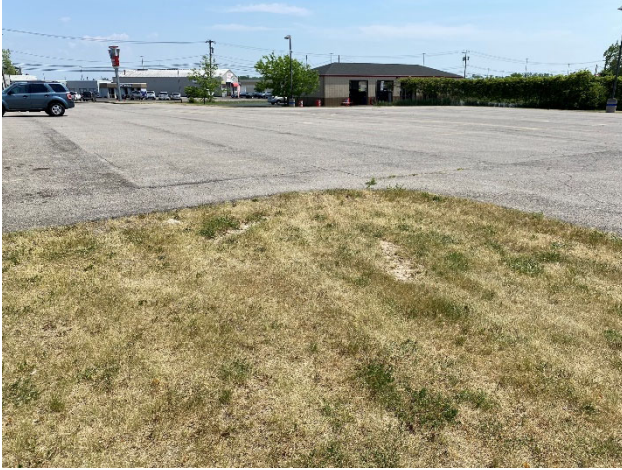
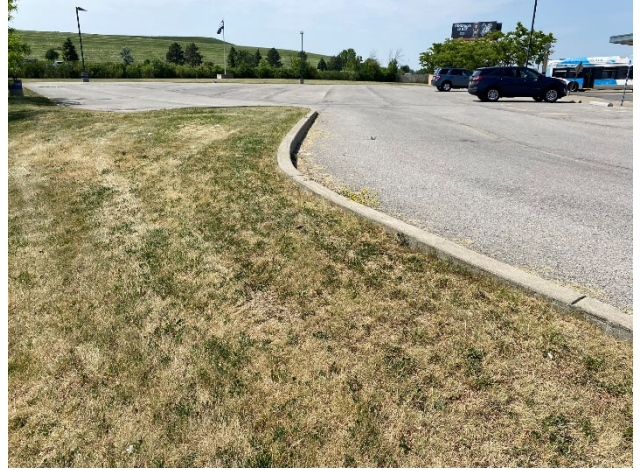
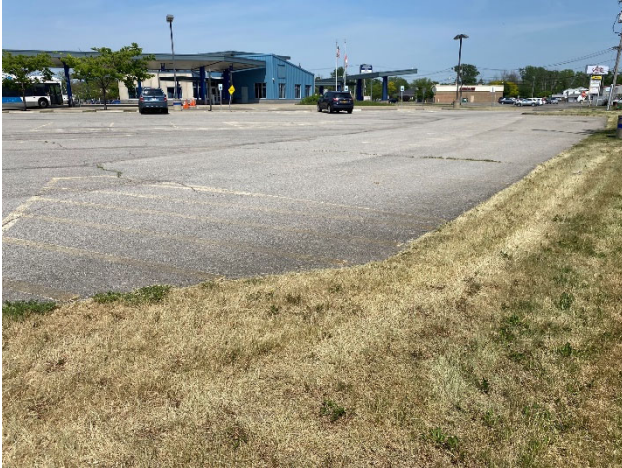
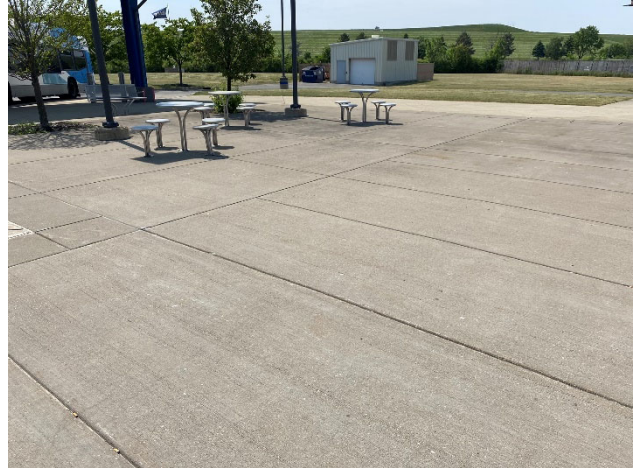
- Photo 5: Exterior Site conditions – asphalt parking lot (looking southeast)
- Photo 6: Exterior Site conditions – asphalt parking lot and vegetated area (looking northwest)
- Photo 7: Exterior Site conditions – asphalt parking lot (looking northeast)
- Photo 8: Exterior Site conditions – concrete surfaces from rear of building (looking west)

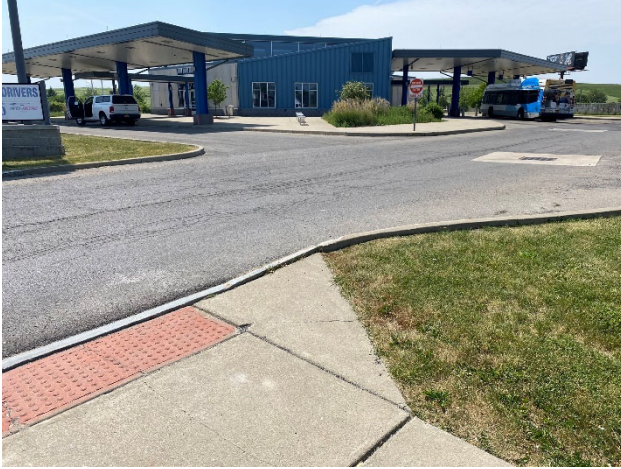
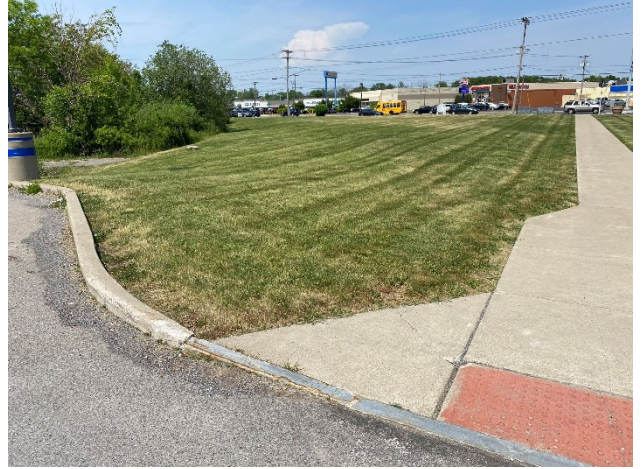
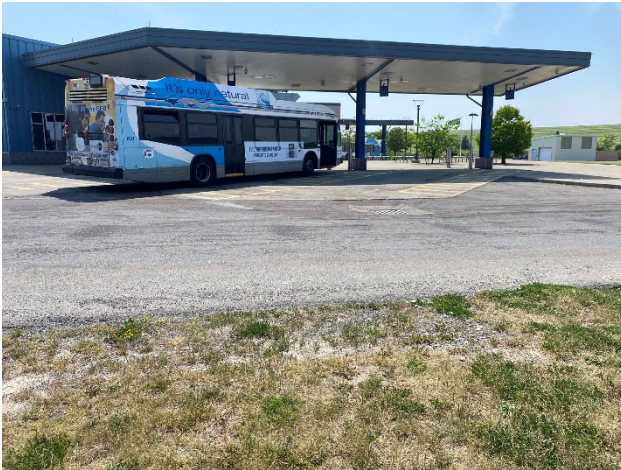
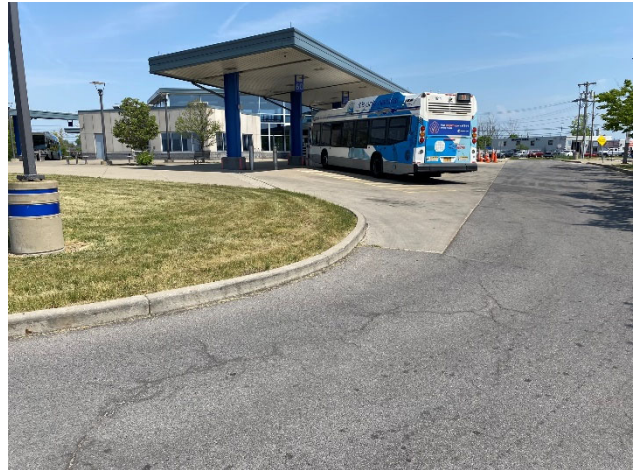
- Photo 9: Exterior Site condition from eastern Site entrance (looking west)
- Photo 10: Exterior Site conditions from eastern Site entrance showing landscaping (looking north)
- Photo 11: Exterior Site conditions from eastern side of building showing asphalt and concrete surfaces (looking southwest)
- Photo 12: Exterior Site conditions from western side of building showing asphalt, concrete and landscaped areas (looking east)

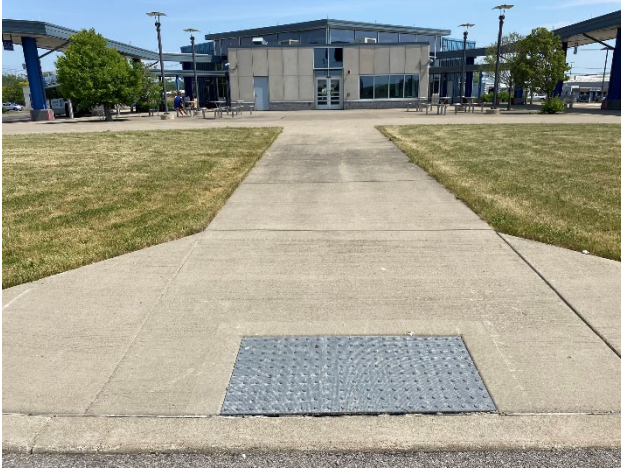
Photo 13: Exterior Site condition – rear of building (looking southeast)

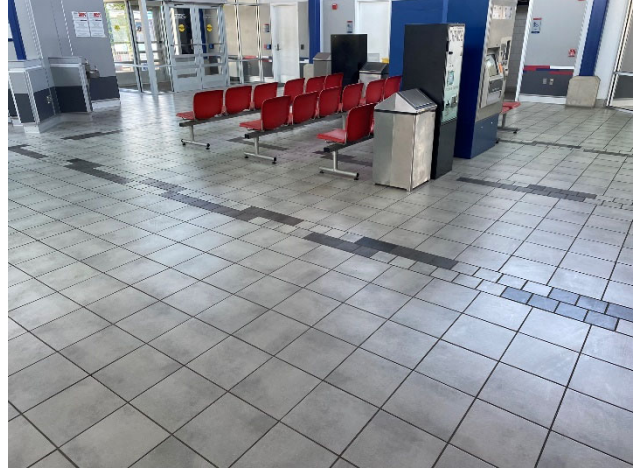
Photo 14: Interior Site conditions

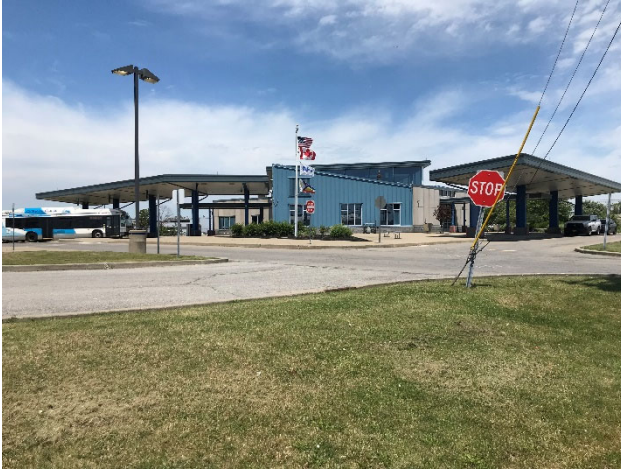
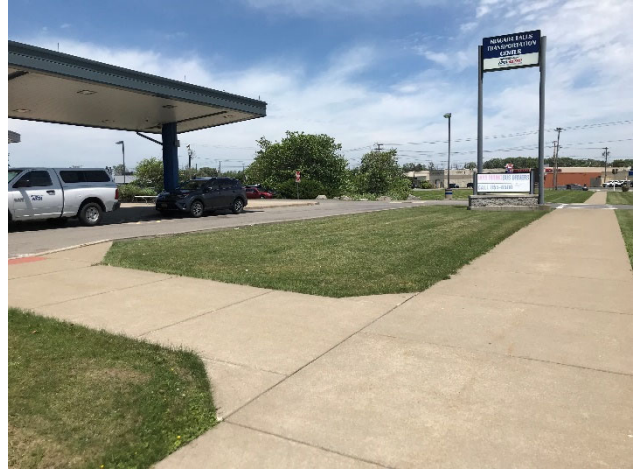
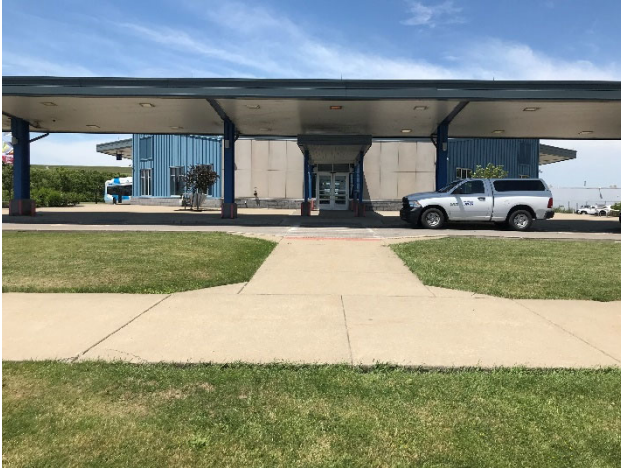
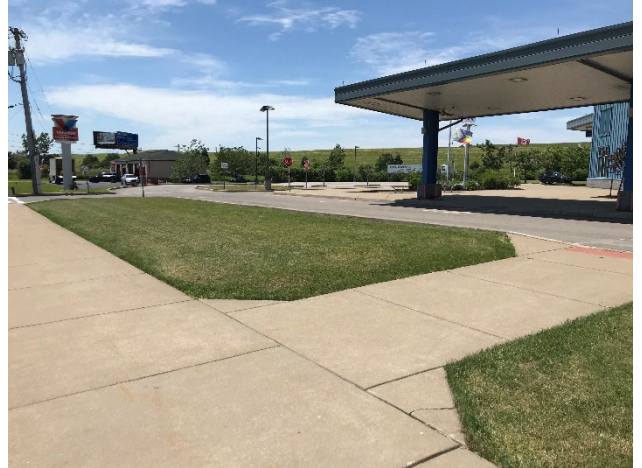
- Photo 1: Exterior Site condition (looking northeast)
- Photo 2: Exterior Site conditions from front walkway (looking northeast)
- Photo 3: Exterior Site conditions from front walkway - asphalt and concrete surfaces (looking northwest)
- Photo 4: Exterior Site conditions from front walkway - asphalt, concrete, and landscaped areas (looking west)

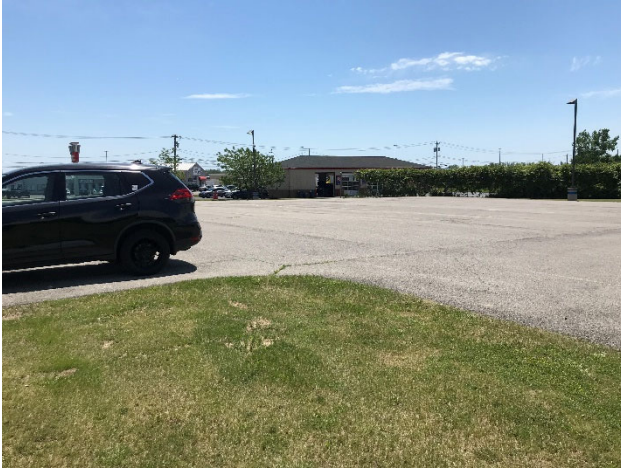
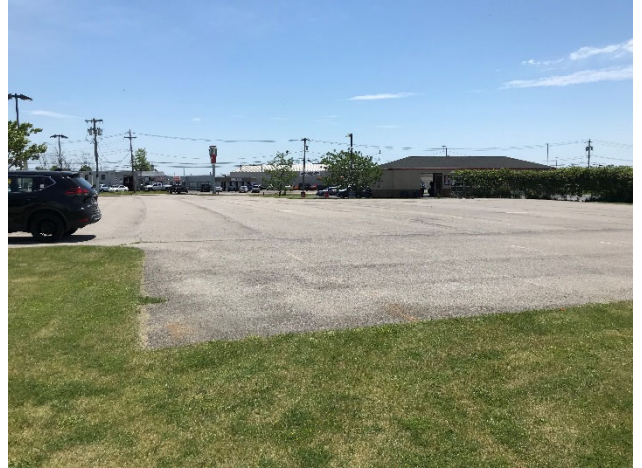
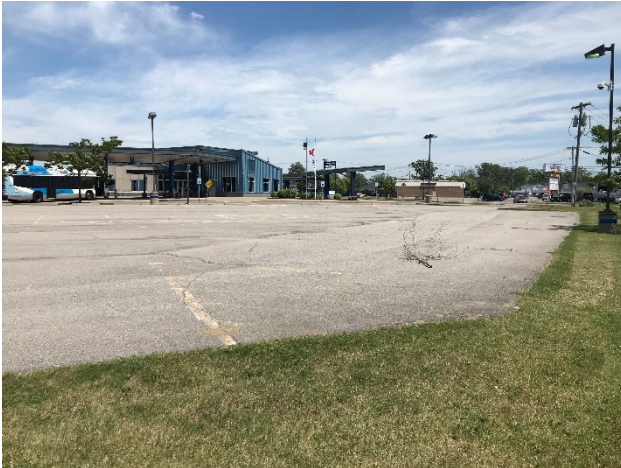
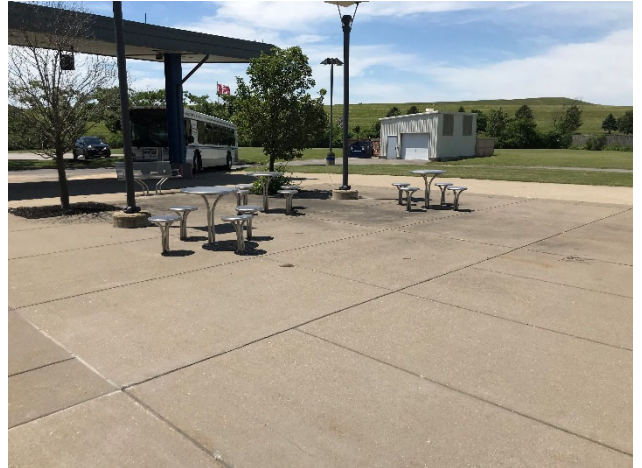
- Photo 5: Exterior Site conditions – asphalt parking lot and vegetated area (looking south)
- Photo 6: Exterior Site conditions – asphalt parking lot and vegetated area (looking southeast)
- Photo 7: Exterior Site conditions – asphalt parking lot (looking northeast)
- Photo 8: Exterior Site conditions – concrete surfaces from rear of building (looking west)

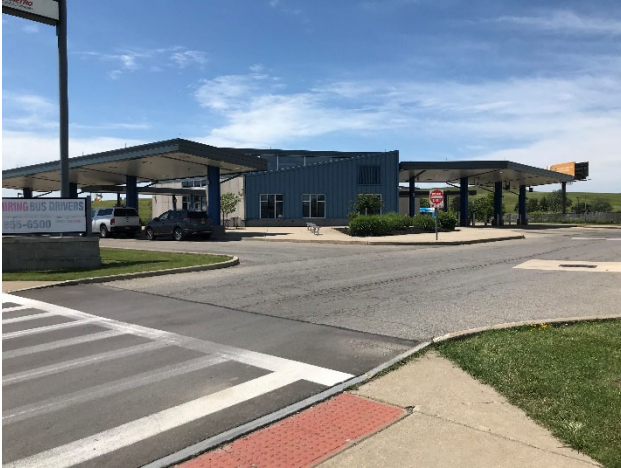
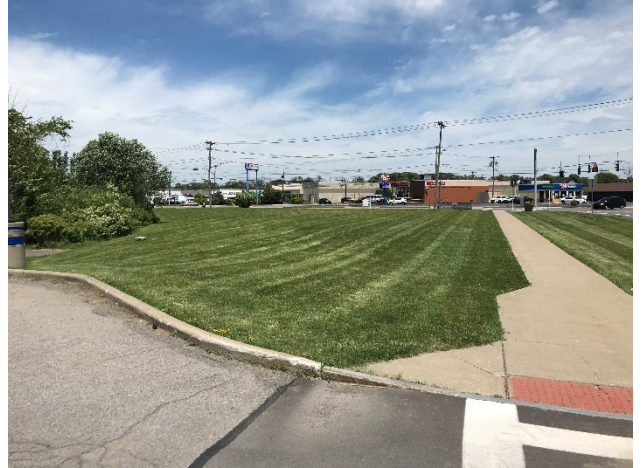
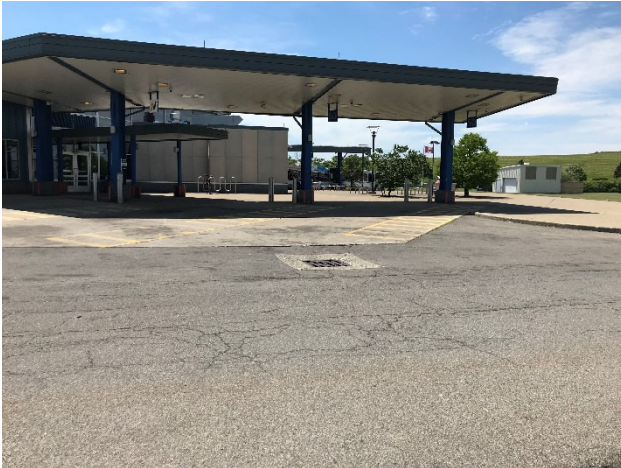
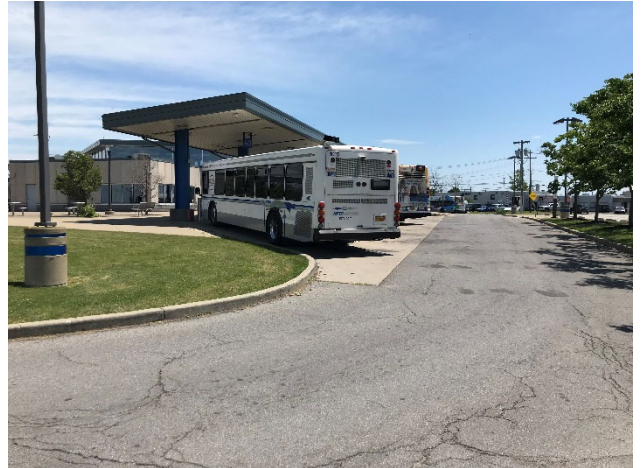
- Photo 9: Exterior Site condition from eastern Site entrance (looking west)
- Photo 10: Exterior Site conditions from eastern Site entrance showing landscaping (looking northeast)
- Photo 11: Exterior Site conditions from eastern side of building showing asphalt and concrete surfaces (looking southwest)
- Photo 12: Exterior Site conditions from western side of building showing asphalt, concrete and landscaped areas (looking southeast)

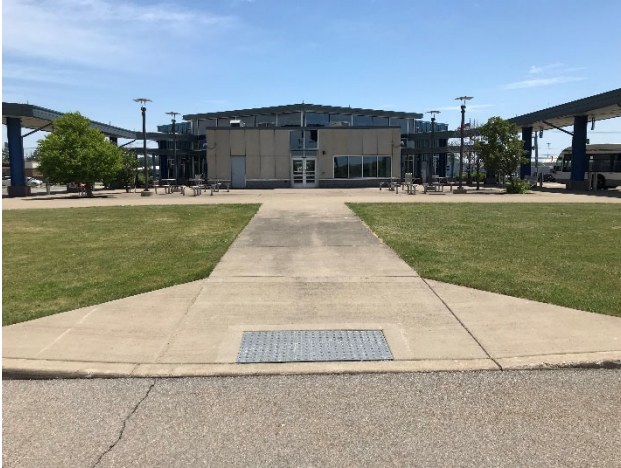
Photo 13: Exterior Site condition – rear of building (looking southeast)

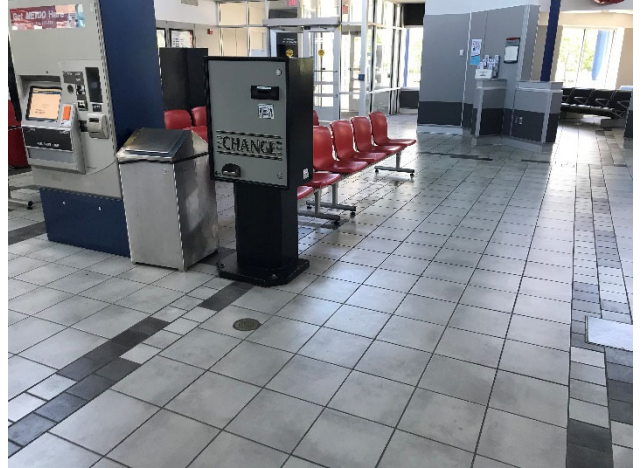
Photo 14: Interior Site conditions

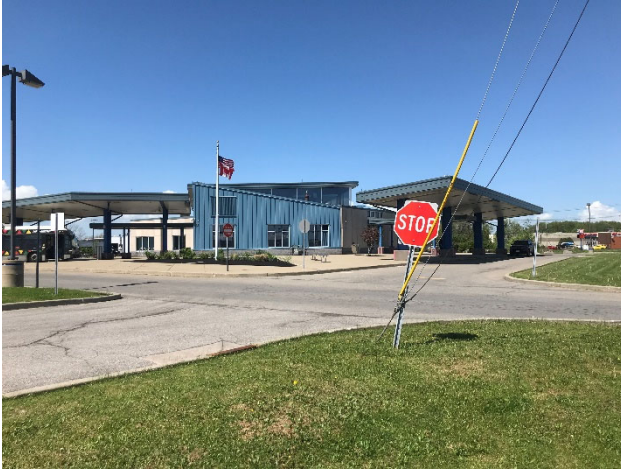
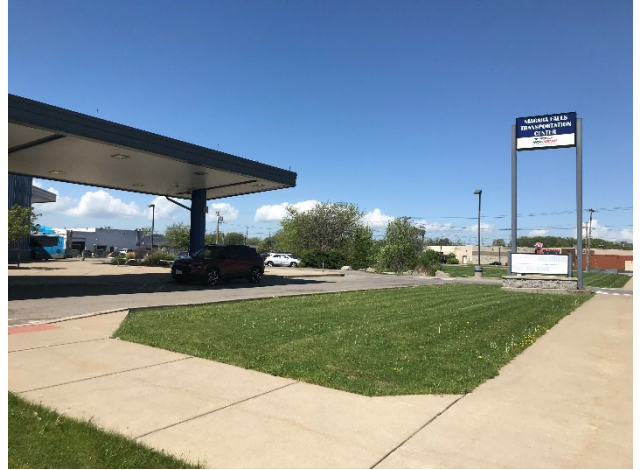
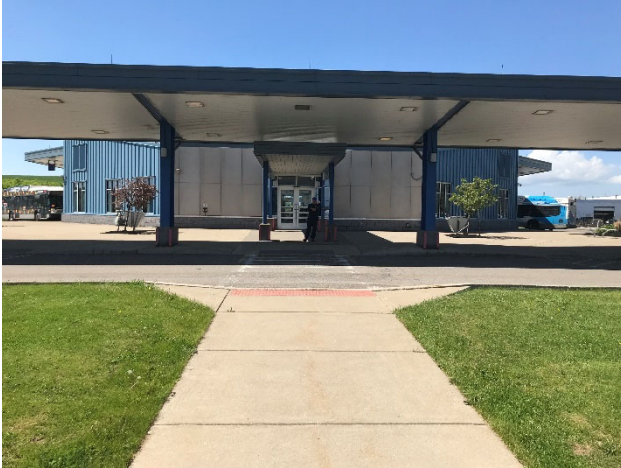
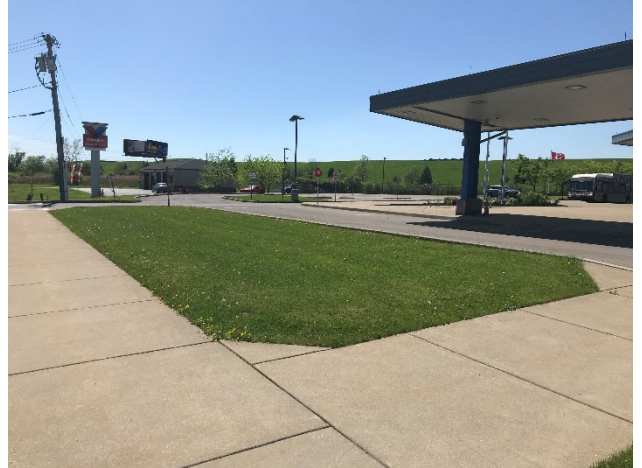
- Photo 1: View of Site from southern corner along Factory Outlet Blvd (looking north)
- Photo 2: View of Site from southeastern edge along Factory Outlet Blvd (looking northeast)
- Photo 3: View of Site from southeastern edge along Factory Outlet Blvd (looking northwest)
- Photo 4: View of asphalt, concrete, and landscaped areas from southeastern edge along Factory Outlet Blvd (looking west)

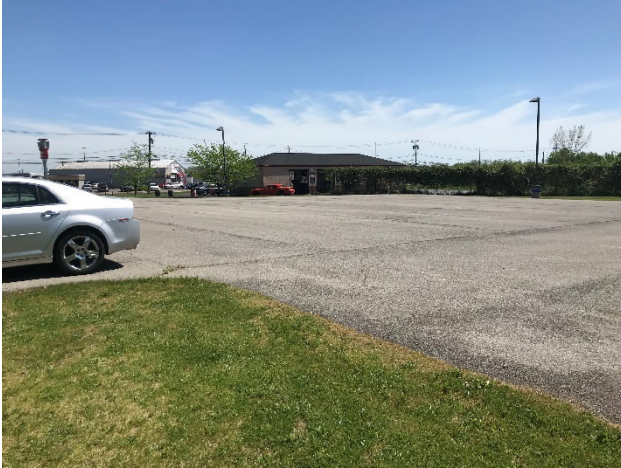
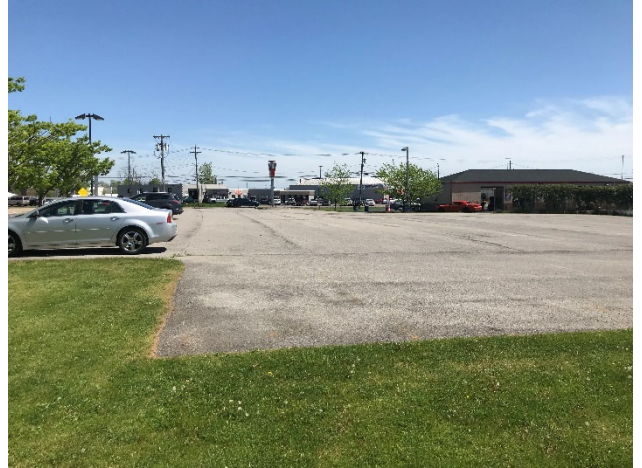
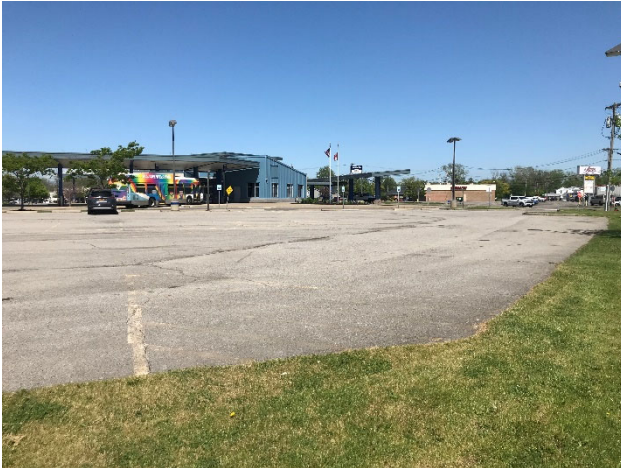
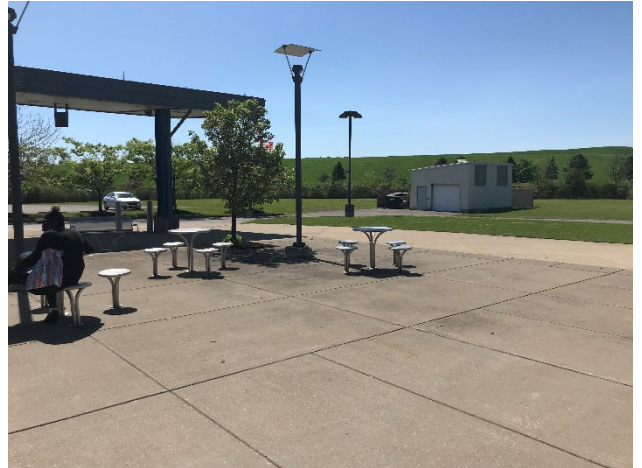
- Photo 5: View of asphalt parking lot and vegetated area (looking south)
- Photo 6: View of asphalt parking lot and vegetated area (looking southeast)
- Photo 7: View of asphalt parking lot and vegetated area from southern Site edge (looking northeast)
- Photo 8: View concrete surfaces from rear of the building in the center of the Site (looking west)

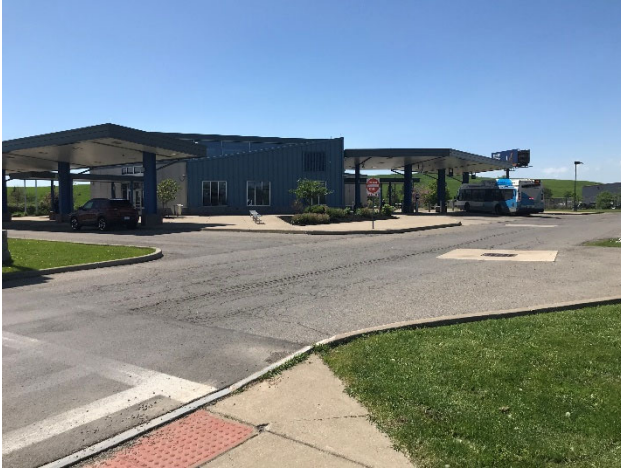
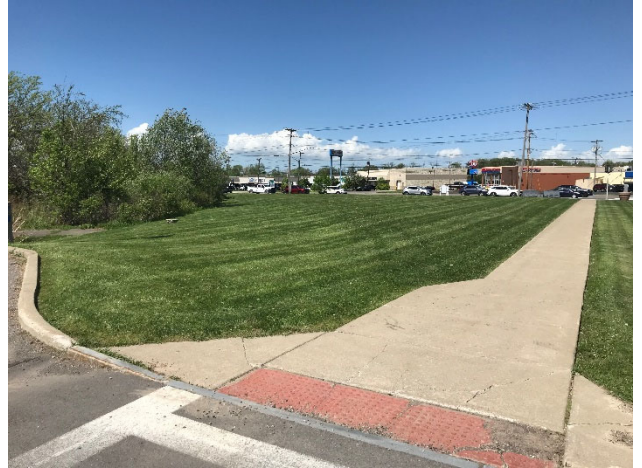
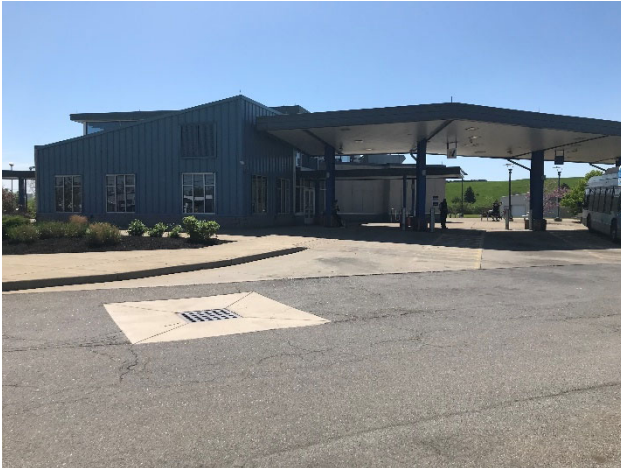
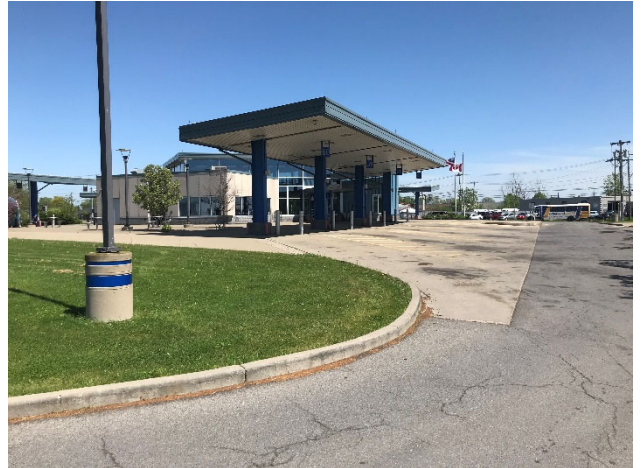
- Photo 9: View of Site from eastern entrance (looking west)
- Photo 10: View of Site from eastern entrance of landscaped area (looking northeast)
- Photo 11: View from eastern side of building showing asphalt and concrete surfaces (looking southwest)
- Photo 12: View from western side of building showing asphalt, concrete and landscaped areas (looking southeast)

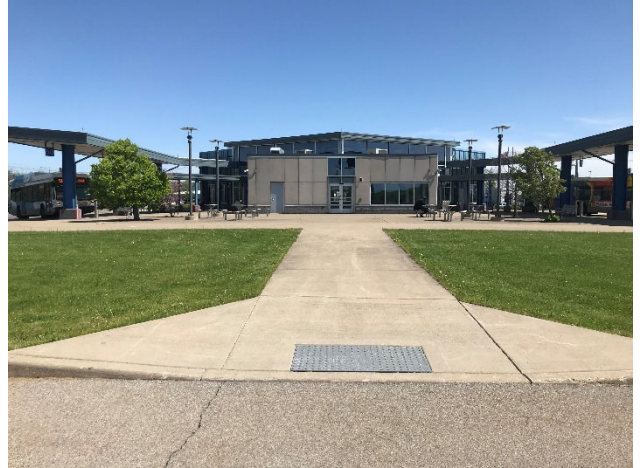
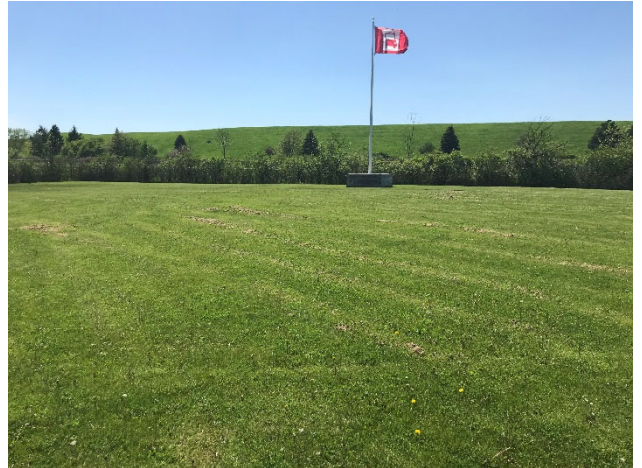
- Photo 13: View from eastern side of building showing asphalt and concrete surfaces (looking southwest)
- Photo 14: View of rear of building (looking southeast)
- Photo 15: View of vegetated area northwest of building (looking west)
- Photo 16: View of vegetated area west of building (looking northwest)

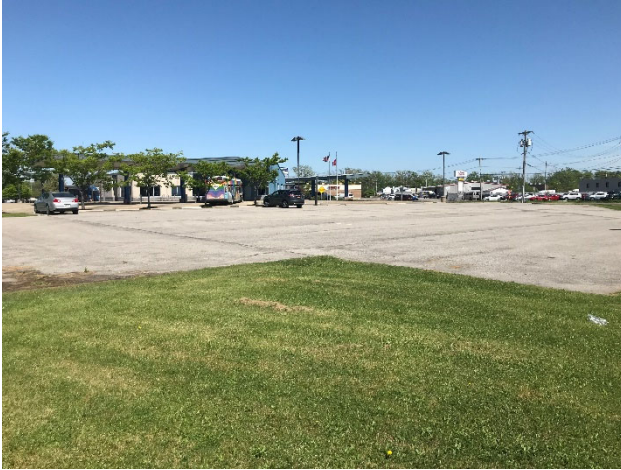
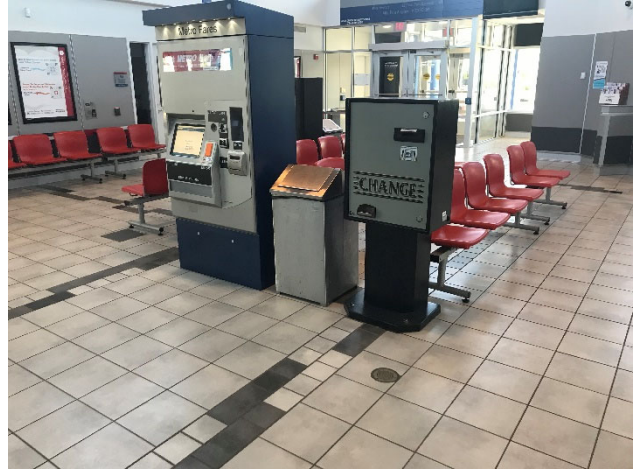
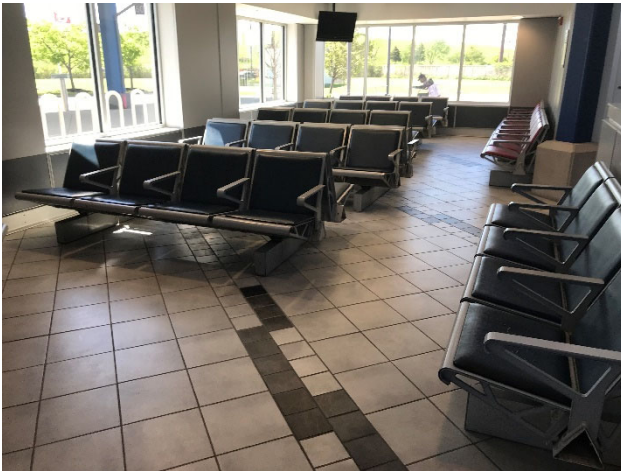
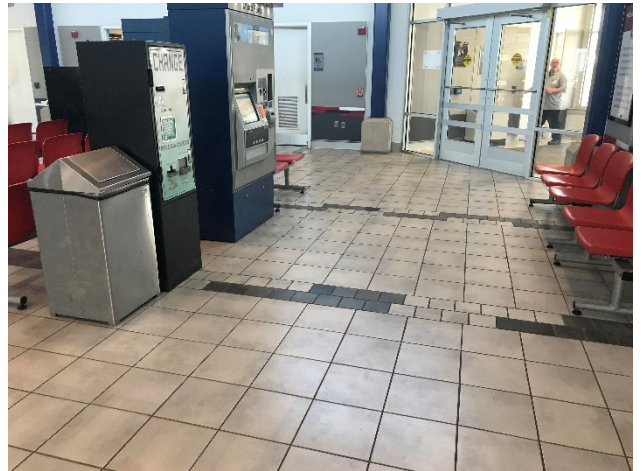
- Photo 17: View of asphalt parking lot and vegetated area (looking east)
- Photo 18: View of interior of on-site building
- Photo 19: View of interior of on-site building
- Photo 20: View of interior of on-site building
