### STORM SEWER SAMPLING REPORT BCP SITE NOS. C932138, C932139, C932140 LOCKPORT (C) NIAGARA COUNTY, NEW YORK

Reason of inspection : <b>gen. condition control</b>	Pipe shape : <b>round</b>
Section type : <b>storm water</b>	Pipe size : <b>12 inch</b>
Area : <b>bldg 7-10</b>	Pipe material : <b>clay tile</b>
Lining :

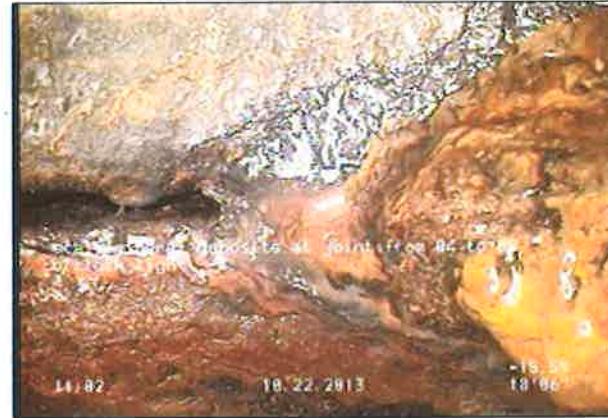
Photo: MH-1\_2-16\_3\_22102013\_110749\_A.JPG  
scale/mineral deposits at joint from 04 to 05 o'clock light

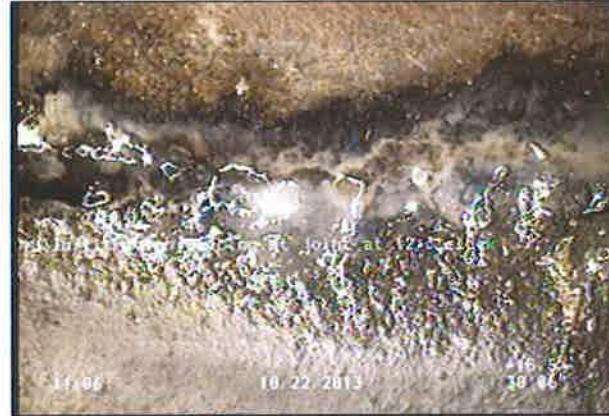
Photo: MH-1\_2-16\_4\_22102013\_111149\_A.JPG  
Infiltration Seeping at joint at 12 o'clock

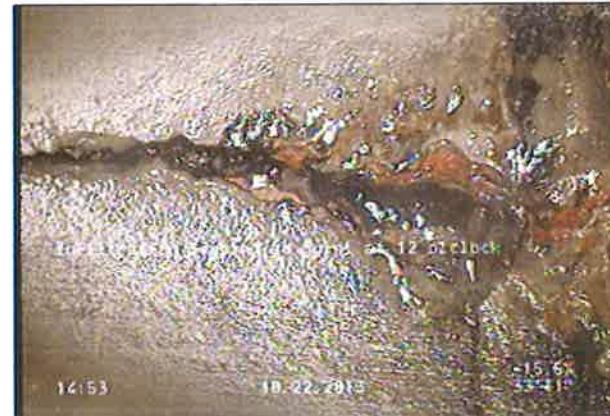
Photo: 2-16\_MH-3\_5\_22102013\_145907\_A.JPG  
Infiltration Seeping at joint at 12 o'clock

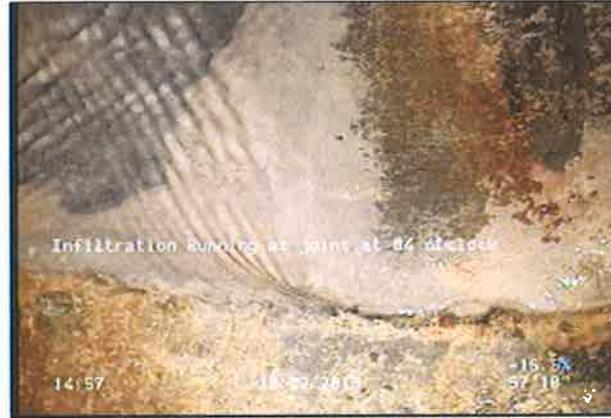
Photo: 2-16\_MH-3\_7\_22102013\_150240\_A.JPG  
Infiltration Running at joint at 04 o'clock

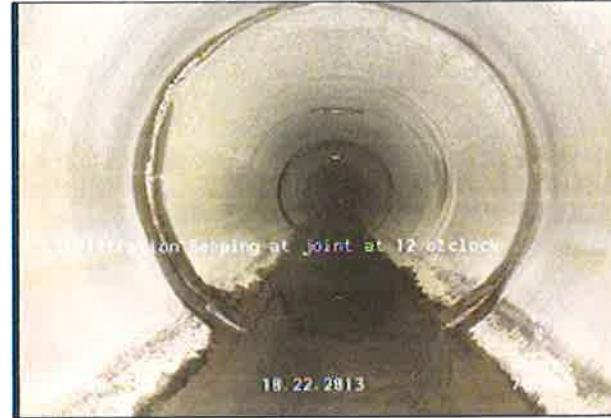
Photo: 2-16\_MH-3\_10\_22102013\_150555\_A.JPG  
Infiltration Seeping at joint at 12 o'clock

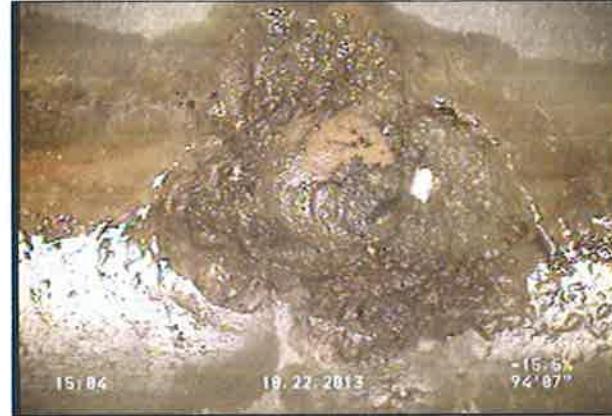
Photo: 2-16\_MH-3\_13\_22102013\_150929\_A.JPG  
Hole in pipe at 12 o'clock / repaired but leaking

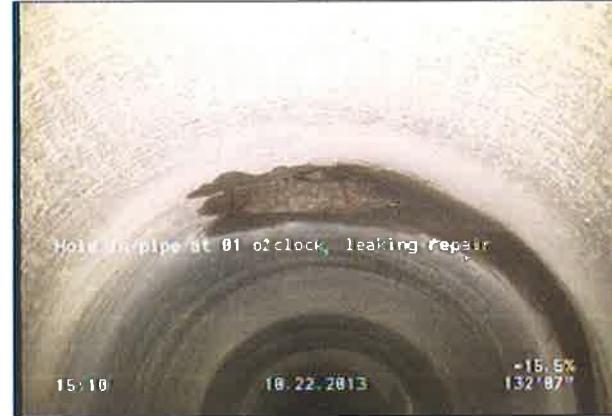
Photo: 2-16\_MH-3\_18\_22102013\_151530\_B.JPG  
Hole in pipe at 01 o'clock / leaking repair

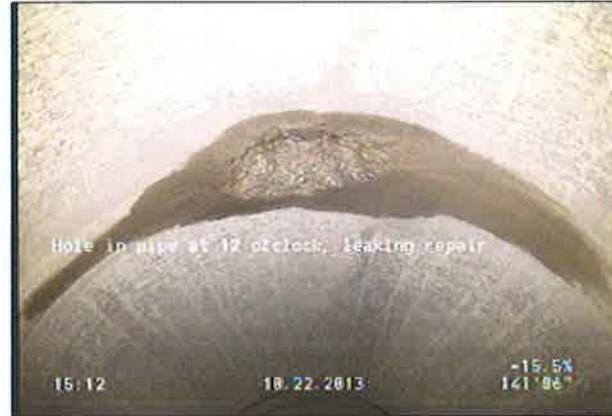
Photo: 2-16\_MH-3\_20\_22102013\_151719\_B.JPG  
Hole in pipe at 12 o'clock / leaking repair

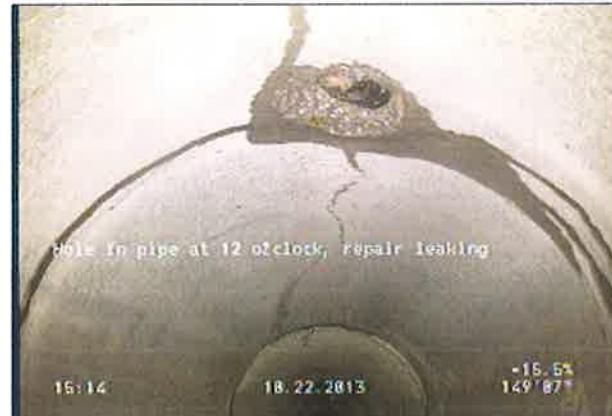
Photo: 2-16\_MH-3\_22\_22102013\_151913\_B.JPG  
Hole in pipe at 12 o'clock / repair leaking

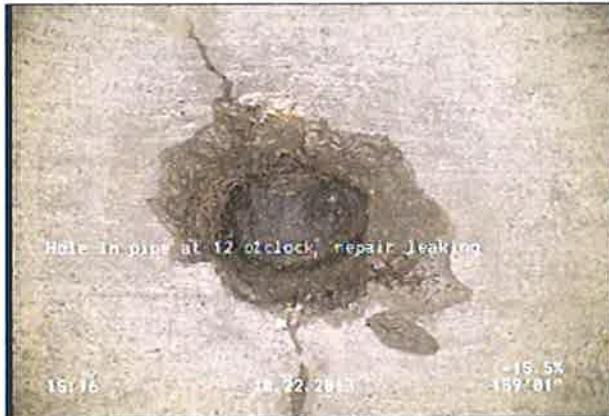
Photo: 2-16\_MH-3\_24\_22102013\_152118\_A.JPG  
Hole in pipe at 12 o'clock / repair leaking

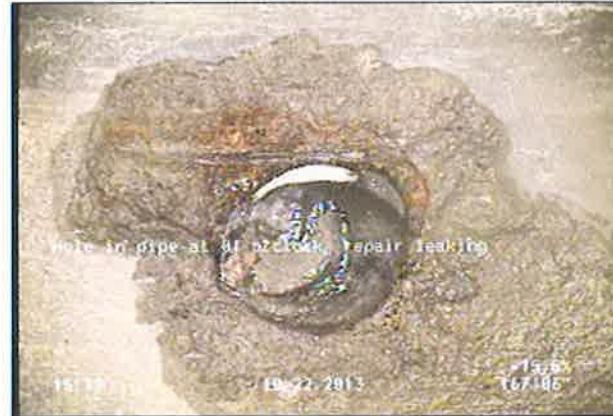
Photo: 2-16\_MH-3\_26\_22102013\_152412\_A.JPG  
Hole in pipe at 01 o'clock / repair leaking

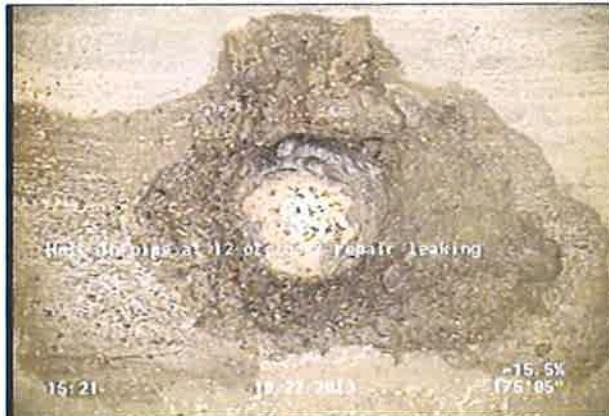
Photo: 2-16\_MH-3\_28\_22102013\_152620\_A.JPG  
Hole in pipe at 12 o'clock / repair leaking

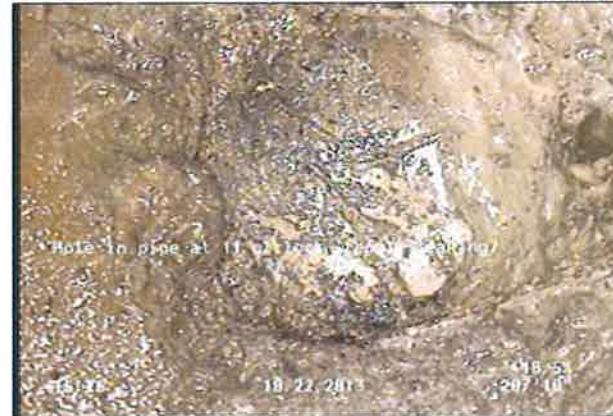
Photo: 2-16\_MH-3\_32\_22102013\_153138\_A.JPG  
Hole in pipe at 11 o'clock / repair leaking

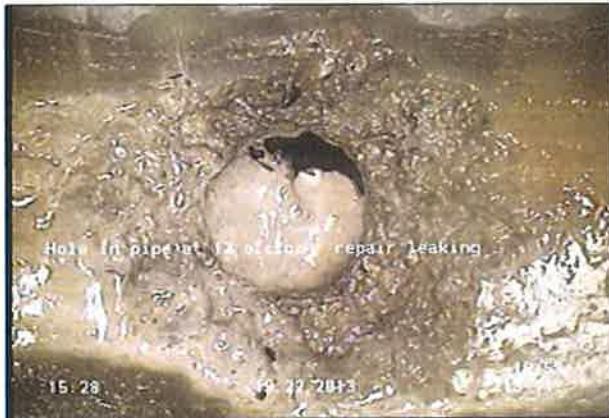
Photo: 2-16\_MH-3\_34\_22102013\_153325\_A.JPG  
Hole in pipe at 12 o'clock / repair leaking

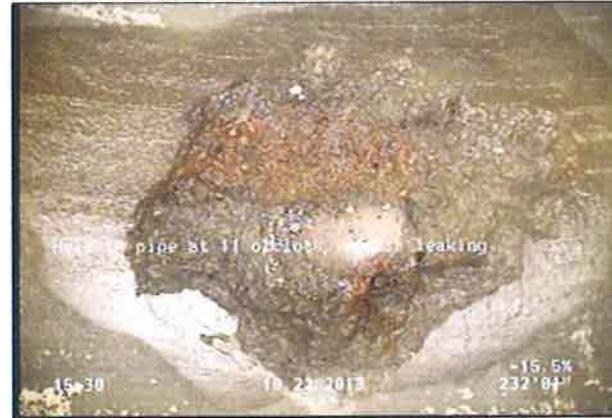
Photo: 2-16\_MH-3\_36\_22102013\_153553\_A.JPG  
Hole in pipe at 11 o'clock / repair leaking

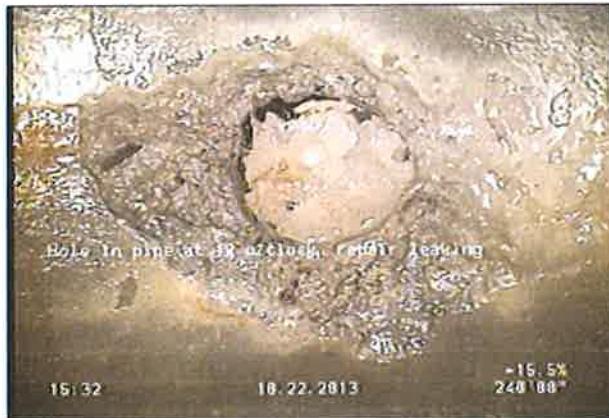
Photo: 2-16\_MH-3\_38\_22102013\_153733\_A.JPG  
Hole in pipe at 12 o'clock / repair leaking

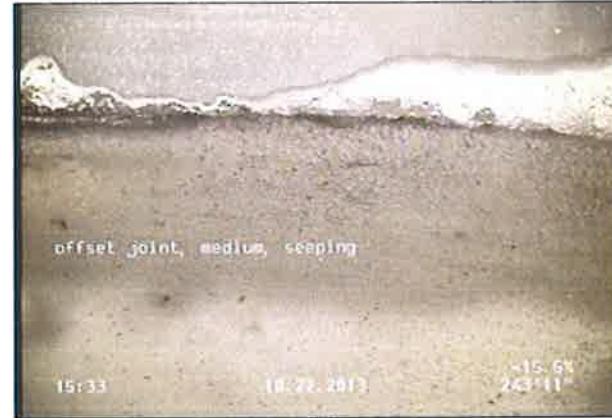
Photo: 2-16\_MH-3\_39\_22102013\_153833\_A.JPG  
offset joint, medium / seeping

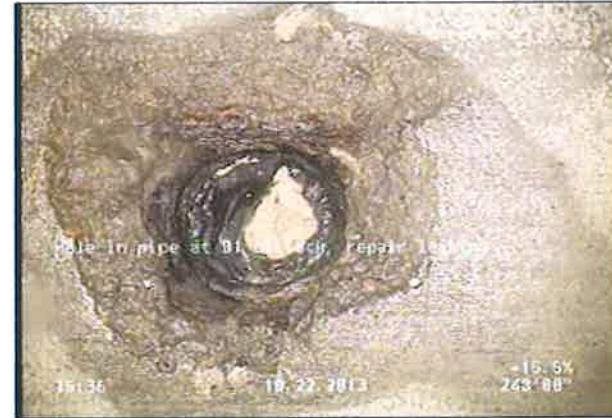
Photo: 2-16\_MH-3\_41\_22102013\_154128\_A.JPG  
Hole in pipe at 01 o'clock / repair leaking

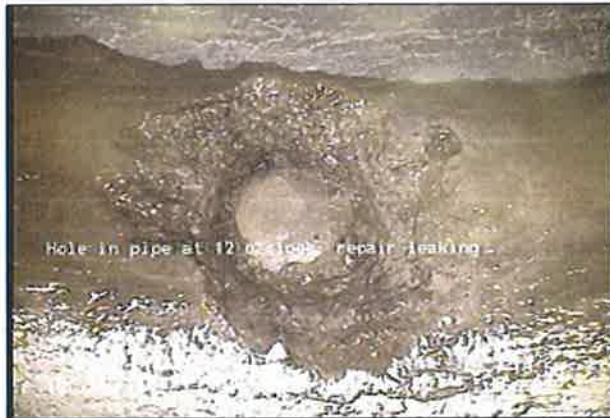
Photo: 2-16\_MH-3\_43\_22102013\_154253\_A.JPG  
Hole in pipe at 12 o'clock / repair leaking

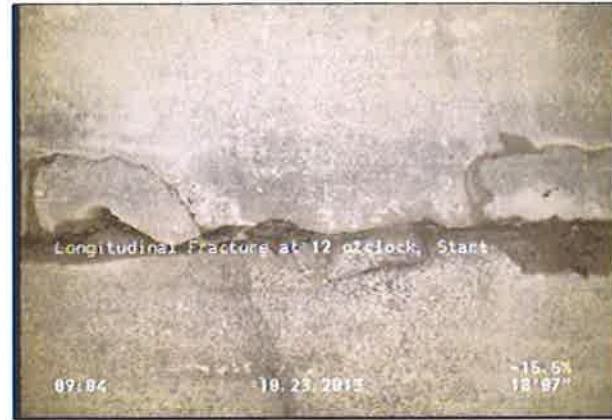
Photo: 10-3\_10-4\_5\_23102013\_090910\_A.JPG  
Longitudinal Fracture at 12 o'clock, Start

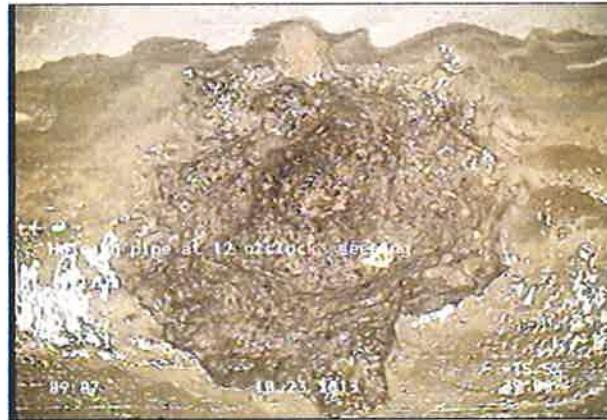
Photo: 10-3\_10-4\_8\_23102013\_091213\_A.JPG  
Hole in pipe at 12 o'clock / seeping

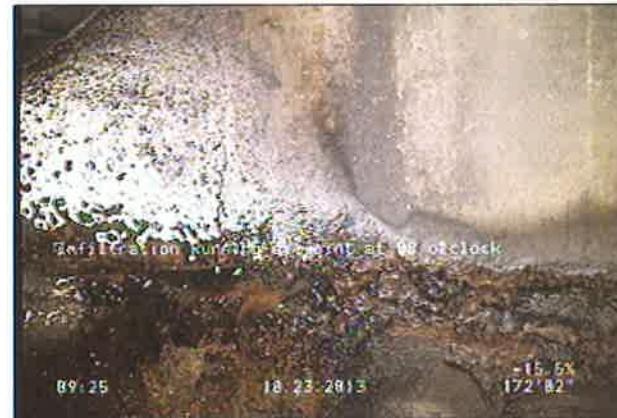
Photo: 10-3\_10-4\_18\_23102013\_093033\_A.JPG  
Infiltration Running at joint at 08 o'clock

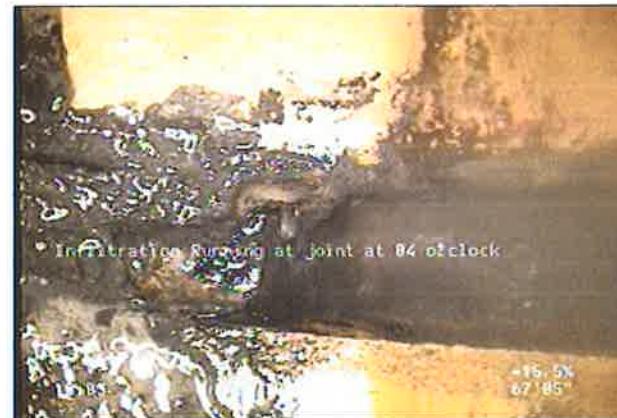
Photo: 10-1\_10-2-16\_8\_23102013\_100842\_A.JPG  
Infiltration Running at joint at 04 o'clock

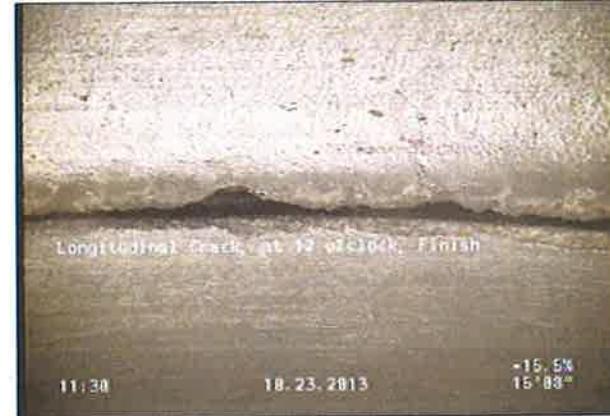
Photo: 10-6\_10-5-7\_3\_23102013\_113546\_A.JPG  
Longitudinal Crack, at 12 o'clock, Finish

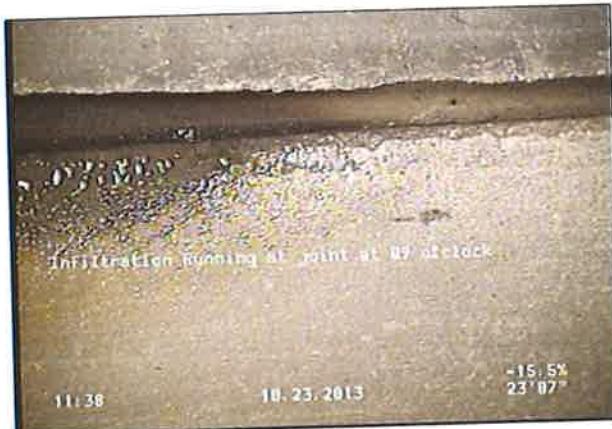
Photo: 10-6\_10-5-7\_4\_23102013\_114354\_A.JPG  
Infiltration Running at joint at 09 o'clock

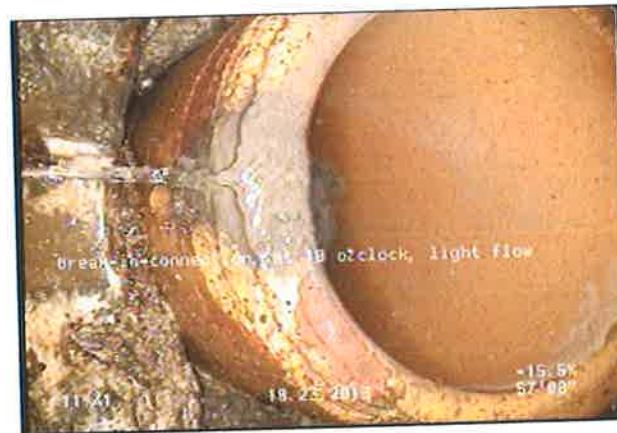
Photo: 10-6\_10-5-7\_5\_23102013\_114625\_A.JPG  
break-in-connection, at 10 o'clock / light flow

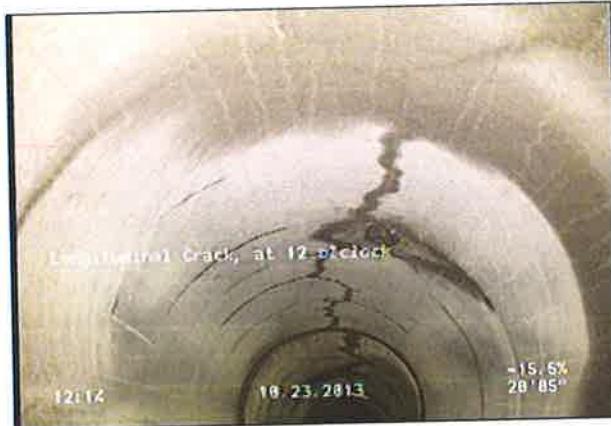
Photo: 10-5-7\_10-7-21\_3\_23102013\_121941\_A.JPG  
Longitudinal Crack, at Start

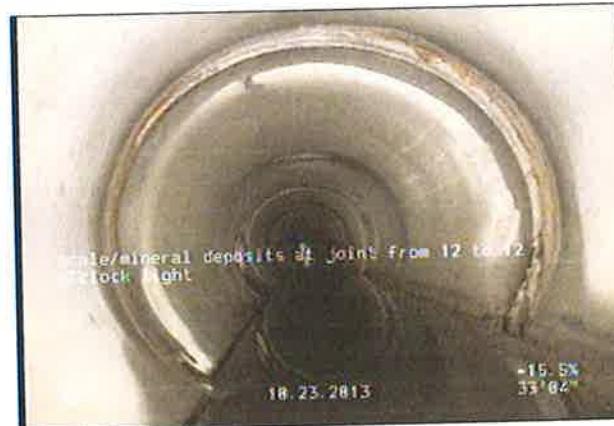
Photo: 10-5-7\_10-7-21\_5\_23102013\_122130\_A.JPG  
scale/mineral deposits at joint from 12 to 12 o'clock light

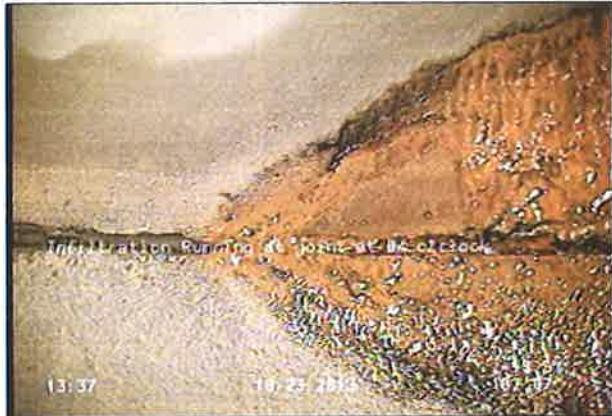
Photo: 10-7\_10-8-21\_6\_23102013\_134244\_A.JPG  
Infiltration Running at joint at 04 o'clock

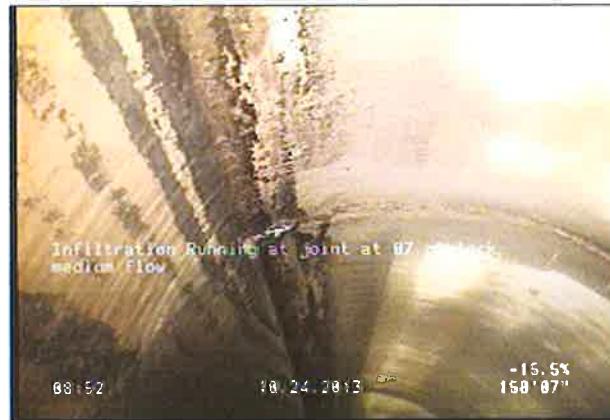
Photo: 10-8-21\_10-9\_7\_24102013\_085748\_B.JPG  
Infiltration Running at joint at 07 o'clock / medium flow

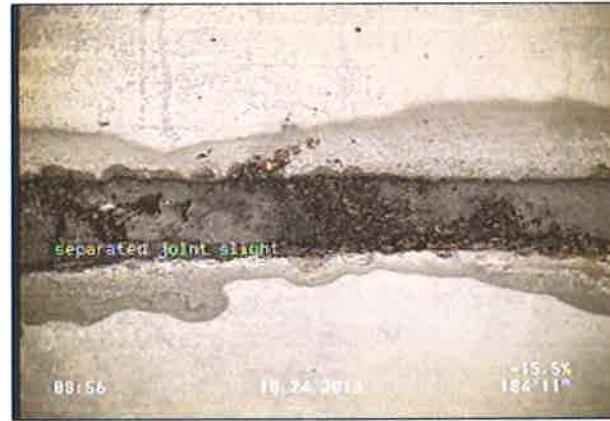
Photo: 10-8-21\_10-9\_9\_24102013\_090132\_A.JPG  
separated joint slight

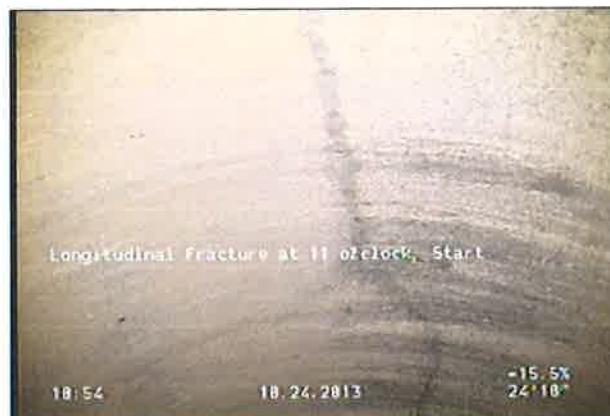
Photo: 10-9\_10-10-6\_2\_24102013\_105910\_A.JPG  
Longitudinal Fracture at 11 o'clock, Start

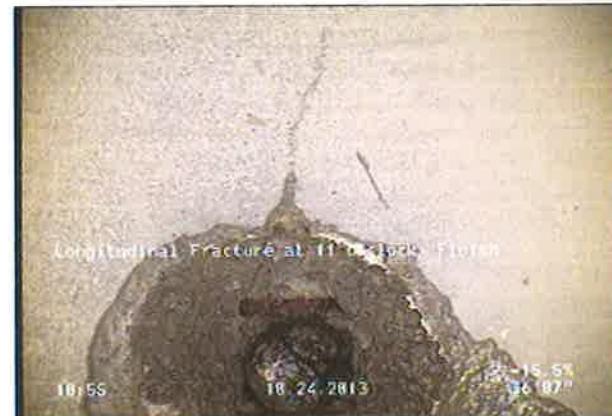
Photo: 10-9\_10-10-6\_3\_24102013\_110043\_A.JPG  
Longitudinal Fracture at 11 o'clock, Finish

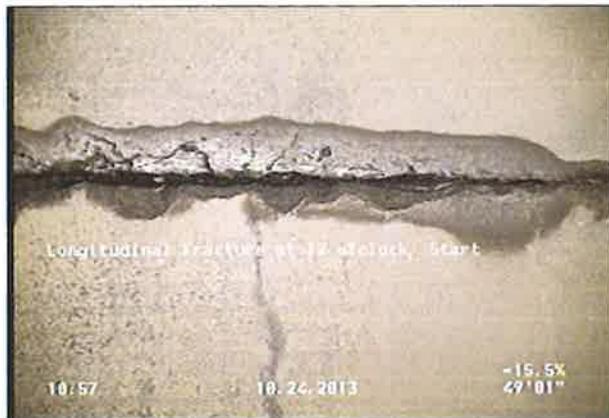
Photo: 10-9\_10-10-6\_5\_24102013\_110253\_A.JPG  
Longitudinal Fracture at 12 o'clock, Start

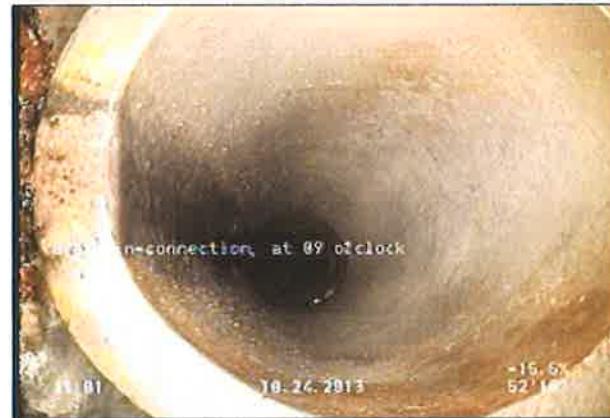
Photo: 10-9\_10-10-6\_6\_24102013\_110627\_A.JPG  
break-in-connection, at 09 o'clock

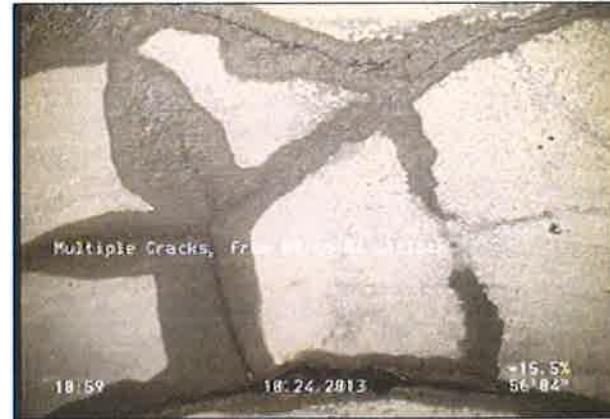
Photo: 10-9\_10-10-6\_6\_24102013\_110443\_A.JPG  
Multiple Cracks, from 09 to 04 o'clock

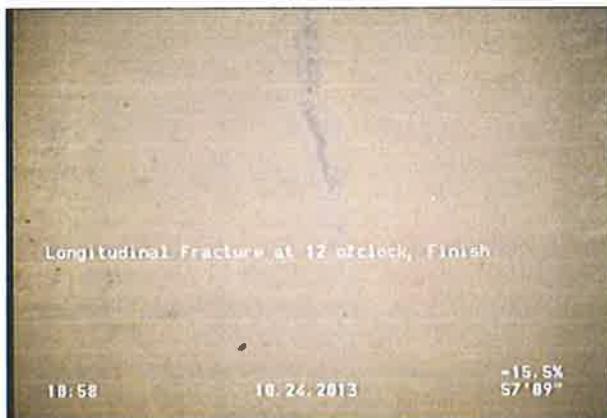
Photo: 10-9\_10-10-6\_6\_24102013\_110342\_A.JPG  
Longitudinal Fracture at 12 o'clock, Finish

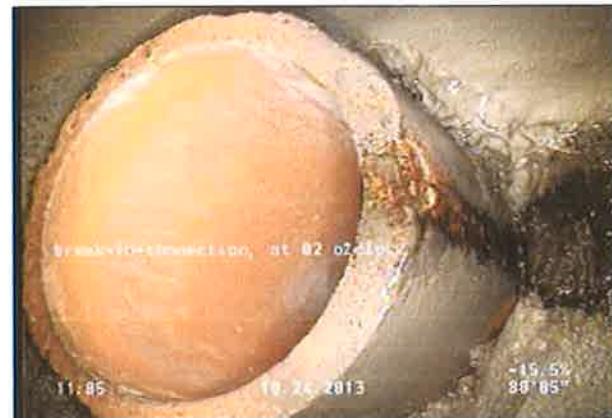
Photo: 10-9\_10-10-6\_11\_24102013\_111047\_A.JPG  
break-in-connection, at 02 o'clock

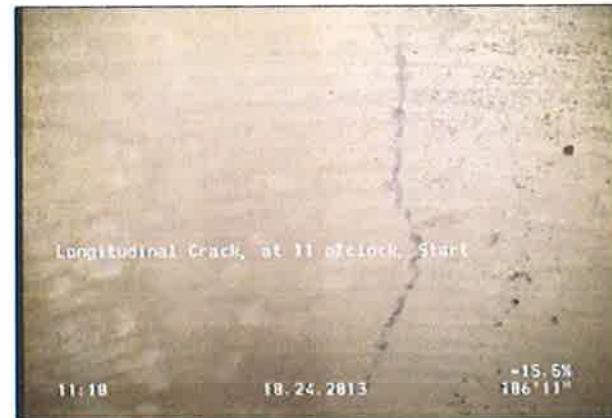
Photo: 10-9\_10-10-6\_12\_24102013\_1111516\_A.JPG  
Longitudinal Crack, at 11 o'clock, Start

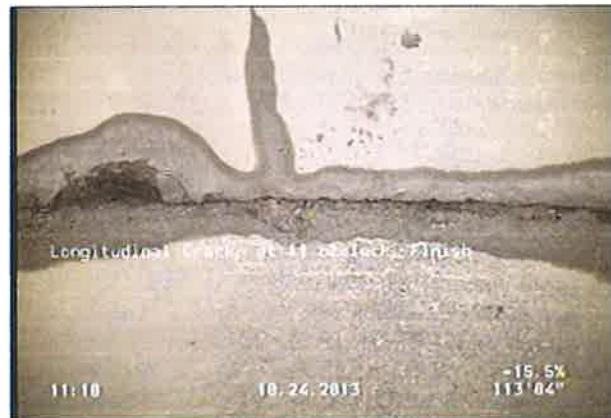
Photo: 10-9\_10-10-6\_14\_24102013\_111553\_A.JPG  
Longitudinal Crack, at 11 o'clock, Finish

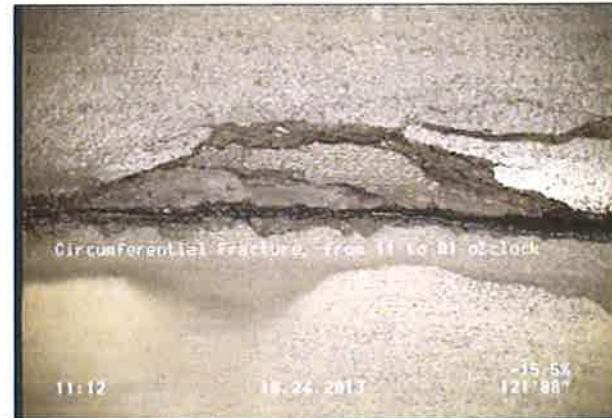
Photo: 10-9\_10-10-6\_15\_24102013\_111723\_A.JPG  
Circumferential Fracture, from 11 to 01 o'clock

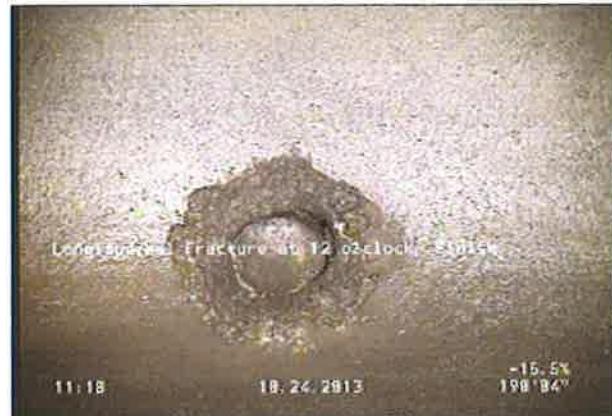
Photo: 10-9\_10-10-6\_17\_24102013\_112322\_A.JPG  
Longitudinal Fracture at 12 o'clock, Finish

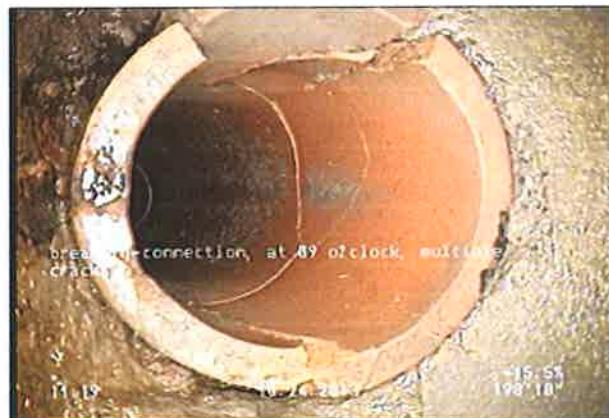
Photo: 10-9\_10-10-6\_18\_24102013\_112435\_A.JPG  
break-in-connection, at 09 o'clock / multiple cracks

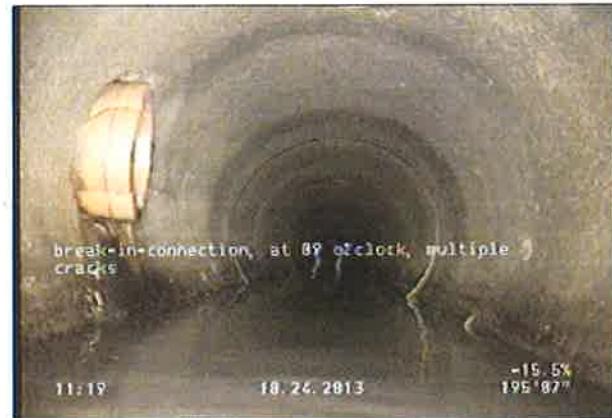
Photo: 10-9\_10-10-6\_18\_24102013\_112450\_B.JPG  
break-in-connection, at 09 o'clock / multiple cracks

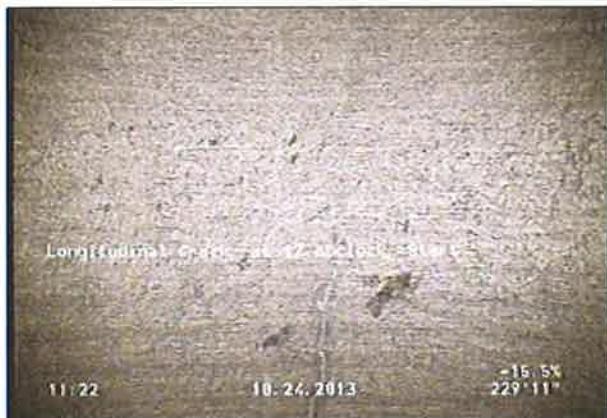
Photo: 10-9\_10-10-6\_19\_24102013\_112710\_A.JPG  
Longitudinal Crack, at 12 o'clock, Start

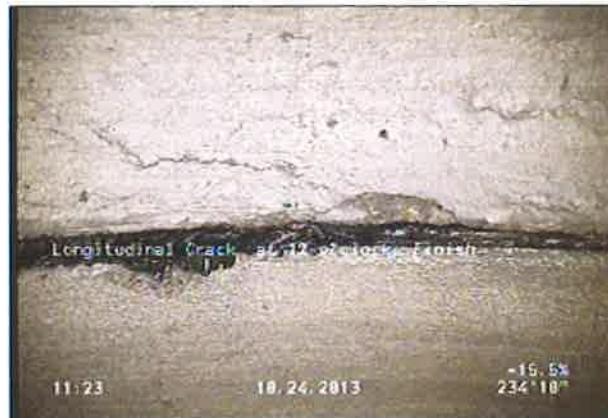
Photo: 10-9\_10-10-6\_20\_24102013\_112809\_A.JPG  
Longitudinal Crack, at 12 o'clock, Finish

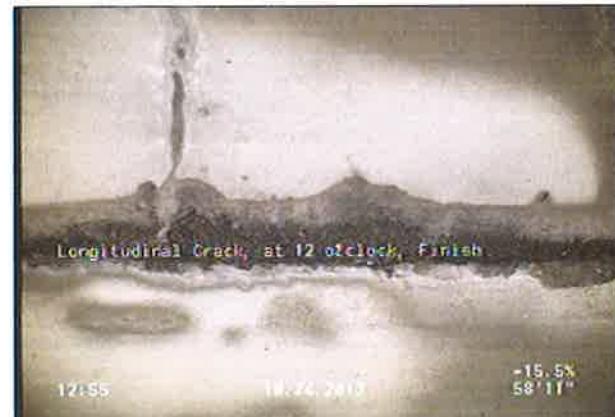
Photo: 10-11-18\_10-10-6\_3\_24102013\_130013\_A.JPG  
Longitudinal Crack, at 12 o'clock, Finish

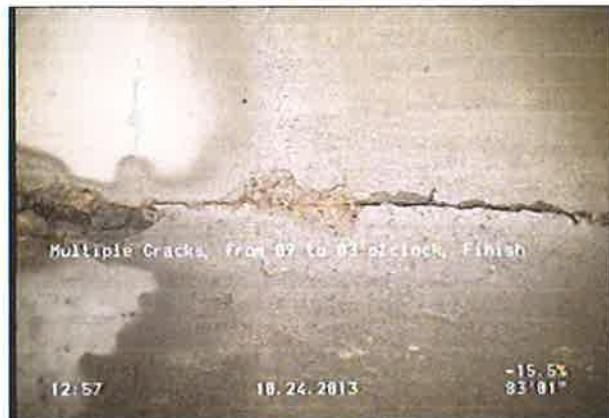
Photo: 10-11-18\_10-10-6\_5\_24102013\_130236\_A.JPG  
Multiple Cracks, from 09 to 03 o'clock, Finish

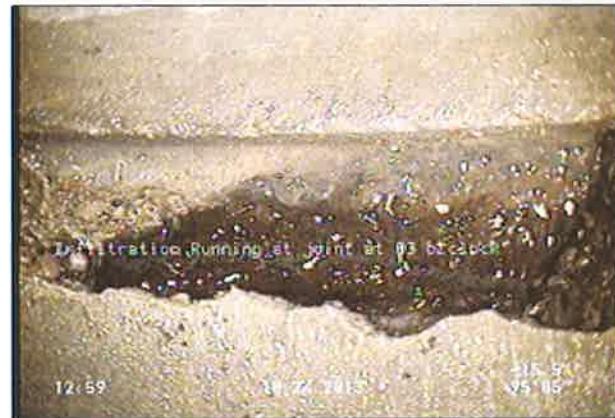
Photo: 10-11-18\_10-10-6\_6\_24102013\_130416\_A.JPG  
Infiltration Running at joint at 03 o'clock

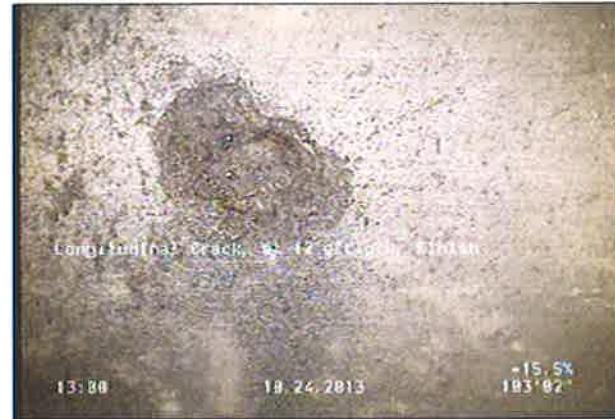
Photo: 10-11-18\_10-10-6\_8\_24102013\_130559\_A.JPG  
Longitudinal Crack, at 12 o'clock, Finish

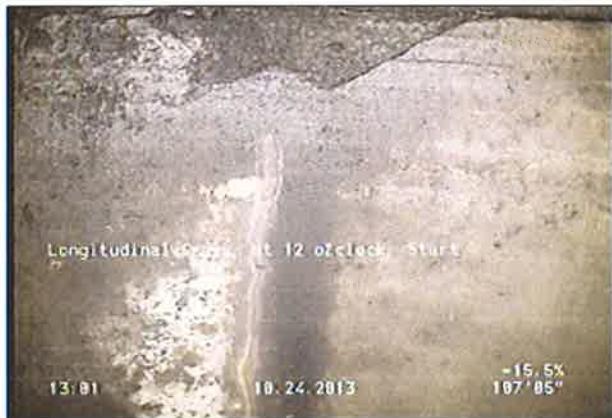
Photo: 10-11-18\_10-10-6\_9\_24102013\_130651\_A.JPG  
Longitudinal Crack, at 12 o'clock, Start

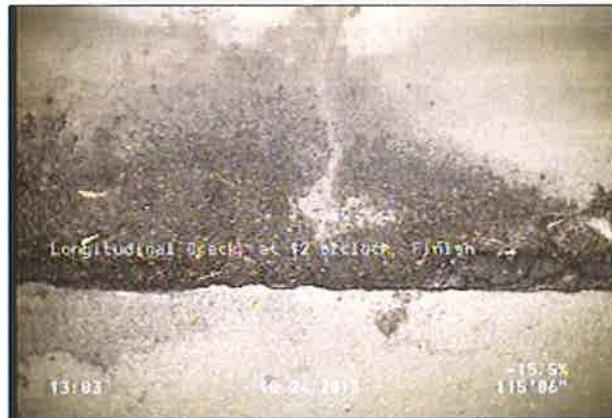
Photo: 10-11-18\_10-10-6\_10\_24102013\_130825\_A.JPG  
Longitudinal Crack, at 12 o'clock, Finish
