January 8, 2014  
File No.: 21.0056546.00

Re: Storm Sewer Investigation Report  
BCP Sites # C932138, C932139, C932140  
GM Components Holdings  
200 Upper Mountain Road  
Lockport, NY 14094

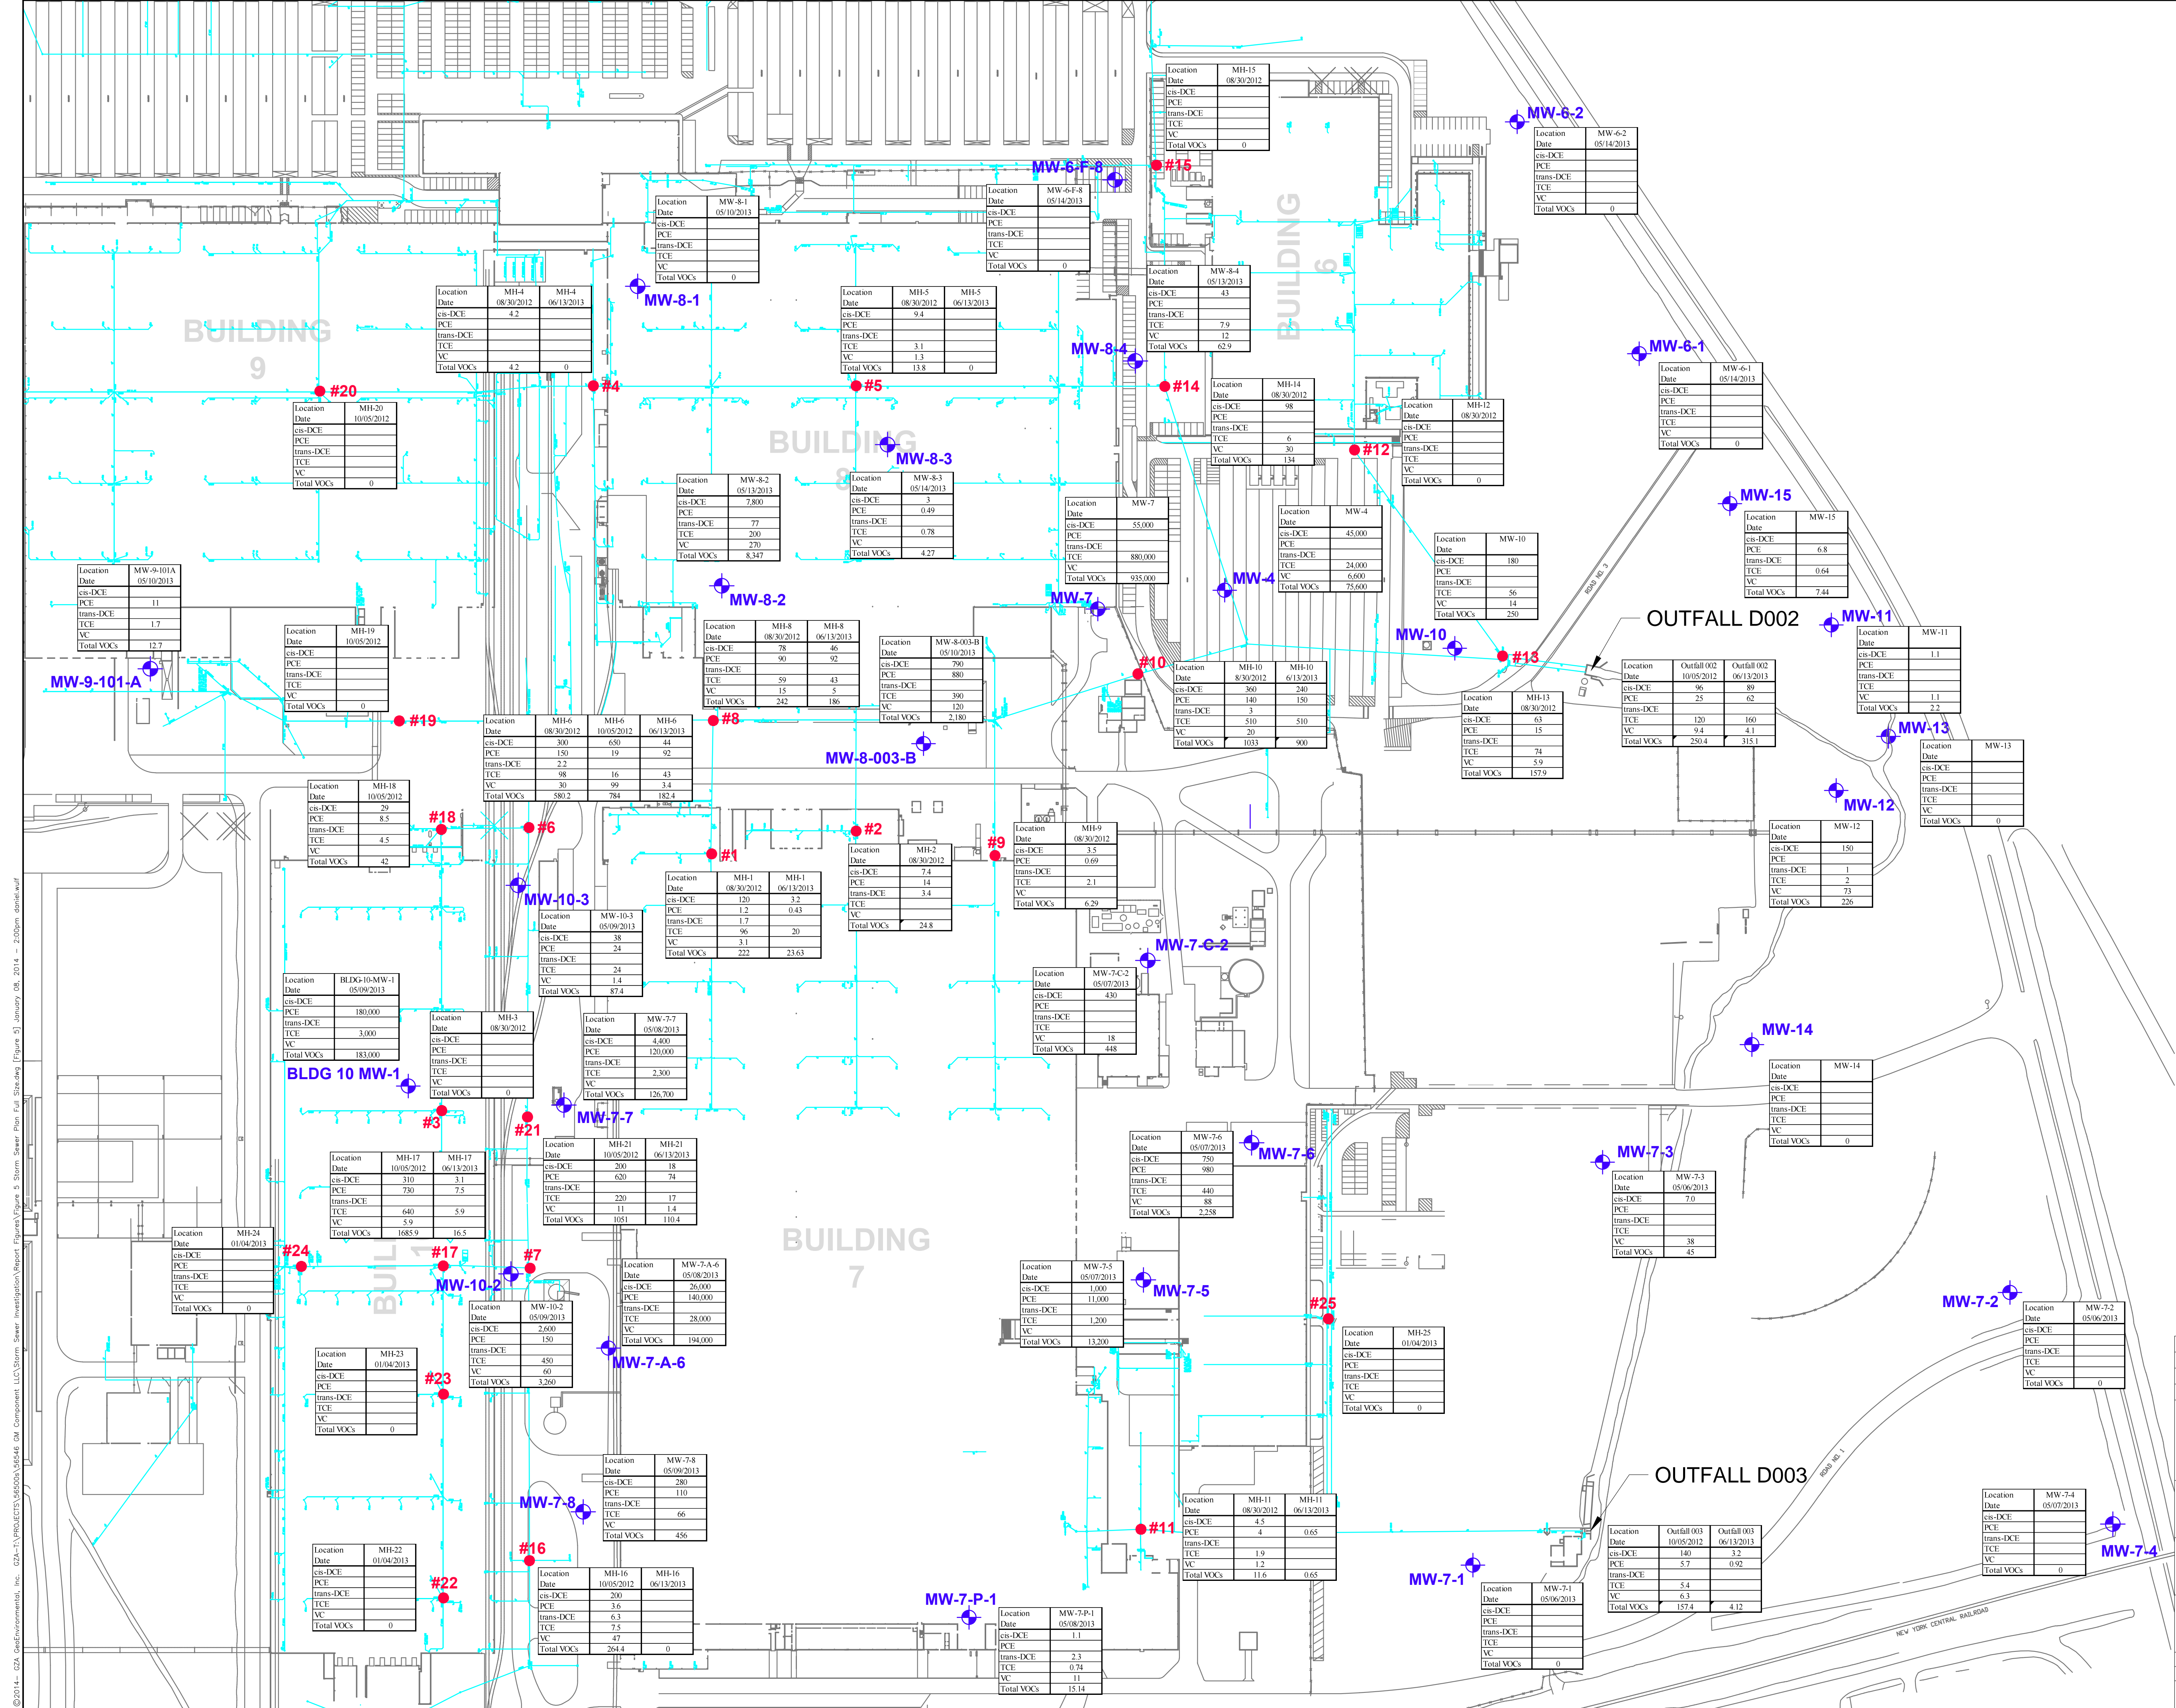
PREPARED BY: <b>GZA</b> GeoEnvironmental of N.Y. Engineers and Scientists www.gza.com	PREPARED FOR: <b>GM COMPONENTS HOLDINGS, LLC.</b>
PROJ MGR: DESIGNED BY: DATE:	REVIEWED BY: DRAWN BY: PROJECT NO.
CZB DEW JANUARY 2014	DEW 21.0056646.00
CHECKED BY:	SCALE: AS SHOWN REVISION NO.
	<b>FIGURE 5</b>

The potential for groundwater infiltration into the storm sewer system appears to be evident at four locations throughout the storm sewer system, when comparing the results of the low-flow storm sewer events to the groundwater results (see Figure 5). They are as follows.

The three (3) manholes that were sampled in association with Building 8 (MH-4, MH-5 and MH-14) have cis-DCE as the COC with the highest detected concentration and have similar cis-DCE concentrations results as the three (3) Building 8 monitoring wells (MW-8-1, MW-8-3 and MW-8-4) that are near the manholes that were sampled. Infiltration into the storm sewer pipes beneath Building 8 may be the cause of the COCs detected at these locations. However, the total COCs detected within each of the three (3) manholes is well below 500 ppb.

MH-6 and MH-18 have similar COC profiles to nearby monitoring well, MW-10-3.

MH-16 has a similar cis-DCE concentration with nearby monitoring well, MW-7-8.

Infiltration into the storm sewer pipes between Buildings 7 and 10 may be the cause of the COCs detected at these locations. With the exception of MH-18, the total COCs detected at each of the other locations exceeds 500 ppb.

The contaminant profile detected at MH-10, MH-13 and Outfall D002 is similar to that of MW-7, but significantly lower in concentration (3 orders of magnitude). The detected concentrations at MH-13 are one order of magnitude lower than at MH-10 and Outfall D002, with the same contaminant profile. Storm water flowing from MH-10 flows through MH-13 (approximately 600 feet downgradient) and then to Outfall D002 (approximately 150 feet downgradient of MH-13). Infiltration in the vicinity of MH-10 may be the cause of the COCs detected at these locations. The total COCs detected at MH-10 are greater than 500 ppb and decrease in concentration to downgradient location MH-13 and Outfall D002 to less than 500 ppb.

We recommend evaluating remedial strategies to limit infiltration into the storm sewer system. The remedial strategies evaluation will be included in the Revised RWP to be submitted and may include slip lining, injection grouting, storm sewer replacement, and/or targeted repair of damaged pipe/joints. It is our opinion that the focus should be on the areas with elevated concentrations detected within the storm sewer system (greater than 500 ppb) and the impact it will have on the overall storm water quality.

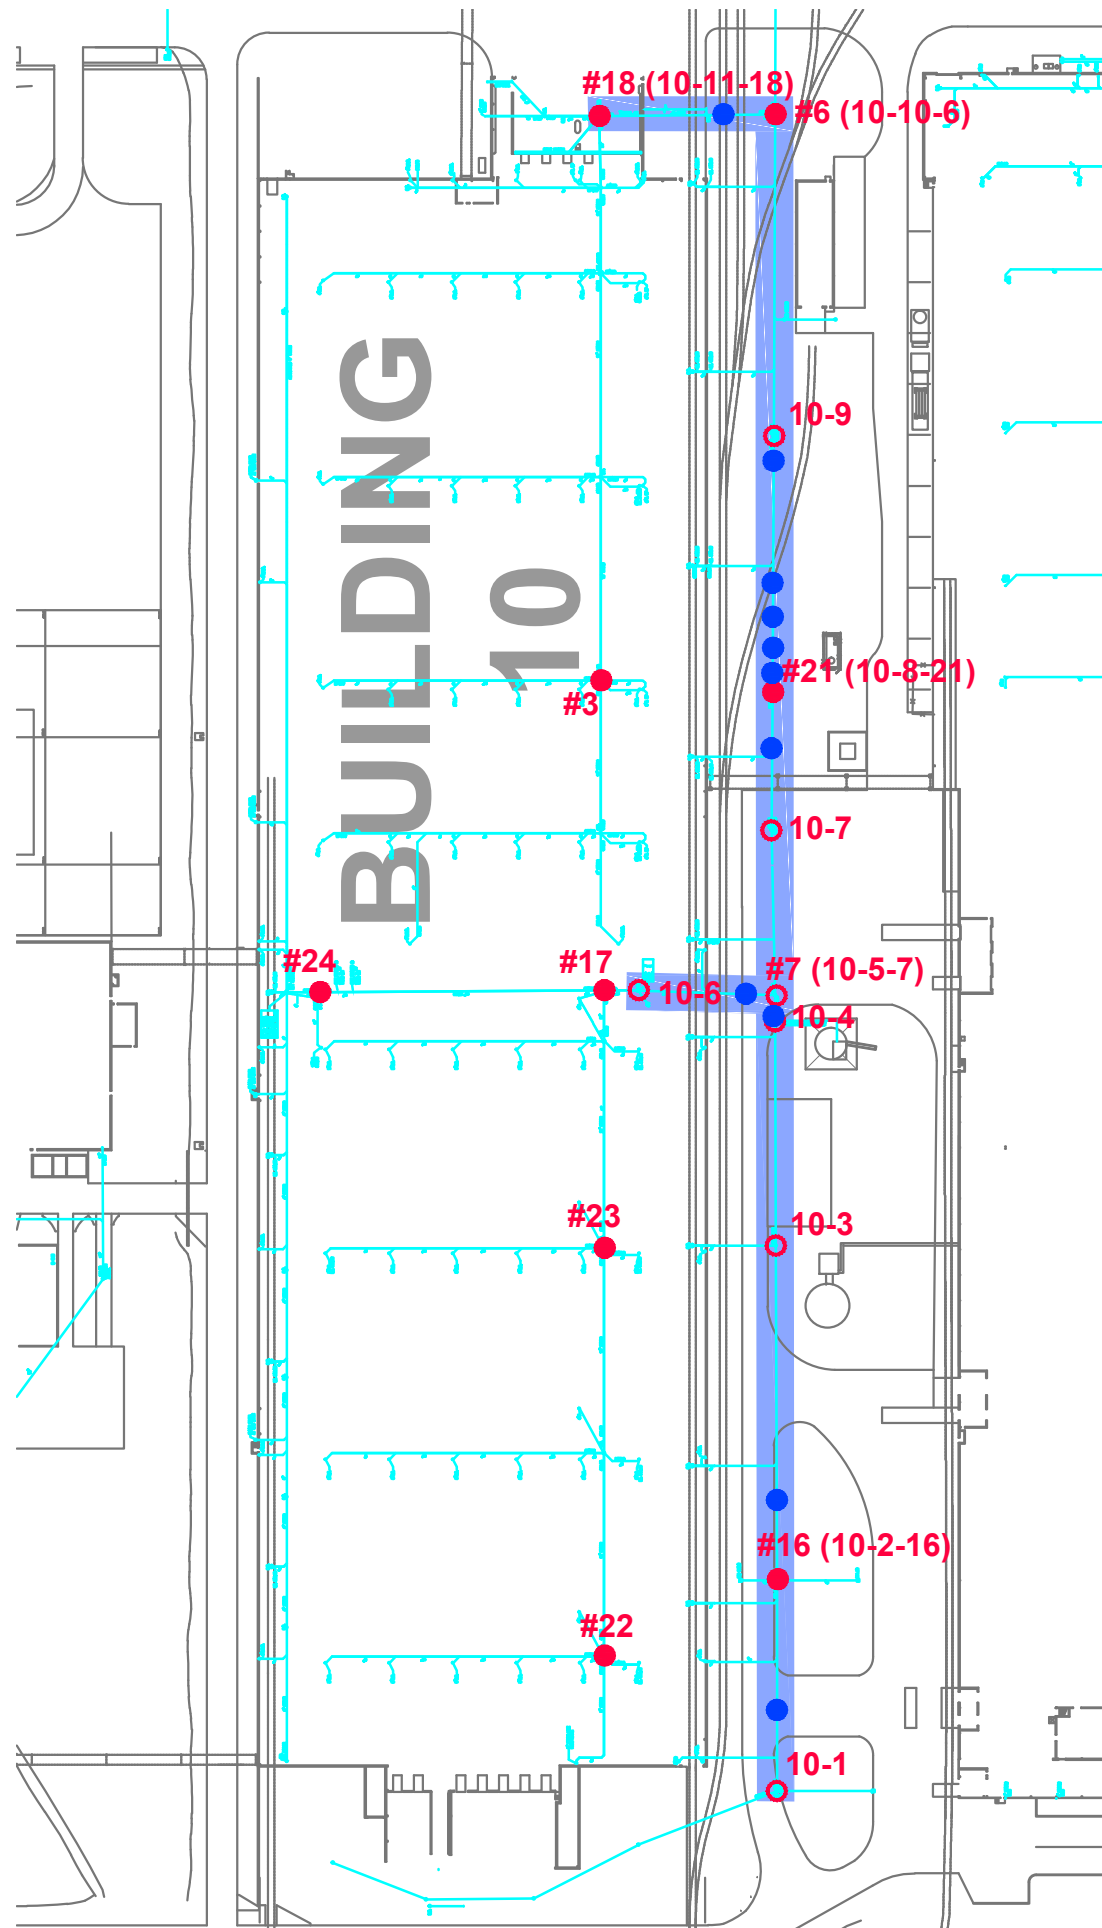
Appendix 4 contains the inspection report generated by National Vacuum. Figure 6 identifies the locations of the manhole structures and storm sewer pipes that were cleaned and inspected. Based on the review of the DVD video and inspection report provided, there are eleven (11) locations of “running” infiltration<sup>4</sup> which are noted on Figure 6. These locations appear to be providing the majority of the infiltration observed in the storm sewer on the video inspection.

- Grout at pipe connections was in poor condition or missing.
- Pipe joint separation.
- Infiltration from pipe bedding from pipe lateral crossing storm sewer.
- Infiltration at section of missing pipe wall.
- Sediment or standing water within pipes.
- Infiltration into manhole from pipe bedding beneath pipe.
- Longitudinal cracks in pipes.

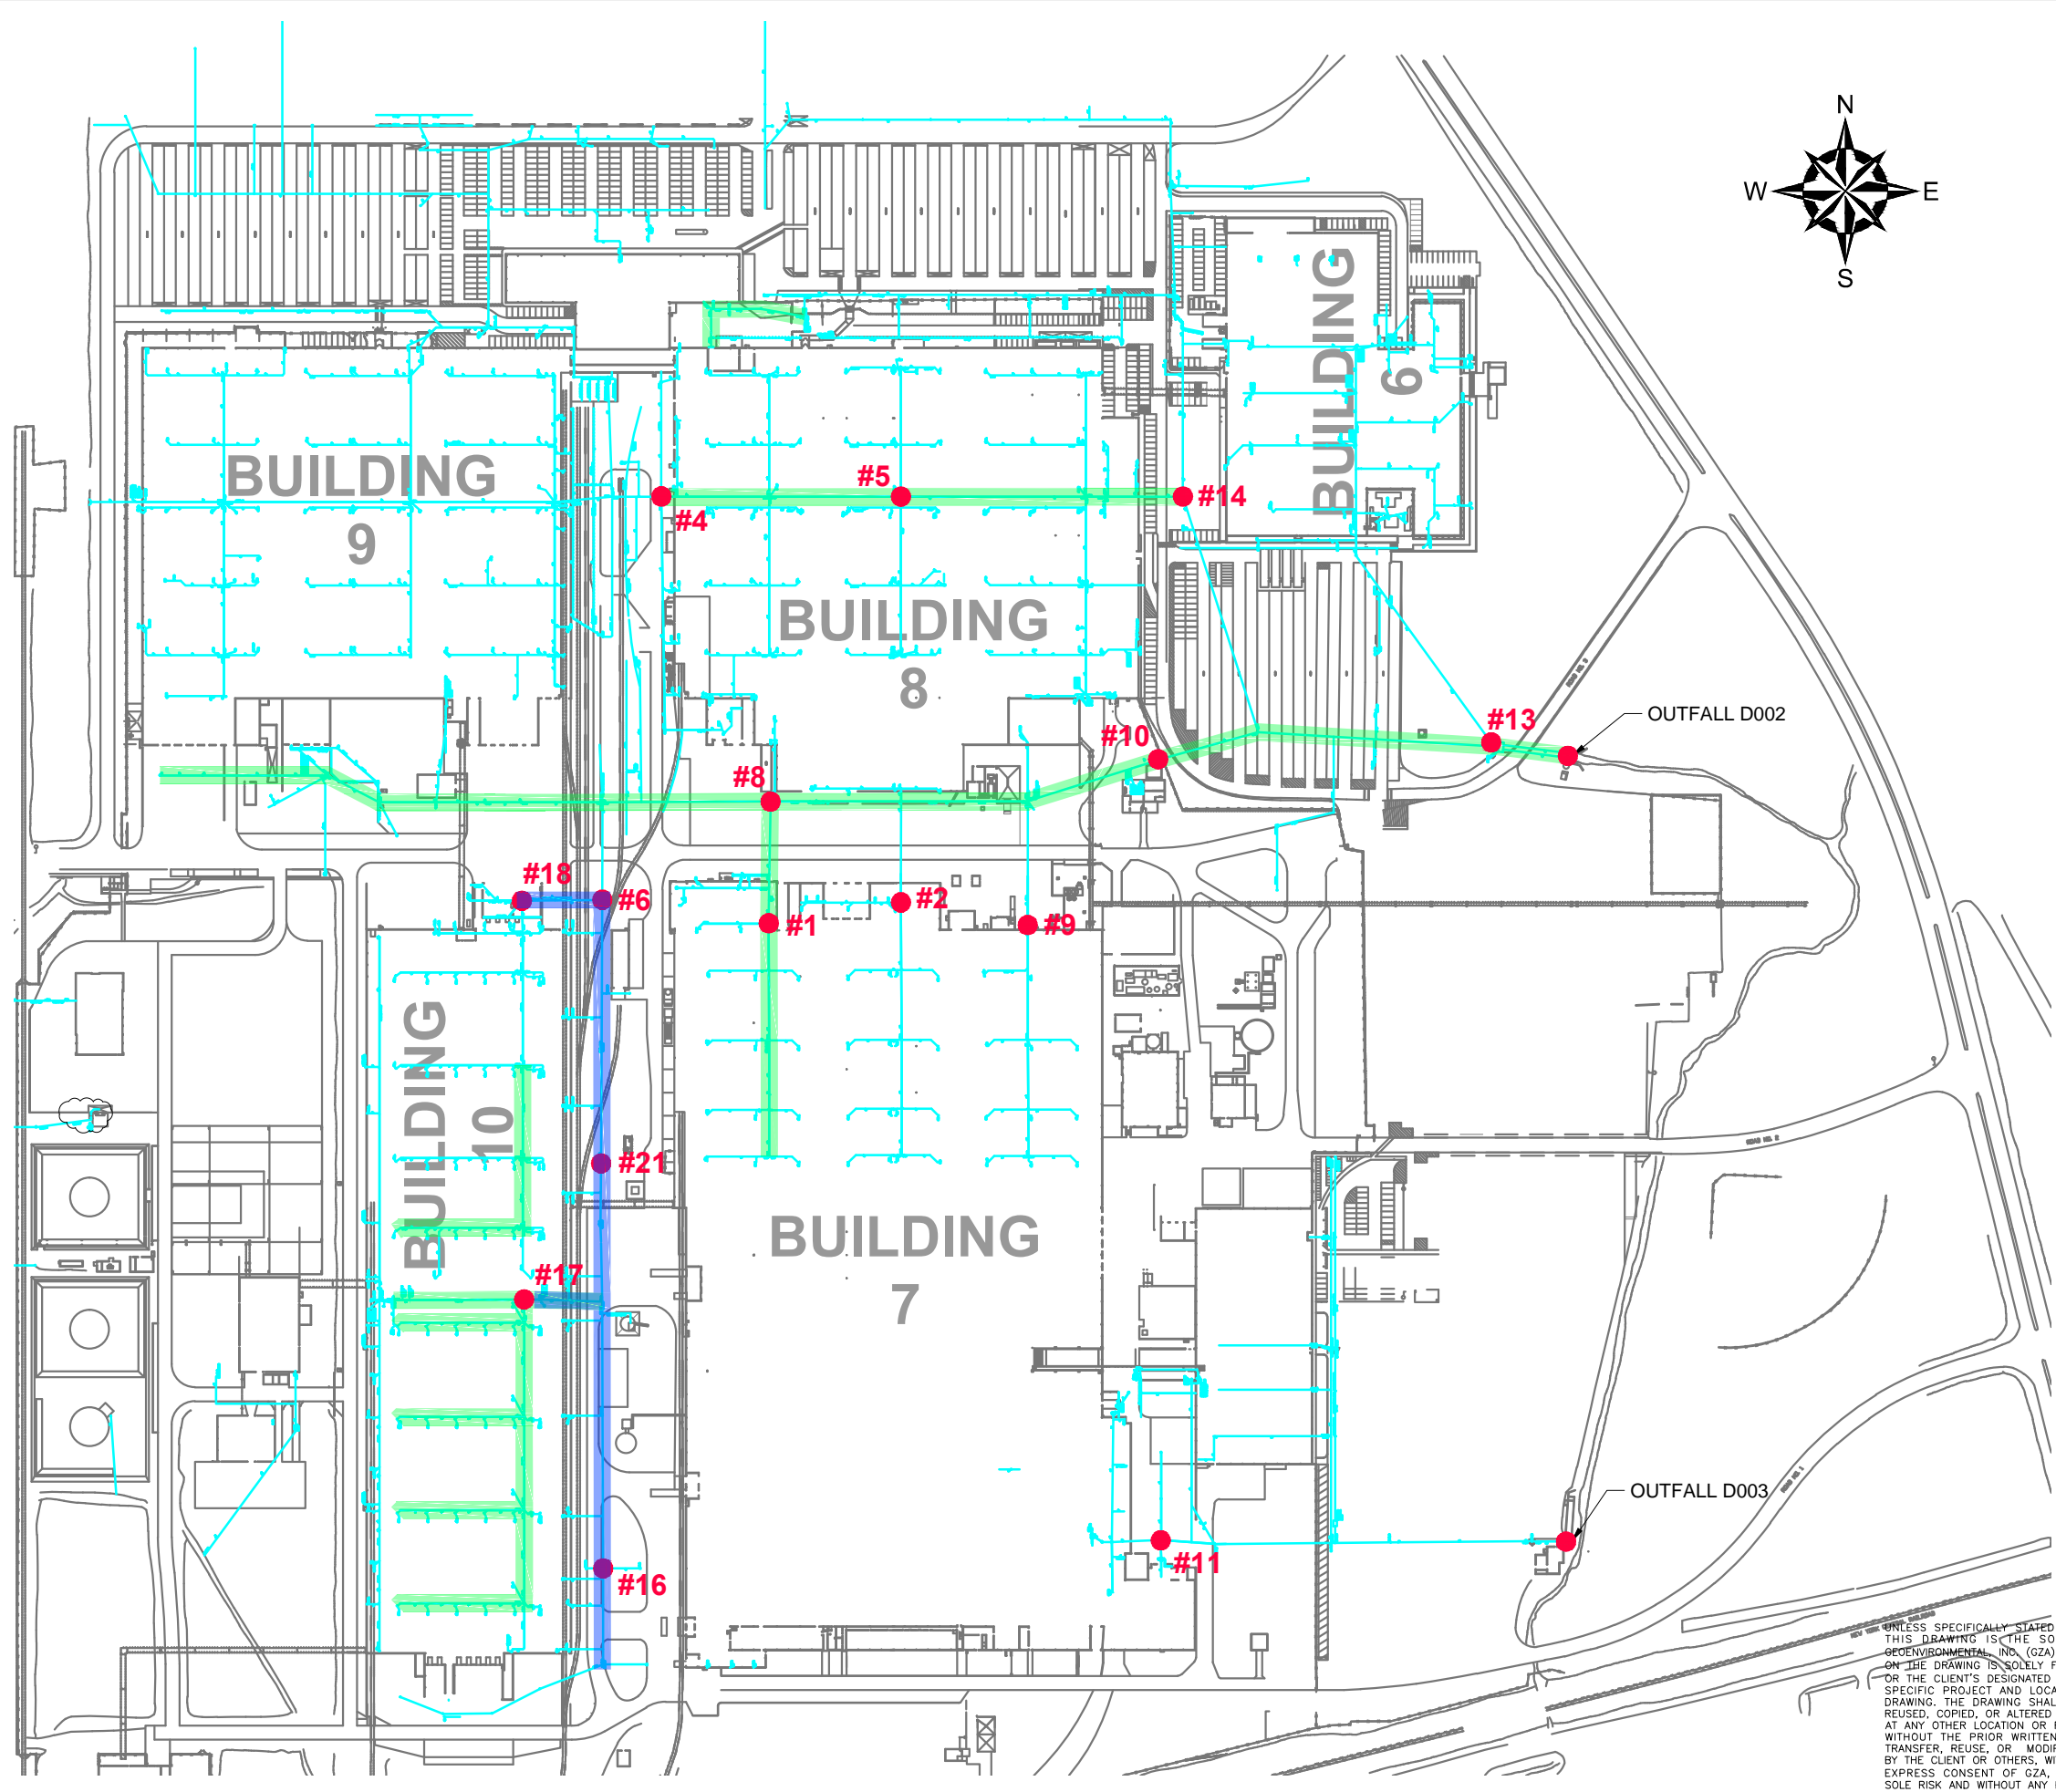
© 2014 GZA GeoEnvironmental of N.Y. GZA-T\PROJECTS\6550a\6546 GM Component LCA\Storm Sewer Investigation\Report Figures\Figure 7 Storm Sewer COCs and Videos.dwg [Figure 7] January 06, 2014 - 10:15am daniel.waf

Although not part of the work plan, GMCH provided GZA with storm sewer videos for review. The videos were from storm sewer inspections completed between May 1994 and May 2002 by various contractors. Figure 7 identifies the approximate location of the storm sewer lines that were video inspected (shown in green). GZA reviewed the videos to assess the conditions of the storm sewers at the time of the video and if groundwater infiltration is potentially occurring. The quality of the videos reviewed varied. Review of the videos identified the following types of infiltration conditions at various locations of the storm sewers previously inspected.
