October 8, 2012

**Re: Periodic Review Report and IC/EC Certification Submittal – Site No. C932142 –
Remington Rand Building**

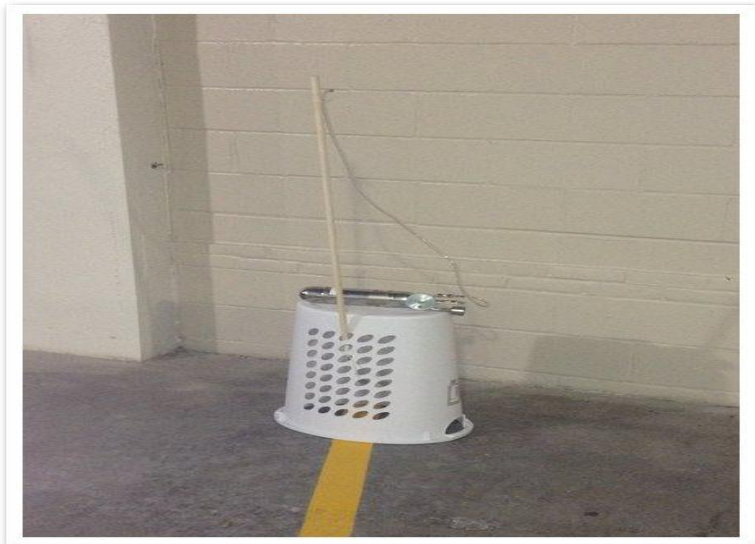
1. Indoor air sampling

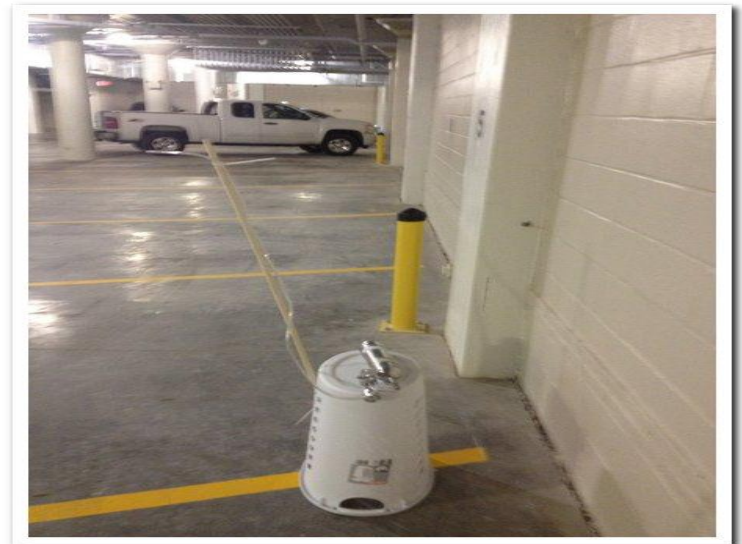
2. Indoor Air sampling

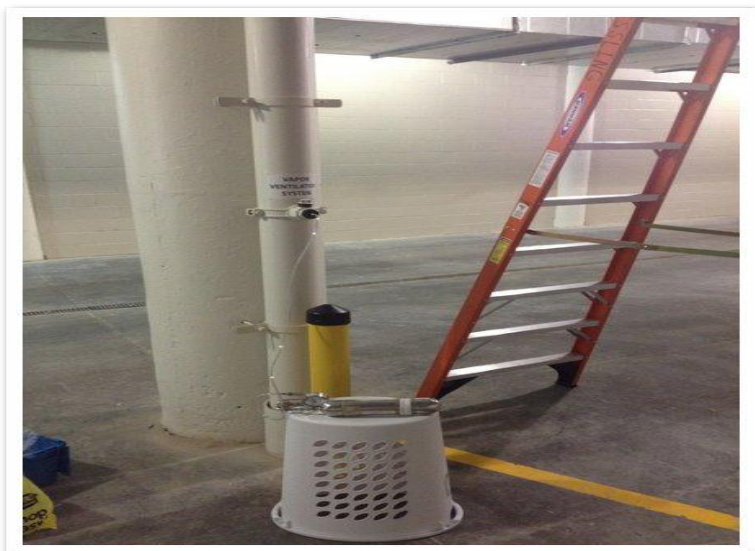
3. Vent Port Vapor Sampling

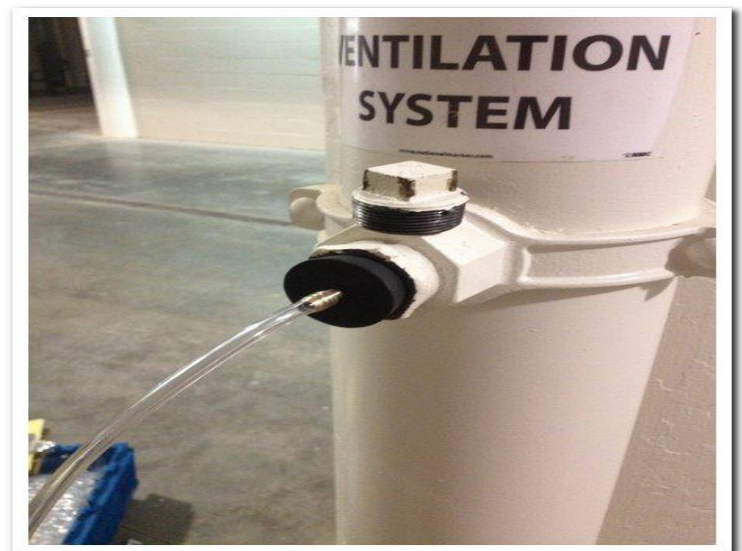
4. Vent Port Vapor Sampling

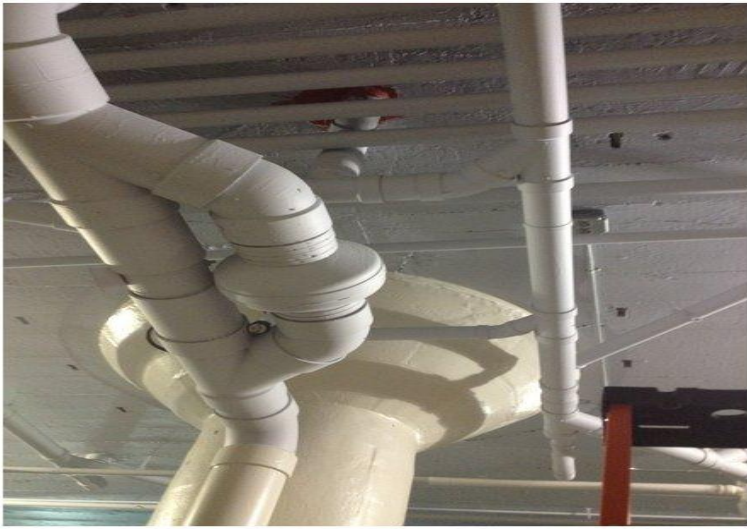
During the yearly inspection the knife valve will be manually closed and the fan turned on for a minimum of 15 minutes to assure it is operational. This was completed on September 13, 2012 during the periodic field inspection. The caulking seals were also inspected and were deemed satisfactory. No O & M deficiencies were noted during the inspection.

5. Ventilation System Fan

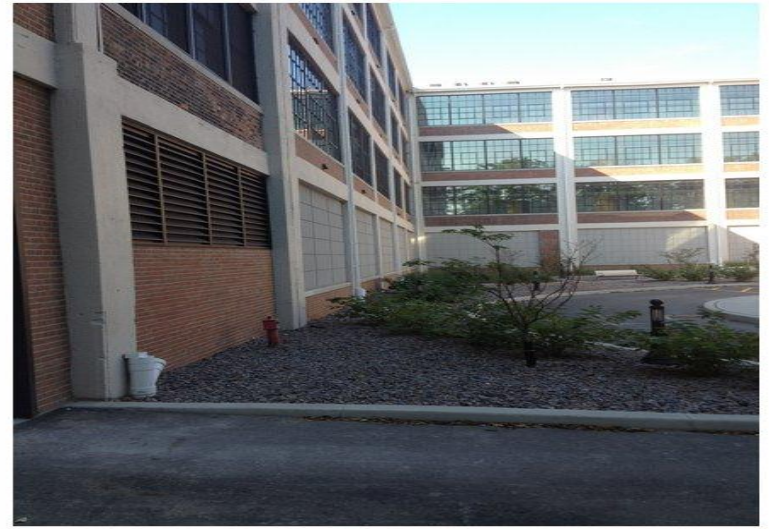
The soil cover was inspected and appears to be in place with no disturbances since its initial placement and is in compliance with the requirements of the SMP (refer to attached photos).

6. Site Condition Center Courtyard

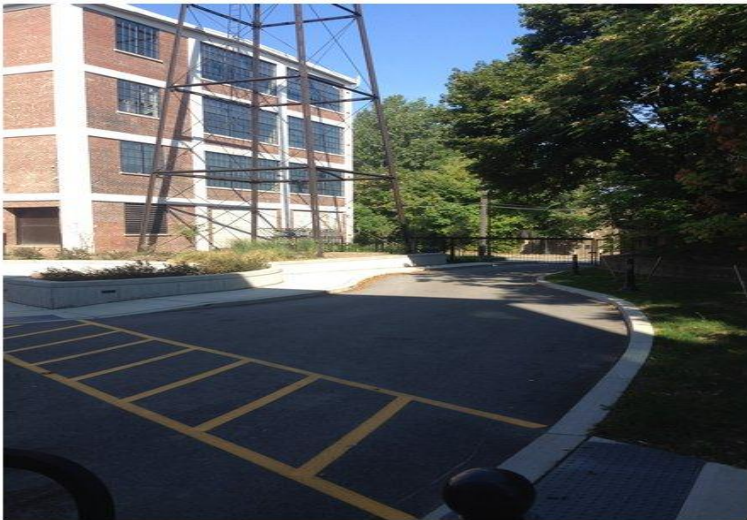
7. Site Condition Entrance Rd East side

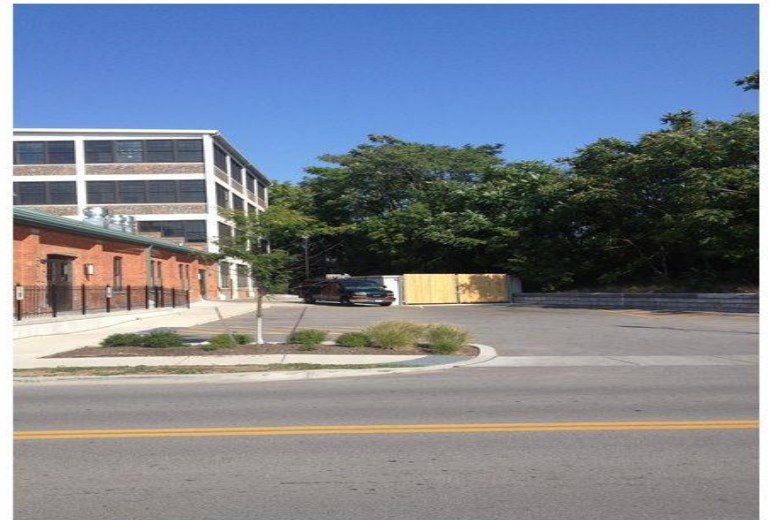
8. Site Condition Parking Area SE Side

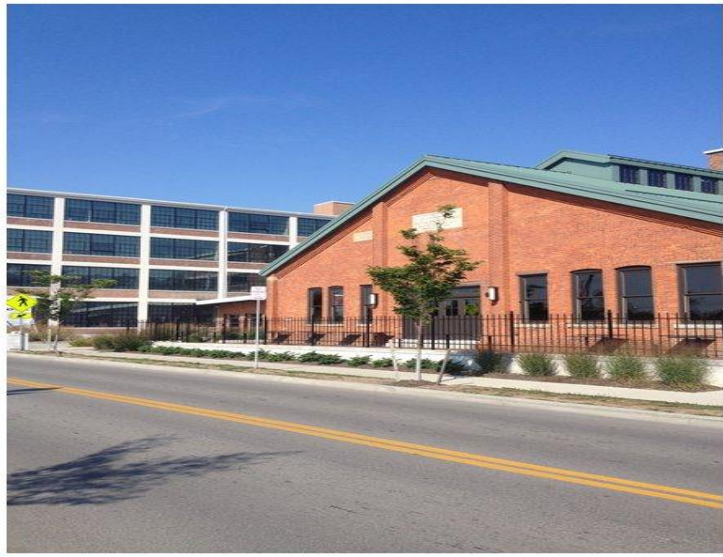
9. Site Condition South Side-Front of Building

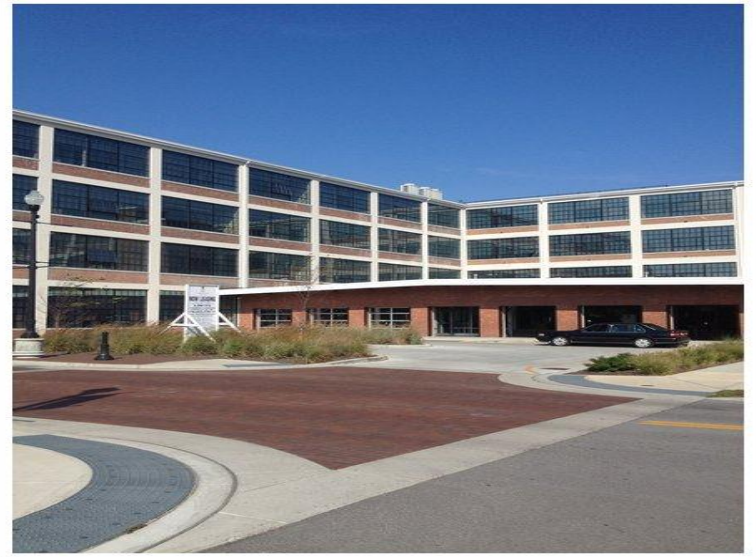
10. Site Condition South Side-Front Courtyard

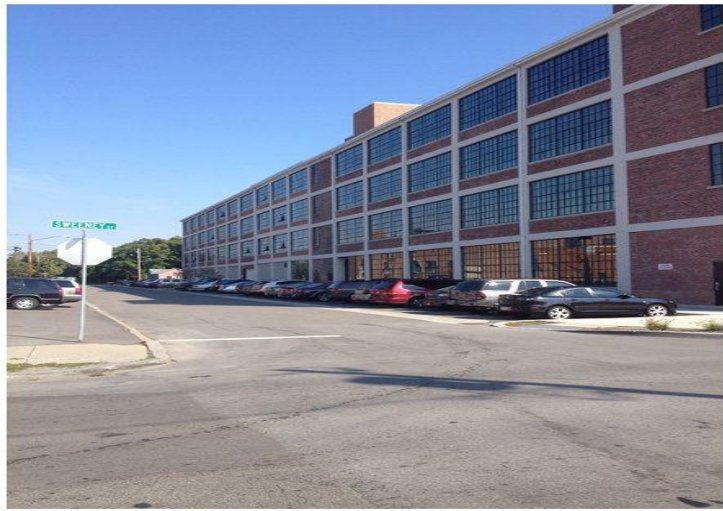
11. Site Condition-West side

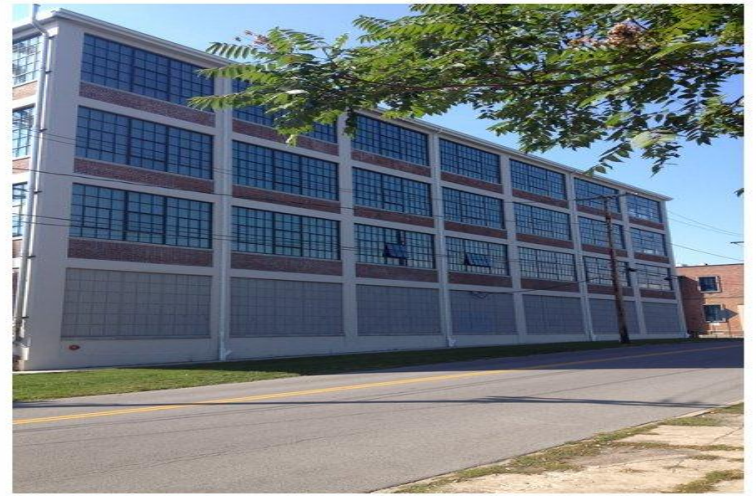
12. Site Condition North Side-Rear of Building
