Subject: Annual 2021 Site Inspection and Certification Letter Report
FONF Expansion/Sabre Park BCP Site No. C932162

Atlas ATC Engineering Inc. (Atlas), on behalf of Macerich Management Company, hereby submits this Site Management Inspection Report for the Fashion Outlet Niagara Falls (FONF) / Sabre Park Brownfield Cleanup Program (BCP), Site No. C932162, located at 1900 Military Road, Niagara County, Niagara Falls, New York 14304 (hereafter referred to as Site). The inspection was completed in accordance with the Revised Site Management Plan (SMP), dated January 2020, prepared by Langan Engineering. In accordance with the New York State Department of Environmental Conservation (NYSDEC) approval of the Annual 2020 Site Inspection and Certification Letter, dated November 22, 2021, this letter represents the Annual 2021 Site Inspection and Certification Letter Report. The next Periodic Review Report is scheduled to be submitted to the NYSDEC in the 1st Quarter of 2025.

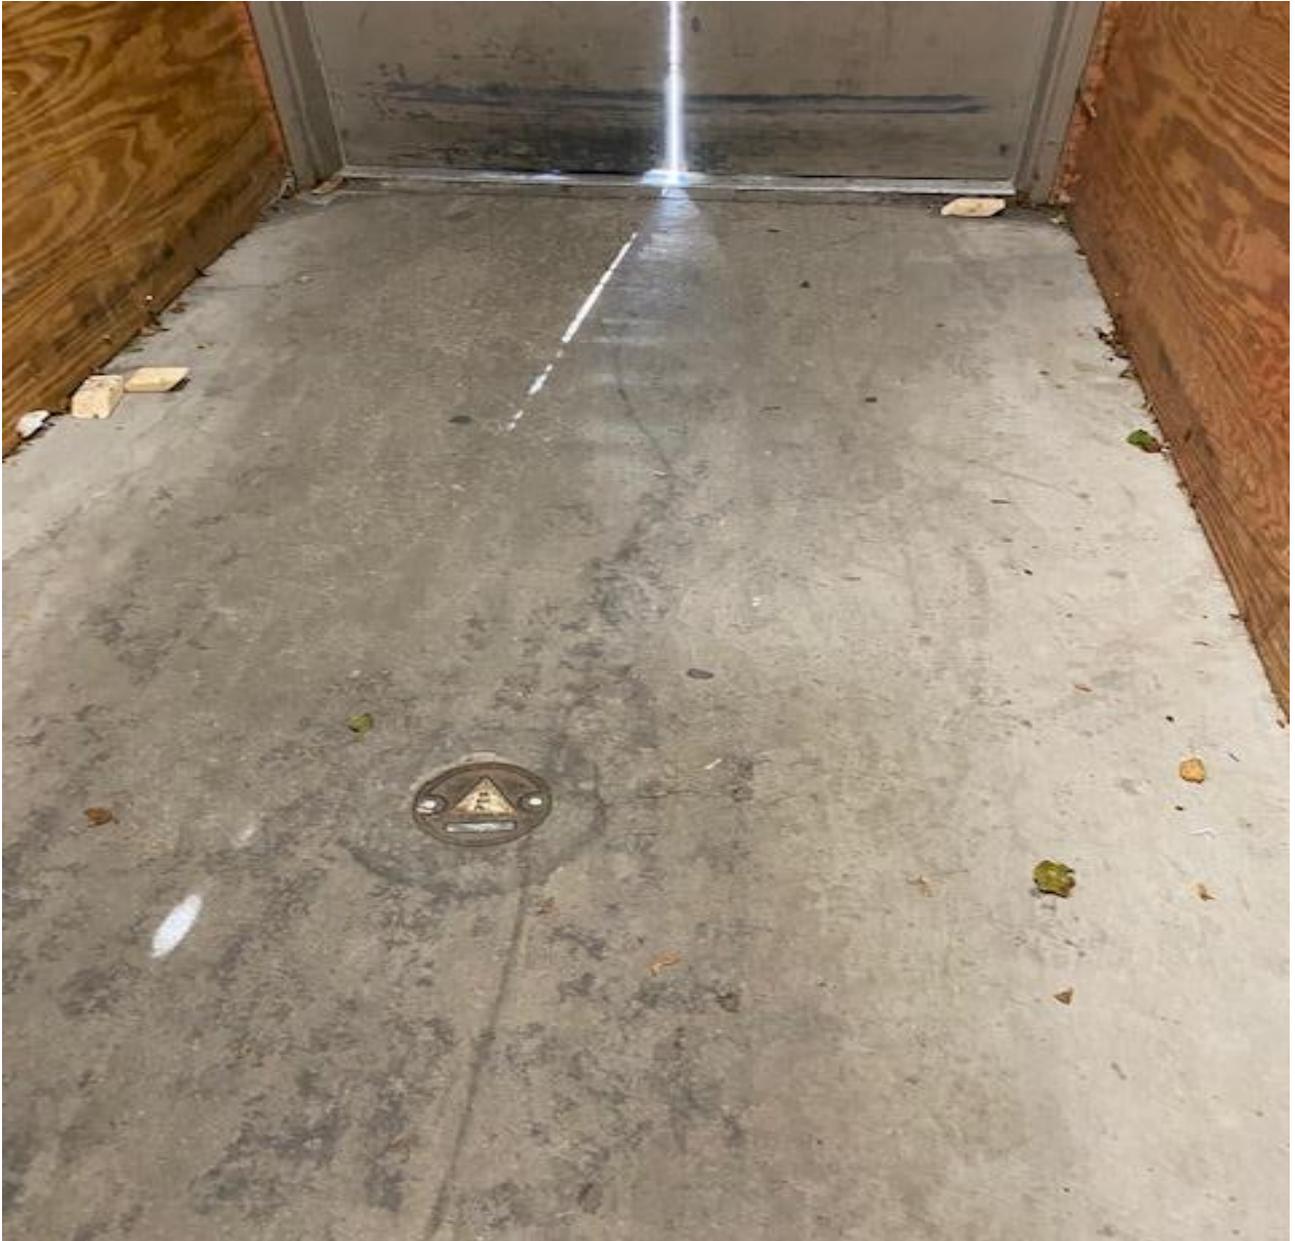
Photo 1: First vapor point in FONF Expansion hallway.

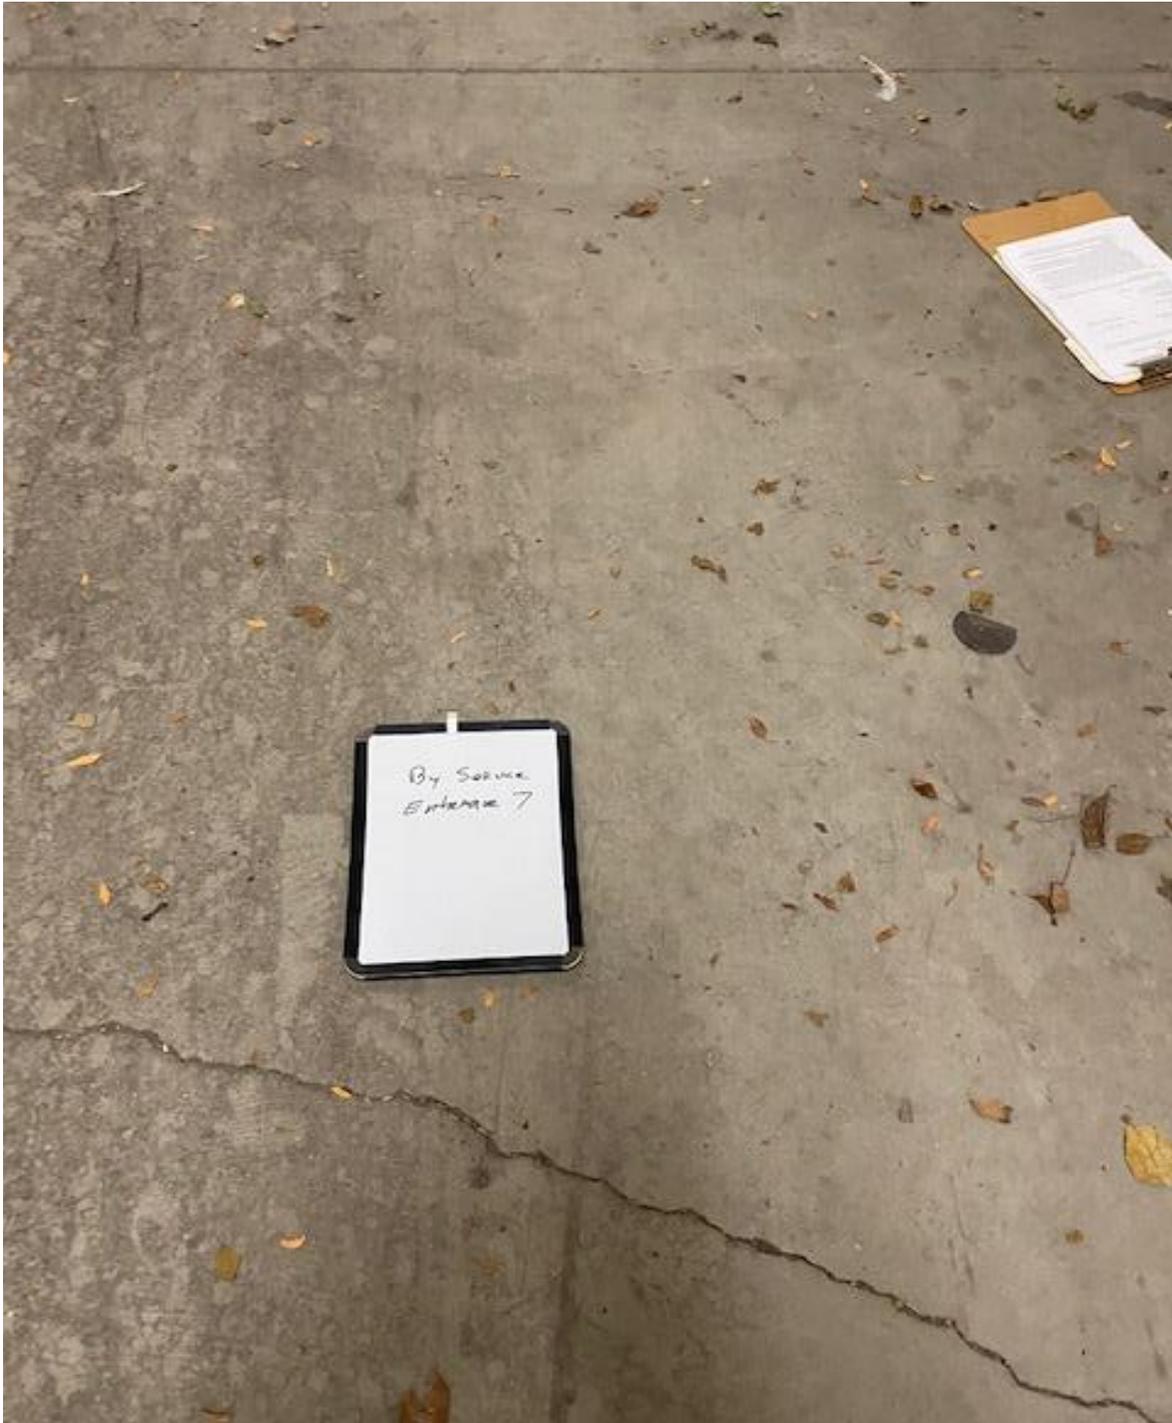
During the site inspection, Mr. Strum was escorted by Joe Schultz, with FONF and Mary Mendetta, with Secure Self Storage. ATC inspected the composite cover system including the asphalt parking area and landscape areas, which was found to be undisturbed with no evidence of prior excavation. The building concrete slab-on-grade and sidewalks were found to be intact with no evidence of physical damage or cracks equal to or greater than 1/4-inch in diameter.

Photo 2: Crack in concrete by service entrance 7 of FONF Expansion.

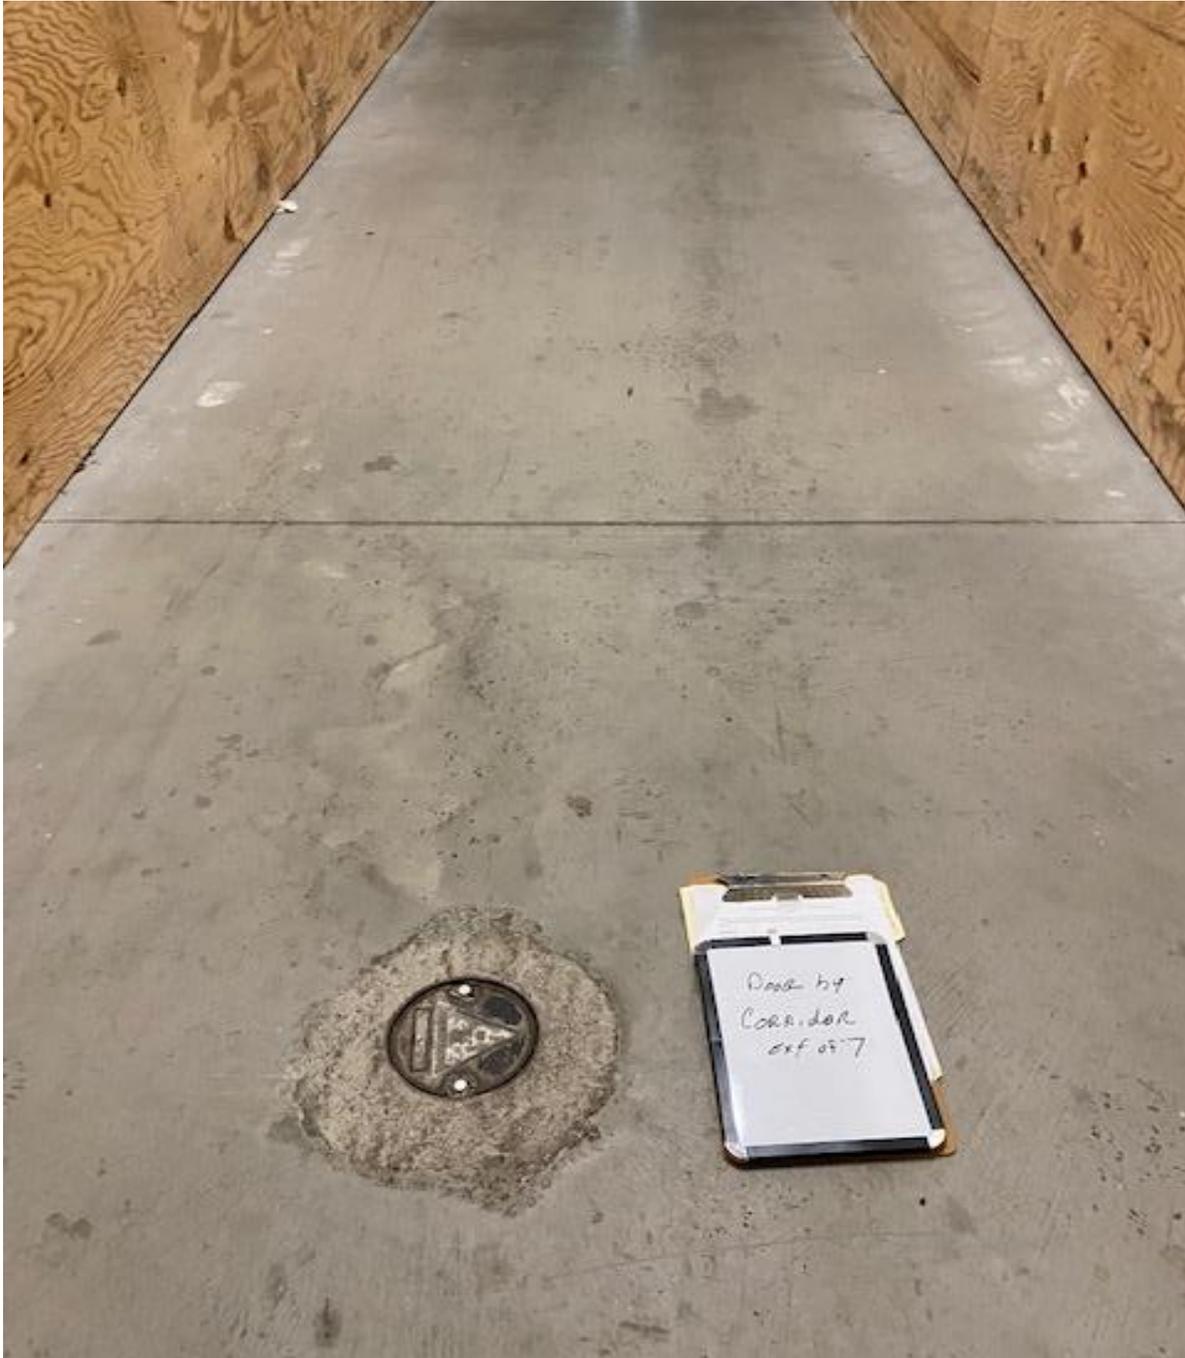
Photo 3: Vapor point #2 within corridor near service entrance 7 of FONF Expansion.

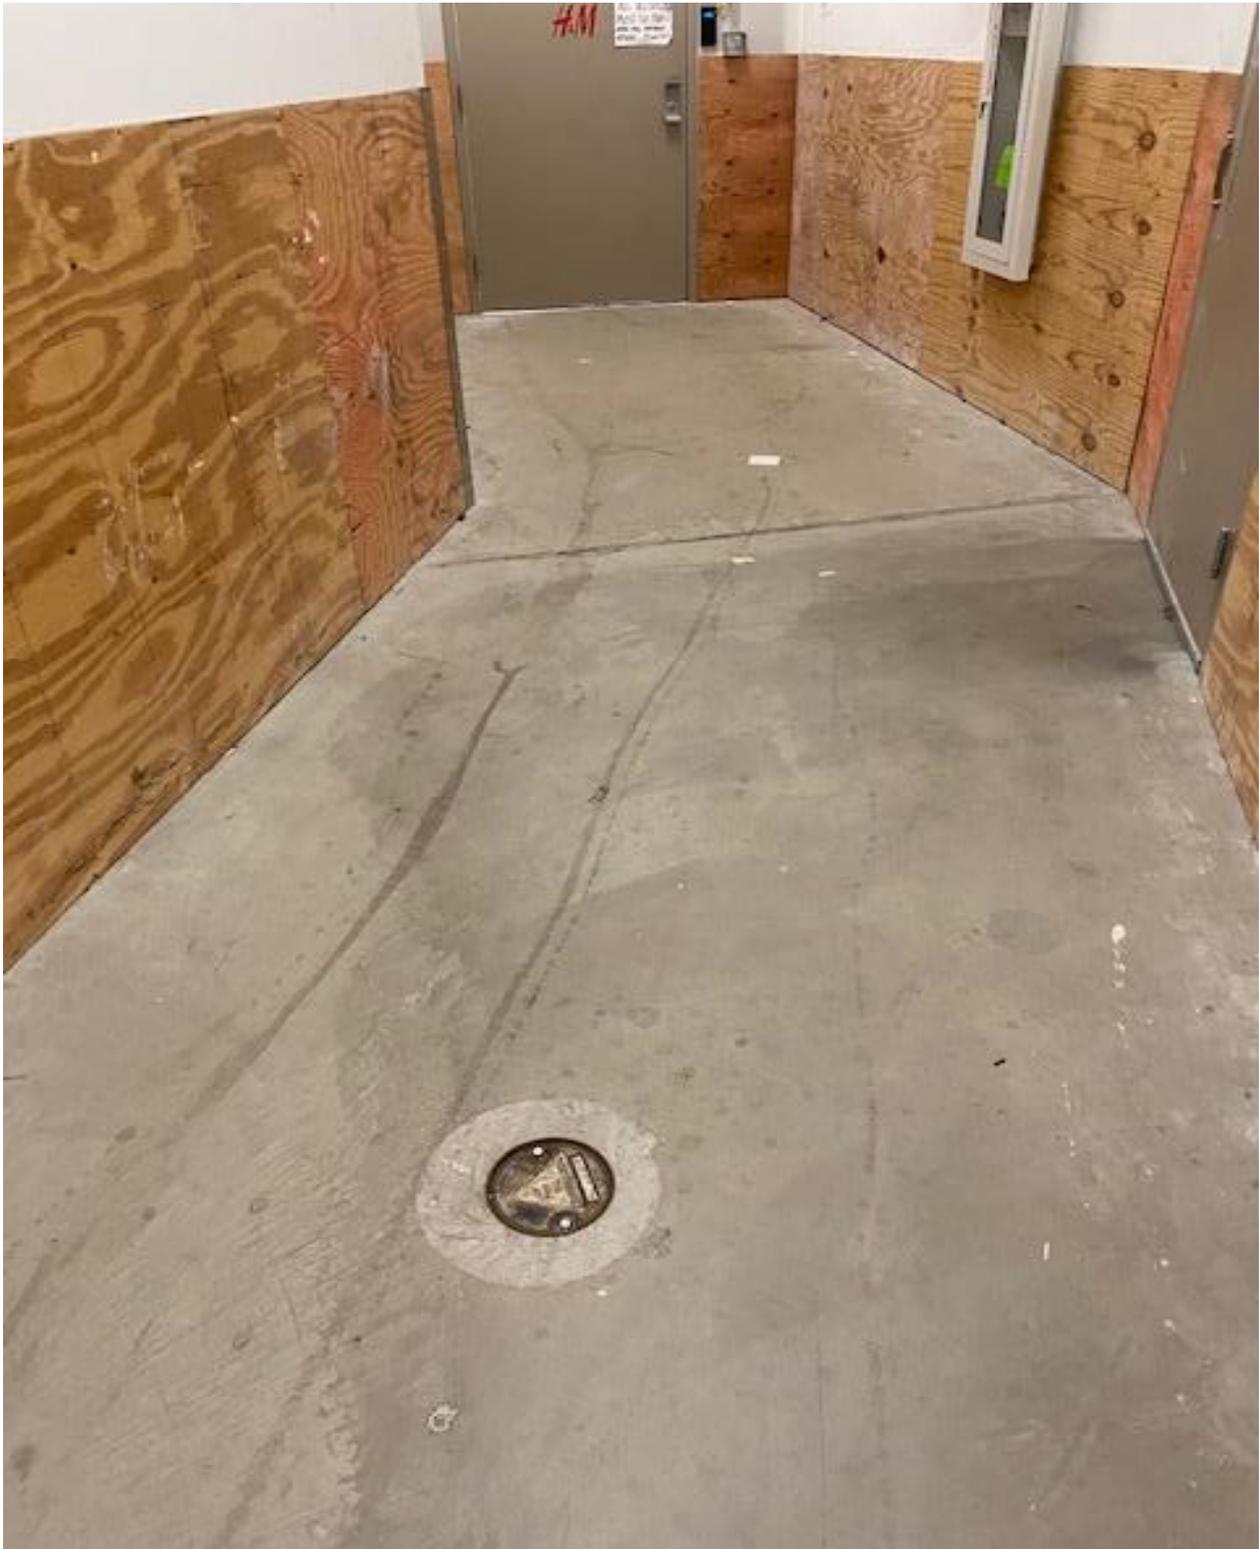
Photo 4: Vapor point #3 within FONF Expansion.

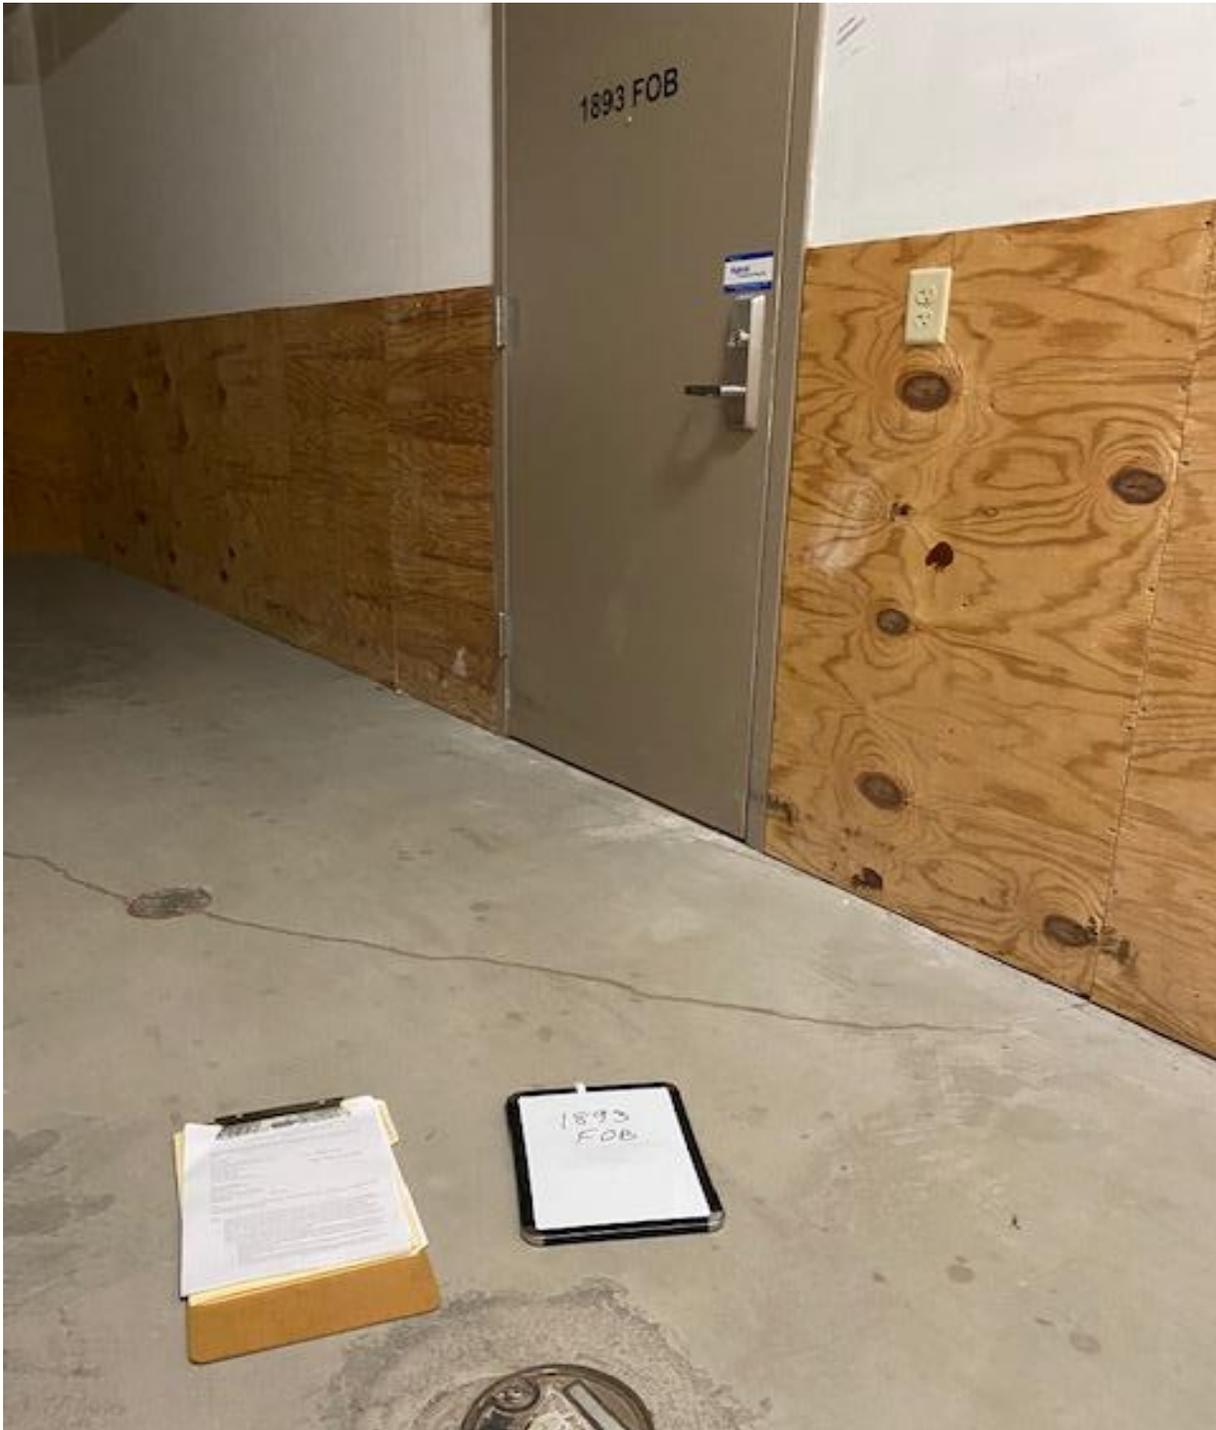
Photo 5: Vapor point #4, within FONF Expansion, by 1893 FOB.

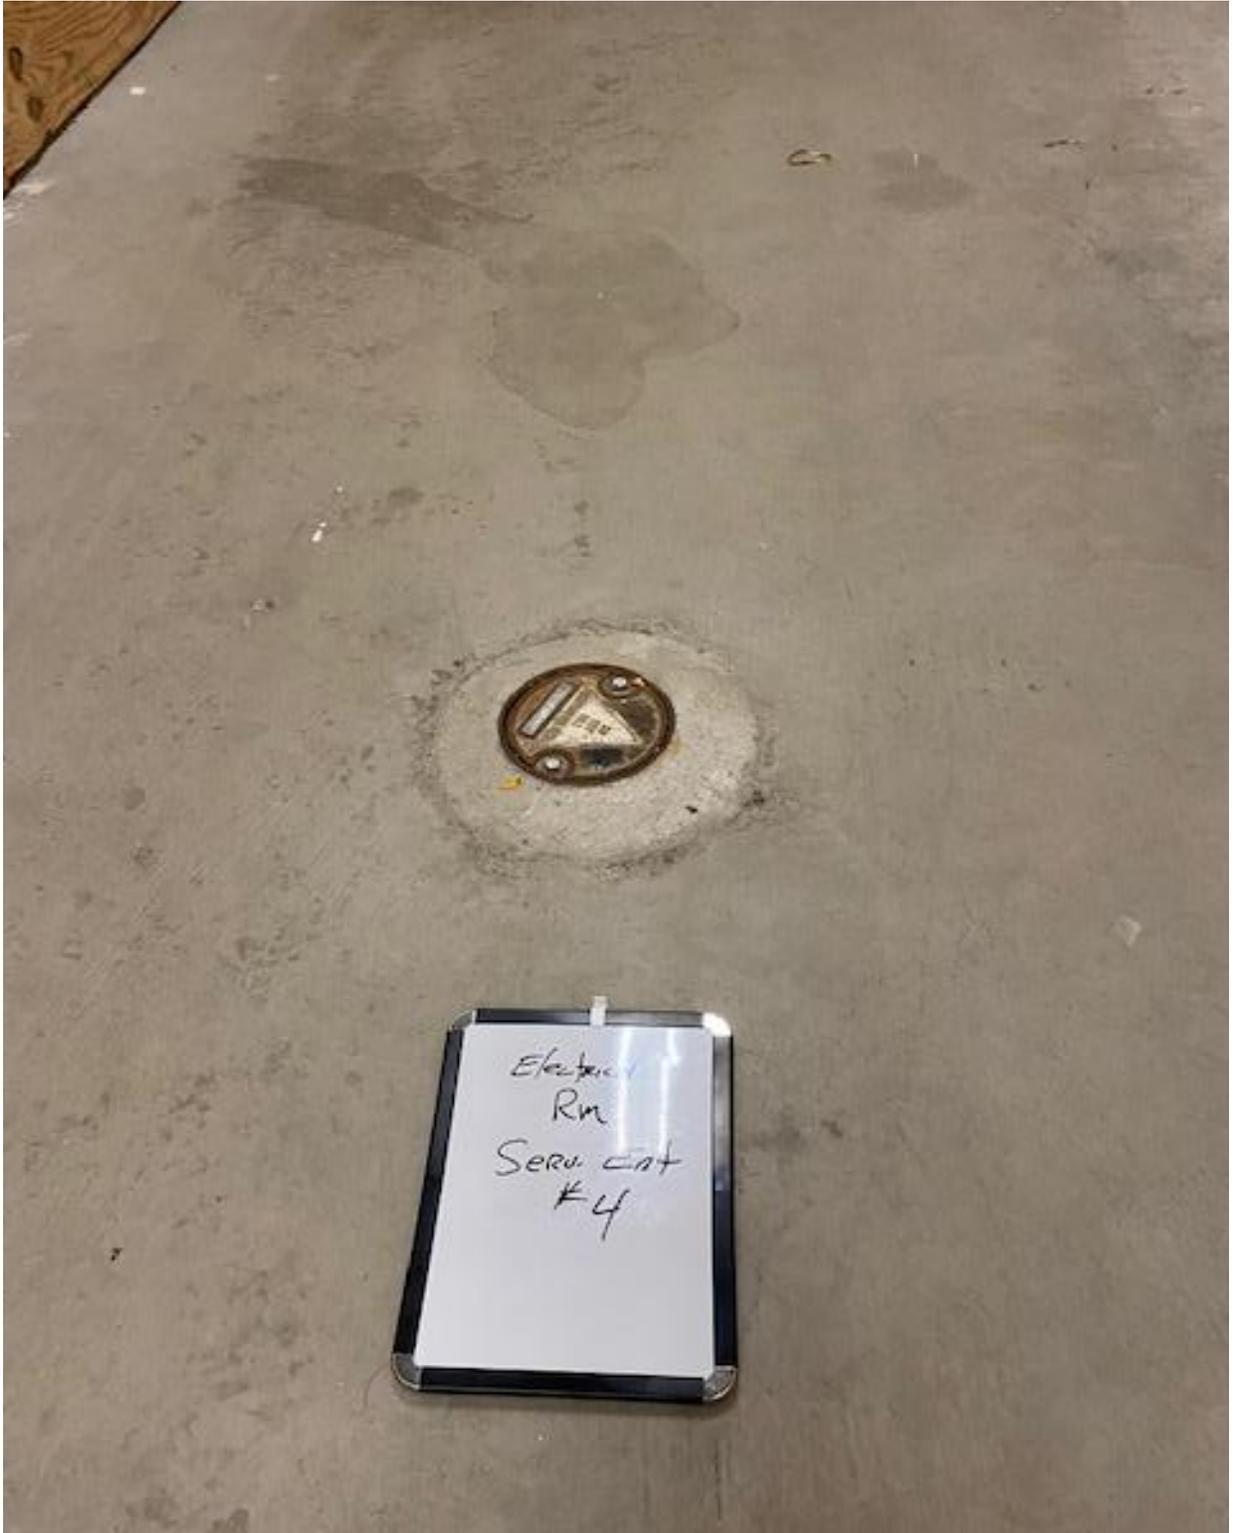
Photo 7: Vapor point #5 by Electrical Room and Service Entrance #4 of FONF Expansion.

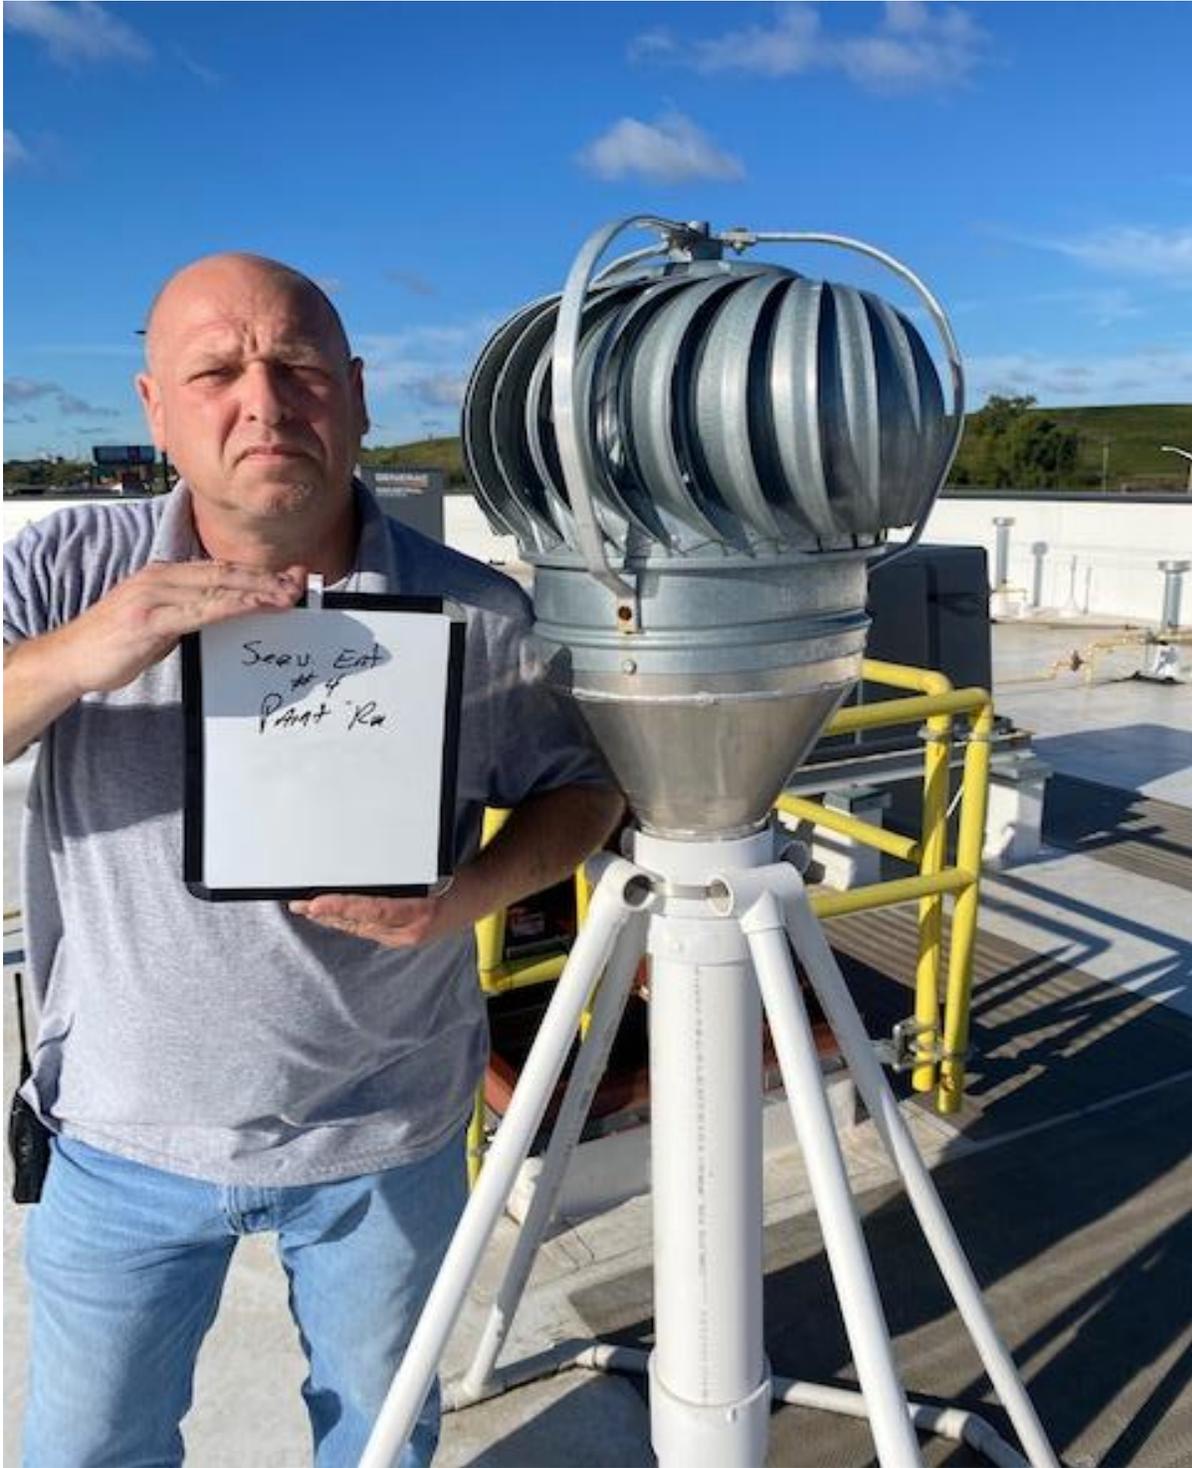
Photo 8: Passive Exhaust Fan #1 on roof of FONF Expansion, above Paint Room.

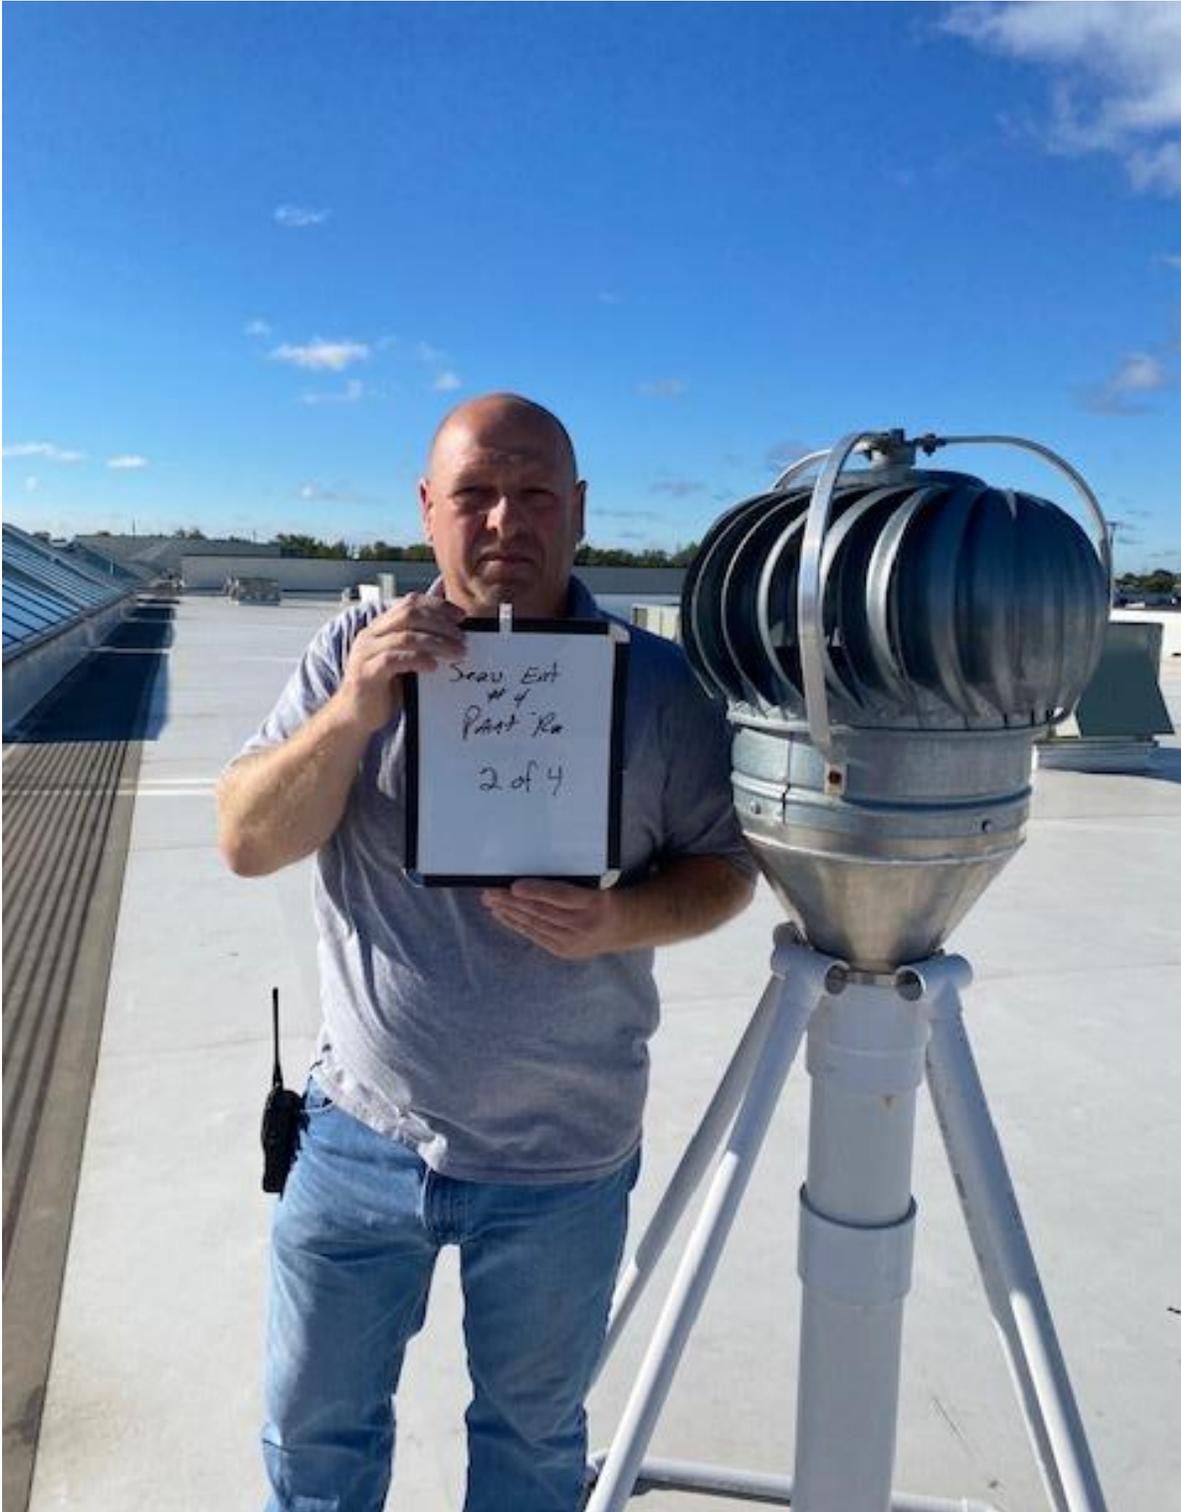
Photo 9: Exhaust Fan #2 on roof of FONF Expansion, above Service Entrance #4 Paint Room.

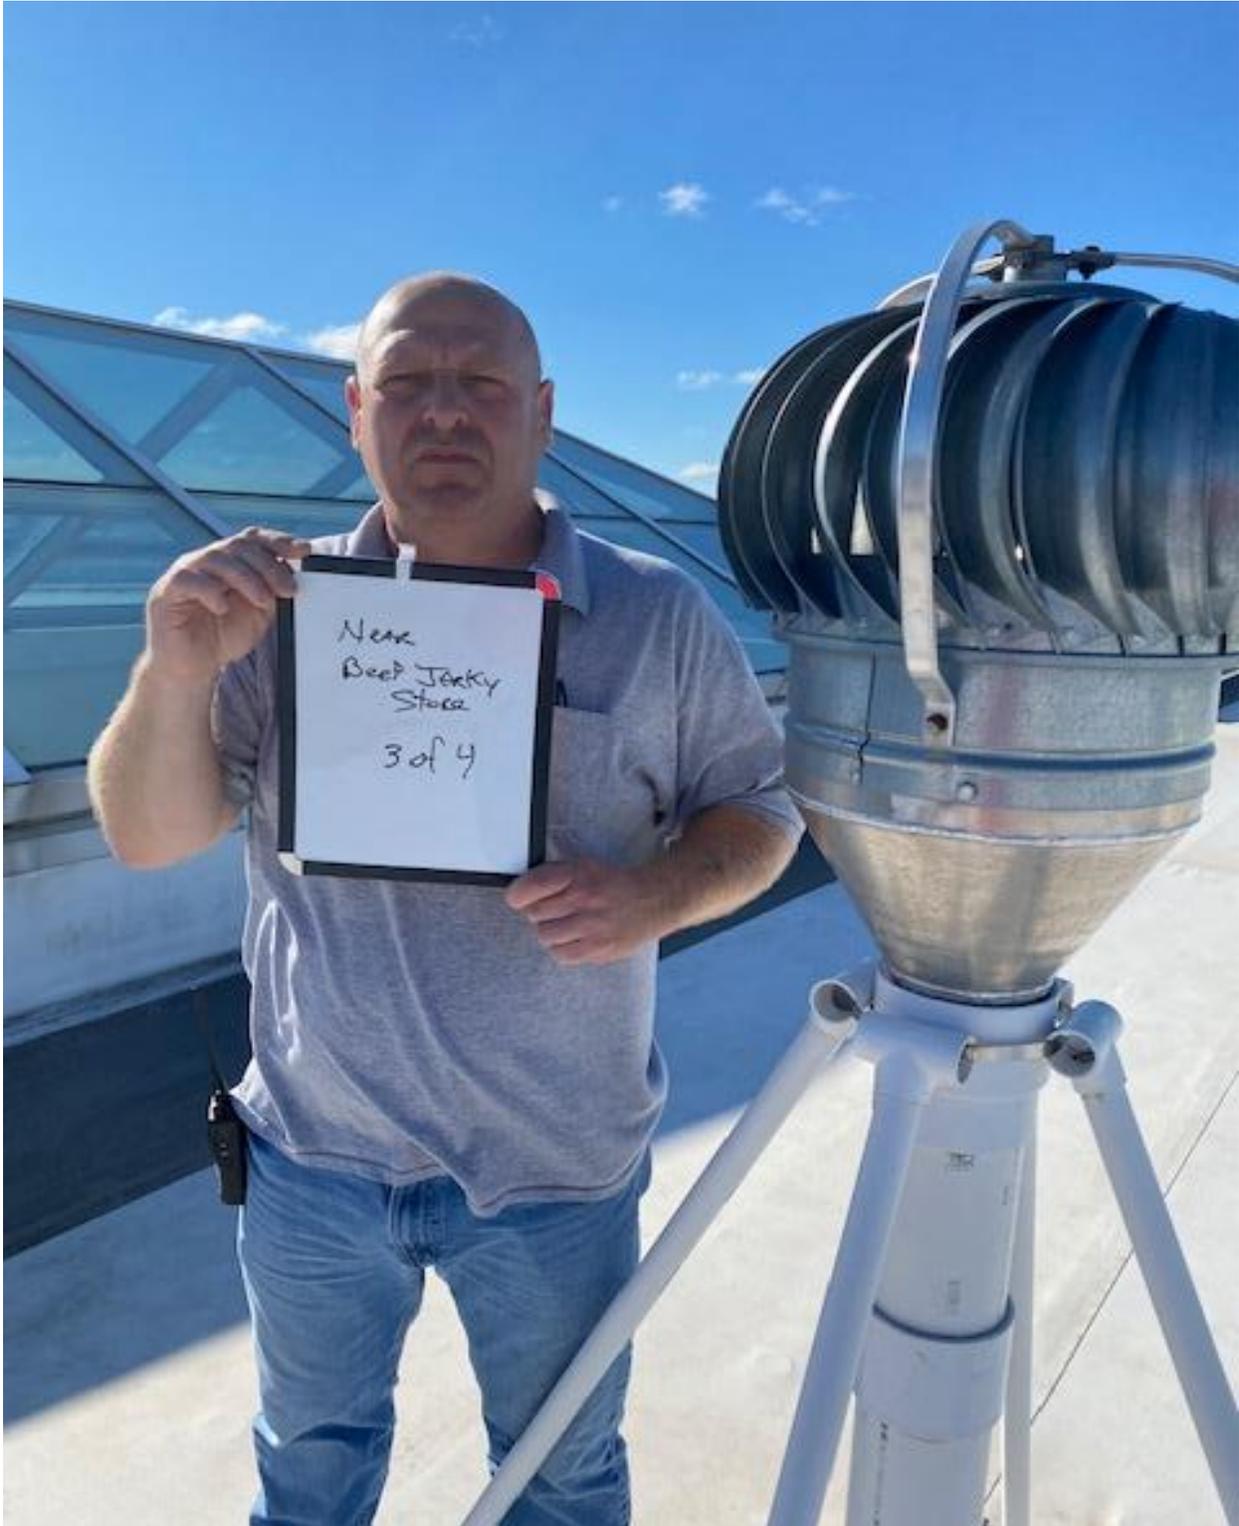
Photo 10: Exhaust Fan #3 on roof of FONF Expansion, above Beef Jerky Store.

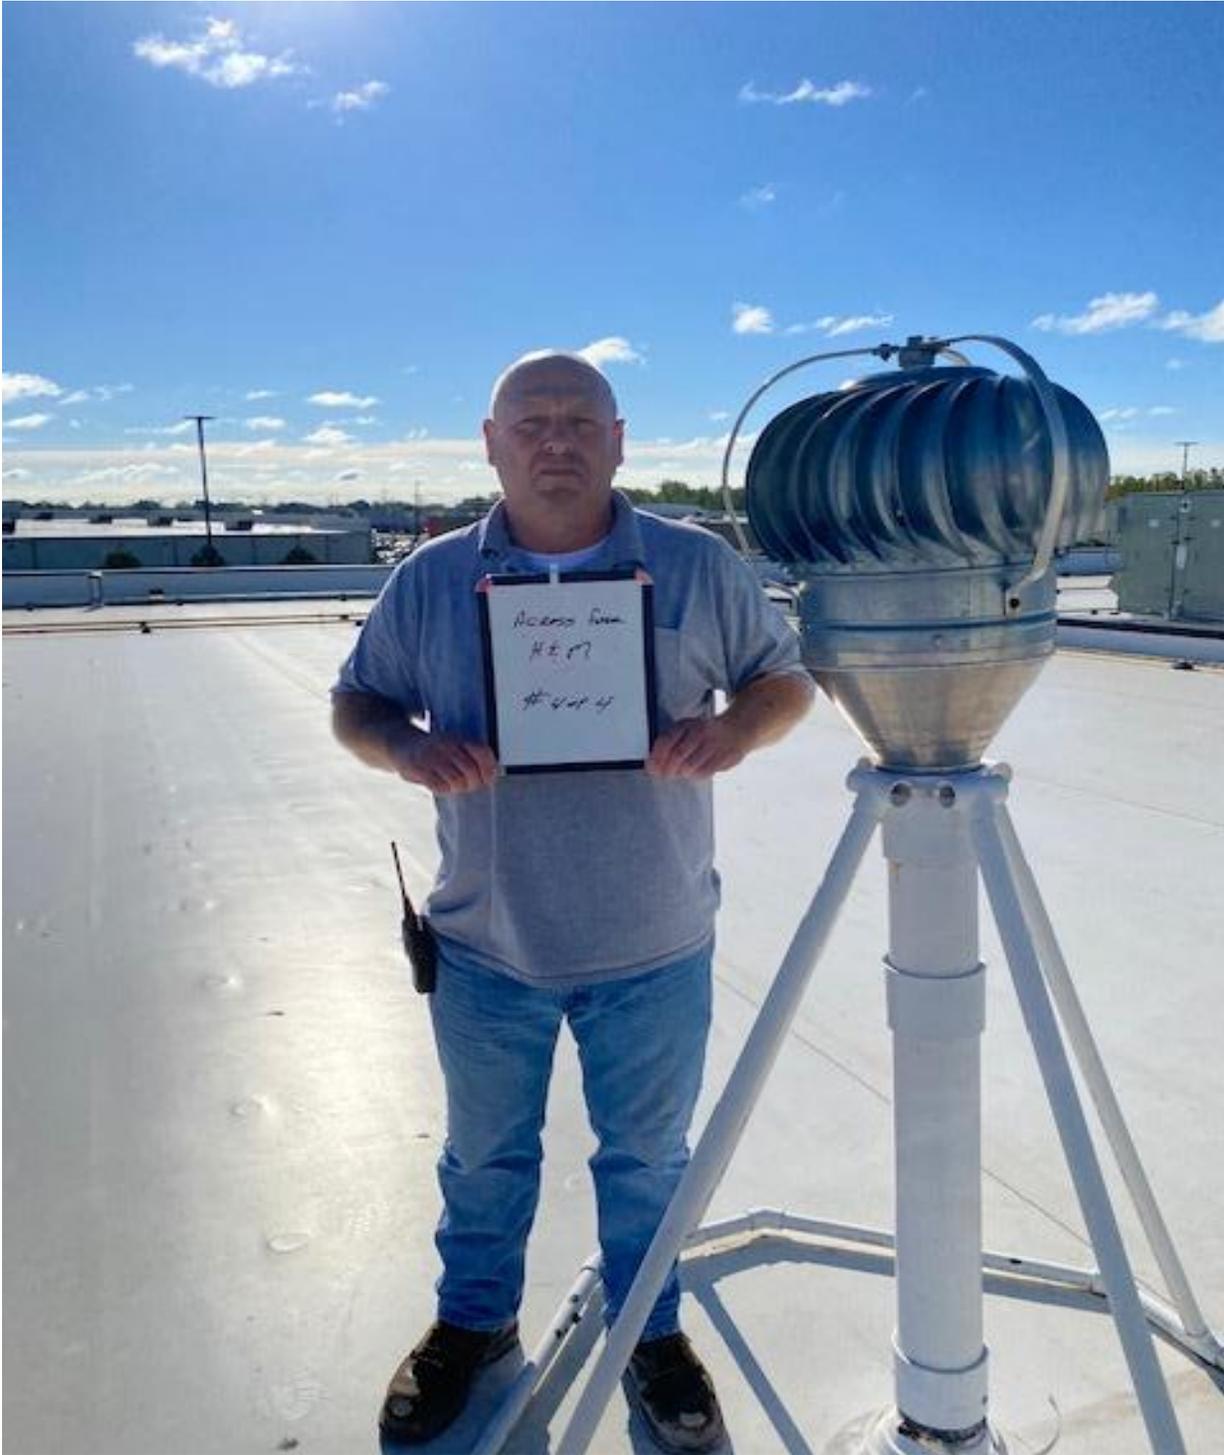
Photo 11: Exhaust Fan #4 on roof of FONF Expansion, across from H&M.

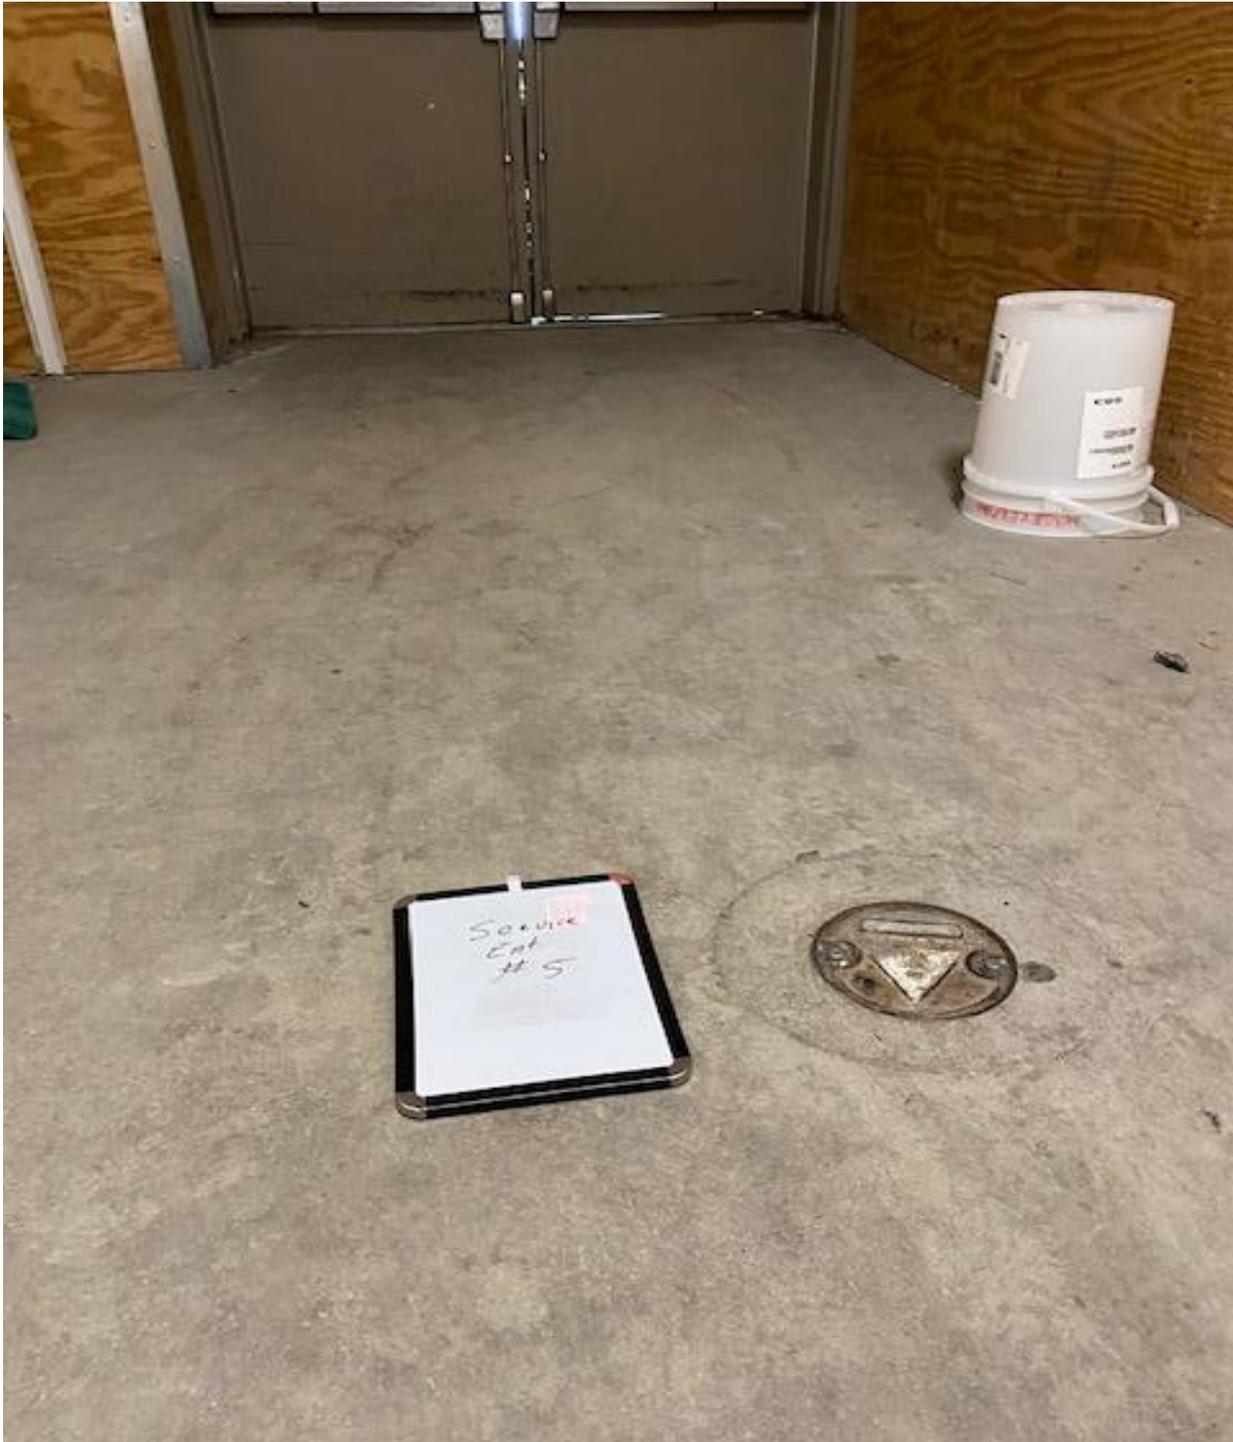
Photo 12: Vapor Point #6 by service entrance #5 of FONF Expansion.

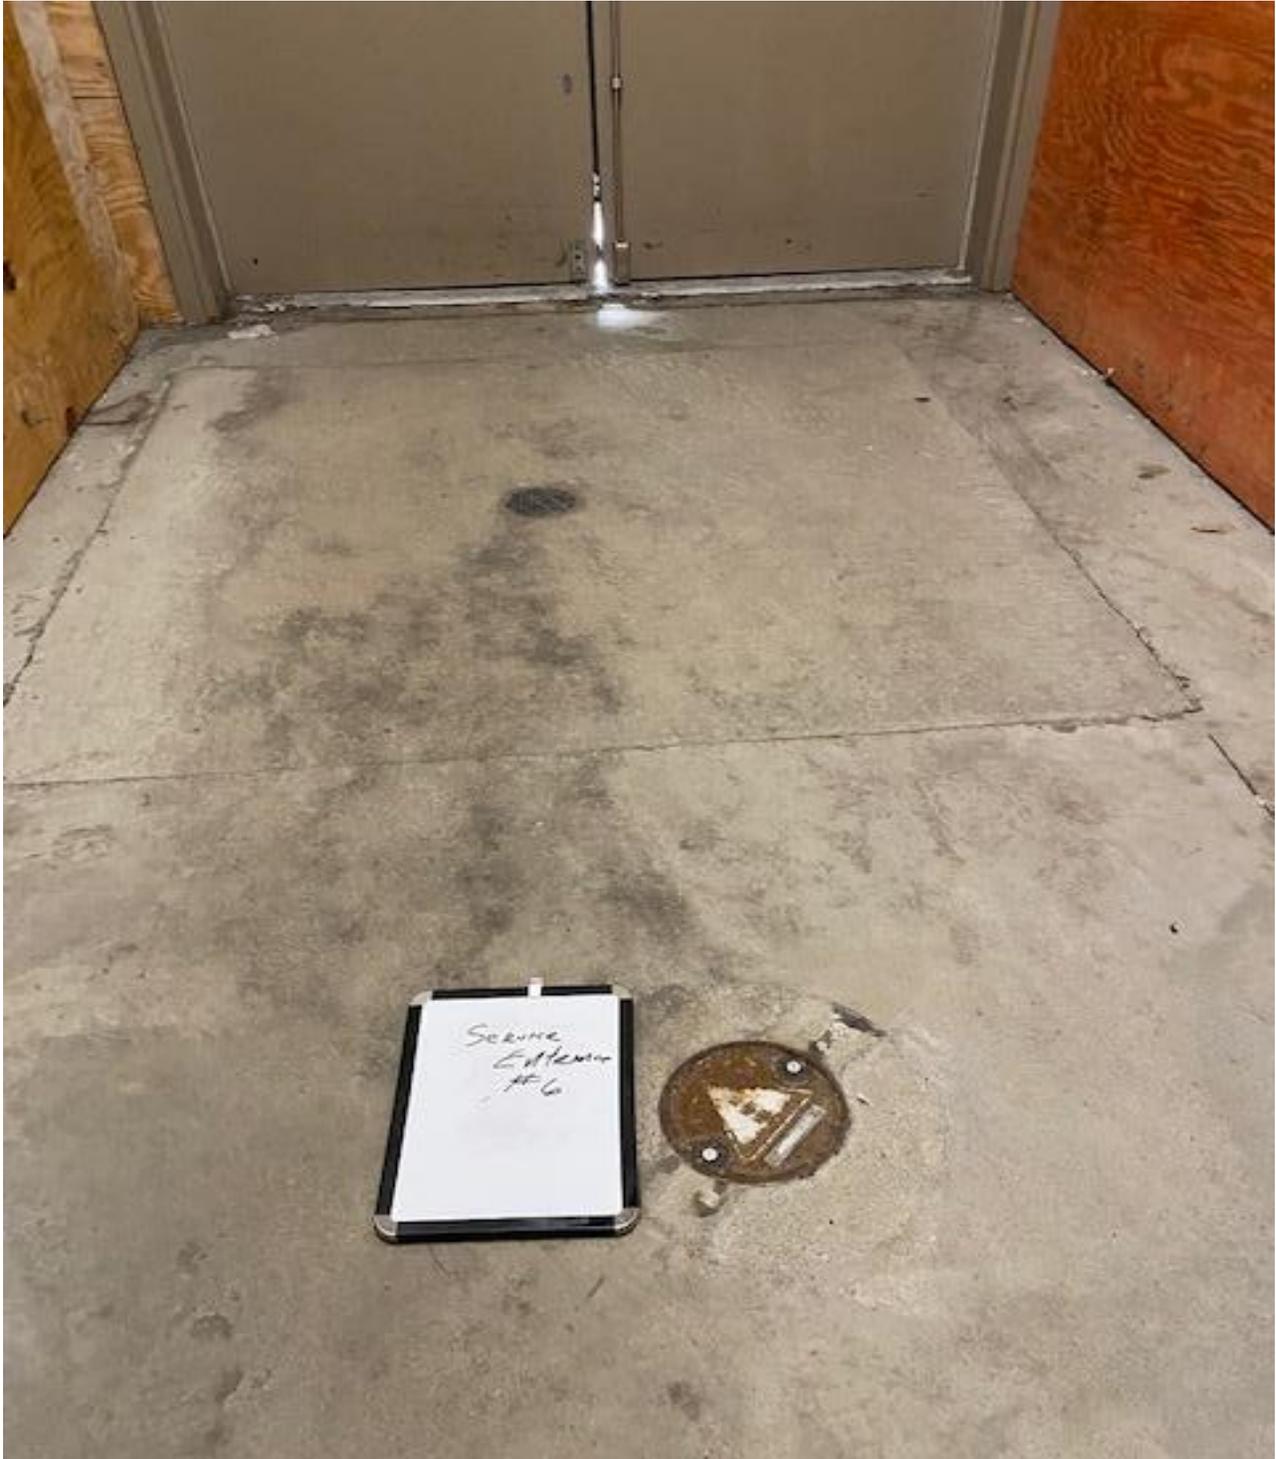
Photo 13: Vapor Point #7 near service entrance #6 of FONF Expansion.
