Subject: Annual 2021 Site Inspection and Certification Letter Report
FONF Expansion/Sabre Park BCP Site No. C932162

Atlas ATC Engineering Inc. (Atlas), on behalf of Macerich Management Company, hereby submits this Site Management Inspection Report for the Fashion Outlet Niagara Falls (FONF) / Sabre Park Brownfield Cleanup Program (BCP), Site No. C932162, located at 1900 Military Road, Niagara County, Niagara Falls, New York 14304 (hereafter referred to as Site). The inspection was completed in accordance with the Revised Site Management Plan (SMP), dated January 2020, prepared by Langan Engineering. In accordance with the New York State Department of Environmental Conservation (NYSDEC) approval of the Annual 2020 Site Inspection and Certification Letter, dated November 22, 2021, this letter represents the Annual 2021 Site Inspection and Certification Letter Report. The next Periodic Review Report is scheduled to be submitted to the NYSDEC in the 1st Quarter of 2025.

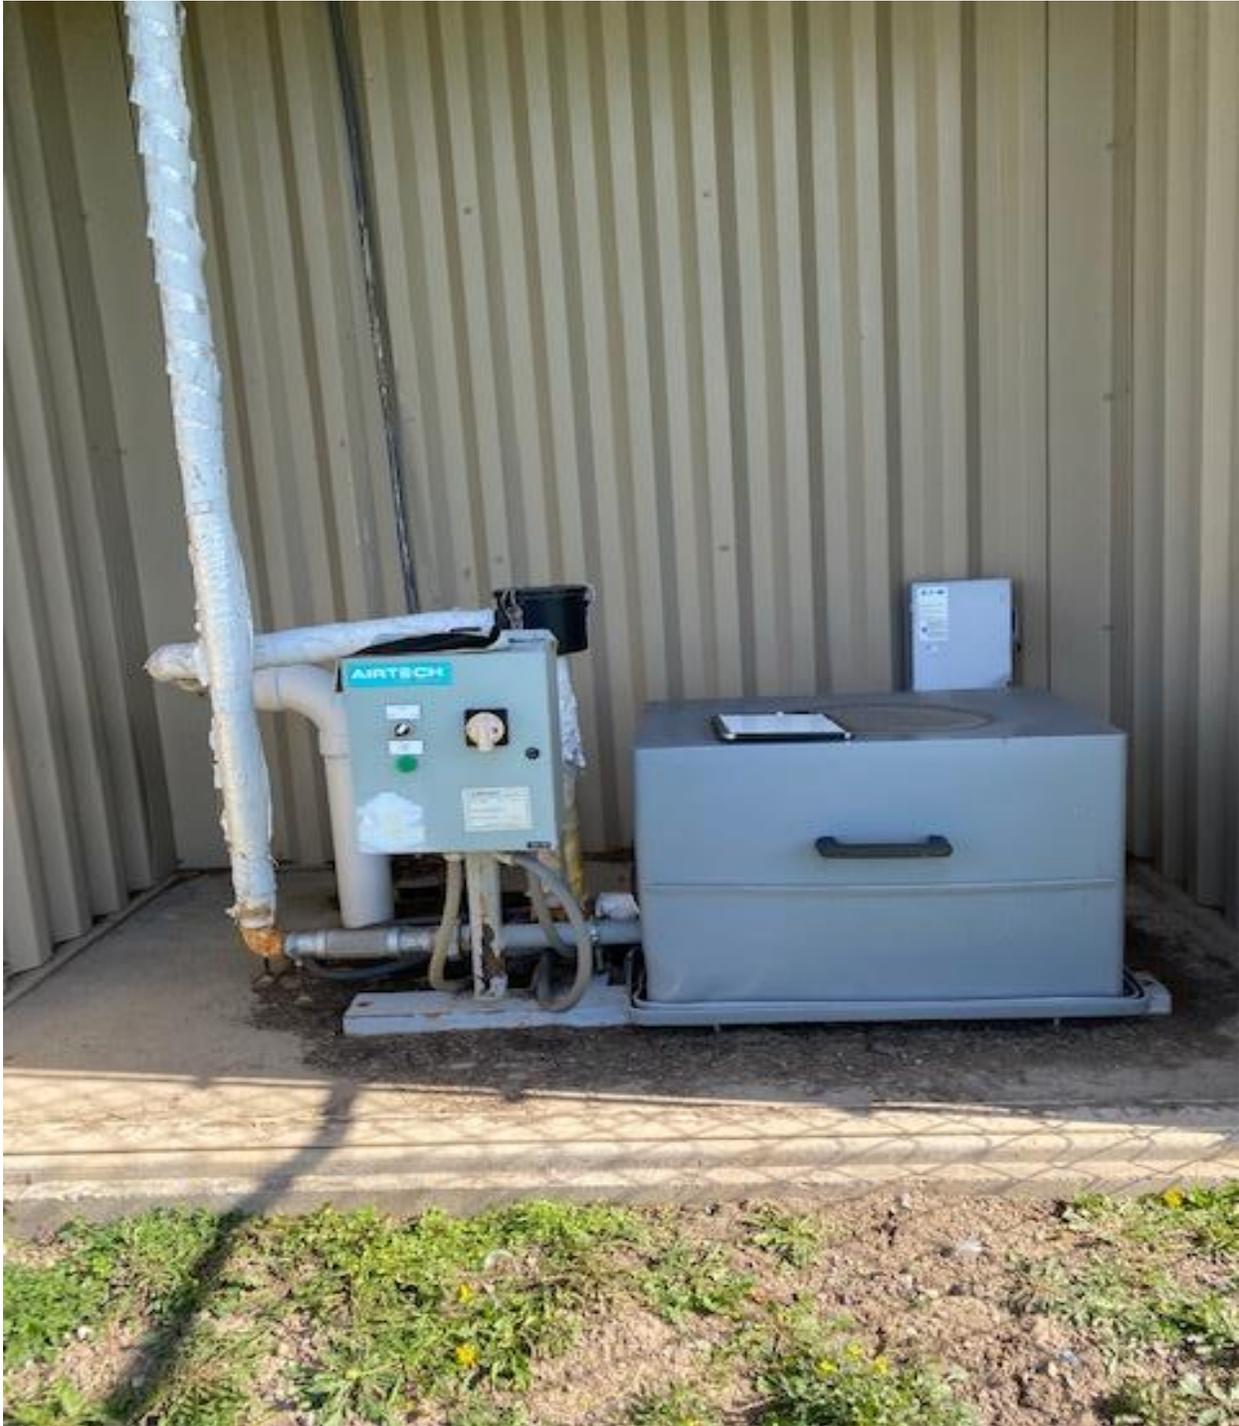
System was not operational at time of inspection. At 6.00 PM on 9/28/21 the maintenance manager at the facility called and stated the system is up and running.

Photo 14: SSD system at Secure Self Storage facility.

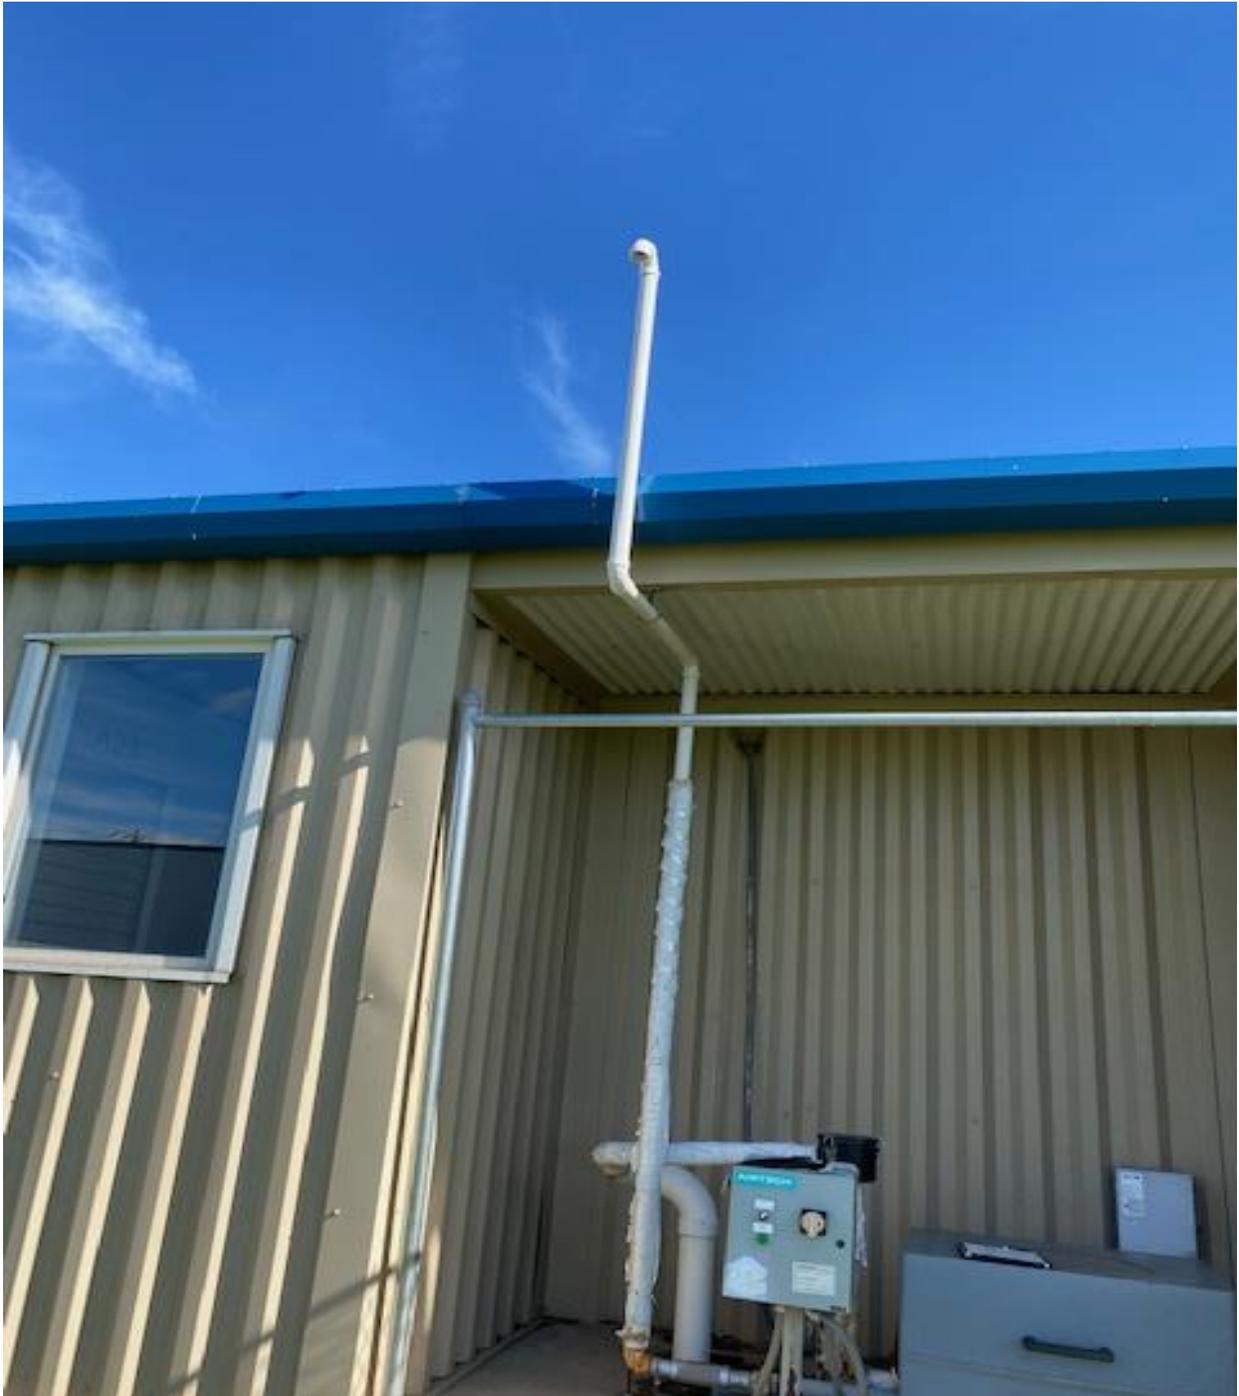
Photo 15: Vent pipe for SSD System at Secure Self Storage.

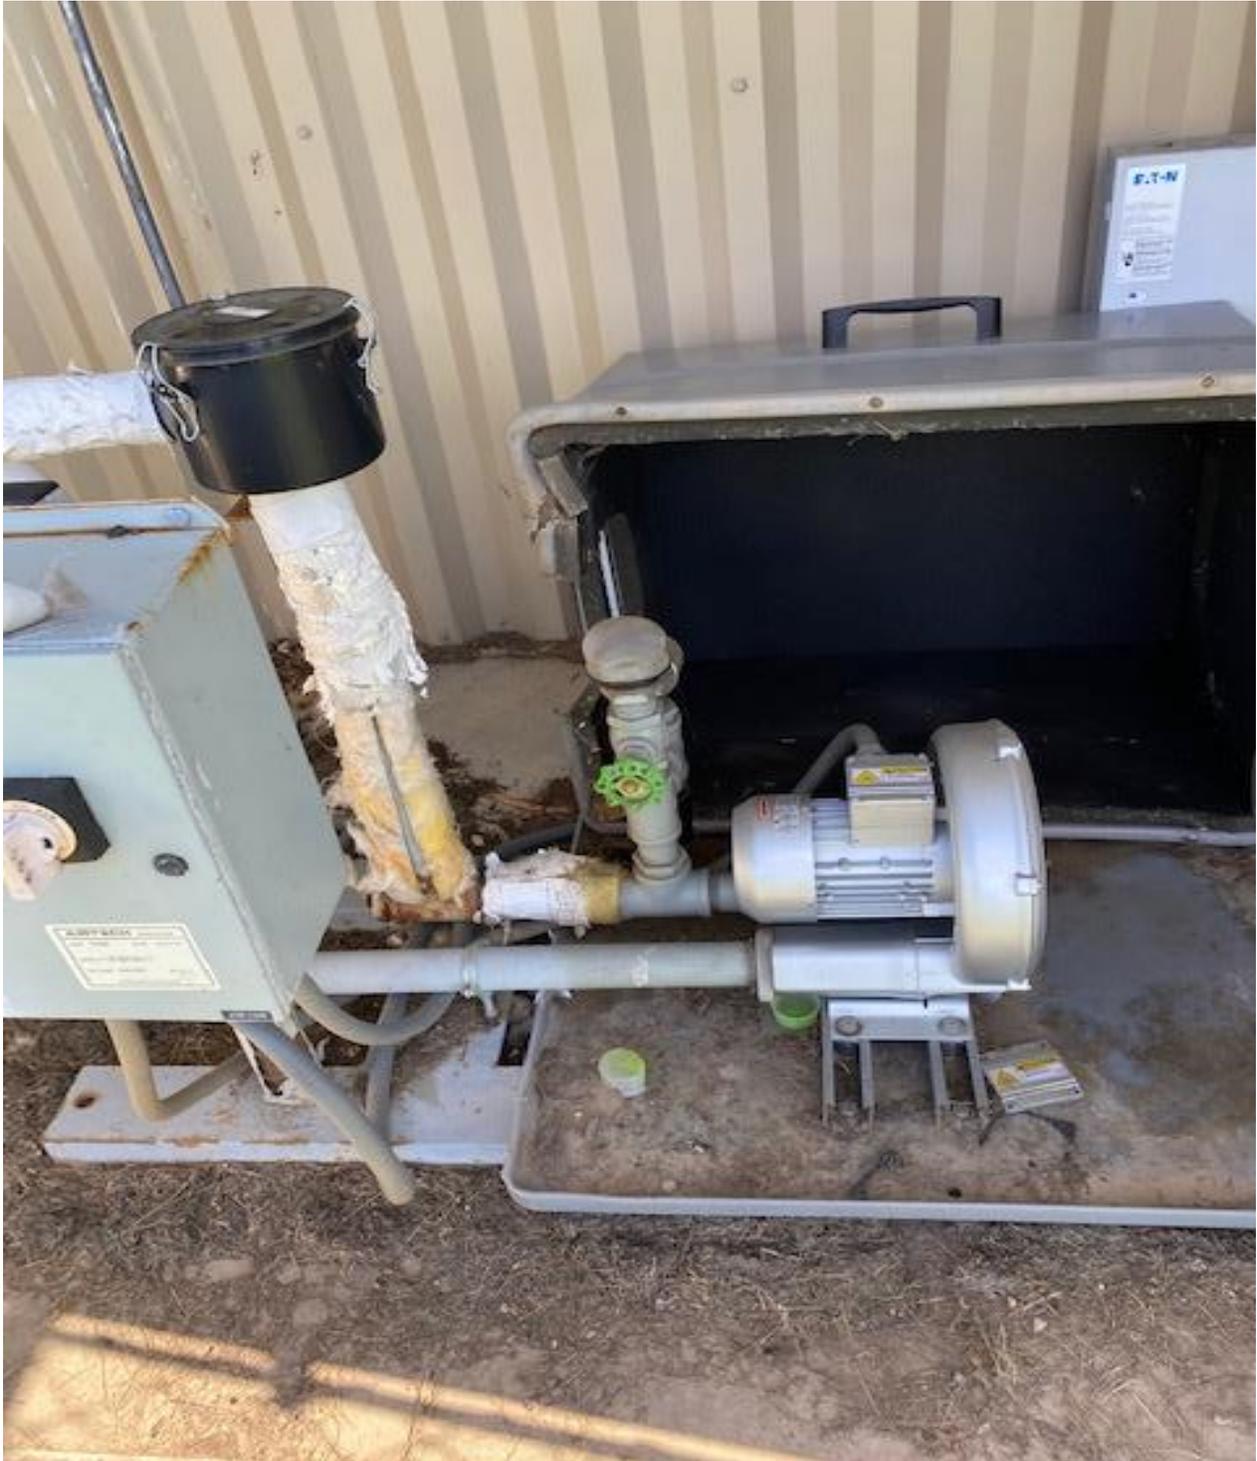
Photo 16: Close look at pump motor for Secure Self Storage SSD system.

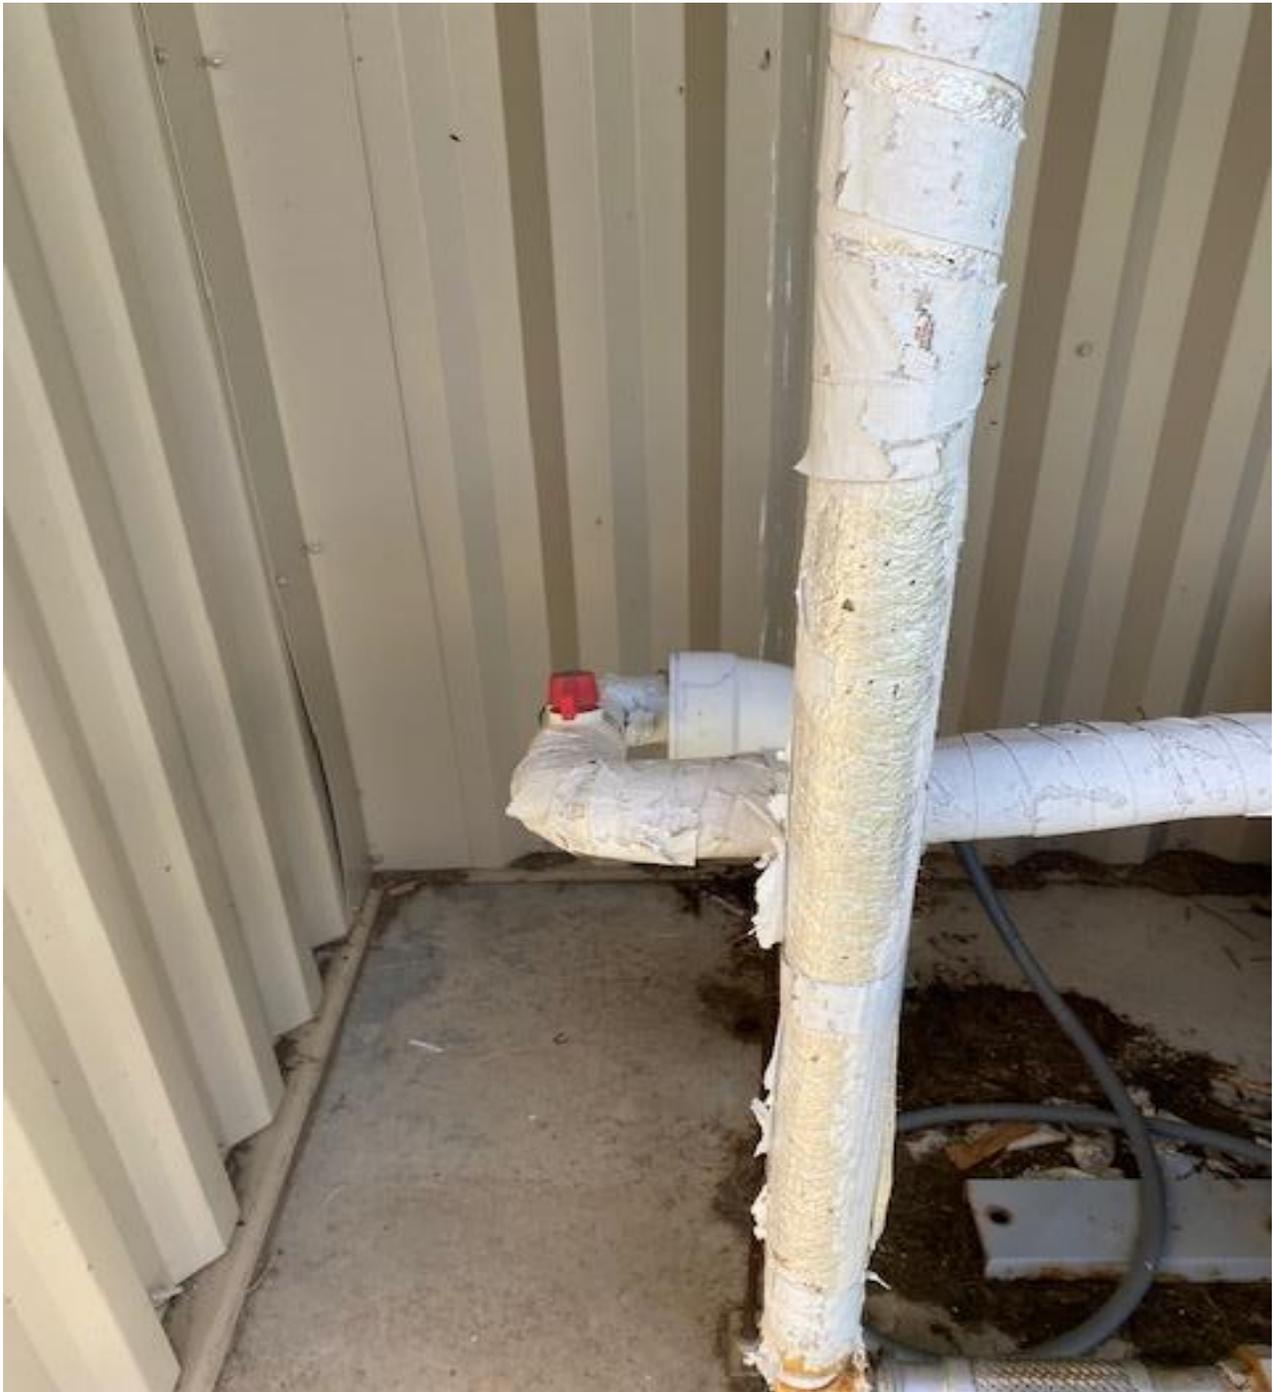
Photo 17: Piping for Secure Self Storage SSD System.

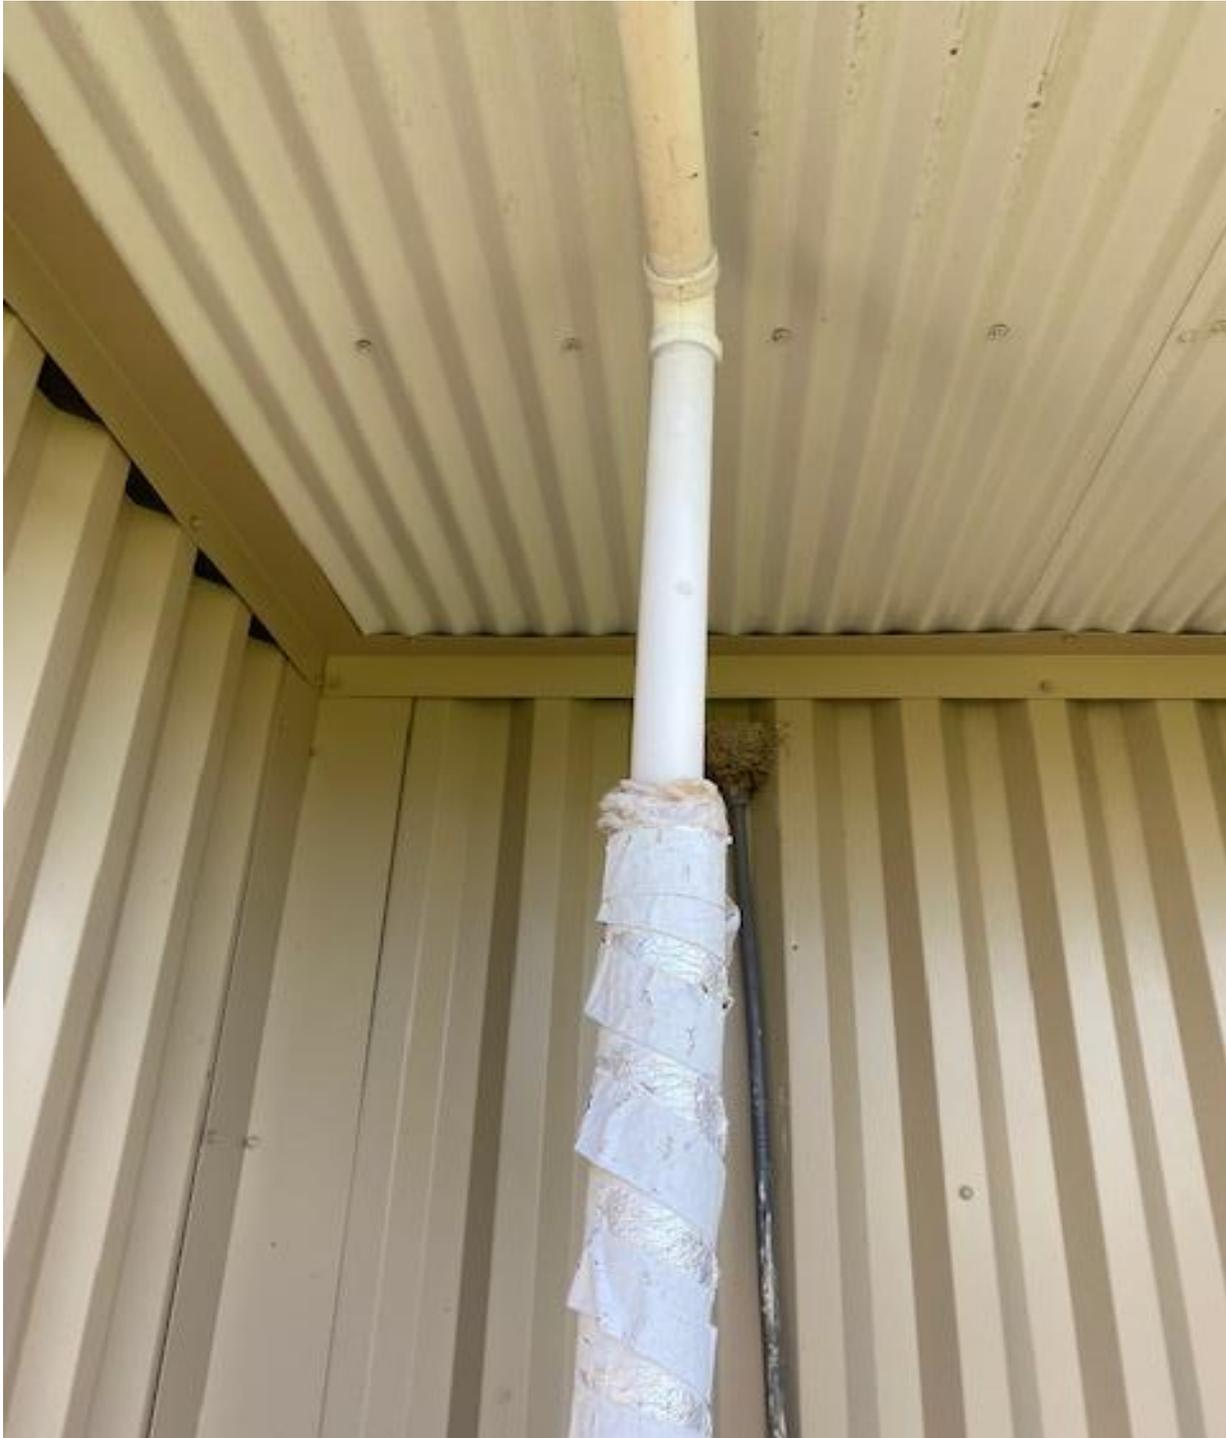
Photo 18: Piping for Secure Self Storage SSD System.

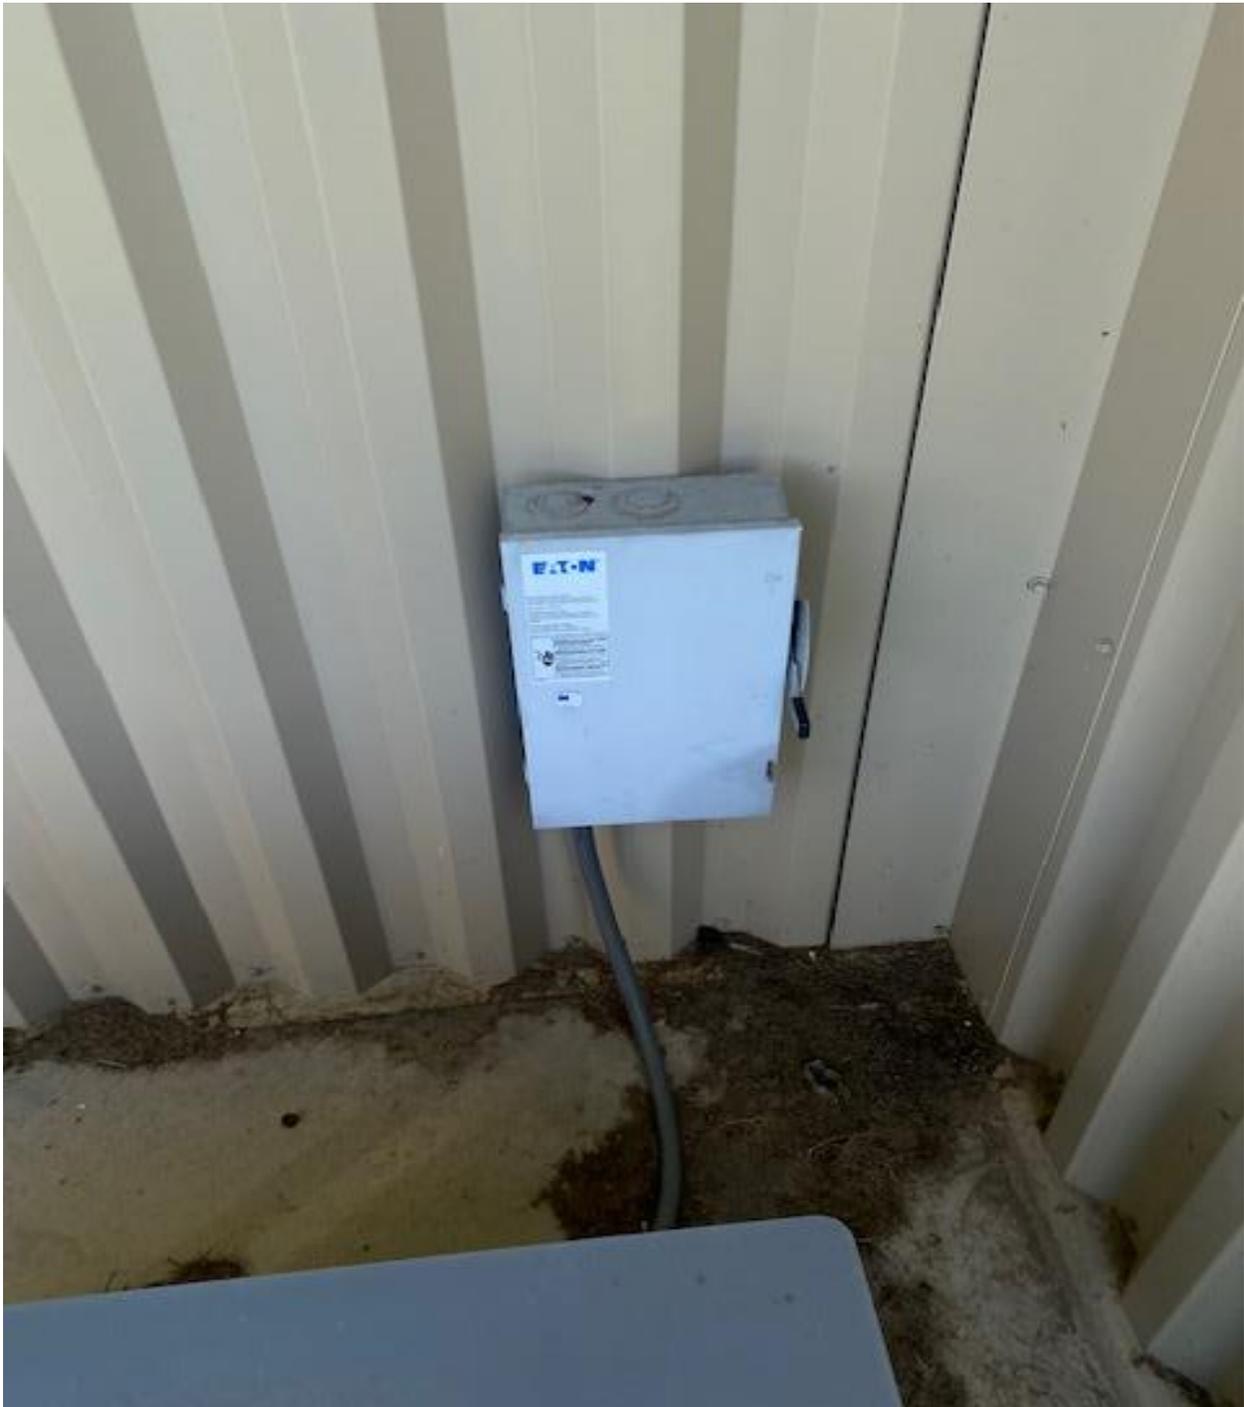
Photo 19: Electrical relay box for Secure Self Storage SSD System.

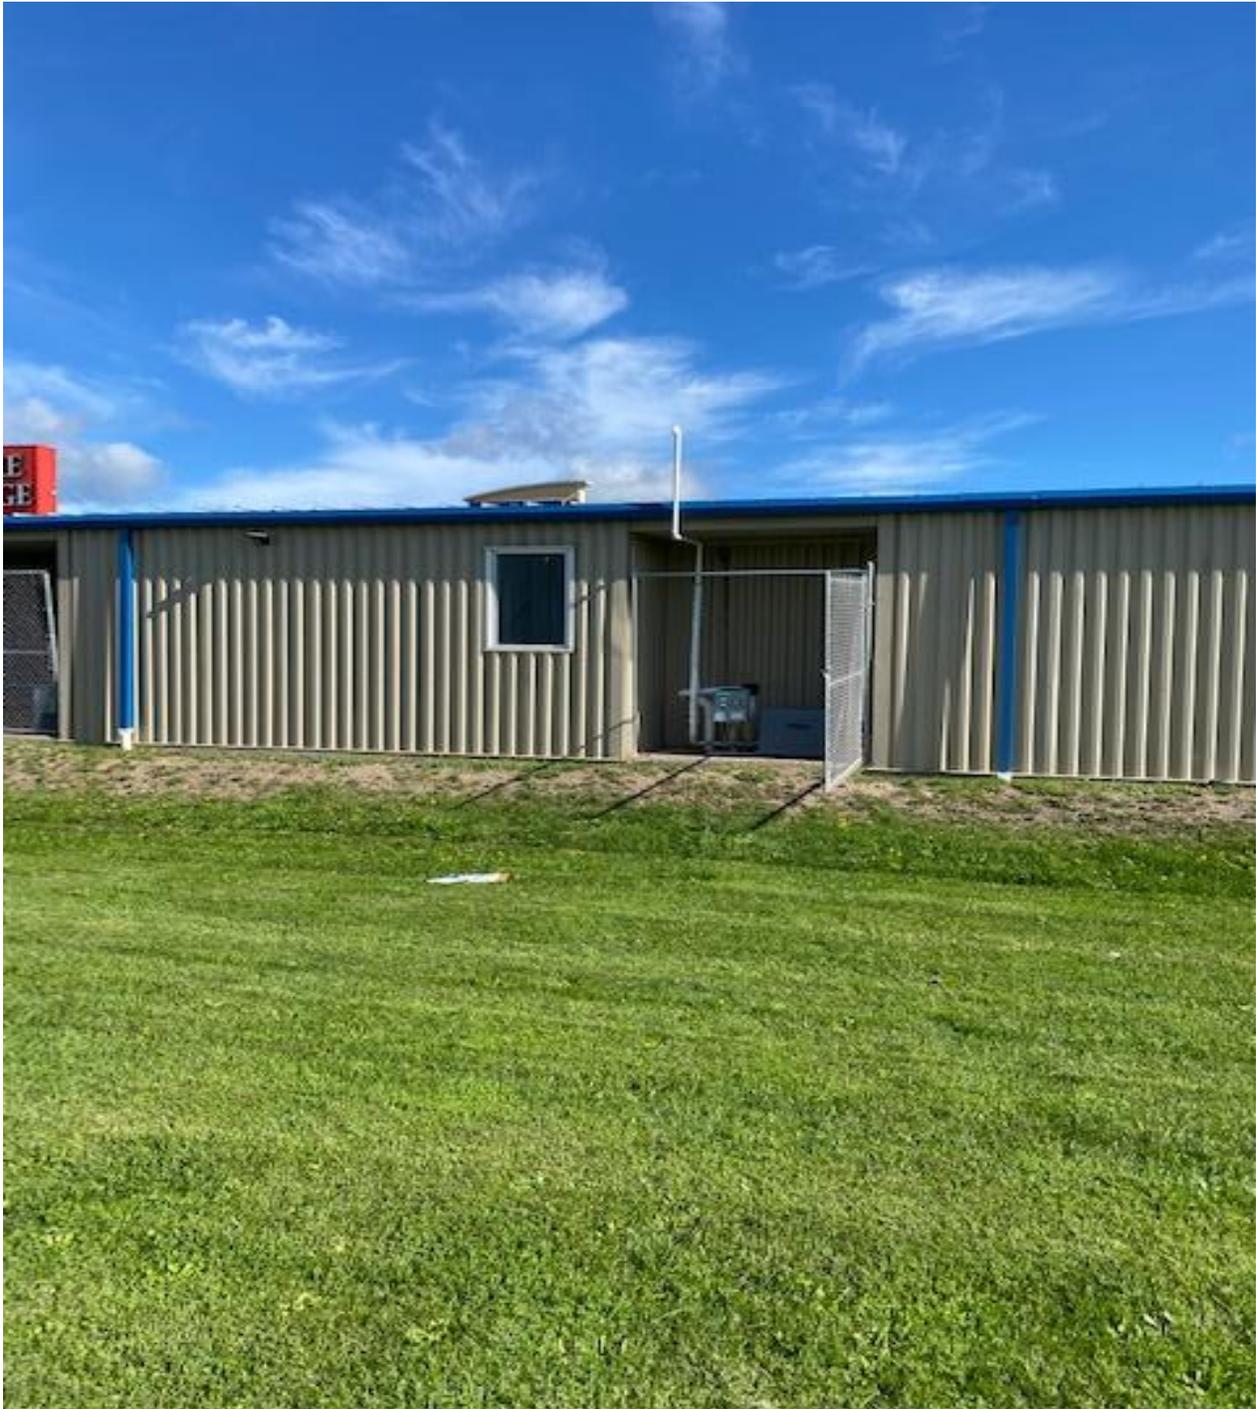
Photo 20: View of SSD System enclosure at the Secure Self Storage building.

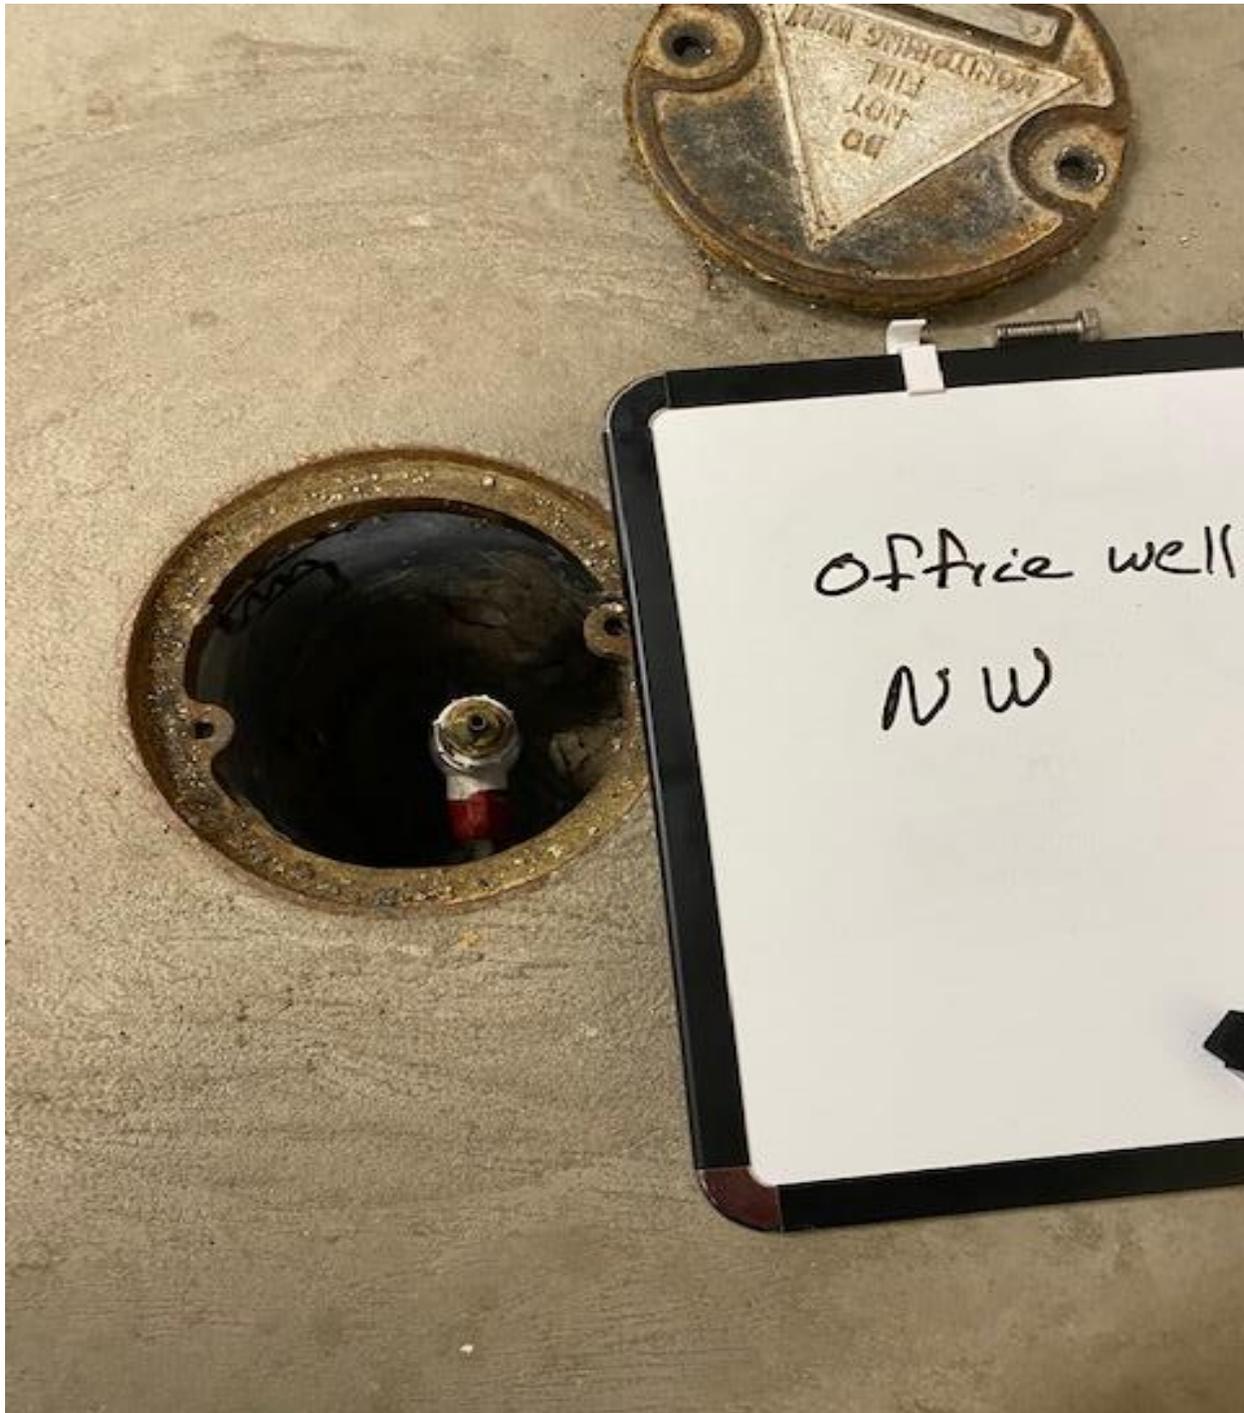
Photo 21: Northwest vapor sampling point in office of the Secure Self Storage building.

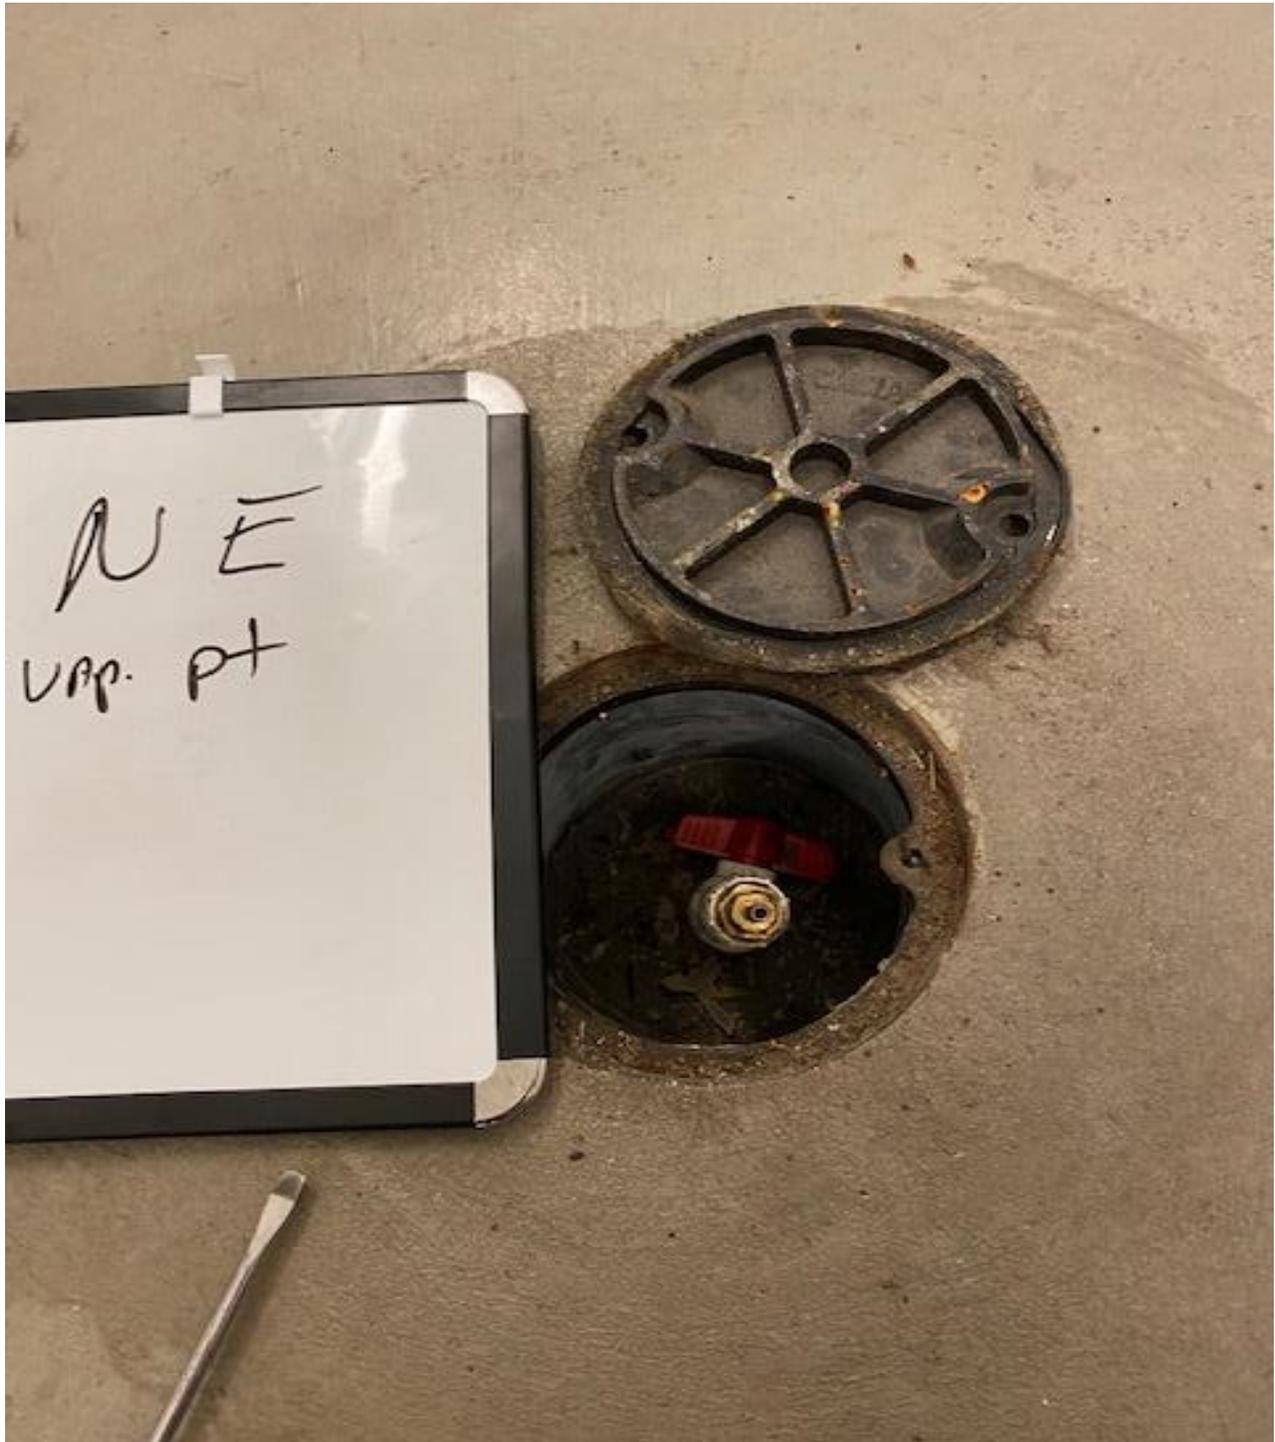
Photo 22: Northeast vapor sampling point in Secure Self Storage building.

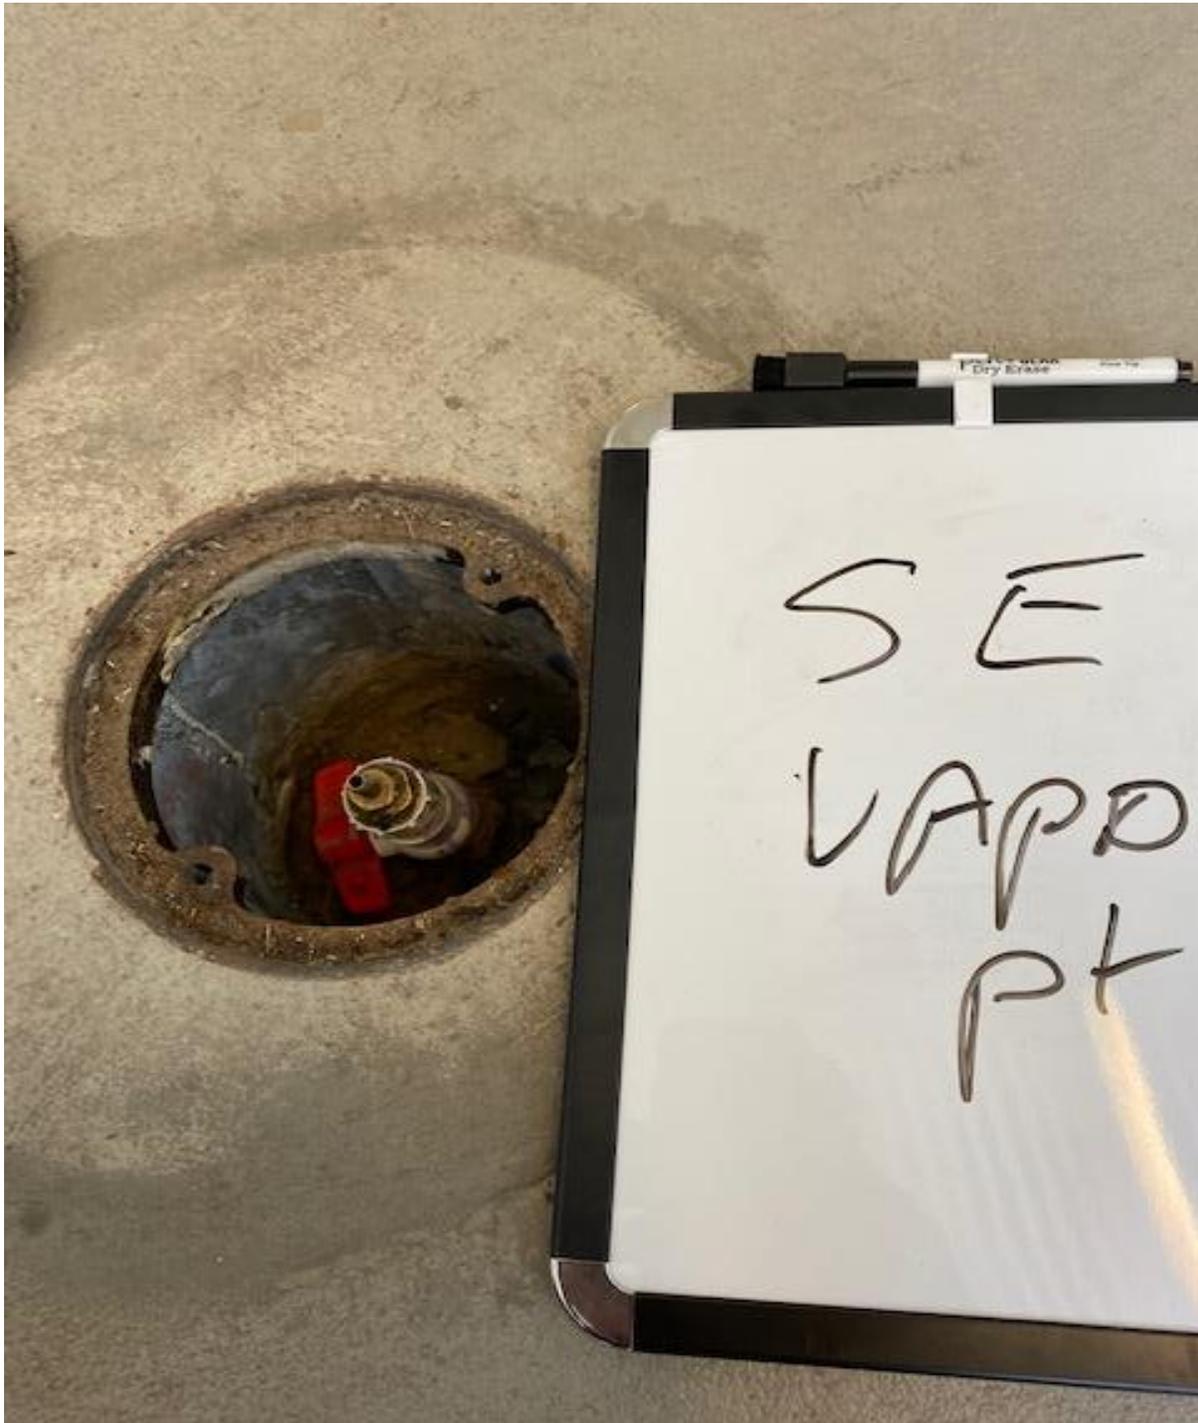
Photo 23: Southeast vapor sampling point in the Secure Self Storage building.

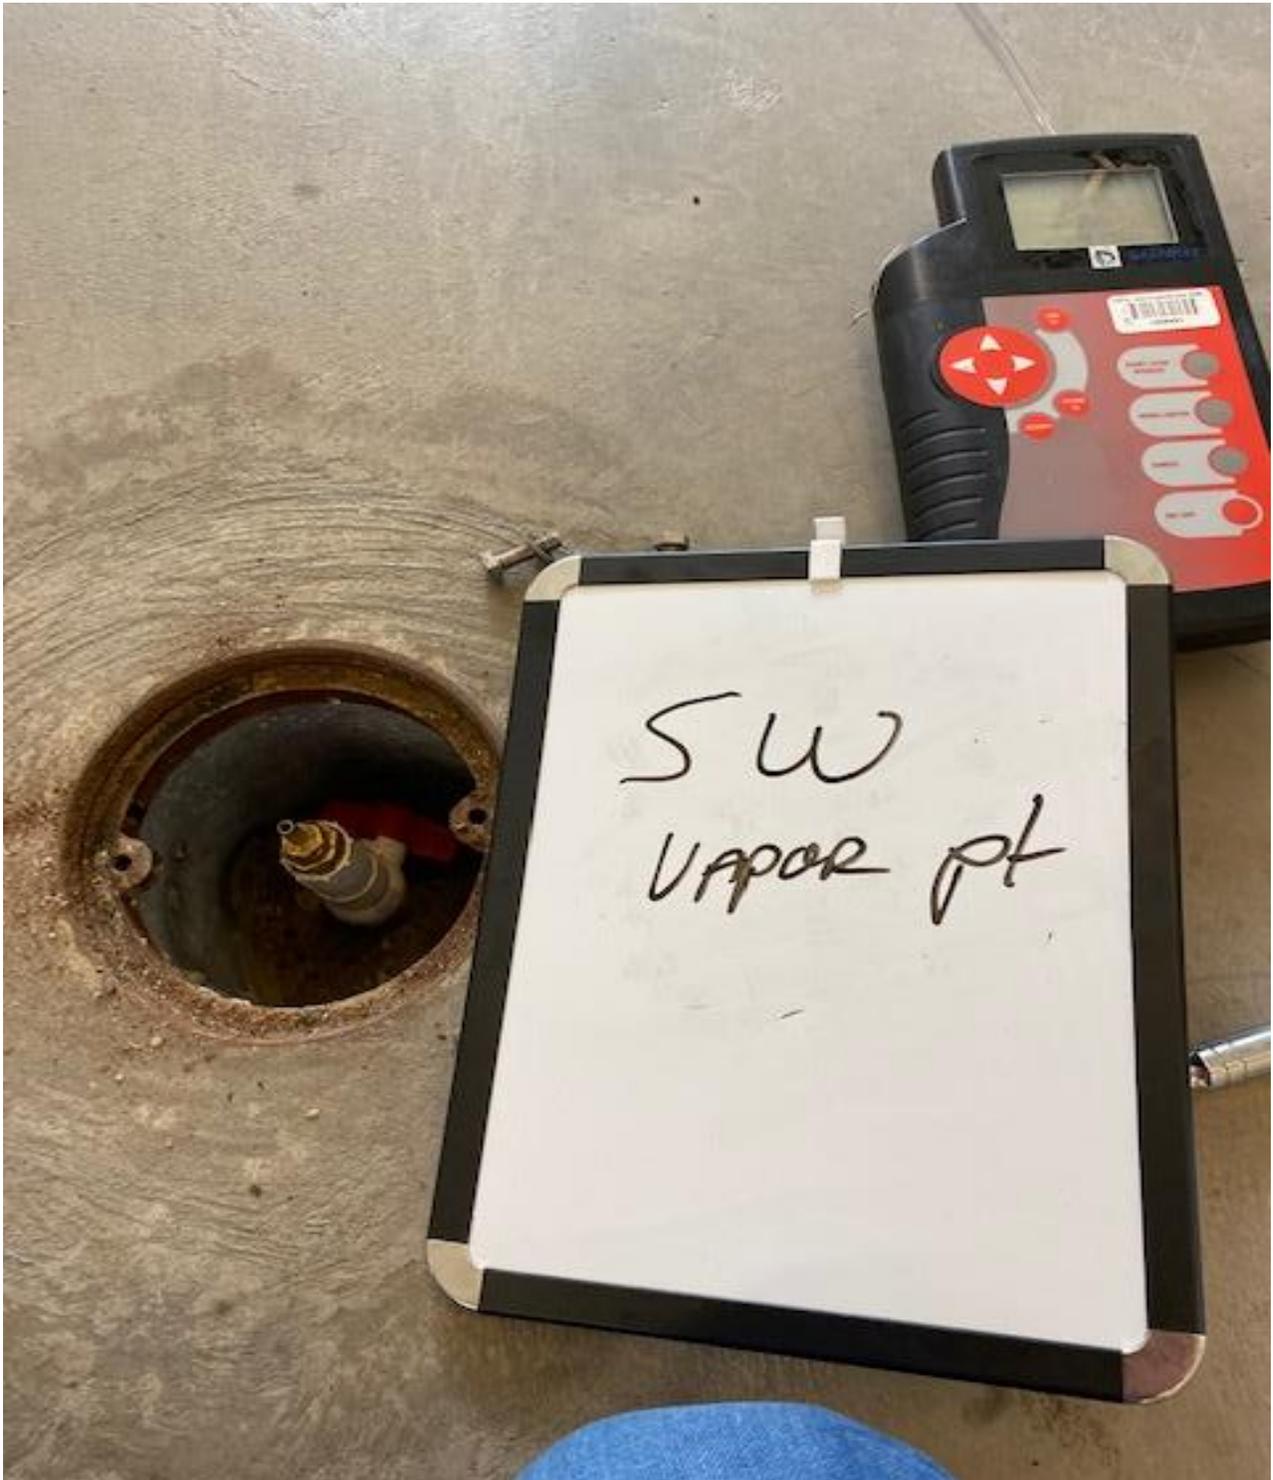
Photo 24: Southwest vapor sampling point in the Secure Self Storage building.

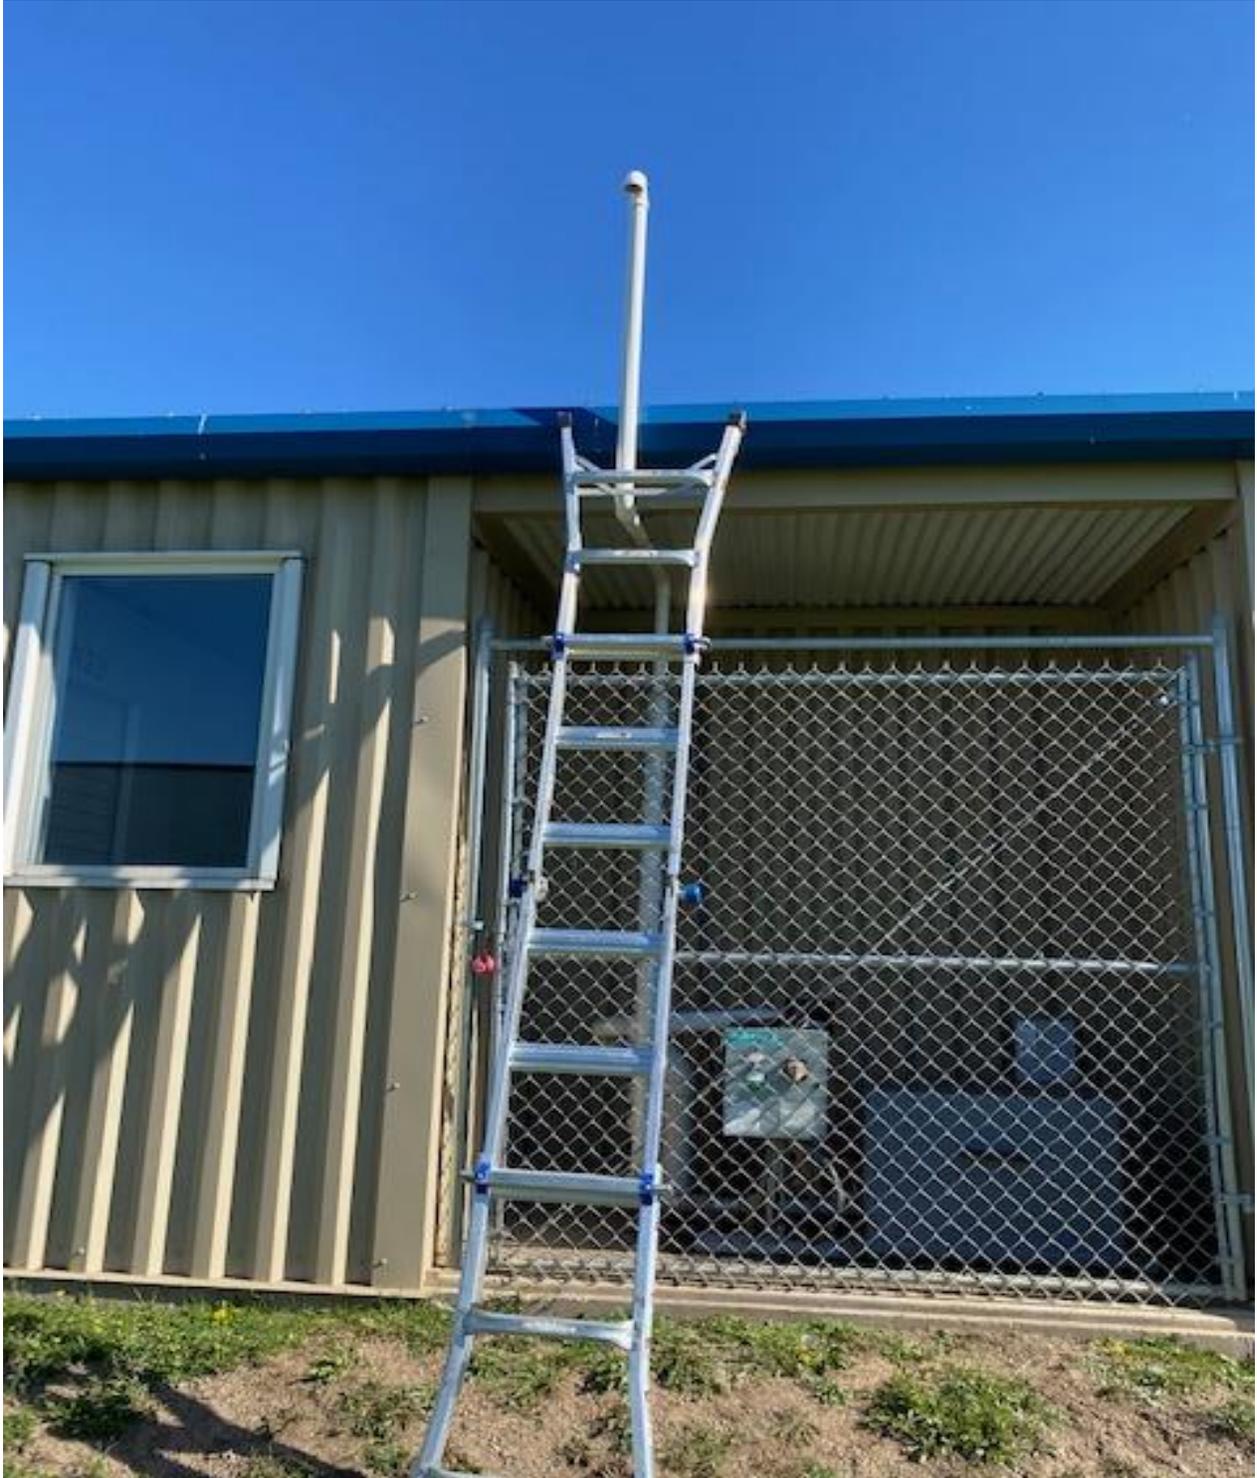
Photo 25: Checked SSD System to determine if air was being discharged from top exhaust vent. Strong air flow was observed at this roof vent.
