October 24, 2023

Subject: Annual 2023 Site Inspection and Certification Letter Report  
FONF Expansion/Sabre Park BCP Site No. C932162

**INSPECTION PHOTOGRAPHIC LOG  
SEPTEMBER 29, 2023**

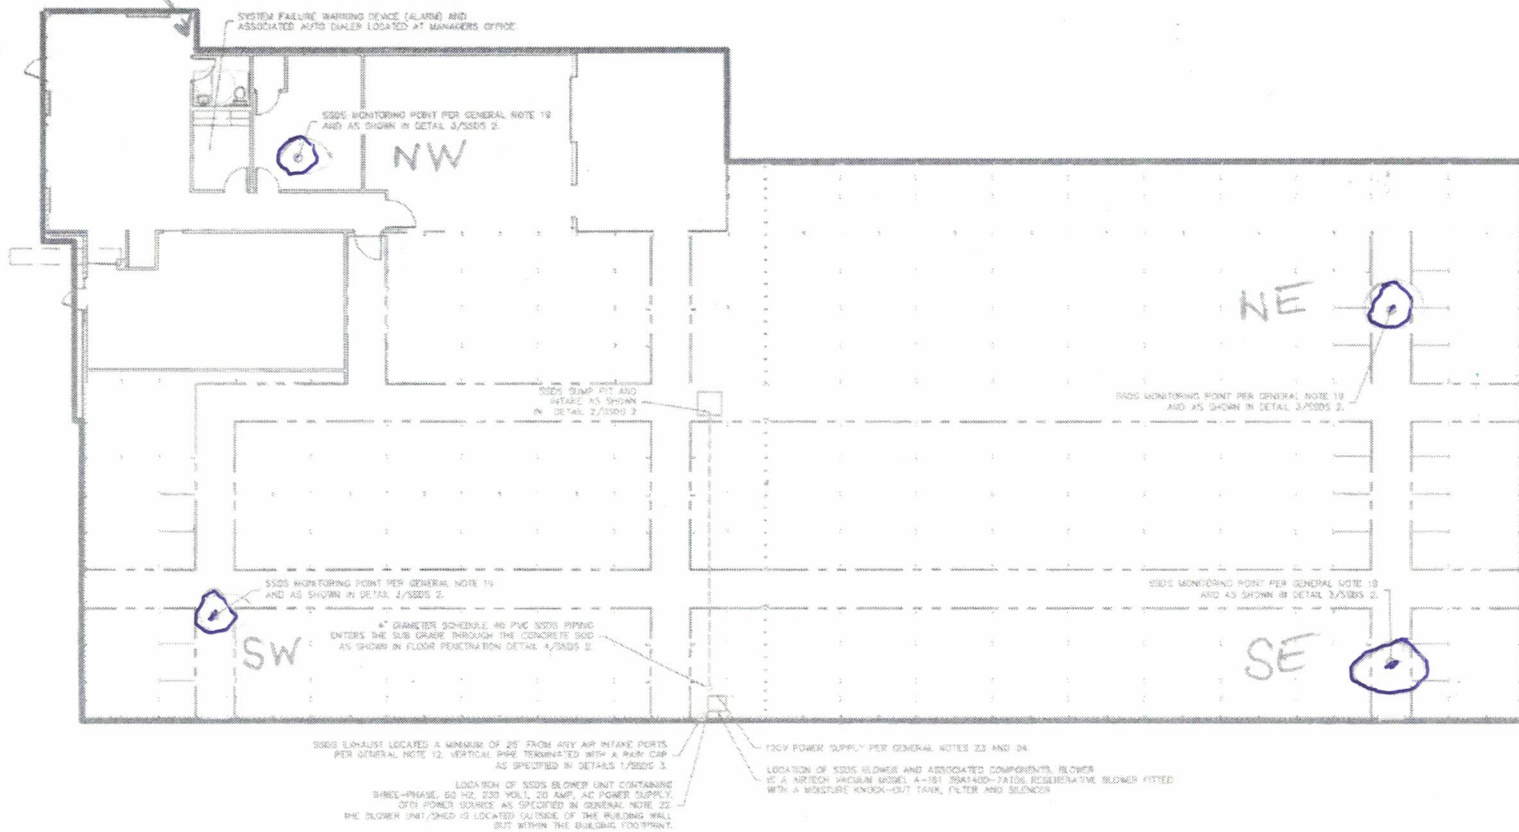
OFF-103

① - MONITORING POINTS

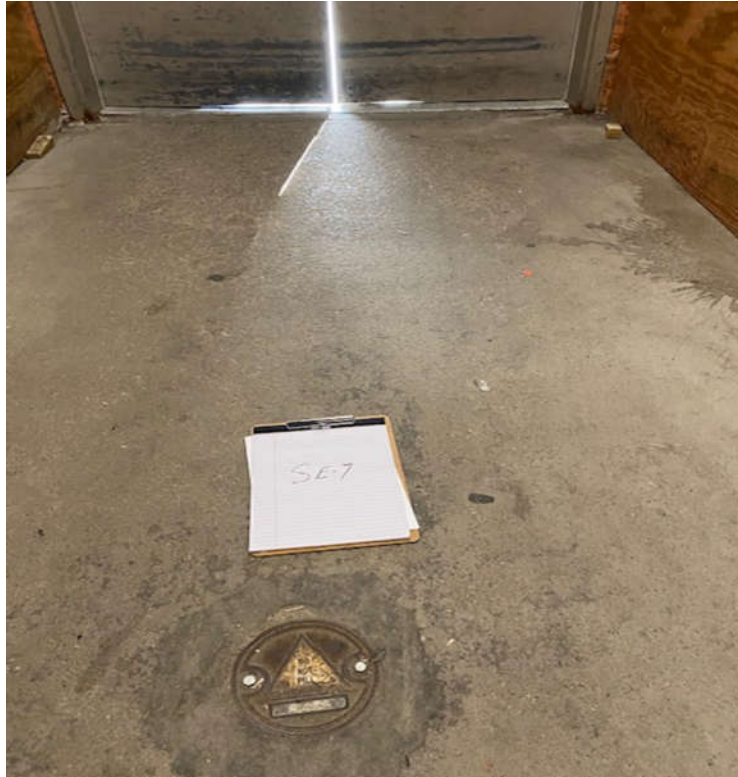
Photo 1: Vapor point near Service Entrance (SE) #7.

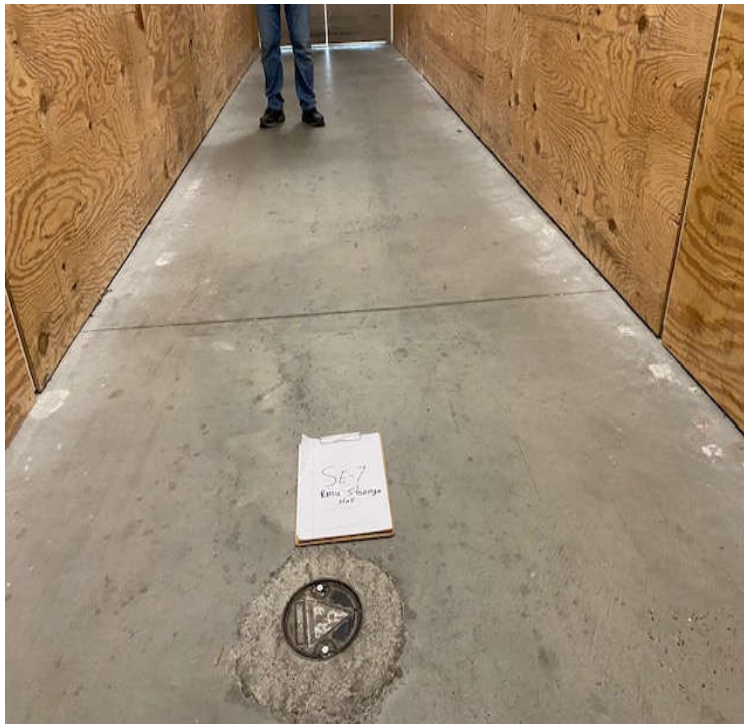
Photo 2: Vapor Point near SE-7 and RMU Storage Hall.

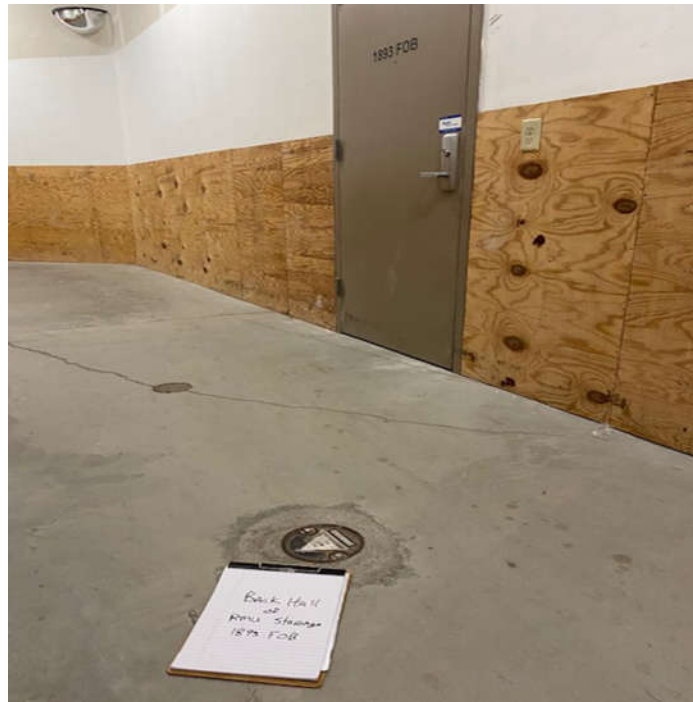
Photo 3: Back Hall of RMU Storage (1893 FOB).

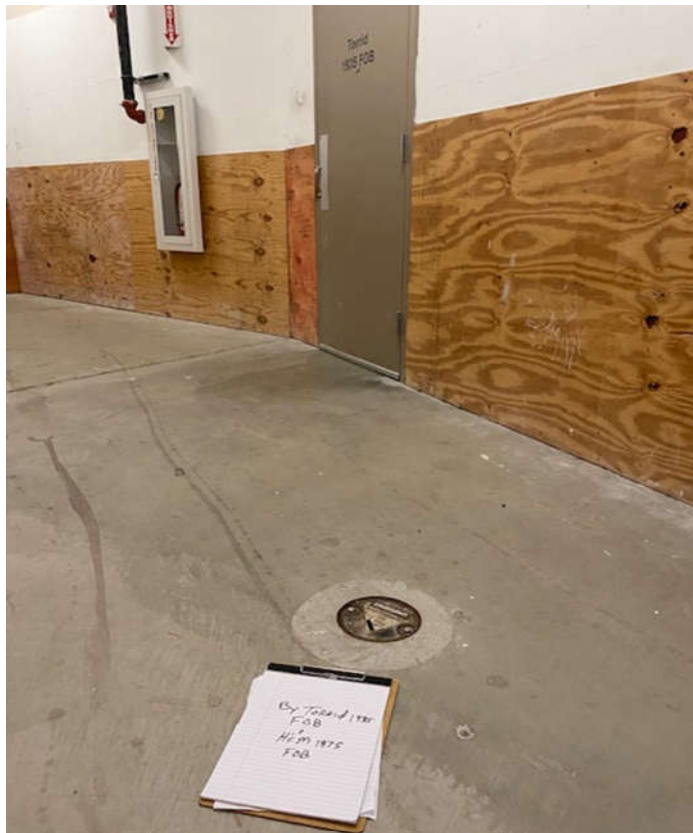
Photo 4: By Torrid 1935 FOB and H&M 1875 FOB.

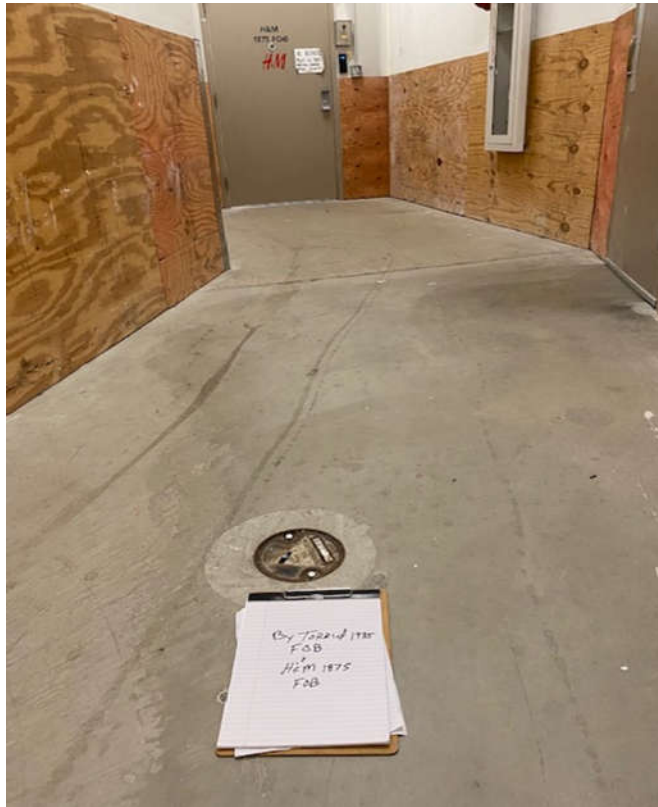
Photo 5: By Torrid 1935 FOB & H&M 1875 FOB.

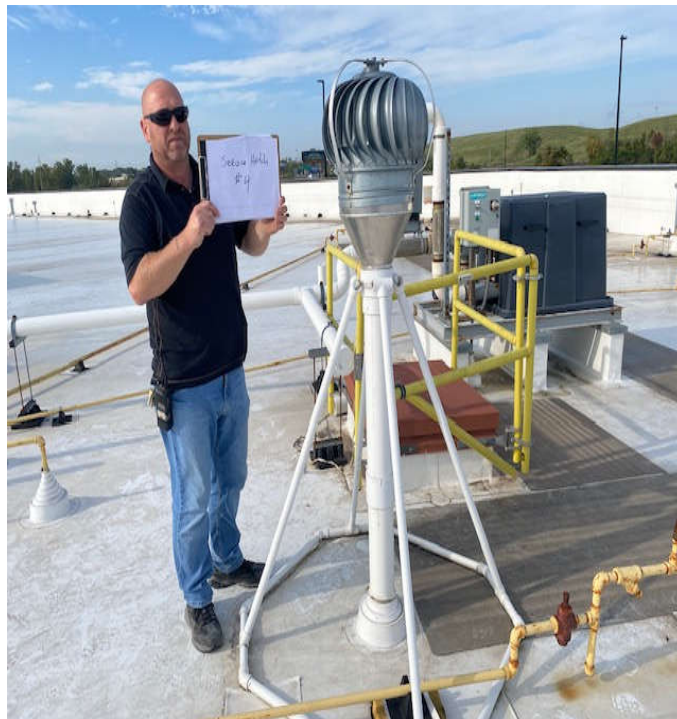
Photo 6: Outlet fan on roof near Service Hatch #4.

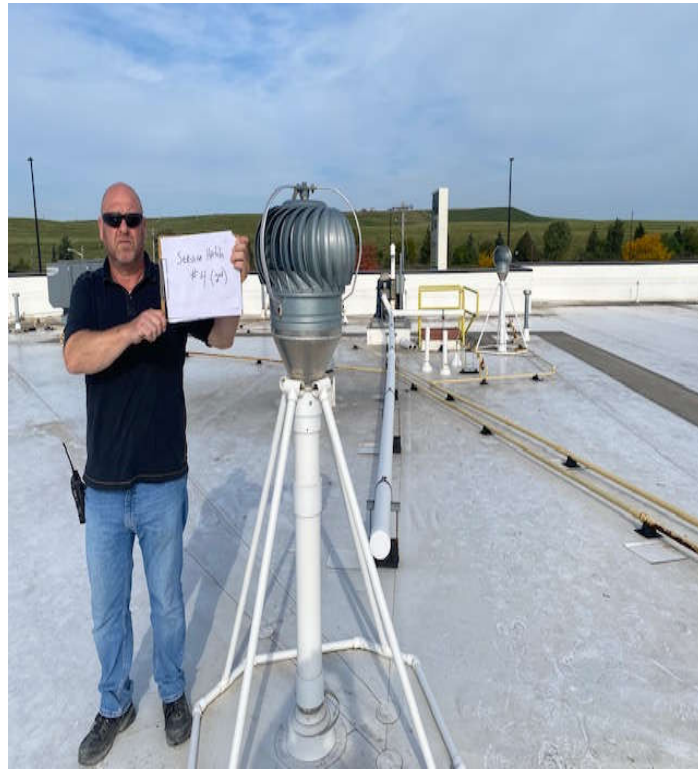
Photo 7: Second outlet fan near Service Hatch #4.

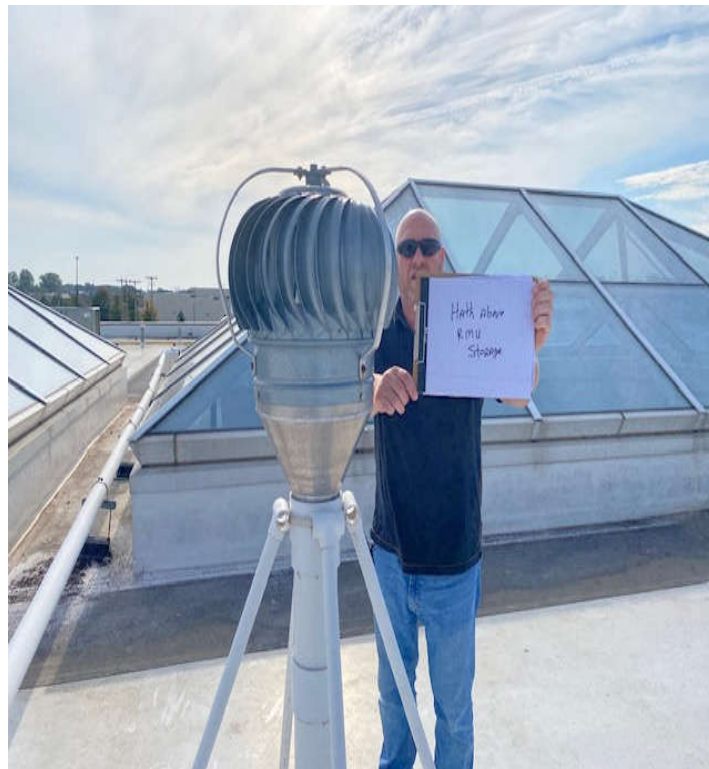
Photo 8: Outlet fan near Hatch above RMU Storage.

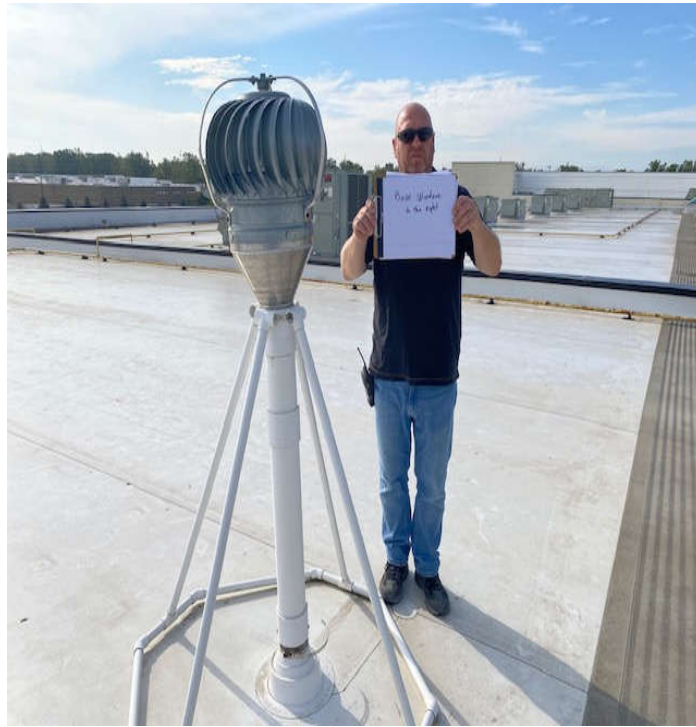
Photo 9: Outlet fan above Windsor.

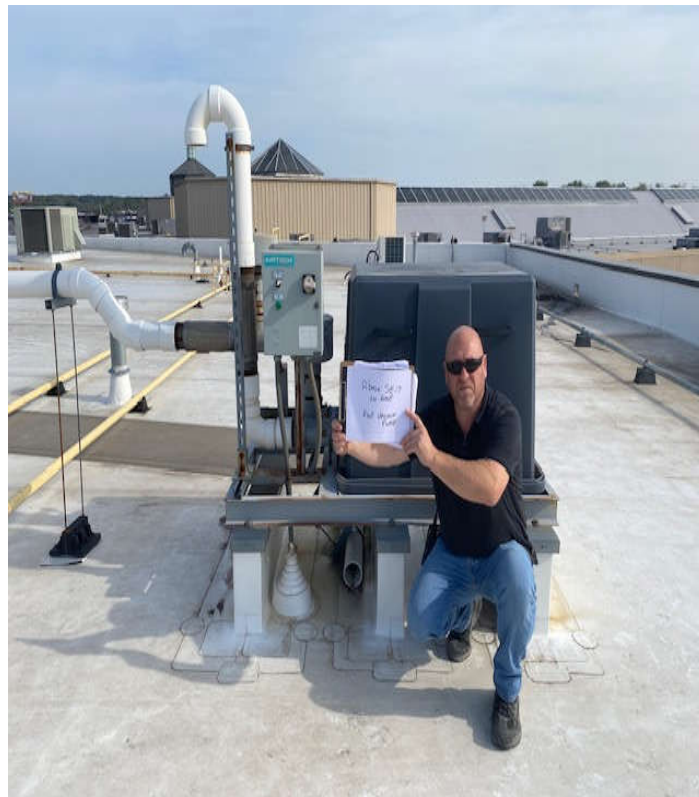
Photo 10: This is the SVE pump above SE-7 on roof. It was not operating.

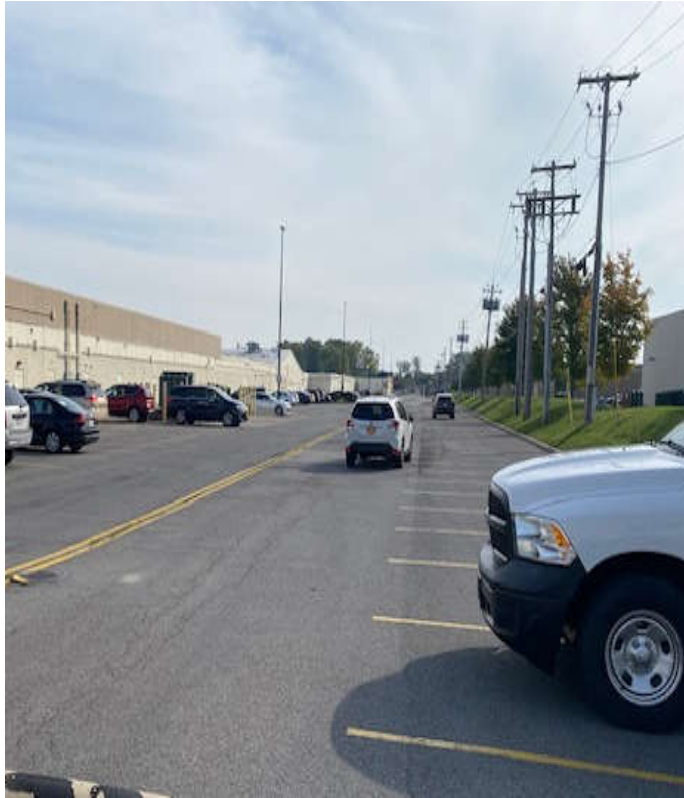
Photo 11: Parking lot on the back side of FONF looking north. All blacktop looked good.

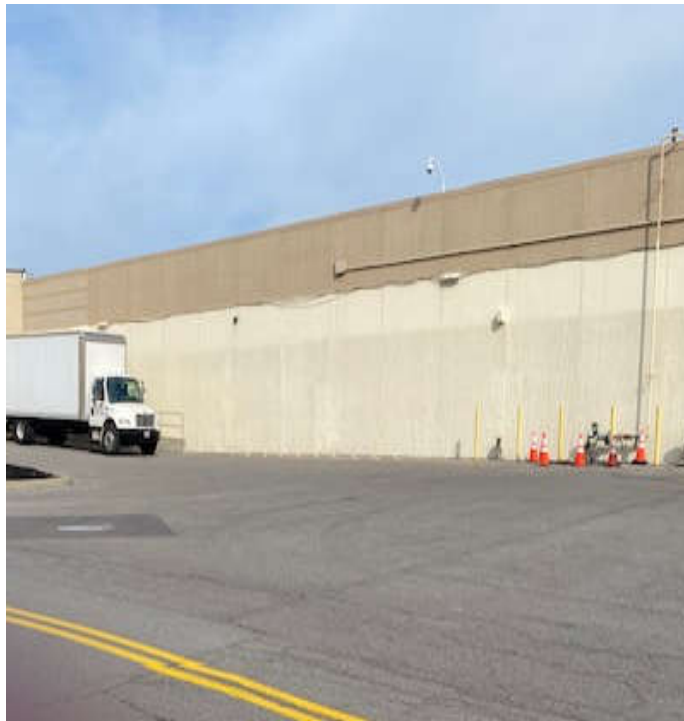
Photo 12: Blacktop in back of mall looking SW. All blacktop looked good.

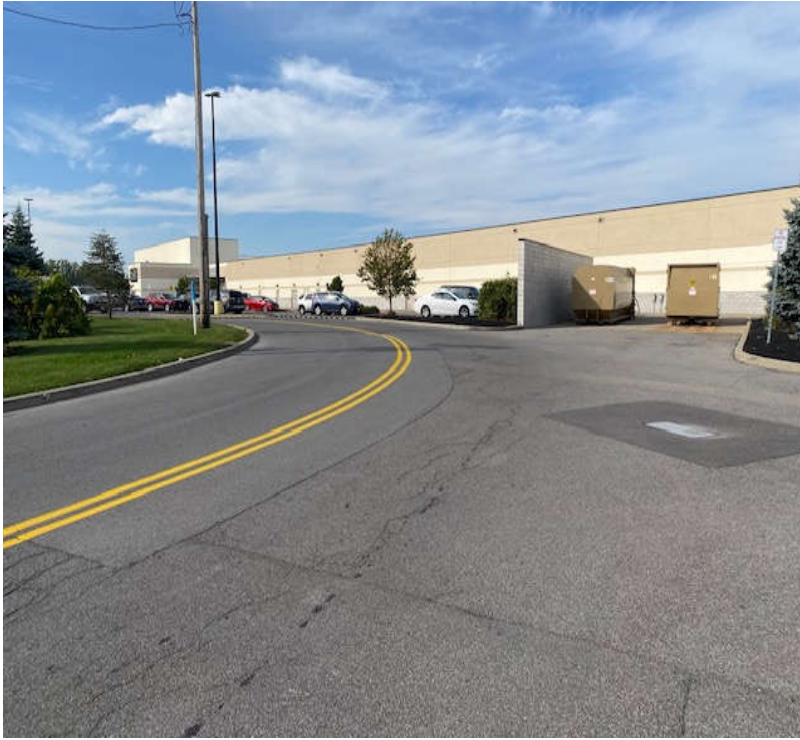
Photo 13: Blacktop in the back of the mall looking SE. All blacktop looked good.

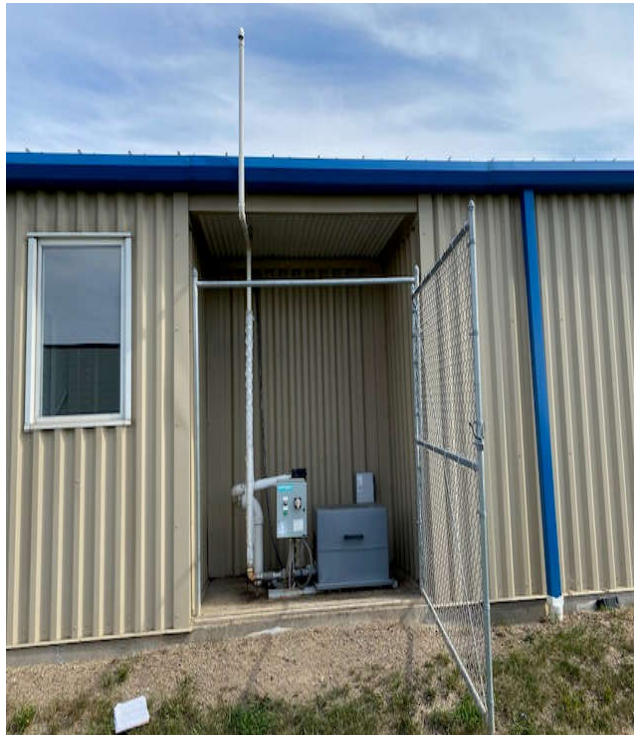
Photo 15: SVE system at the Extra Space Storage Building.

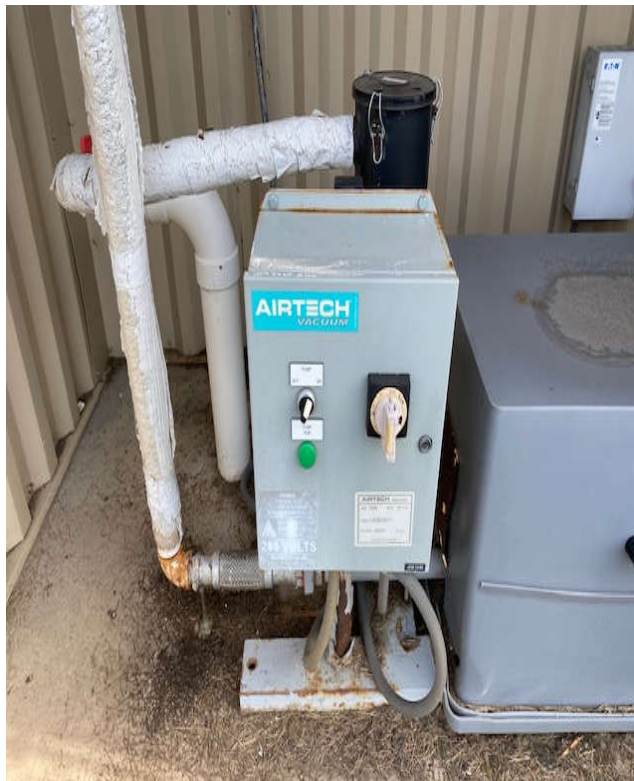
No deviations in the performance of the engineering and institutional controls were identified, except for the non-operational alarm at the Extra Space Storage SSDS. The maintenance manager for the Secure Self Storage was notified of the deficiency.

- No leaks noticed
- Blower fan was on & good flow at discharge
- Alarm light & sound not working
- Tripping Alarm did nothing

Photo 19: Control panel of the SVE system at the Extra Space Storage Building.

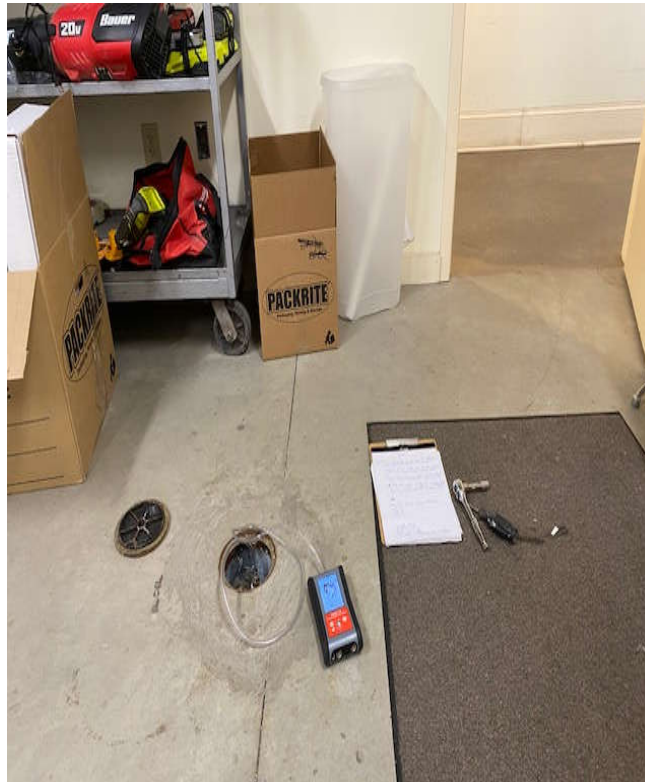
Photo 20: Soil Vapor Point (NW) in the Extra Space Storage Building.

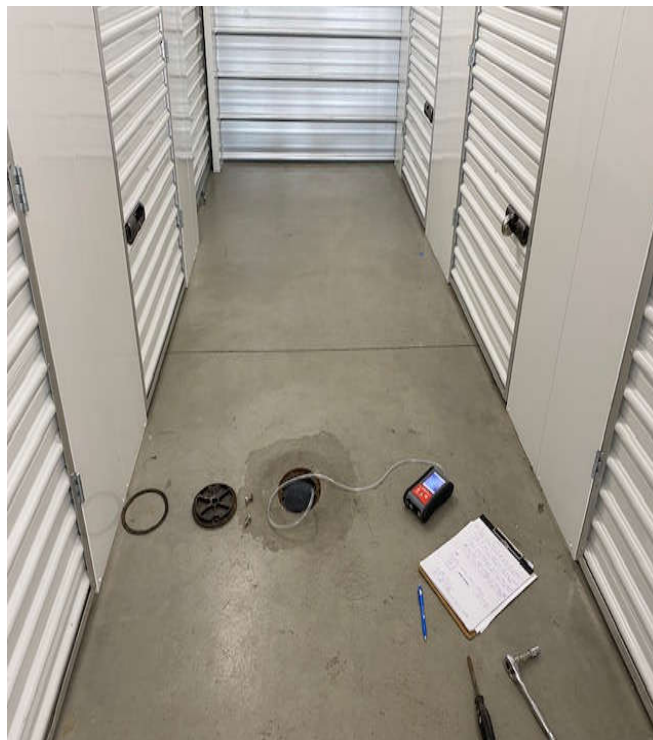
Photo 21: Soil Vapor Point (NE) in the Extra Space Storage Building.
