From: Mazurkiewicz, Richard [richard.mazurkiewicz@aecom.com]
Sent: Thursday, November 21, 2013 9:54 AM
To: Jim Carter External
Cc: John Signore; Brehm, Kevin
Subject: Draft Remediation Report - Tulip Corp. 3125 Highland Avenue Niagara Falls, NY
Attachments: 13-11-20 DRAFT Tulip Remediation Report.pdf

November 20, 2013

**Subject: Remediation Documentation Report
Tulip Corporation
3125 Highland Avenue
Niagara Falls, New York
AECOM Project 60271770**

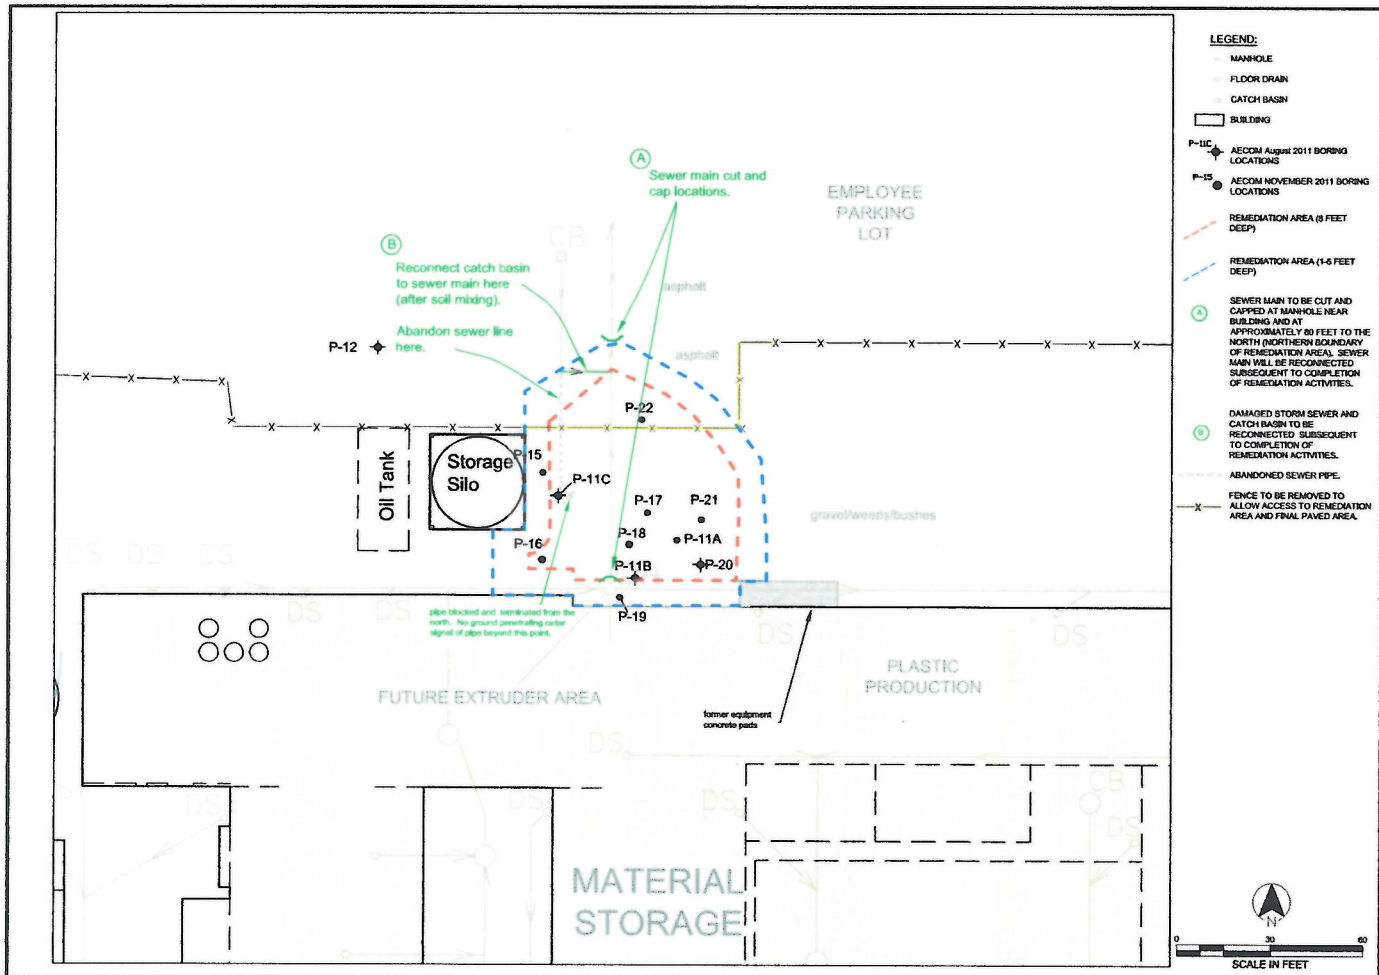
Sewer Preservation and Repair Map

On October 11, 2012, AECOM encountered a previously undisclosed or/and unknown stormwater sewer utility located in cell 10 (**Figure 5**). The utility consisted of a 10-inch diameter clay tile pipe (4 feet deep) running parallel to, and 8 feet out from, the building. The pipe was traced to the west within the remediation area and was found to elbow (90 degrees) towards the building, 3 feet west of the sewer manhole. The pipe was in deteriorated condition. Water appeared to be flowing out of the pipe; however, it was unclear if it was an active or abandoned utility. AECOM discussed the sewer pipe with the plant manager, Mr. John Signore. Mr. Signore was not aware of the pipe but requested that it be reconnected after the soil mixing and testing was completed. On February 4, 2013, the pipe was reconnected to the existing sewer that runs parallel to the building (5 feet out from the building).

On October 13, 2012, AECOM encountered a second 10-inch diameter clay tile pipe (running perpendicular from the building and in line with the manhole located 5 feet from the building) in the remediation area. The perpendicular pipe was traced to the north and was broken and discontinuous and appeared to be a formerly abandoned utility. Water was not observed in the pipe. Mr. Signore was notified of the perpendicular pipe. Mr. Signore was not aware of the perpendicular pipe's existence. Based on no water appearing in the pipe and its broken and discontinuous condition, Mr. Signore did not request that the pipe be reconnected. The sewer utility locations are illustrated on **Figure 5**.

- On January 29 through February 4, 2013, the storm water catch basin (located to the north of the remediation area) and an unknown sewer (running parallel to, and 8 north of, the building) were reconnected to the existing sewer utility running parallel to the building;

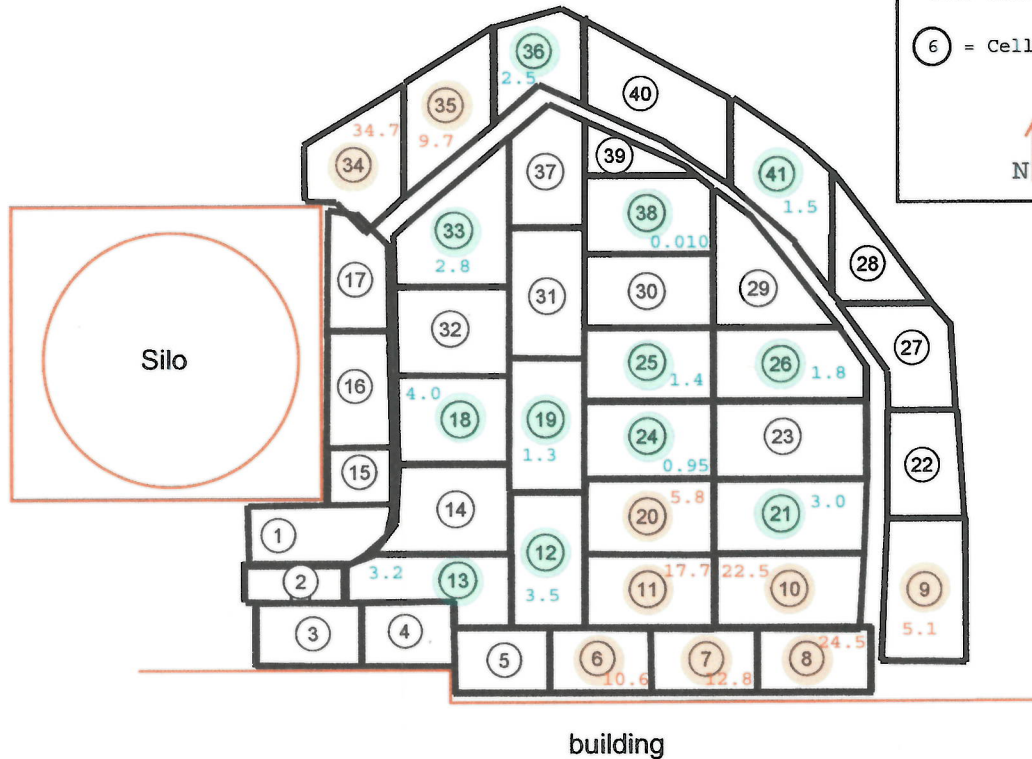
CELL FIELD MAP

Based on the project objective of getting leachable lead within the remediation area to below 5 mg/L, AECOM recommended remixing approximately 11,150 pounds of the phosphate mixture into nine treatment cells (C-6, C-7, and C-8 to 2 feet deep; C-9, C-34, and C-35 to 5 feet deep; and C-10, C-11, and C-20 to 8 feet deep) within the remediation area (approximately 230 to 250 cubic yards).

REMIX AREAS IN RED

The remixing was completed from December 13 through 18, 2012. AECOM collected three post-polishing TCLP lead samples from cells 34, 10, and 8. AECOM selected these three cells, which had the highest post calcium oxide mixing lead TCLP concentrations, to evaluate the efficacy of the phosphate re-treatment. Post phosphate treatment lead TCLP samples were collected on December 15, 2012. The TCLP lead results from cells C-10 and C-34 were below 5.0 mg/L and the lead TCLP result from cell C-8 was above 5.0 mg/L. Redox-Tech stated that phosphate mixture may take a little longer to dissolve completely and help bind to the lead. The phosphate mixture was allowed to chemically react for an
