**RE: Phase I Environmental Site Assessment
4185 Military Road, Niagara, New York
LaBella Project No. 2151439**

Phase I Environmental Site Assessment

4185 Military Road
Niagara, New York

LaBella Project No. 2151439

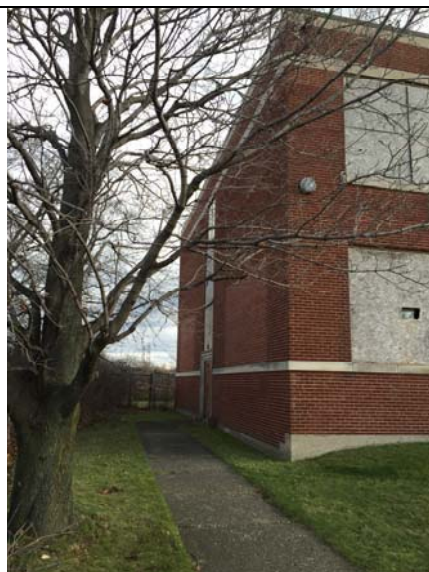
North exterior of Site Building

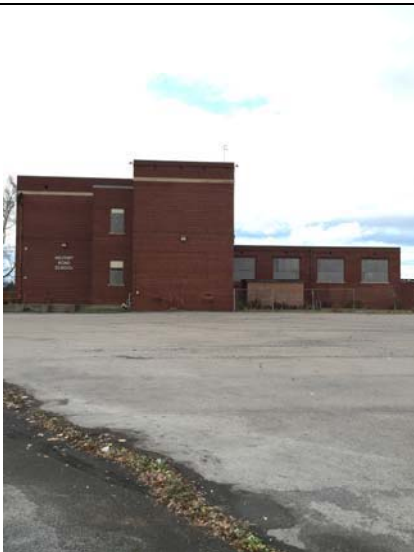
South exterior of Site Building

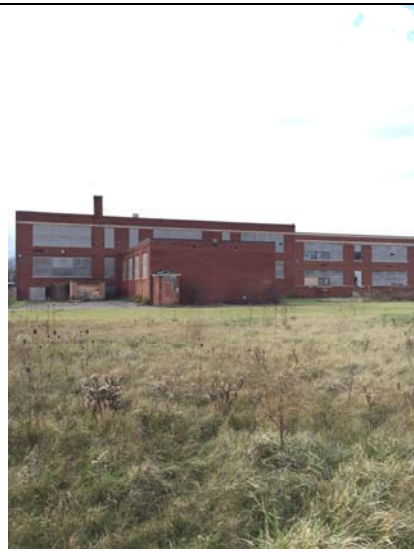
East exterior of Site Building

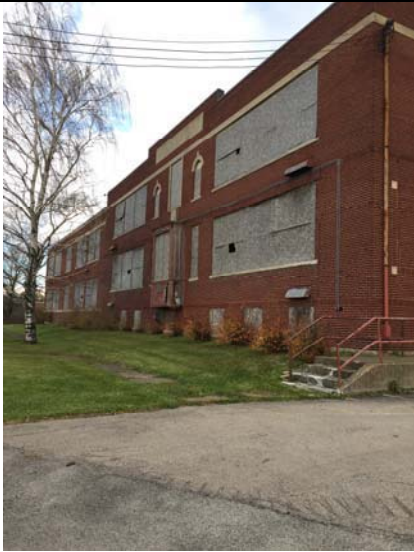
West exterior of Site Building

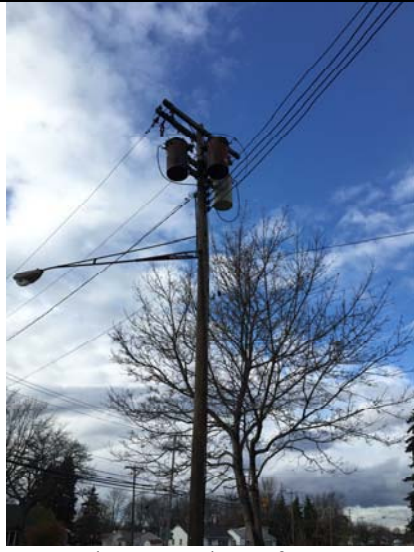
The pole mount transformers did not appear to be leaking at the time of the site visit. Based on the condition of the transformers, there are no apparent RECs related to the presence of the transformers on the Site at this time.

Pole-mounted transformers

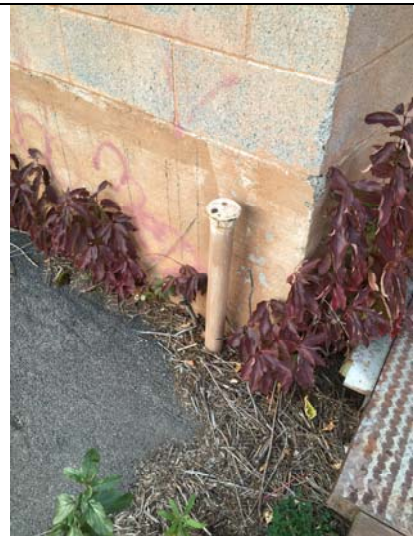
One suspect vent pipe and a large asphalt patch was observed proximate the southeast exterior of the Site Building. According to NYSDEC records, one 6,000-gallon fuel oil UST was installed at the Site in 1950 and closed-removed in 1987. As no other tank closure documentation was obtained within the scope of this assessment (i.e. tank closure report, confirmatory soil sampling results, etc.), the status of the 6,000-gallon fuel oil UST and subsurface conditions proximate the 6,000-gallon fuel oil UST cannot be confirmed. Refer to Section 5.1 for additional information.

Fill port

- Additional investigation should be completed to assess whether the 6,000-gallon fuel oil UST remains on-site and to determine the subsurface conditions proximate the 6,000-gallon fuel oil UST. Such may include, but not be limited to, completion of a geophysical survey, advancement of exploratory test pits, and collection of subsurface soil and groundwater samples for laboratory analysis. Should the 6,000-gallon fuel oil UST remain on-site, such should be closed or removed in accordance with NYSDEC regulations.
- It is LaBella's understanding that the Site Building is being considered for renovation. LaBella recommends that asbestos containing building materials be handled in accordance with local, state, and federal regulations.

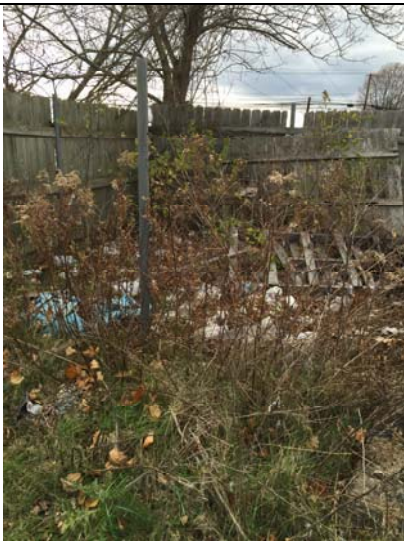
Debris

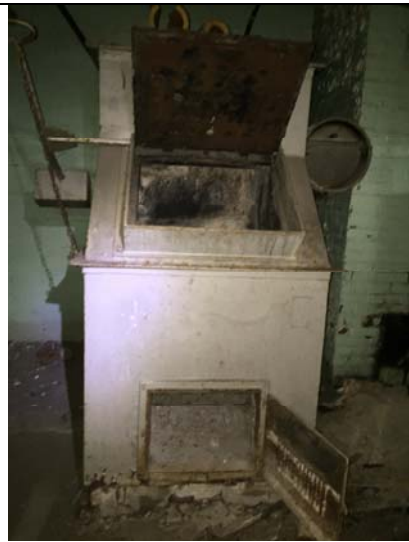
Incinerator

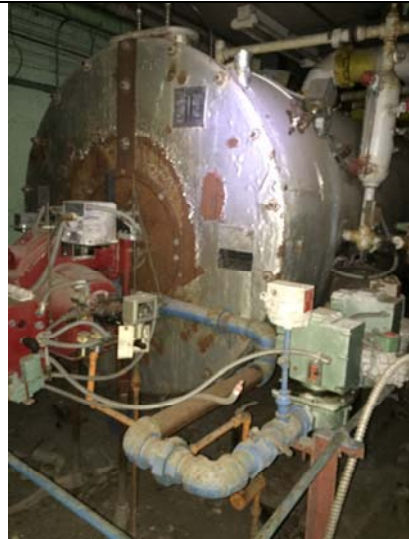
Water Heater

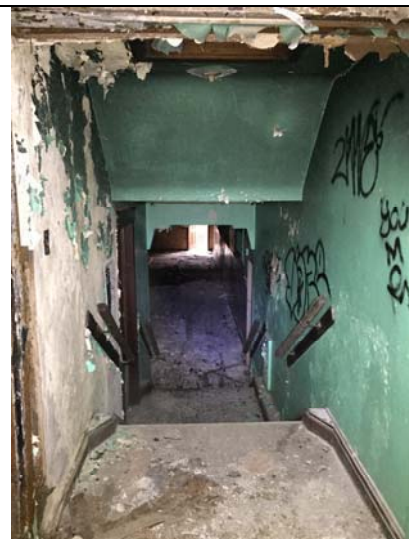
Typical hallway

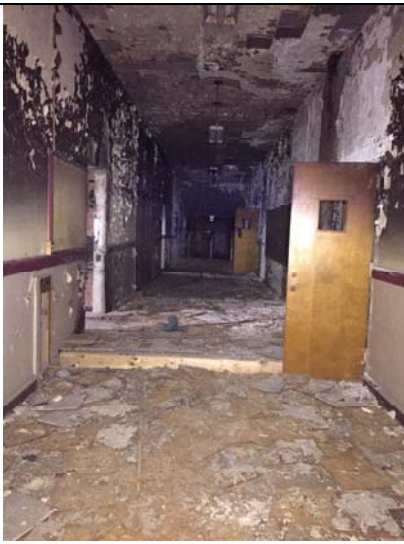
Typical hallway

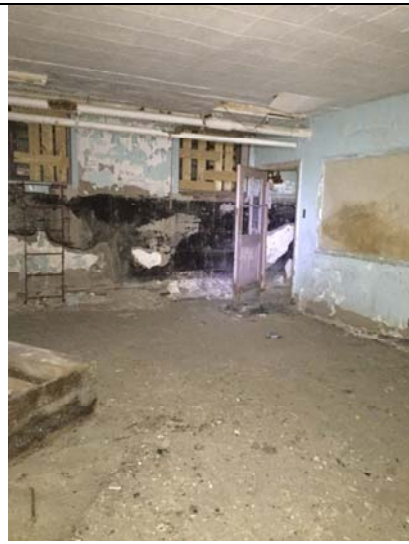
Typical classroom

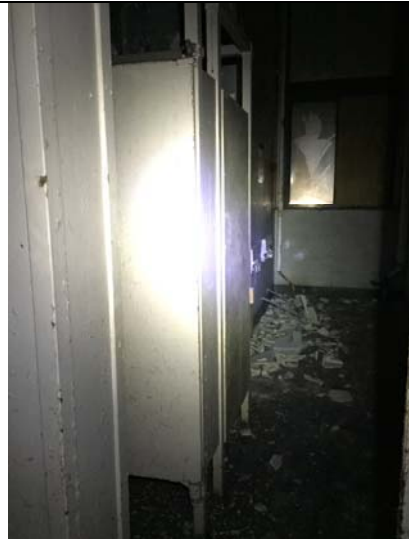
Typical restroom
