Pre-Renovation Asbestos Inspection Report

515 6th Street
Niagara Falls, NY 14301

Project ID: 18-0531JD-A

Report Amended: June 26th, 2018

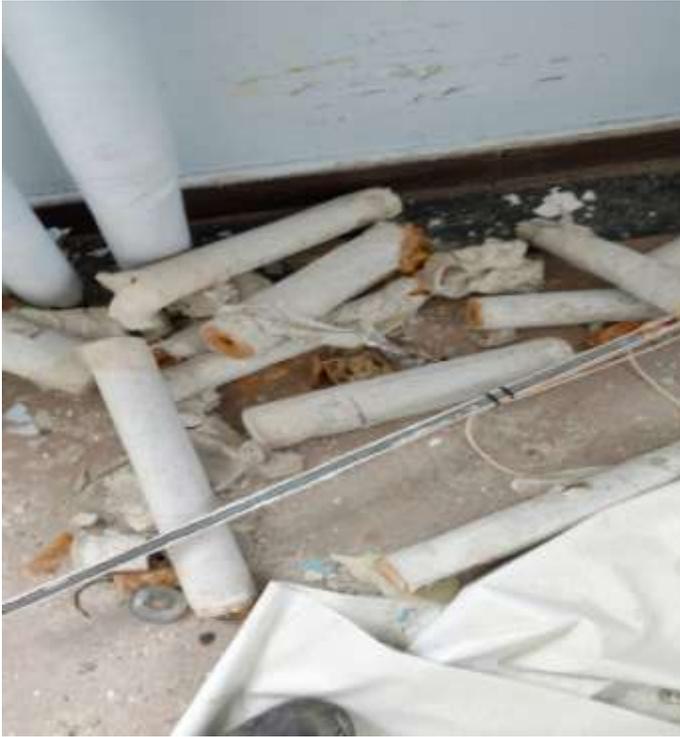
Pipe fittings with asbestos containing debris present.

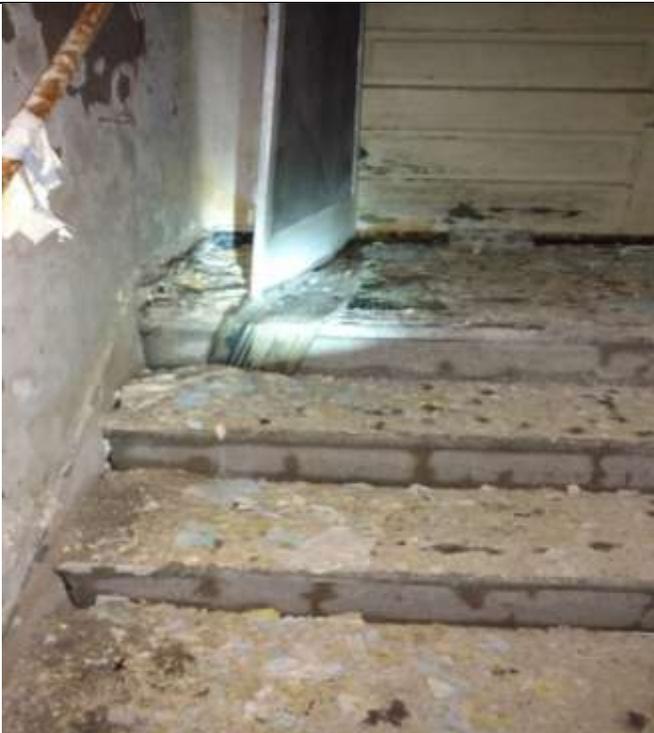
Visible asbestos debris scattered throughout bldg.

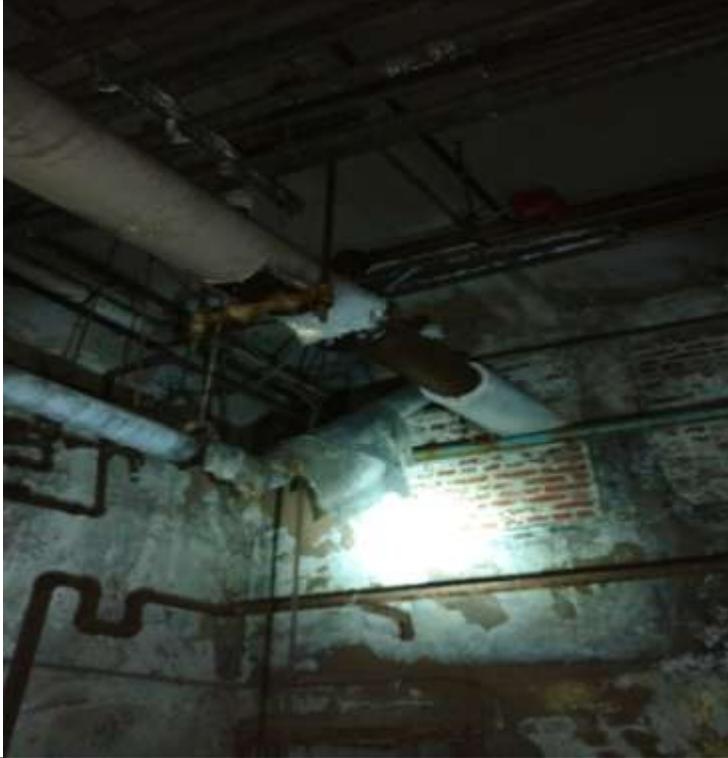
Location:
Basement

Observation:
Asbestos Containing Thermal
Systems Insulation.

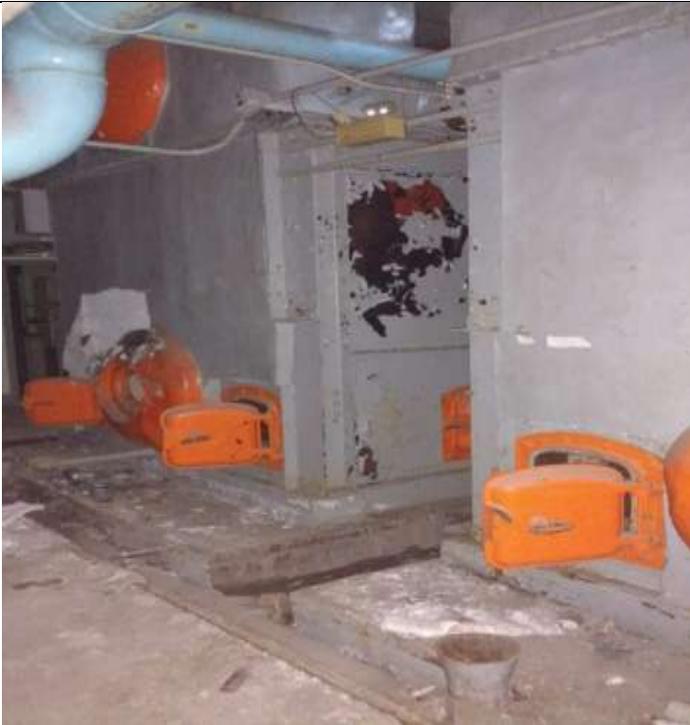
Location:
Basement

Observation:
Boiler with assumed
asbestos containing material

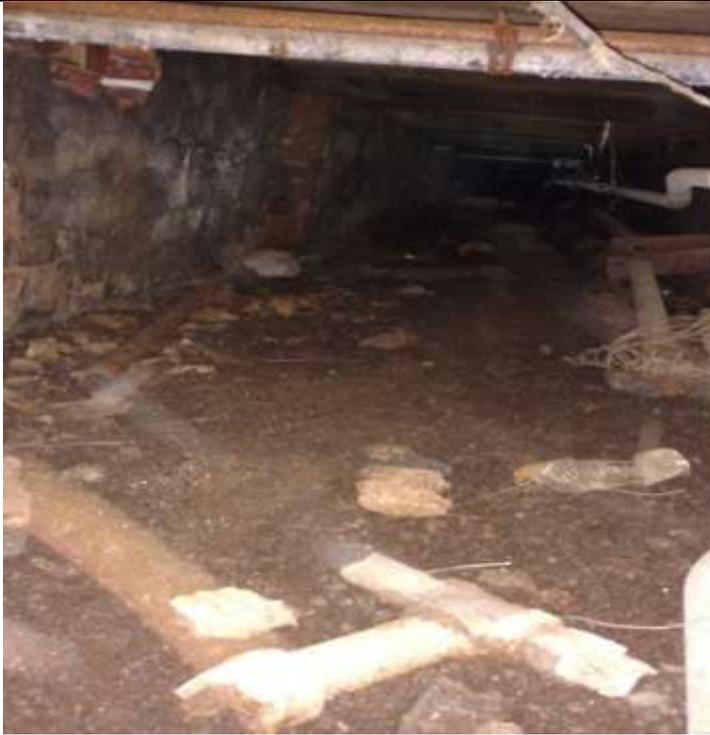
Location:
Basement

Observation:
Visible debris scattered
throughout area

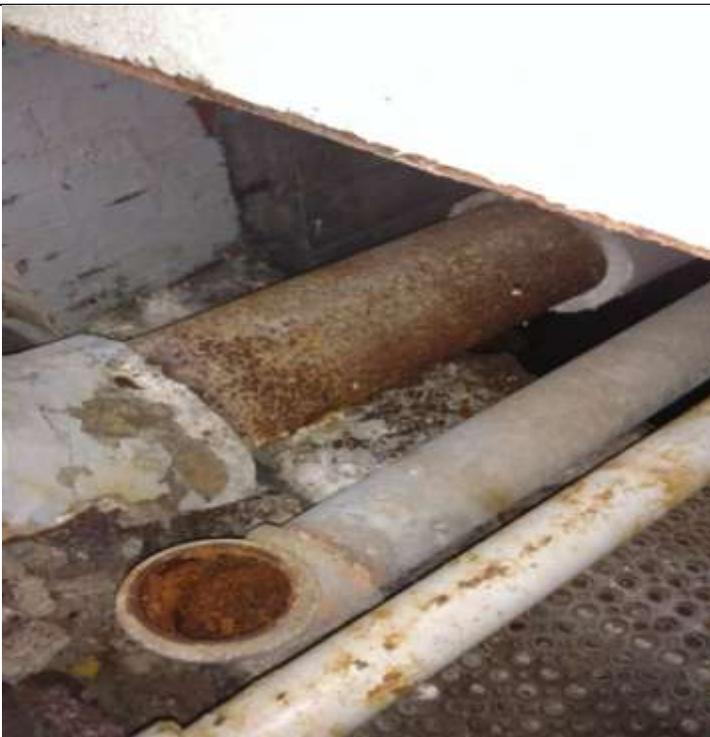
Location:
Basement

Observation:
Visible debris scattered
throughout area

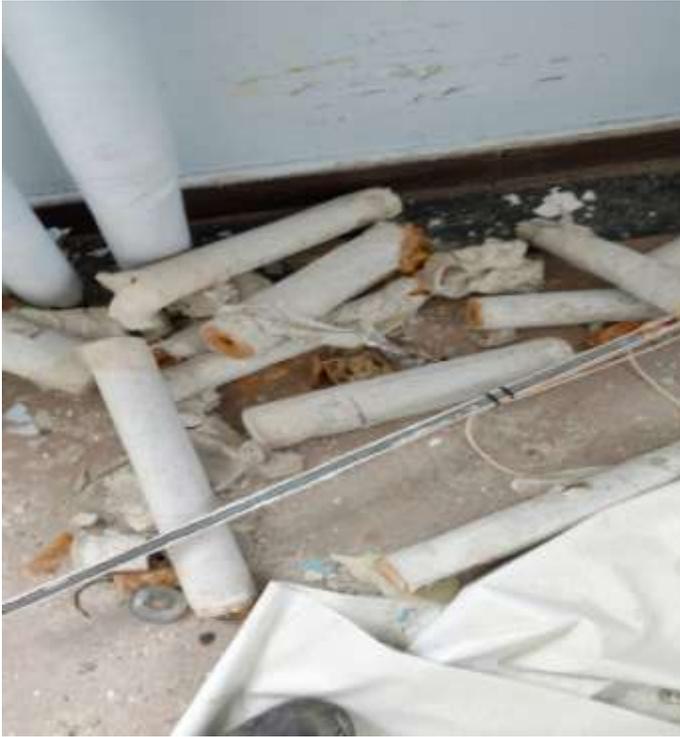
Pipe fittings with asbestos containing debris present.

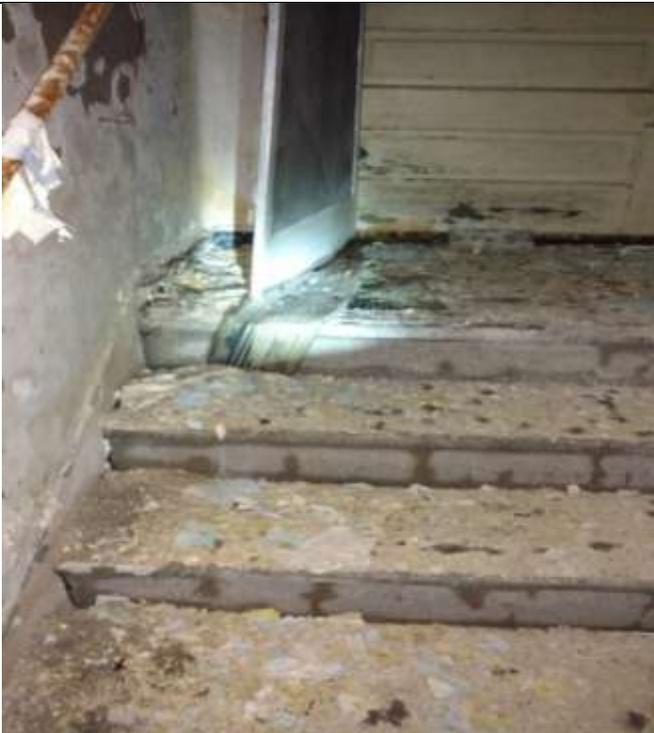
Visible asbestos debris scattered throughout bldg.

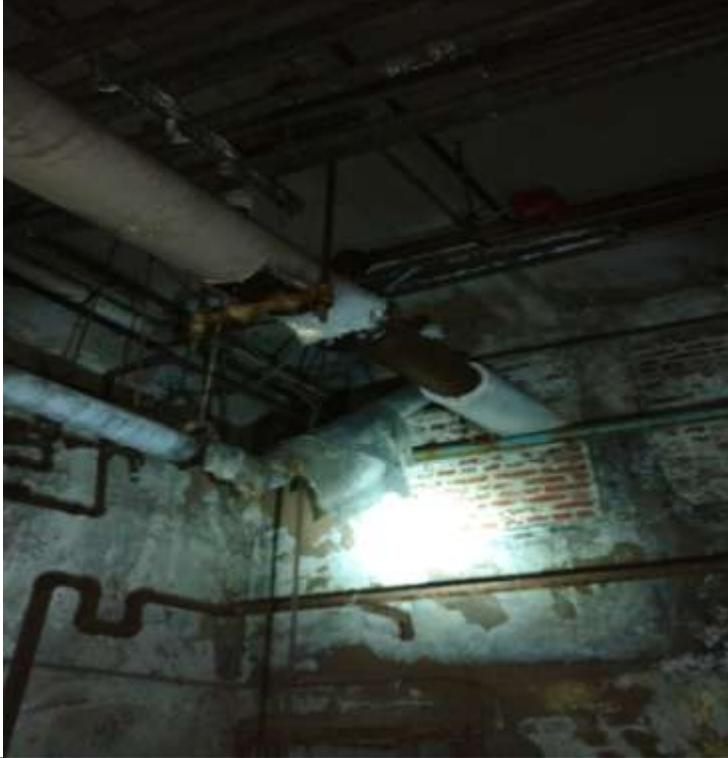
Location:
Basement

Observation:
Asbestos Containing Thermal
Systems Insulation.

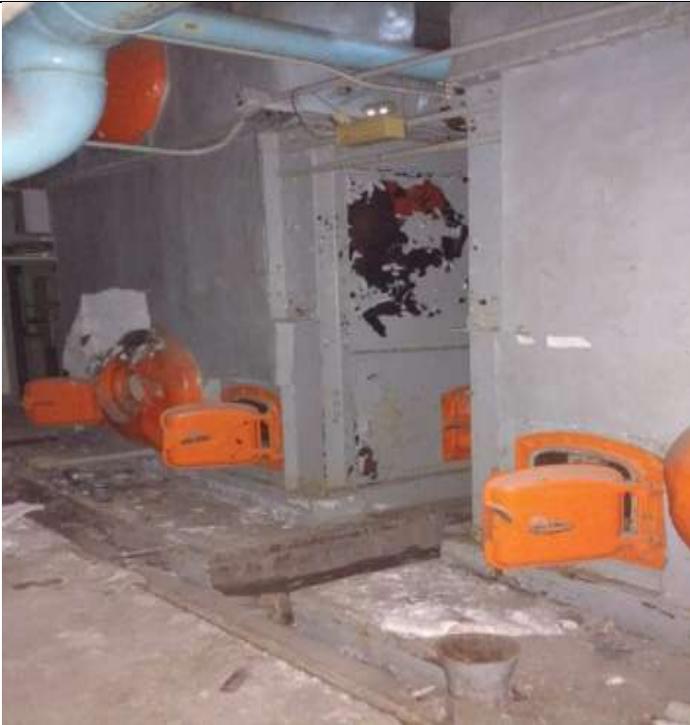
Location:
Basement

Observation:
Boiler with assumed
asbestos containing material

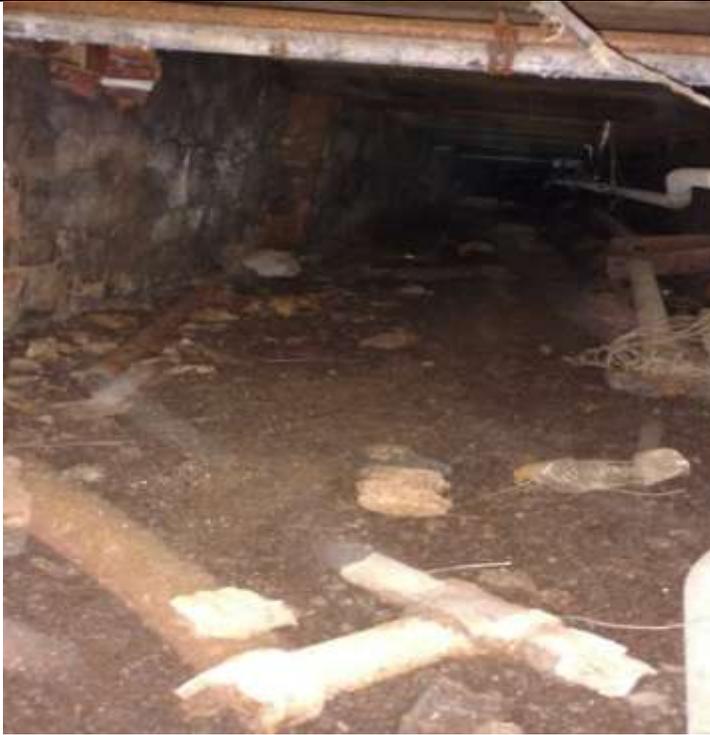
Location:
Basement

Observation:
Visible debris scattered
throughout area

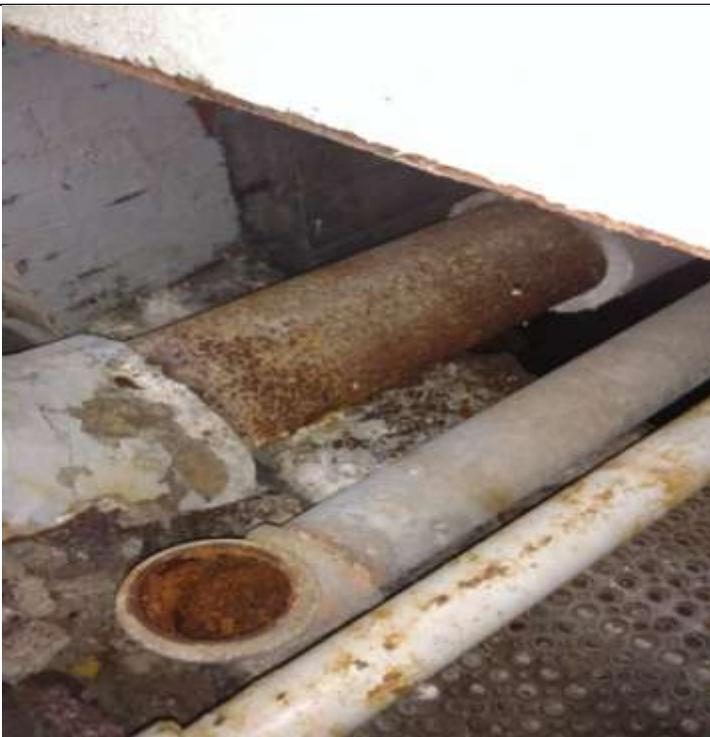
Location:
Basement

Observation:
Visible debris scattered
throughout area
