# C.T. MALE ASSOCIATES

Re: *Site Management Plan Annual Site-Wide Inspection  
Chalmers Building Site (NYSDEC Site No.: E429011)  
21 - 41 Bridge Street and 32 Gilliland Avenue  
City of Amsterdam, Montgomery County, New York  
Reporting Period: March 31, 2020 to March 31, 2021  
C.T. Male Project No. 21.1279*

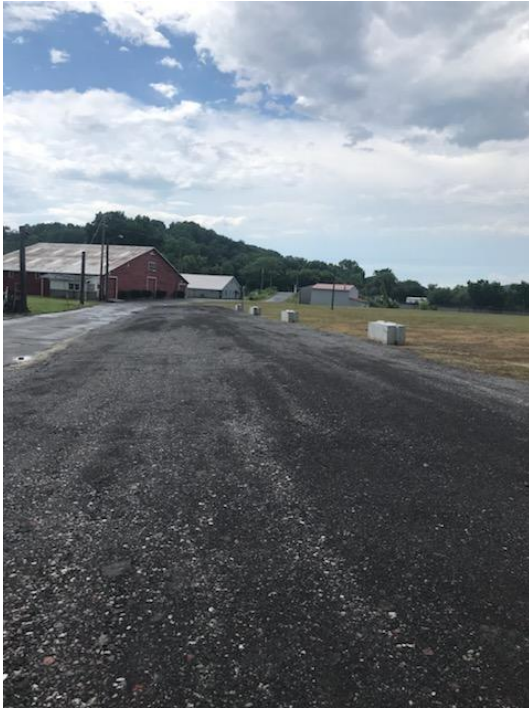
Picture #1

Subsequent to the June 4, 2021 site visit, AIDA took action to correct the portions of the site where the surface cover system was not in good condition, as described above. AIDA coordinated the placement of fabric and asphalt millings to create additional parking along the frontage along Gilliland Avenue. The placement of the fabric and asphalt milling covered the areas of ruts/disturbance and stabilized those areas that had surface erosion occurring near the intersection of Gilliland Avenue and Bridge Street. Pictures of the placement of asphalt millings are shown below and on Figure 2.

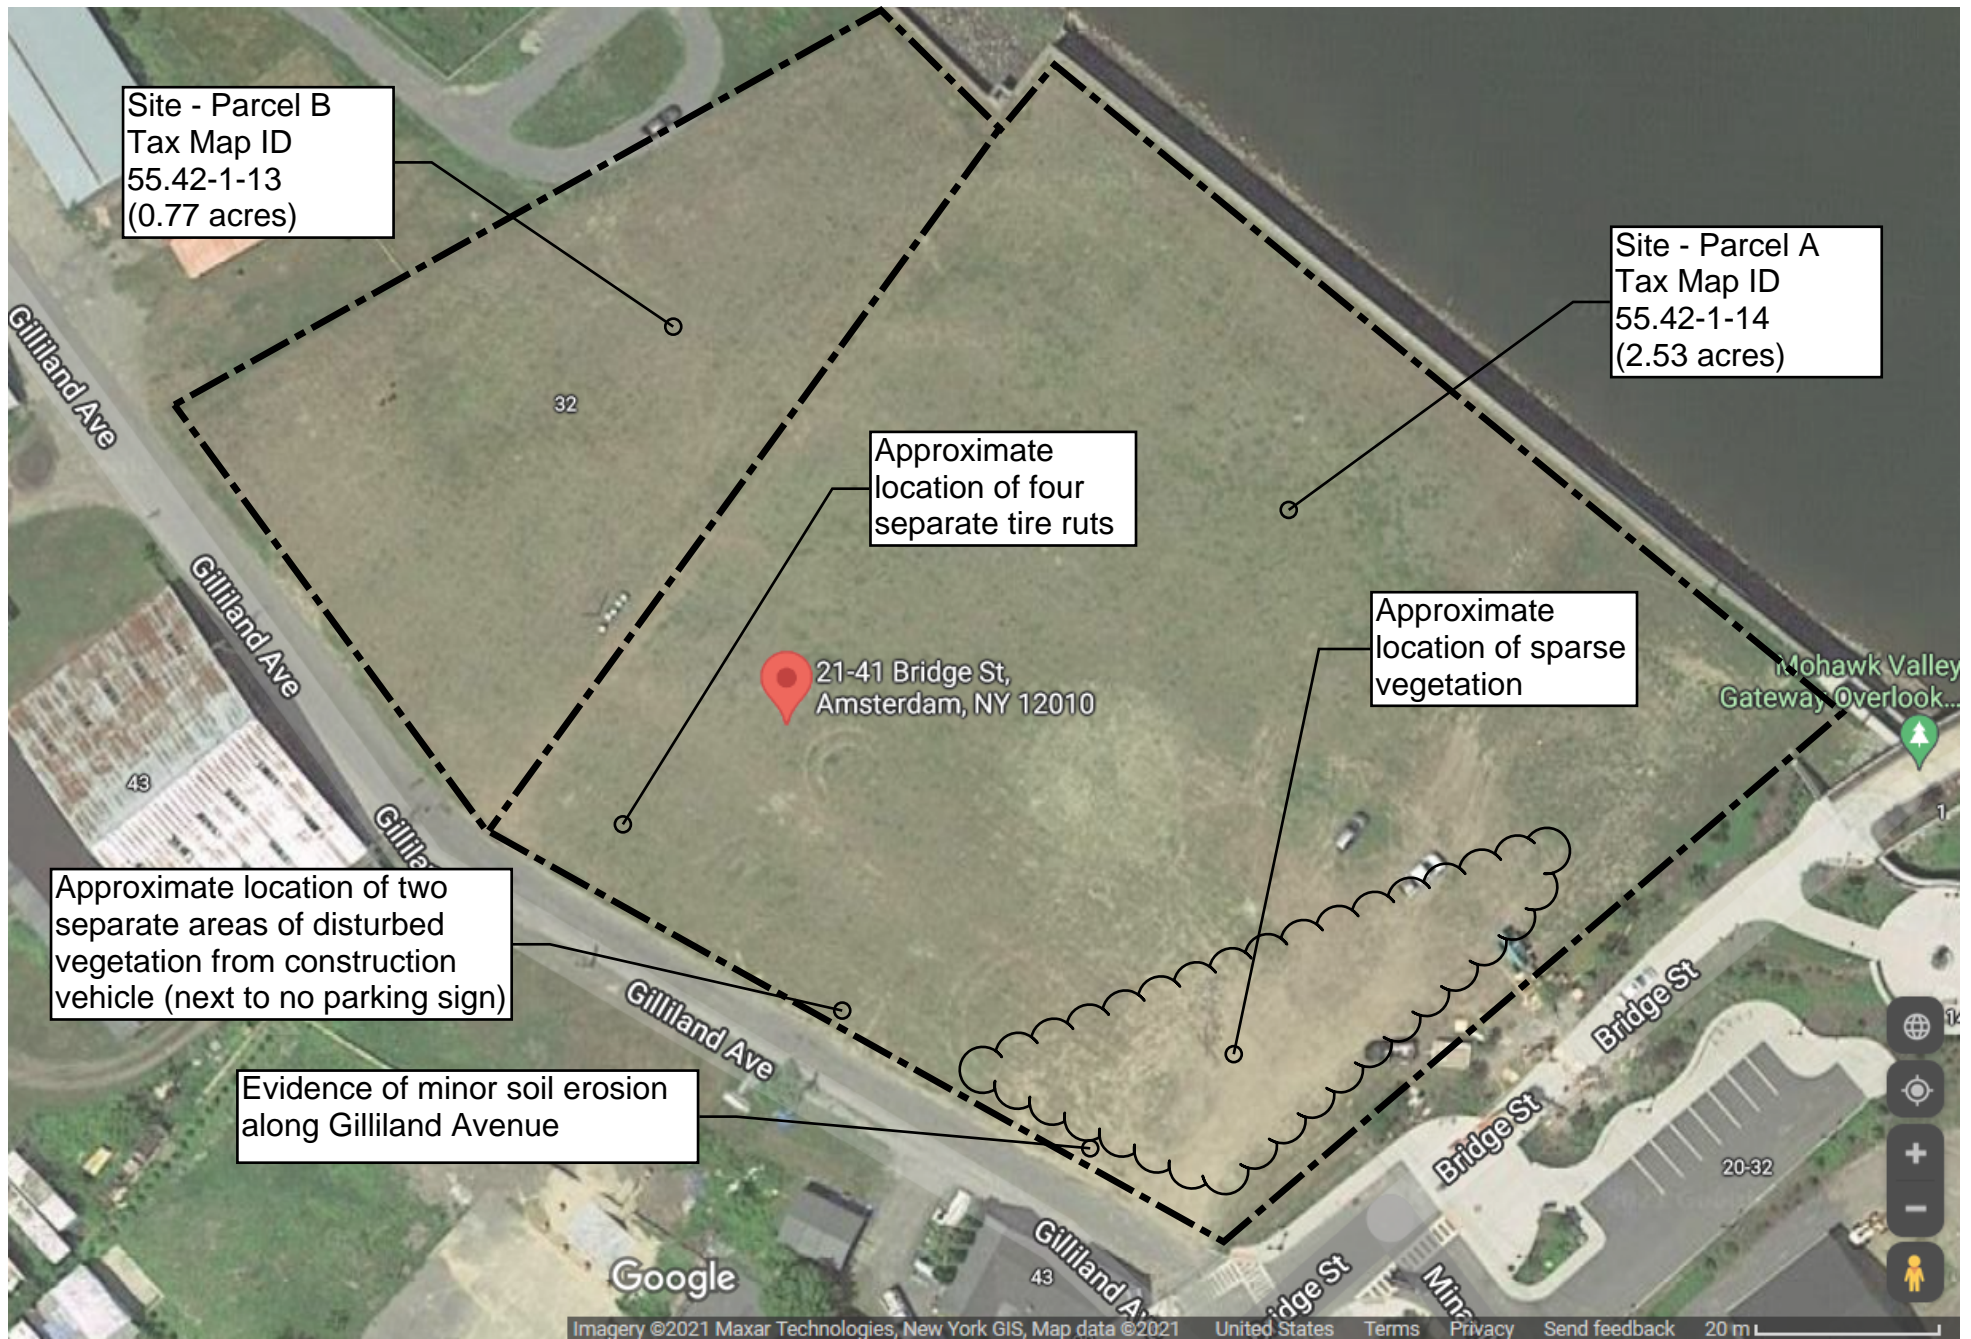
## FIGURE 1

The remedial action for the Chalmers Building Site was completed in 2015 and the Certificate of Completion was issued on December 1, 2015. The Site consists of two (2) contiguous parcels more commonly referred to as Parcel A (2.53 acres – 21 to 41 Bridge Street) and Parcel B (0.77 acres – 32 Gilliland Avenue). An aerial photograph was used to show the site boundaries and select observations from the Site-Wide Inspection, and is attached as Figure 1.
