Re: Corrective Measures Summary Letter
Former Scolite Site
2 Madison Street
Troy, New York
Site No. E442037

Professional Service Industries, Inc. (an Intertek Company) is submitting this Corrective Measures Summary Letter behalf of the City of Troy, New York that documents the repair to an isolated area of the cover system that was damaged in July 2022. A Site Location Map is included as **Figure 1**.

COVER SYSTEM BREACH

CORRECTIVE MEASURES

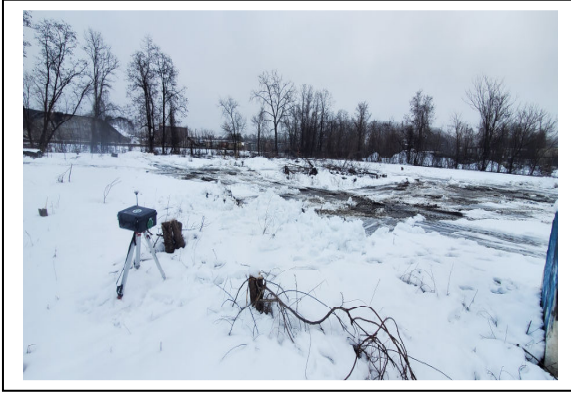
Looking northeast toward the breach area. Camp monitoring equipment in foreground left.

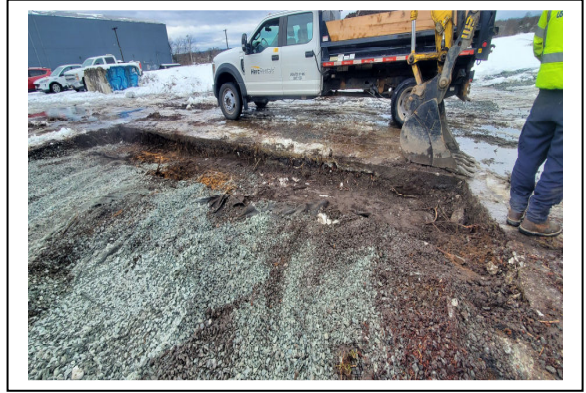
Breach area cleared down to existing fabric.

US Ecology utilized a Kebelco mini excavator to clear the breach area and expose the fabric and stone. During the preparation of the breach area, excess intermingled soil and existing stone was placed in the fly wheel area. The flywheel area was brought up to grade, filter fabric was placed over the area and a minimum of 12" of No. 2 stone was placed on top of the fabric.

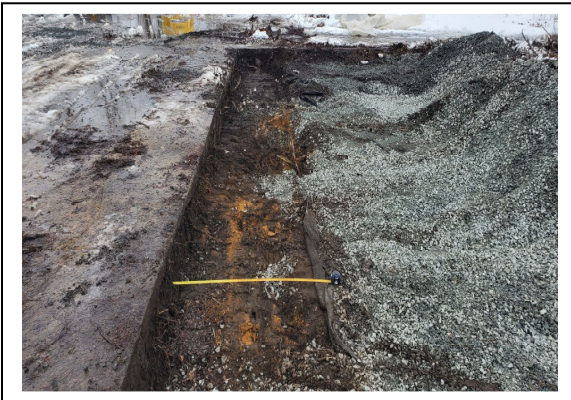
Breach area fabric cut away to prepare overlap of new fabric.

After the preparation of the main repair area, filter fabric was placed in the excavation area overlapping the existing fabric by 6 feet. Filter fabric was then extended over existing grade by 3 feet prior to the placement of minimum of 12" of No. 2 stone. See attached photos of the breach and flywheel areas.

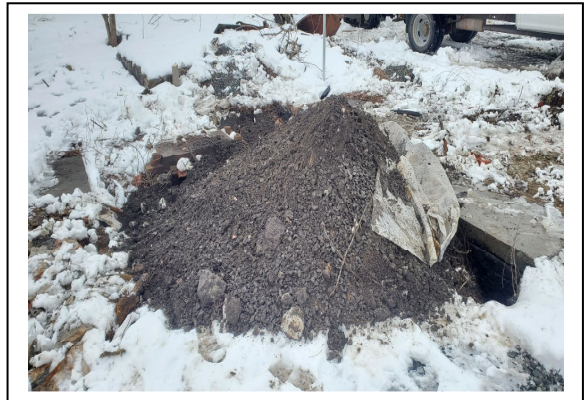
the slab was pushed onto the slab to create space for the crane and trailer. When doing this, the root structure below the fabric pulled the fabric to the surface, damaging it and disturbing the soils. Additionally, due to the weight of the crane, small pieces of the concrete cover system were broken away where it adjoined the crushed stone areas. The area of cover system damage is approximately 30 feet by 30 feet by one foot deep. In addition, by removing the flywheel structure, a void was created that will require management as described below.

Flywheel area in which spoils from breach were placed prior to installing fabric over this area.

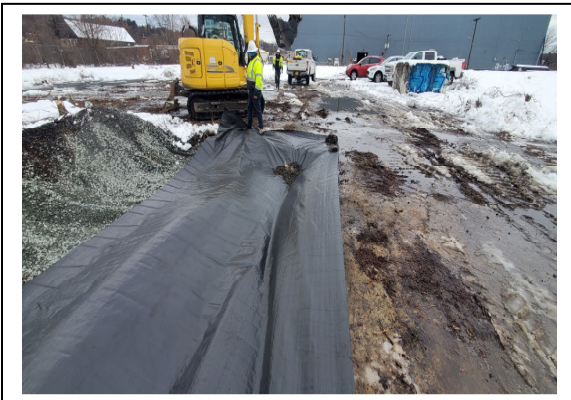
Fabric overlay of existing fabric and extended over concrete prior to placement of No. 2 Stone. Photo looking south.

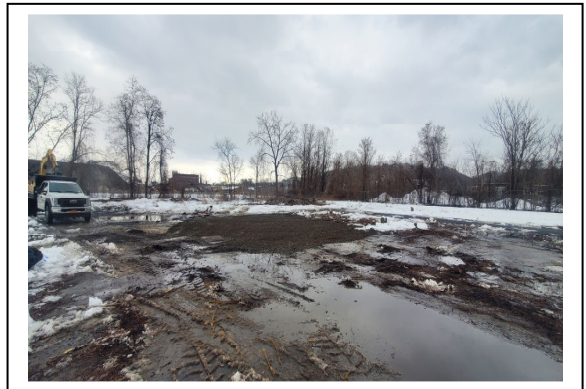
Completed repair of breach with 12" of No. 2 Stone over fabric.

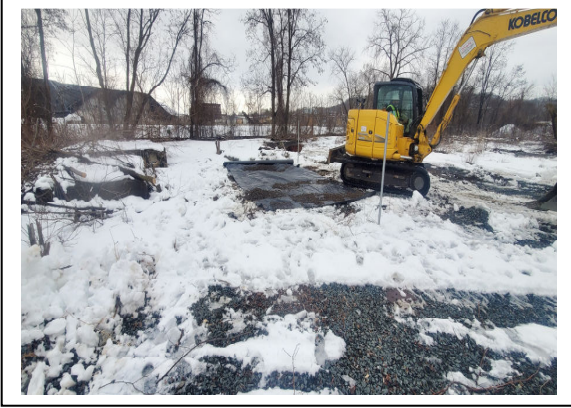
Fabric being spread over flywheel area looking north.

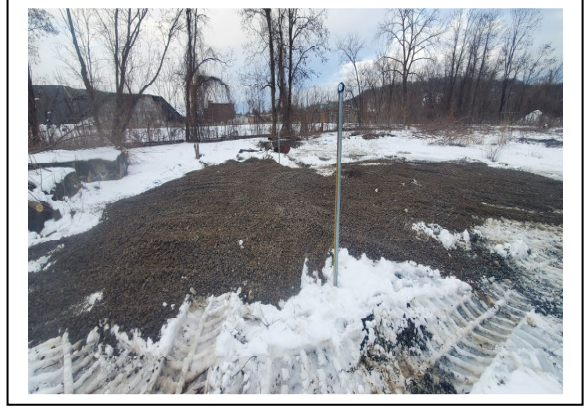
12" of No. 2 Stone placed over fabric in flywheel area.
