# PETROLEUM IMPACTED SOIL EXCAVATION AND DISPOSAL REPORT

Corner of Main and Salmon St Fort Covington, New York 12937 RECEIVED

NYSDEC Spill Number: 0908608 OP-TECH Project No.: LD500473 NYSDEC REGION 5 ENVIRONMENTAL QUALITY

Re: Soil Remediation Report

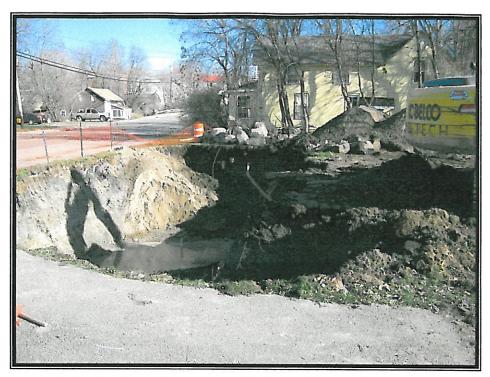
At this time an unknown quantity of contaminated soil remains onsite below State Route 37. Field screenings of the excavation wall running parallel to State Route 37 show elevated levels of VOCs in the soil; see Table 1. As directed by NYSDEC personnel the excavation was restricted from advancing within two feet from the pedestrian sidewalk as to maintain the integrity of State Route 37 and the pedestrian sidewalk that runs parallel to it.

Photograph 1: Northern Excavation Wall and Progressing Excavation Area

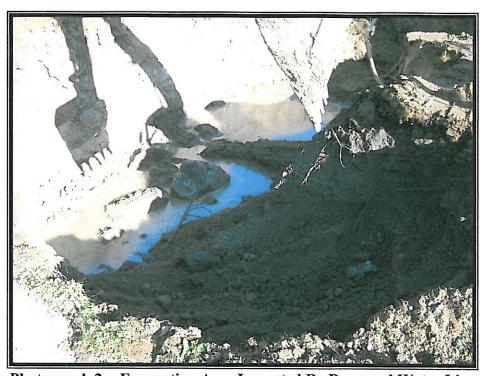
During the excavation activities a water line supplying an abandoned house next door to the subject property was compromised with the excavator due to an inaccurate UFPO mark out by the owner. The Town of Fort Covington was notified and the water was shut off before the excavation collected any significant water. Town of Fort Covington personnel repaired the compromised water line. After the waterline was reconnected the Town of Fort Covington backfilled and graded the area left exposed (See attached select site photographs).

Photograph 2: Excavation Area Impacted By Damaged Water Line

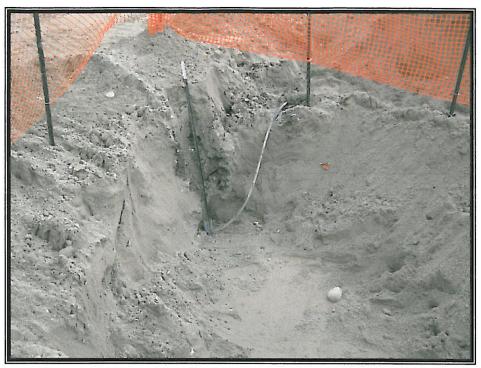
Photograph 3: Damaged Water Line Left Exposed for Town of Fort Covington to Repair

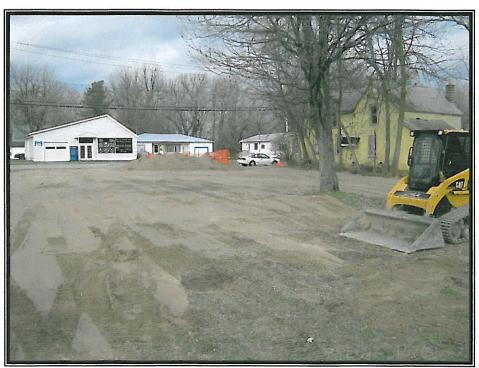
Photograph 4: Subject Property Backfilled and Graded.

A track skid steer was mobilized to the site to assist with backfilling the excavation and grading the subject site. The excavation was backfilled to original grade with 1009.4 tons of sand to complete OP-TECH's remediation efforts for the spill. Due to budget restraints the site will not be restored with top soil and seed (see attached select photographs).
