**Mechanicville Light Industrial Park**  
MECHANICVILLE, SARATOGA COUNTY, NEW YORK

**Periodic Review Report**

**NYSDEC Site Number: E546050**

**JUNE 2013**

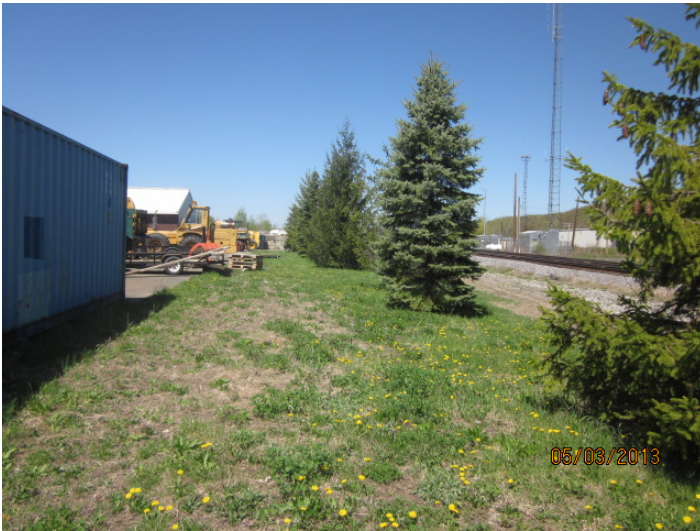
**Photograph of north side of the DPW building.**

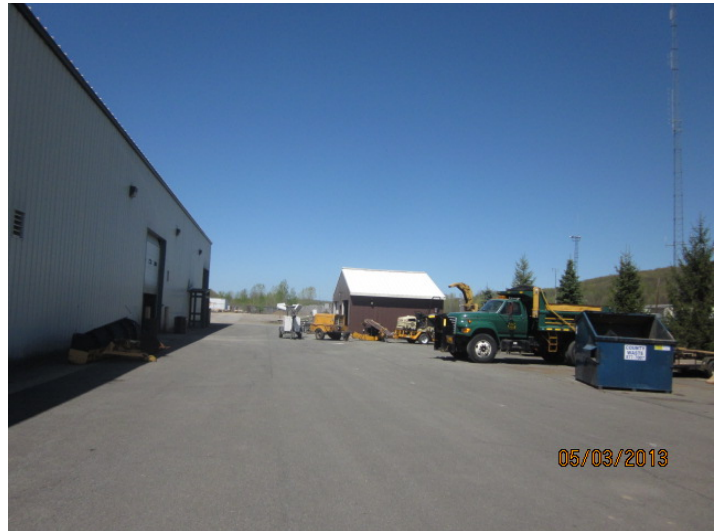
**Photograph of north side of the DPW building.**

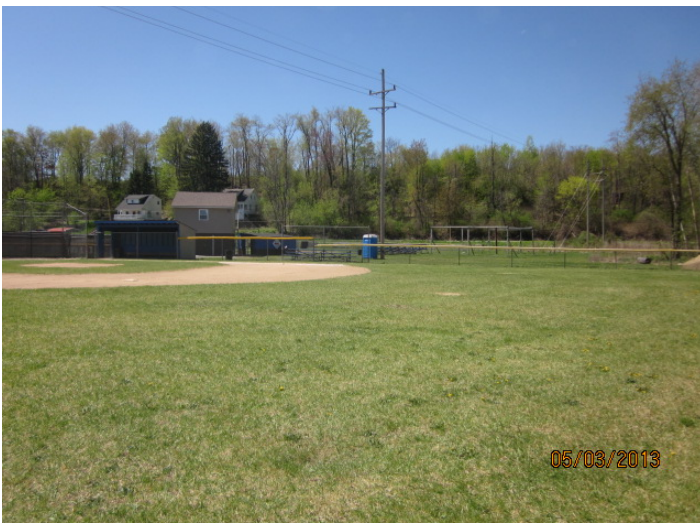
ballfield and batting cages clean fill from off-site was used as surface covering. The existing soil cover in the ballfield appeared to be intact, and no other engineering controls were evaluated since the remainder of the soil cover has not yet been installed.

**Photograph of baseball field.**

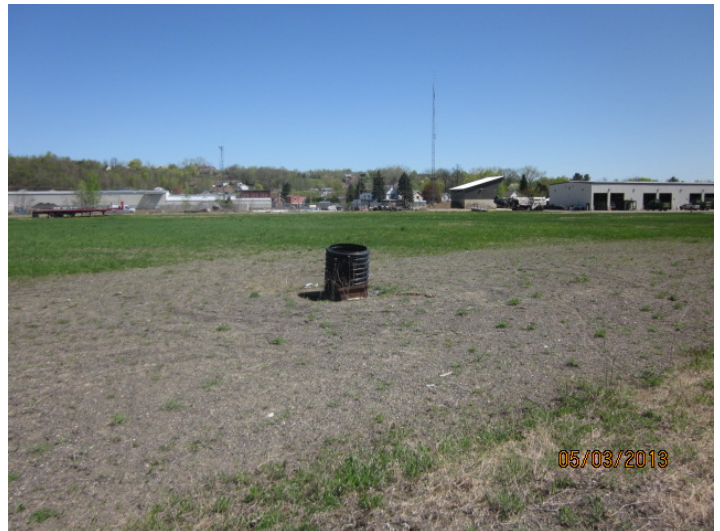
As previously discussed, a plastic vertical riser was observed protruding from the IRM excavation backfill area. Conversations with Mr. Dave Higgins of the Mechanicville DPW indicate that the riser provides access to the abandoned storm water drainage system encountered during the IRM excavation. Surface and/or groundwater was observed to be accumulated inside the base of the culvert and as such should be noted as an engineering control deficiency.

**Photograph of plastic culvert in former excavation area.**

- As indicated in the ROD, the soil cover requirement outlined in the Engineering Control System needs to be implemented before the site can be occupied or used for its intended future use.
- The vertical riser in the IRM excavation area should be removed to reduce the potential for exposure to onsite groundwater and eliminate a possible contamination pathway to the subsurface.

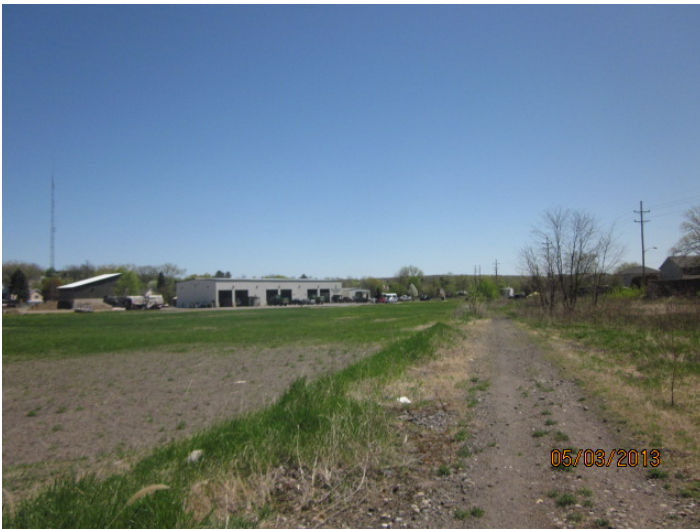
**Representative photograph of site looking north.**

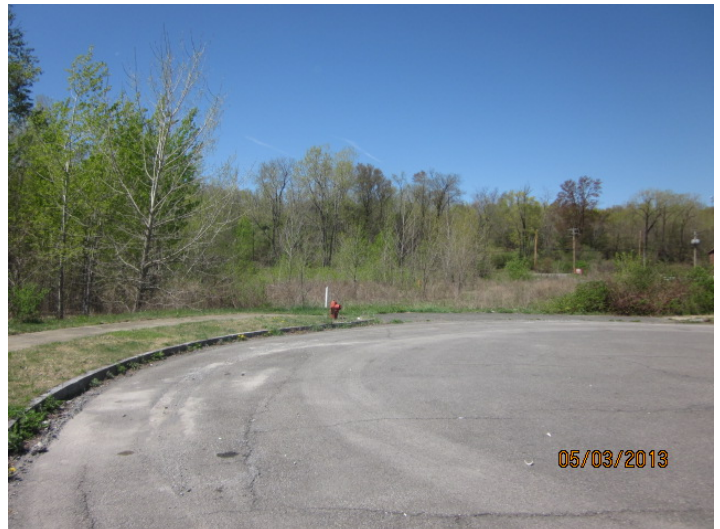
**Photograph of site area facing south of cul-de-sac.**
