Re: Well Decommissioning
47 Utica Street ERP Site
Hamilton, New York
NYSDEC ERP Site #E727011

Madison County Well Decommissioning
47 Utica Street ERP Site
Village of Hamilton
Madison County, NY

FIGURE 1
DECOMMISSIONED WELL LOCATIONS

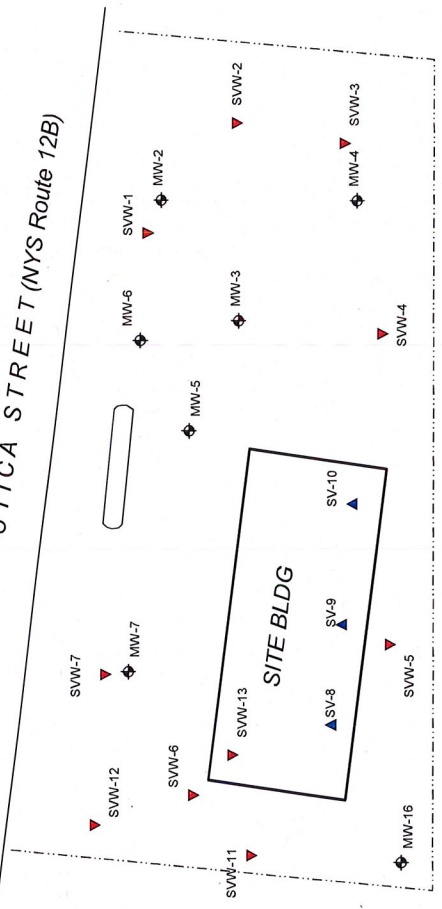
Notes:
Only wells that were readily accessible and able to be located were decommissioned.
