Results of Geophysical Investigation

Former Pratt Oil Works Inland Parcels

Long Island City, New York

**Results of a Geophysical Investigation
Former Pratt Oil Works
Inland Parcels A, D, E, and G
Long Island City, New York**

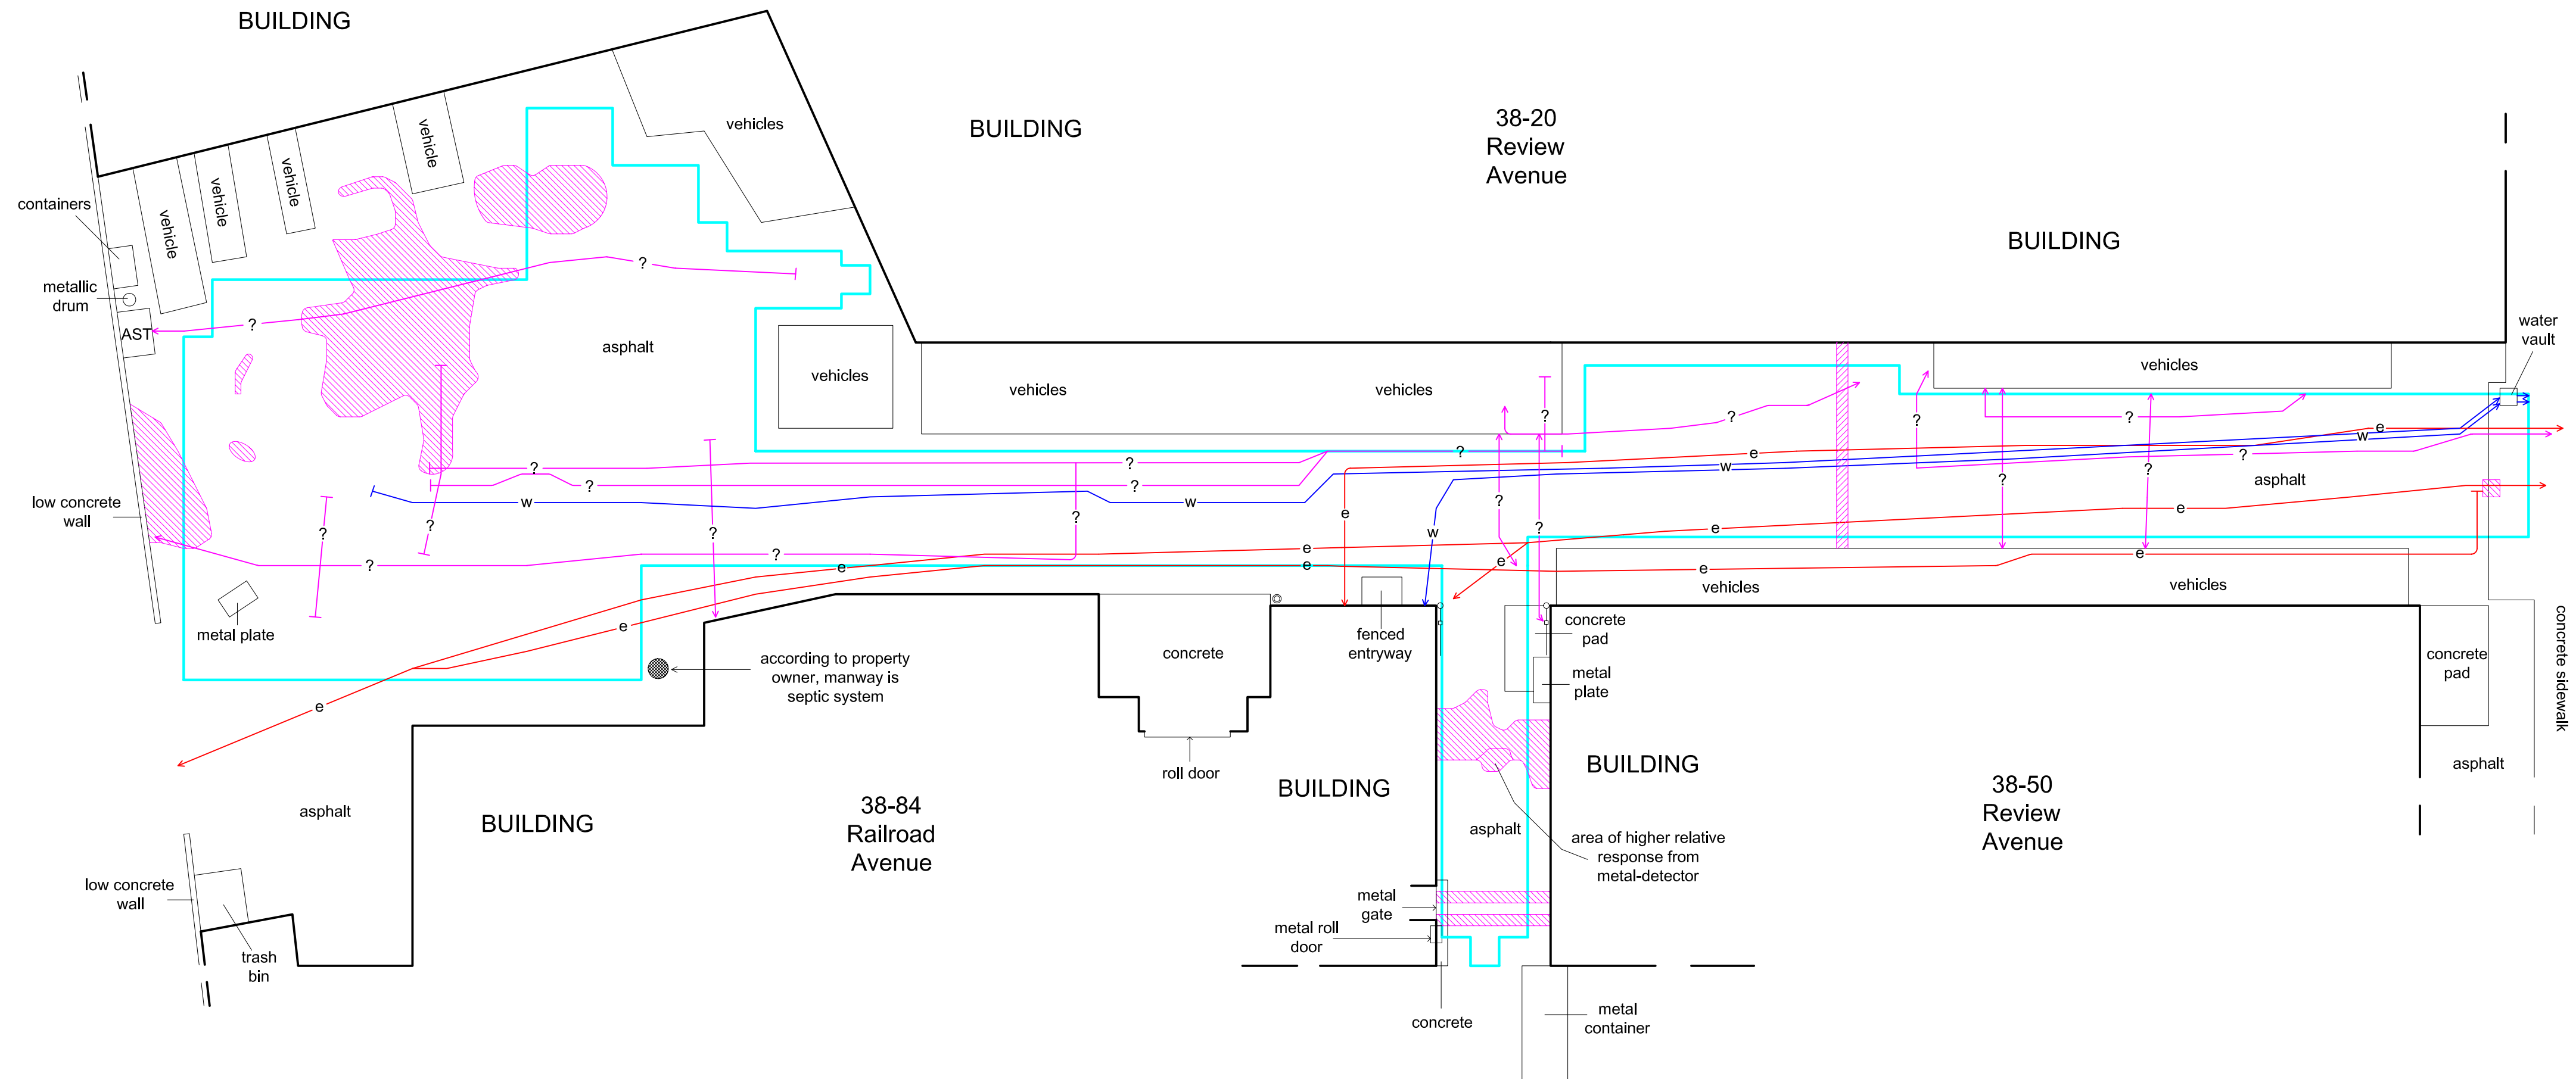
Plate 1: Utility and Culture Map of Former Pratt Oil Works Facility
AREA 1 Consisting of Parcels A, D, and E Located at 38-40
Railroad Avenue, 38-84 Railroad Avenue, and 38-50 Review
Avenue in Long Island City, New York

Within the area of investigation, NAEVA identified three electric lines and two water lines. The first electric line entered the property at 1W/15S, continues northeast to 140E/22N, turns and continues more easterly until it leaves the property at 410E/34N. A second electric line branches off the first at approximately 40E/2N heads east for approximately six feet, turns northeast and heads to 140E/20N, continues east to 401E/22N, then turns north to 401E/33N where it appears to terminate. The third electric line exits the building at 203E/13N heading north to 203E/37N, turns east to 410E/44N where it leaves the property.

Two water lines were traced from a water vault centered at approximately 406E/49N. One water line left the vault heading southwest to 398E/44N, turns west to 33E/33N where it appears to terminate. The EM-61 data shows that this line may continue past the last point NAEVA could detect it (see Plates 2 and 3, and Table 1 anomalies 10 and 11). The second water line leaves the vault and heads southwest to 398E/43N, turns west to 222E/35N, and then heads south into the building at 217E/13N.

Several lines of unknown use were also detected. An unknown line enters the property at approximately 5W/61N, heads northeast to 64E/73N, and turns east to 107E/71N where it appears to terminate. A second line begins at 43E/37N and continues east to 241E/40N where it appears to terminate. Three lines branch off this line with the first starting at 238E/40N heading north to 238E/53N where it appears to terminate. The second line branches off the first at 200E/40N, heads southwest to 195E/34N, then continues west to 43E/34N where it appears to terminate. The last line branches off the first at 156E/38N, heads south to 155E/22N, then turns west until it leaves the property at 5W/25N. Another line begins at 25E/32N heads south to 23E/11N where it terminates. A line begins at 45E/55N, heads south to 42E/22N where it appears to terminate. A line exits the building at approximately 93E/11N heads north to 92E/42N where it terminates. A line exits a building at approximately 239E/13N, heads northwest to 237E/11N, and turns north to 237E/43N where it continues underneath vehicles and towards a building. Another line is first detected at 233E/20N heading northwest to 230E/25N, and then turns north to 230E/43N where it continues underneath vehicles. A line exited from beneath a row of parked vehicles at 231E/48N headed south to 231E/43N, turned east to 268E/45N, and headed northeast to 293E/52N where it continued underneath vehicles. Another line exited a row of parked vehicles at approximately 305E/54N headed southwest to 303E/50N, continued south to 303E/37N, and turned east to 414E/43N where it left the property. A line exits the parked vehicles at 315E/51N heading south to 315E/46N, turns east to 367E/47N, and turns northeast to 371E/50N where it continues underneath vehicles. Another line exits the parked vehicles at 318E/51N heading south underneath parked vehicles at 318E/23N. The last unknown line exits the row of parked vehicles at 344E/50N and heads south underneath more parked vehicles at 343E/23N.

The TW-6 identified two metallic linear features in the alleyway between the two buildings that did not appear in the EM-61 data. The first feature exits one building at approximately 219E/38S and heads east into the other building at approximately 239E/38S. The second feature leaves one building at approximately 219E/42S and heads east into the other building at approximately 239E/42S. These features maybe represent small amounts of metal that could not be detected by the EM-61 and/or were masked by the surrounding aboveground metallic features.

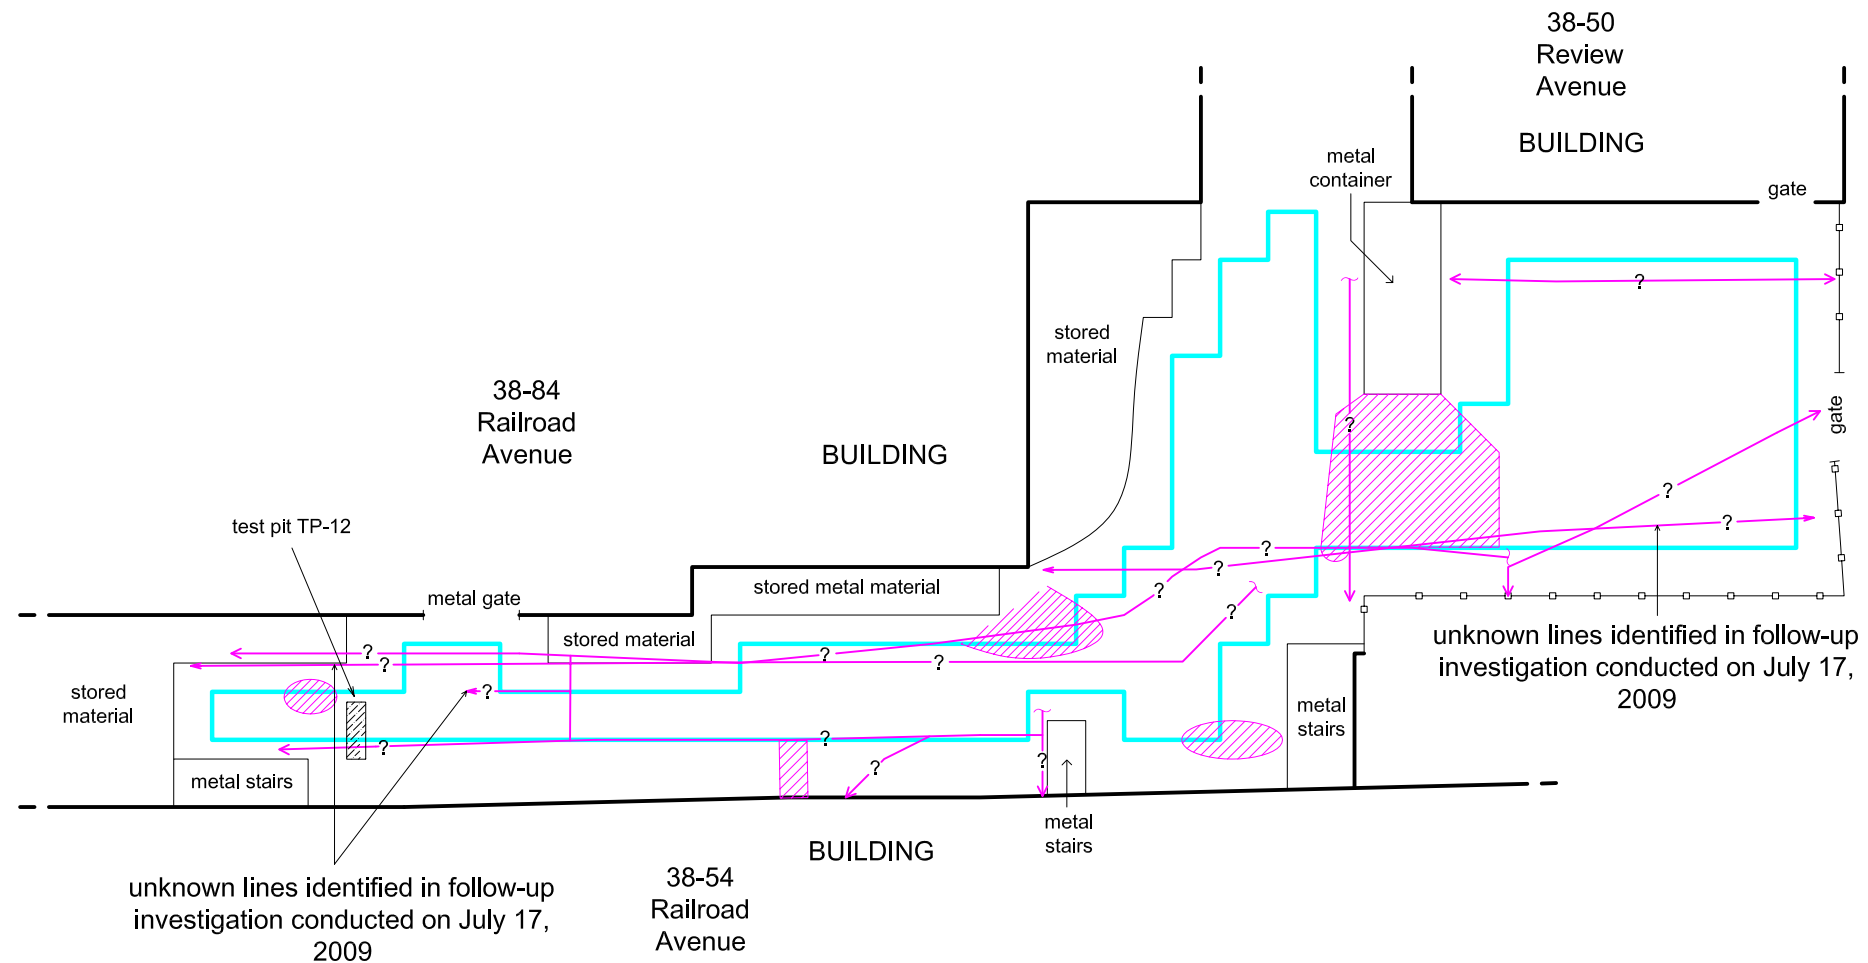
Plate 2: Utility and Culture map of Former Pratt Oil Works Facility AREA 2 Consisting of Parcel E (North Side) Located at 38-54 Railroad Avenue in Long Island City, New York

Several lines of unknown use were identified within the area of investigation. An unknown line exits a building at approximately 235E/115N, heads north for 3 feet, and then turns northeast to 267E/134E where it leaves the property. Another line enters the property at approximately 269E/148N heading west to 229E/148N where it continues underneath a large metal container. A line exits a building at approximately 218E/114N and heads north for 34 feet where it appears to terminate near a large metal container. This line may turn underneath the container and join the previous unknown line. Another line enters the area of investigation at approximately 102E/109N heads east to 195E/113N, turns northeast to 205E/120N, and then heads east again to 235E/119N where it appears to terminate. A line exits a building at approximately 186E/94N and heads north for nine feet where it appears to terminate. A second line branches off this line at 186E/105N and continues west to 107E/99N where it continues toward an inaccessible area. Another line branches off the last line at 175E/100N and heads southwest and enters a building at 166E/94N. A small metal anomaly was identified outside the area of the EM-61 investigation. The anomaly was a 6 foot by 3 foot rectangular feature centered at approximately 160E/97N.

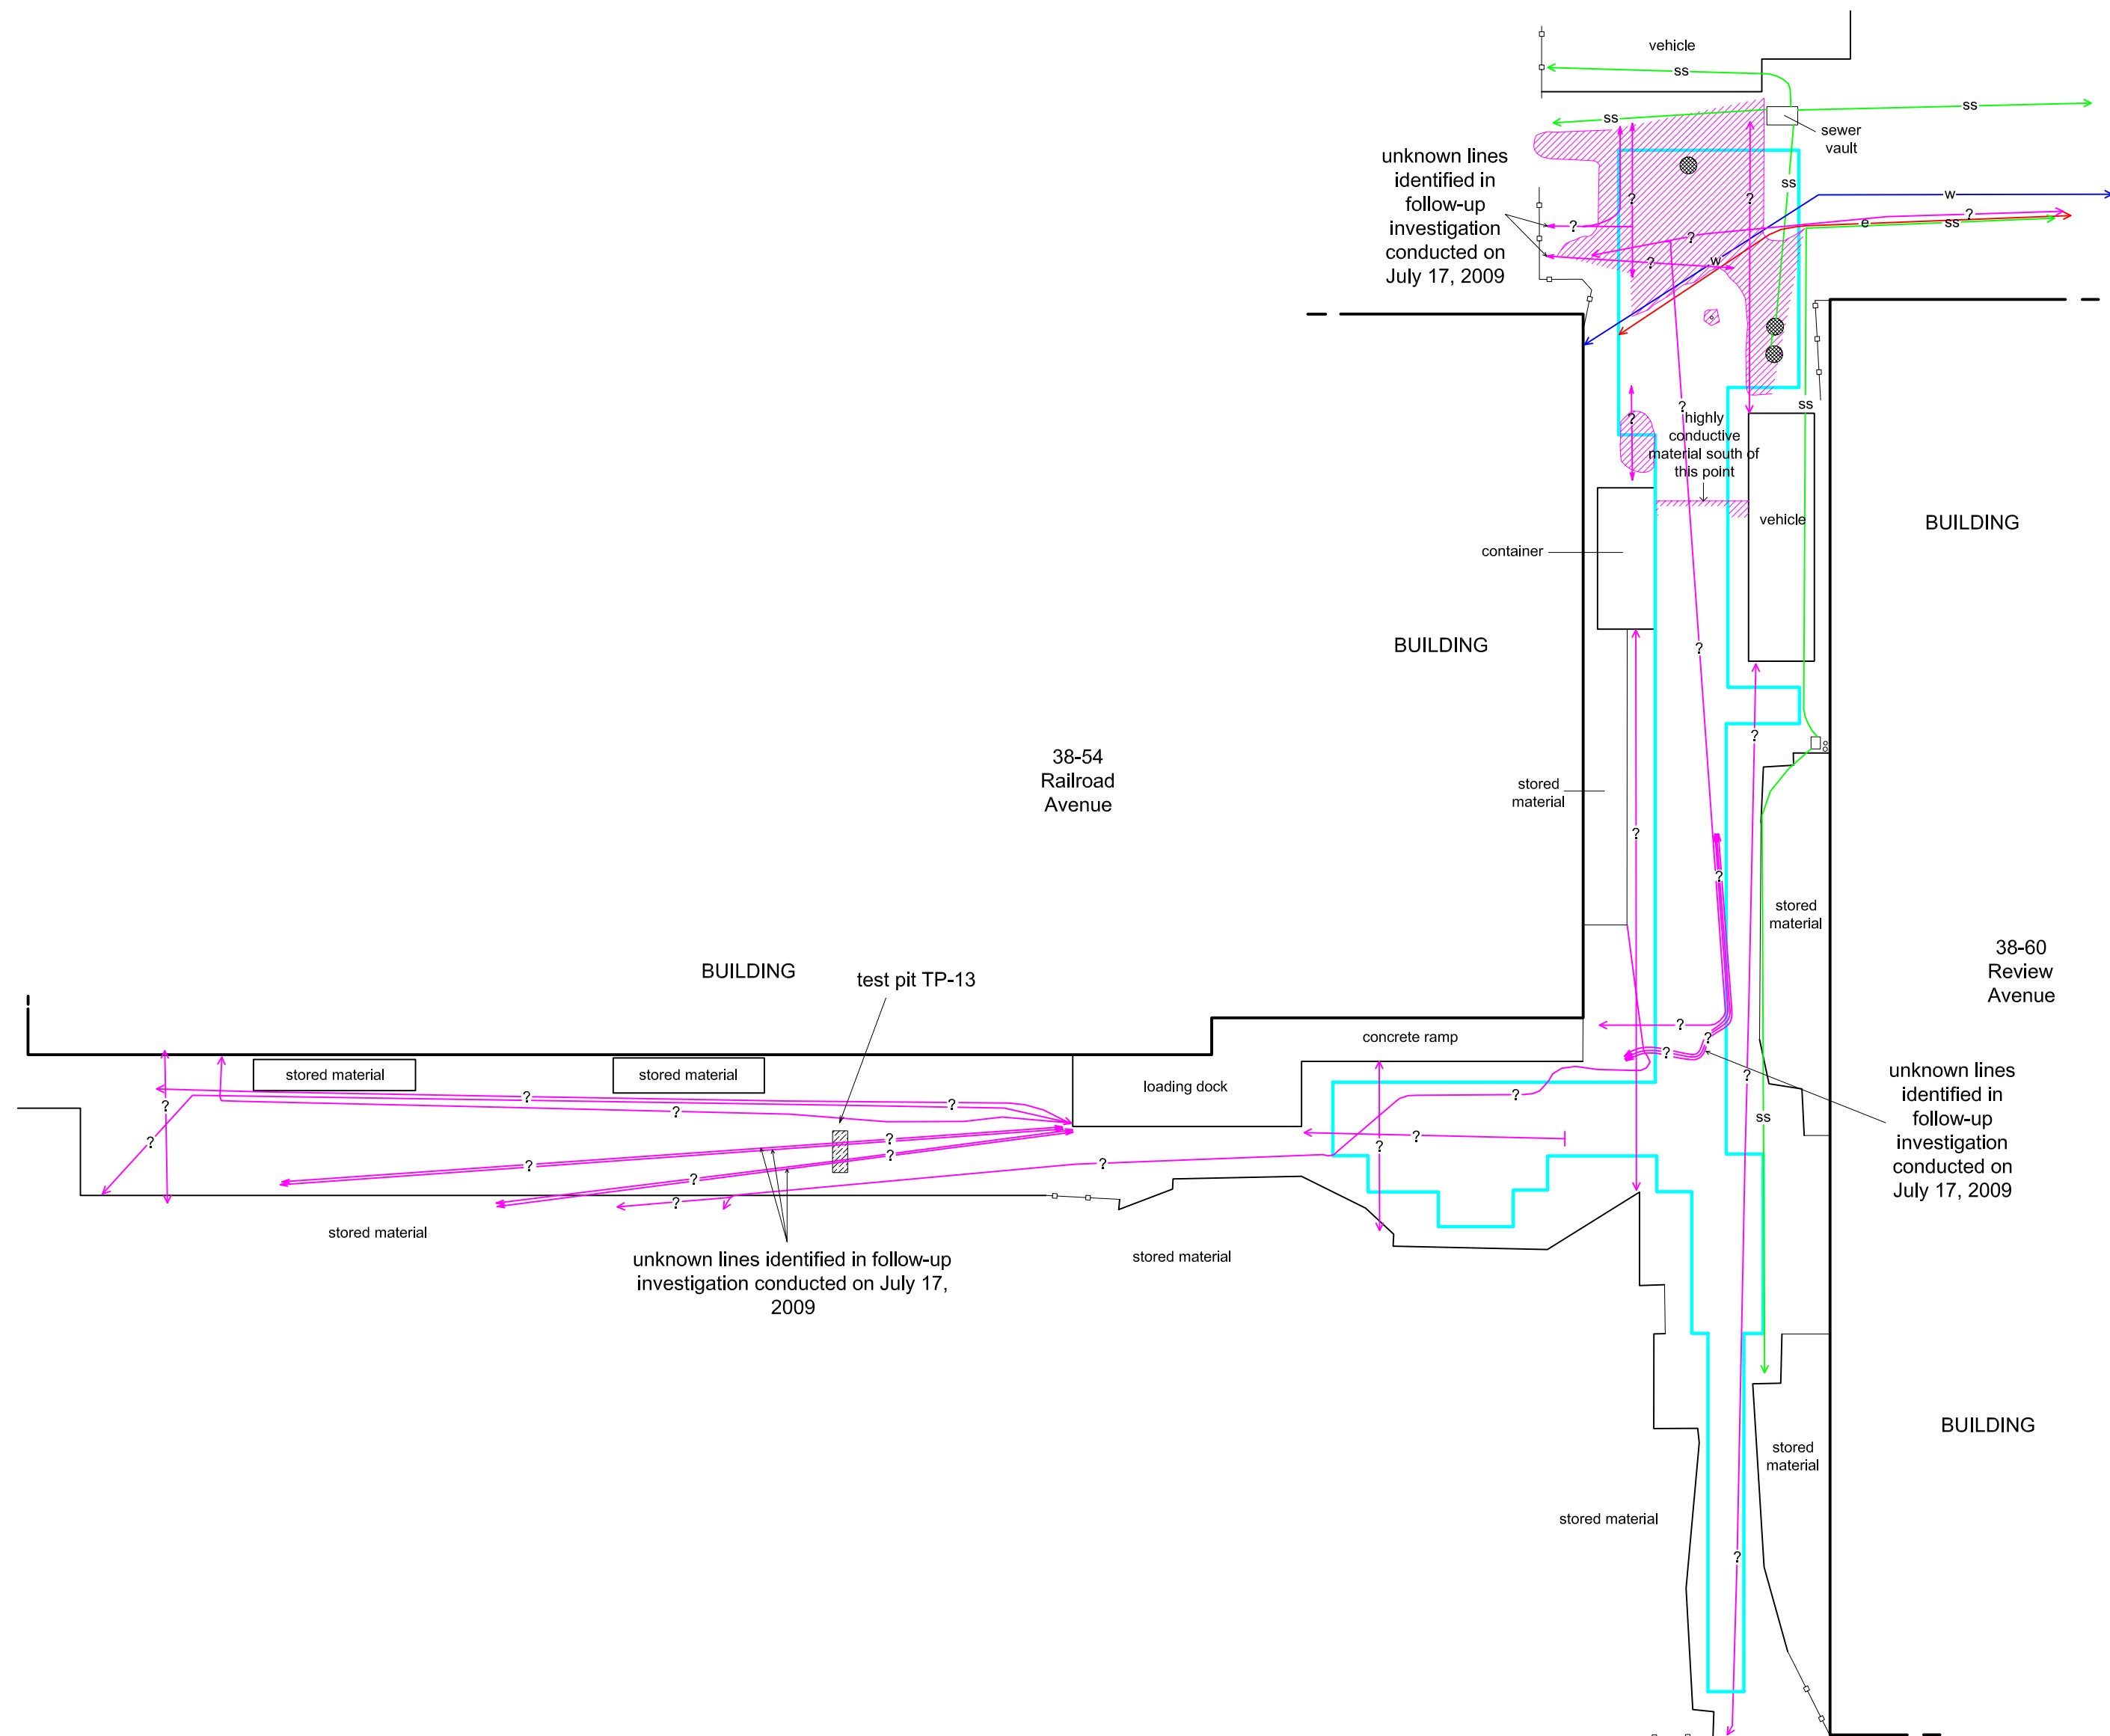
Plate 3: Utility and Culture Map of Former Pratt Oil Works
Facility AREA 3 Consisting of Parcel E Located at 38-54 Railroad
Avenue in Long Island City, New York

A water line, electric line, and several sewer lines were identified within the area of investigation. The water line enters the property at approximately 208E/234N, heads west to 168E/234N, and turns southwest to 135E/213N where it enters a building. The electric line enters the property at approximately 203E/231N, heads west to 162E/229N, turns southwest to 140E/214N and then continues into a building.

Four sewer lines were delineated leaving a sewer vault centered at approximately 163E/245N. One line exits the vault heading west until 131E/244N where it leaves the area of investigation. Another line exits the vault to the north to approximately 163E/250N, turns west underneath some vehicles to 130E/252N where it leaves the area. A third line exits the vault to east to 206E/247N and then continues outside the area. The fourth line exits the vault to the south to 162E/217N where it appears to end near three sewer manholes. Two sewer lines were traced from their surface exposures alongside a building. The first line begins at approximately 169E/157N, heads northwest to 166E/162N, continues north to 166E/229N, and turns east to 201E/231N where it continues outside the area. The second line begins at approximately 168E/157N, heads southwest to 160E/147N, and turns south to 160E/70N where it exits the area.

Several lines of unknown use were identified in the area of investigation. A line enters the area at approximately 155E/19N and heads north to 158E/244N where it continues underneath some vehicles. Another line enters the area at approximately 202E/232N and heads west to 136E/225N where it leaves the area. A second line branches off the previous line at approximately 147E/227N, heads south to 154E/118N, and turns west to 137E/118N where it continues underneath a concrete ramp. A line exits from under a large container at approximately 142E/173N, heads south to 142E/95N, and continues underneath stored material. A line exits an area of stored material at approximately 141E/132N heading south to 143E/112N, turns west to 110E/108N, turns southwest to 100E/100N, continues west to 0E/93N and the continues underneath an area of stored material. A line exits from a concrete ramp at approximately 106E/113N, heads south for approximately 23 feet, and continues underneath an inaccessible area. Another line exits from a loading dock at approximately 96E/103N and heads east to 132E/102N where it appears to terminate. Several unknown lines exit from the southwest corner of the loading dock. One line exits at 64E/104N and heads southwest to 16W/93N where

it continues underneath stored material. Three lines exit the loading dock at approximately 64E/105N. The first line heads west to 64W/109N where it leaves the area of investigation. The second line heads west to 59W/108N, turns southwest to 71W/95N and continues underneath an inaccessible area. The third line heads west to 55W/108N, turns north to 55W/114N where it heads into a building. Another line exits a building at 63W/114N, heads south to 62W/94N and continues into an inaccessible area.

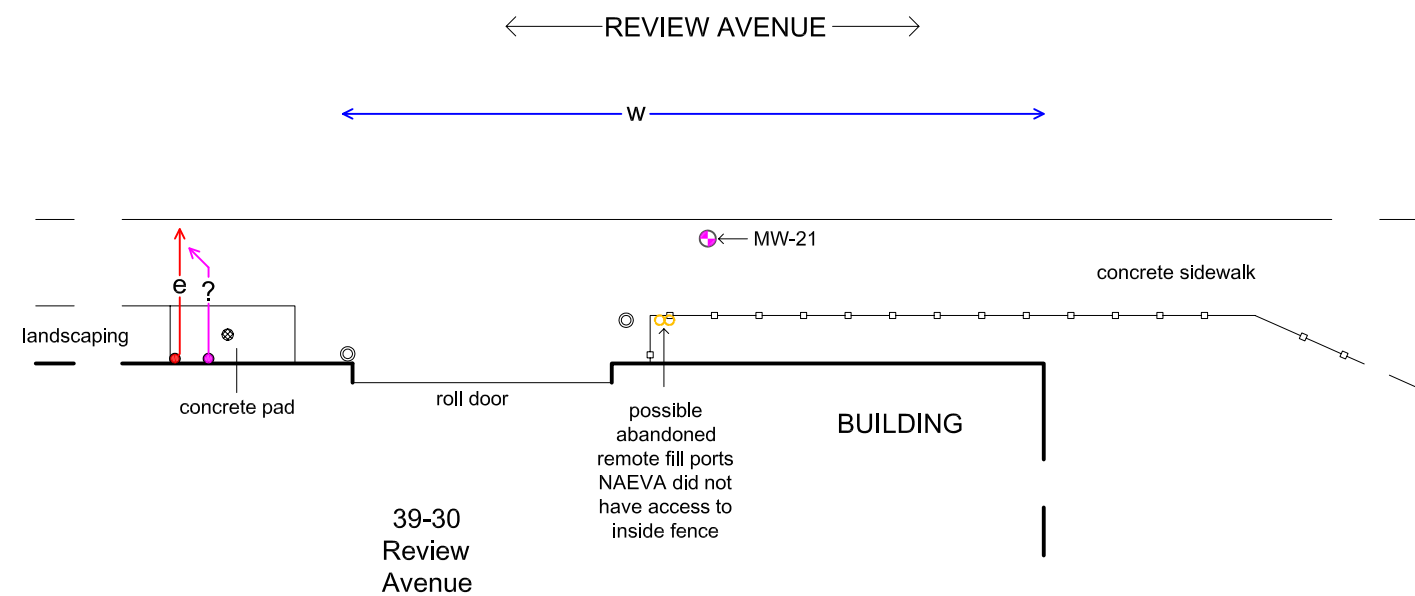
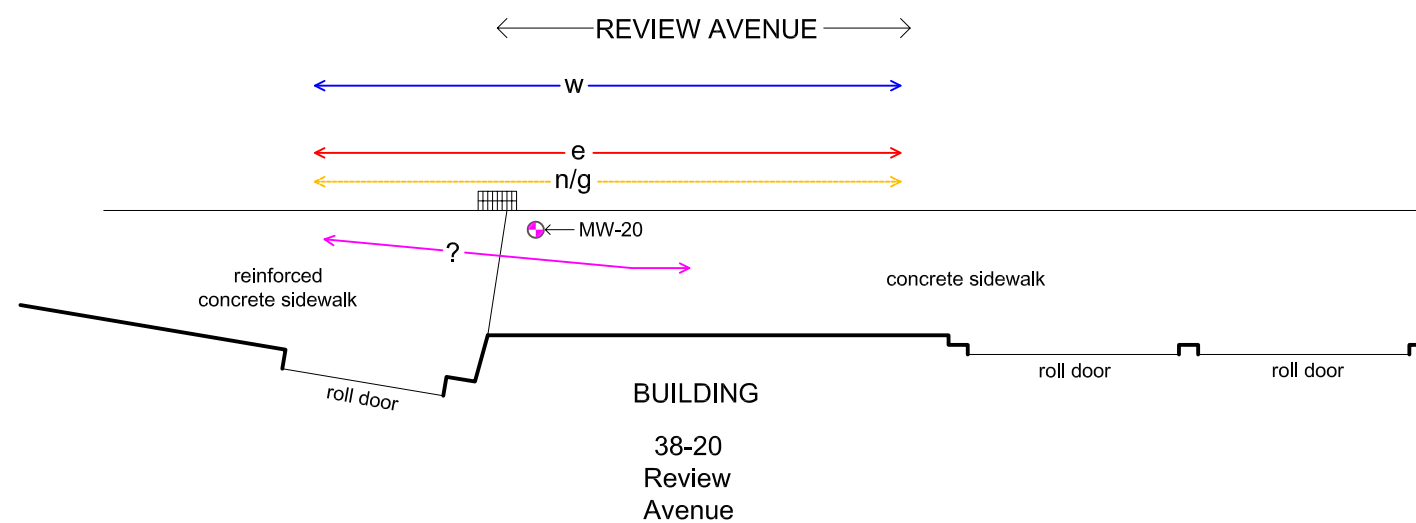
Plate 5: Utility and Culture Map of AREAS 5 and 6 Consisting of Proposed Monitoring Wells MW-20 and MW-21 Located at the Former Pratt Oil Works Facility in Long Island City, New York

A water line, electric line, natural gas line, and an unknown line were identified in the vicinity of the proposed monitoring well location MW-20. The water, electric, and natural gas lines were located in Review Avenue and ran parallel with the street. An unknown line was identified approximately three feet south of MW-20 and headed north and south.

A water line, electric line, and an unknown line were identified in the vicinity of proposed monitoring well location MW-21. The water line was located in Review Avenue and ran parallel to the street. An electric line exited the building approximately 55 feet north of MW-21, and headed east into Review Avenue. An unknown line exited the building approximately 52 feet north of MW-21, headed east for 10 feet, then turned northeast and headed into Review Avenue.
