August 9, 2019

Reference No. 11137172

**Re:    Monitoring Well Assessment and LNAPL Gauging Event Letter Report  
        Southern Terminals  
        Cold Springs Terminal Site, Hillside Road  
        Lysander, New York**

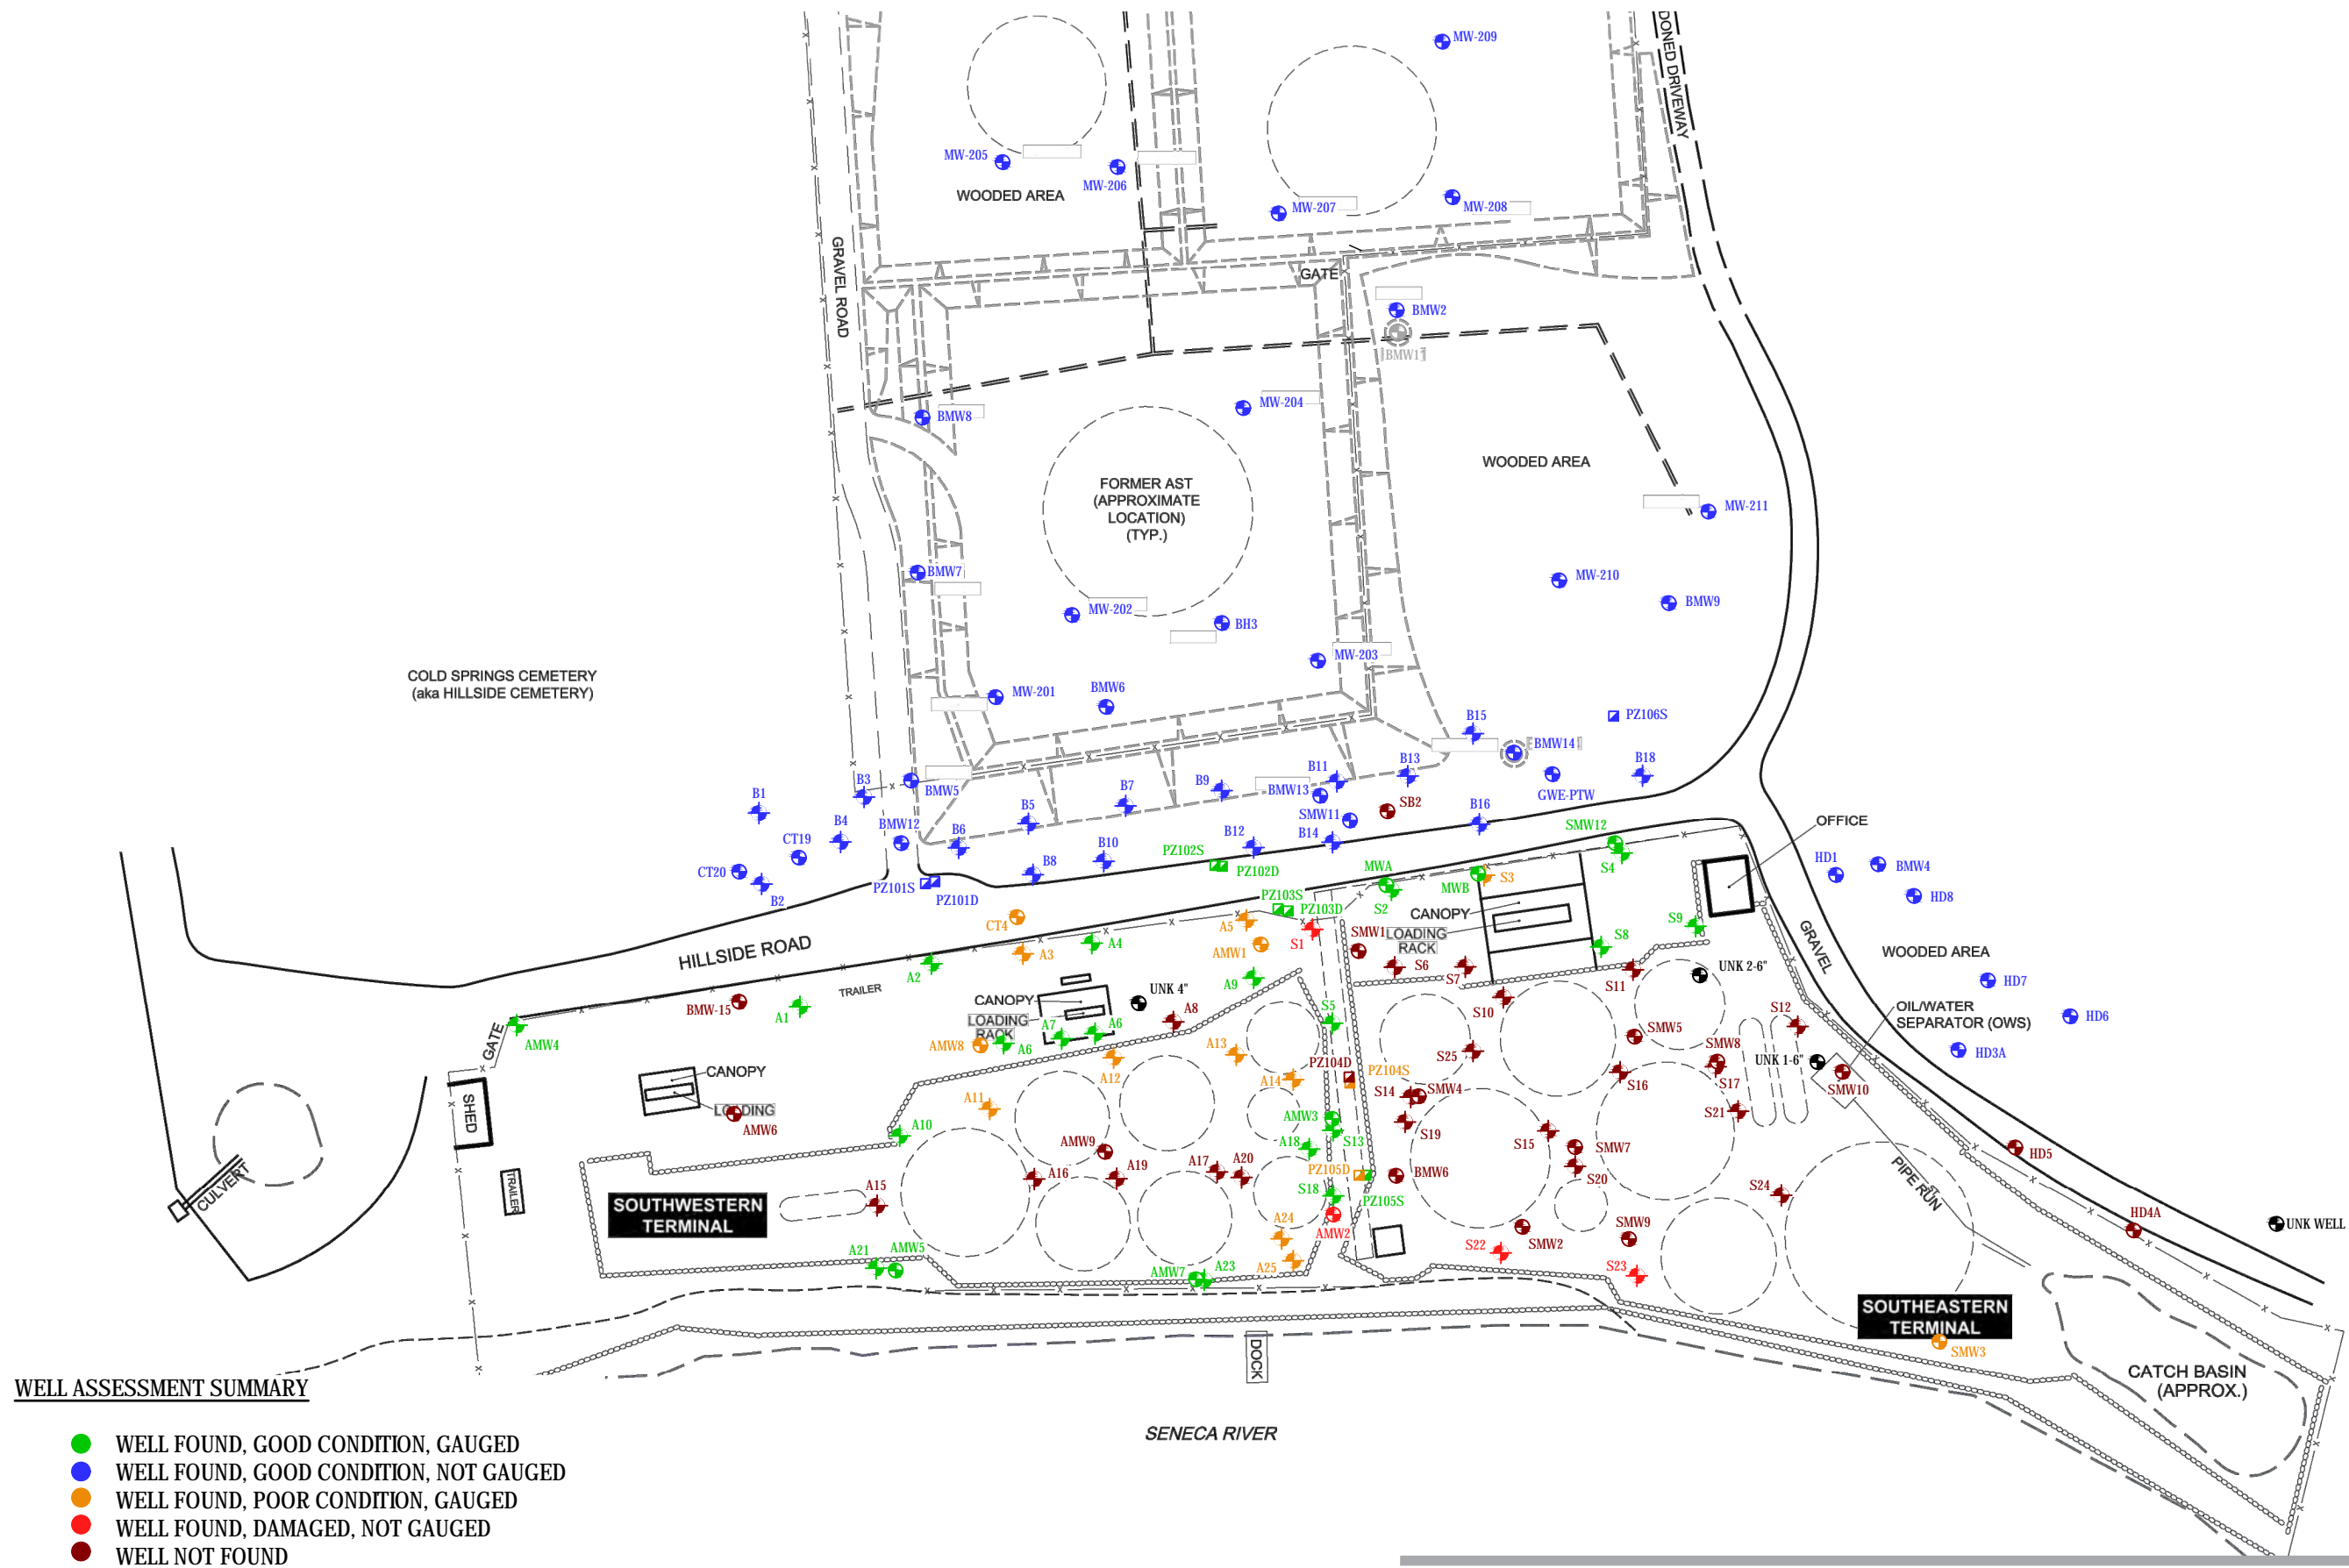
FIGURE 3

Results of the monitoring well network assessment are summarized in Table 1 and on Figure 3.

Results of the monitoring well network assessment are summarized in Table 1 and on Figure 3. LNAPL gauging data is summarized in Table 2 and approximate extents of LNAPL are presented on Figure 4.

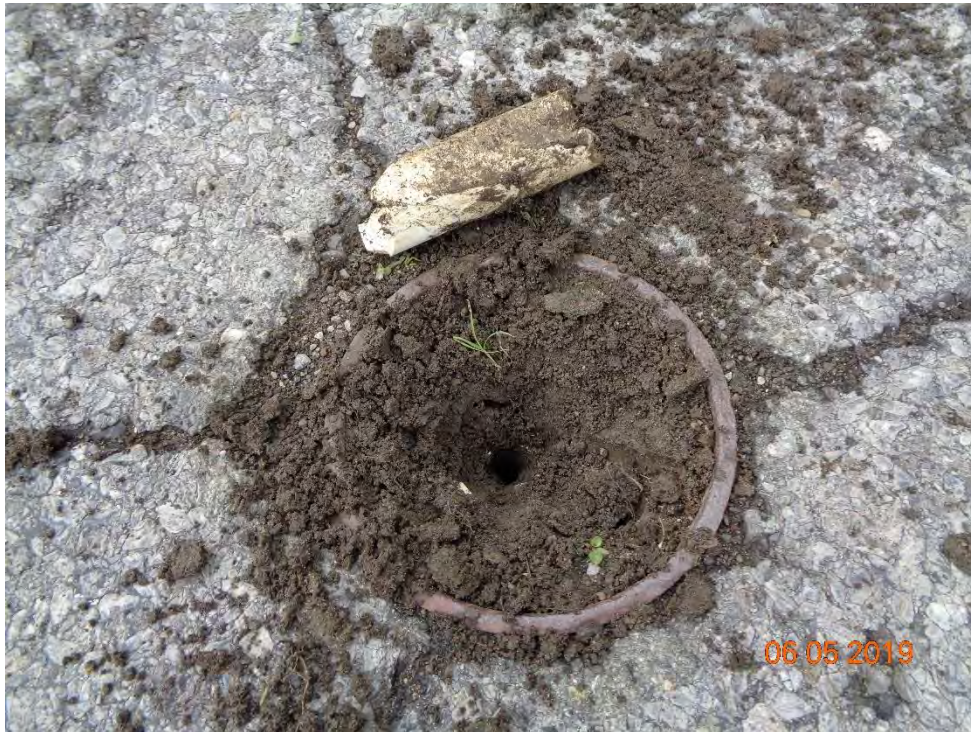
Photo 37 - View of Northern Terminal CT4, close-up of broken casing

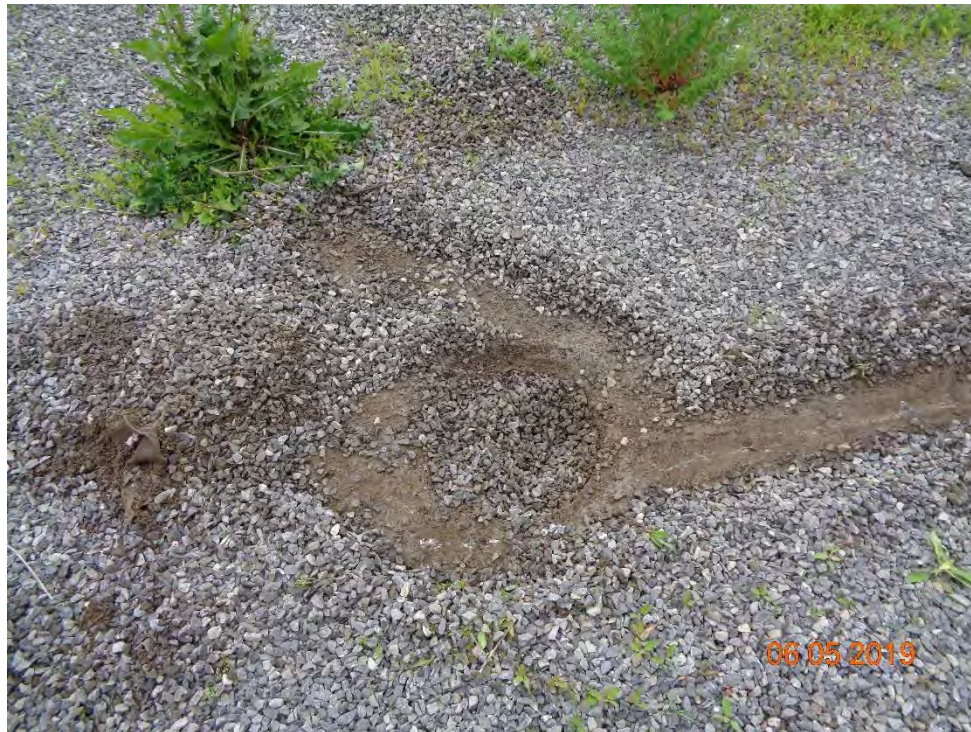
Photo 6 - View of AMW8 prior to digging out stone

- AMW8 – Removed the slip fitting cap from the top of the PVC well riser (which was 3.25 inches above grade) and added a rubber flexible coupling and 14 inches of PVC pipe on the top of the existing 2-inch diameter PVC well riser. The J-plug was reused. The manhole structure, which was missing a cover, was backfilled to grade with stone that was initially removed to locate the monitoring well for gauging.

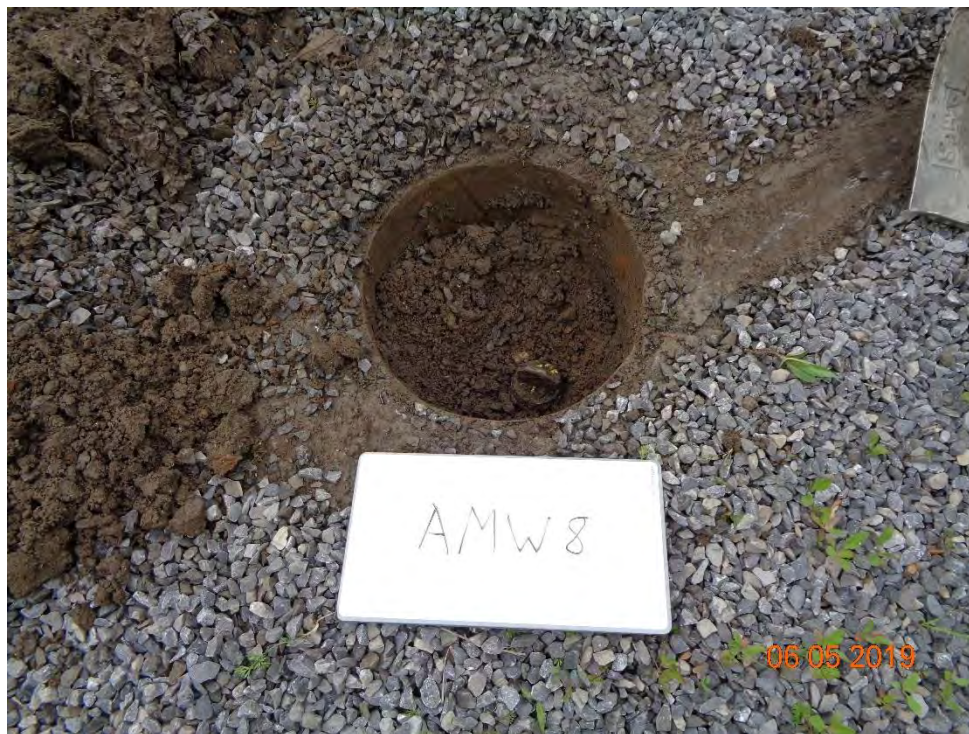
Photo 7 - View of AMW8 after digging out stone

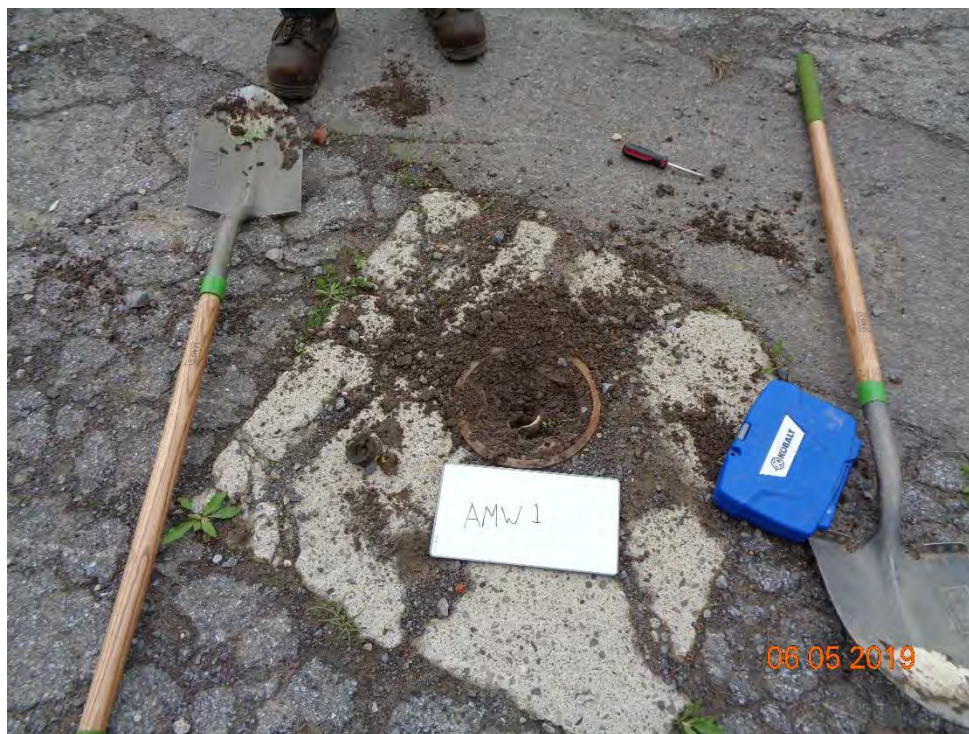
Photo 8 - View of AMW1

- AMW1 – 1.5 inches of the existing 2-inch diameter PVC well riser was removed and a new J-plug was added. The missing flush-mount curb box cover was replaced with the flush-mount cover from the uprooted and overturned concrete pad and flush-mount curb box from assumed PZ104D. The top of the PVC pipe is cracked and the well is in overall poor condition.

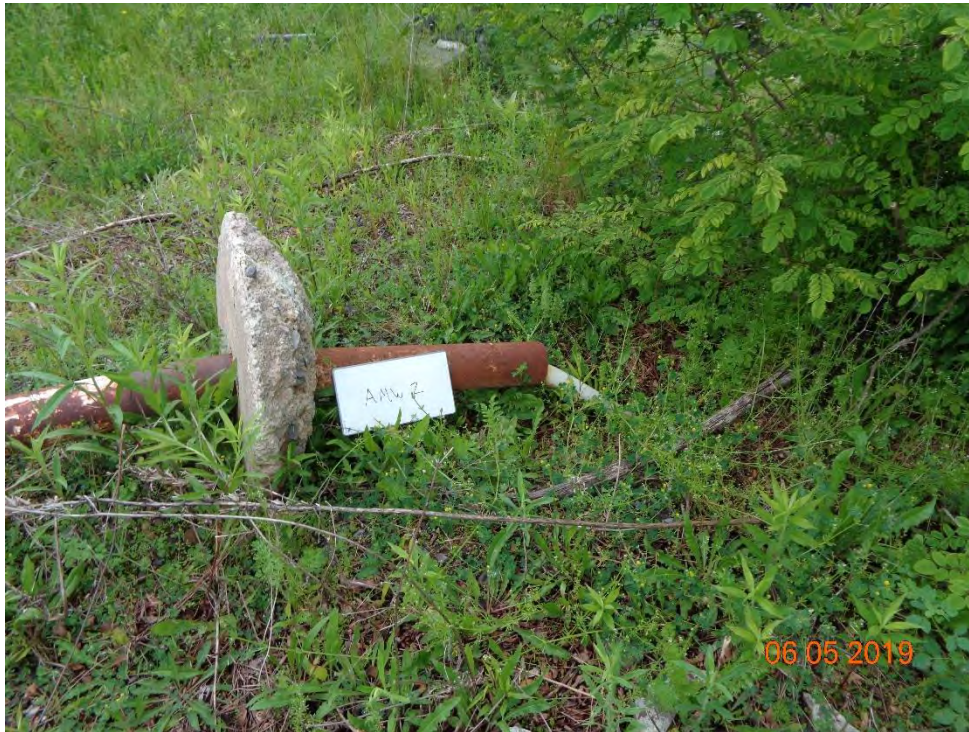
- AMW2 – Stickup protective casing and concrete pad were dislodged and the casing was bent over to ground surface
- S1 – Well riser could not be located within manhole filled with stone
- S22 – Stainless steel riser with no protective casing - riser was bent over to ground surface and crushed flat
- S23 – Stainless steel riser with no protective casing - riser was crushed and the water level meter would not advance beyond that point

Photo 9 - View of AMW2

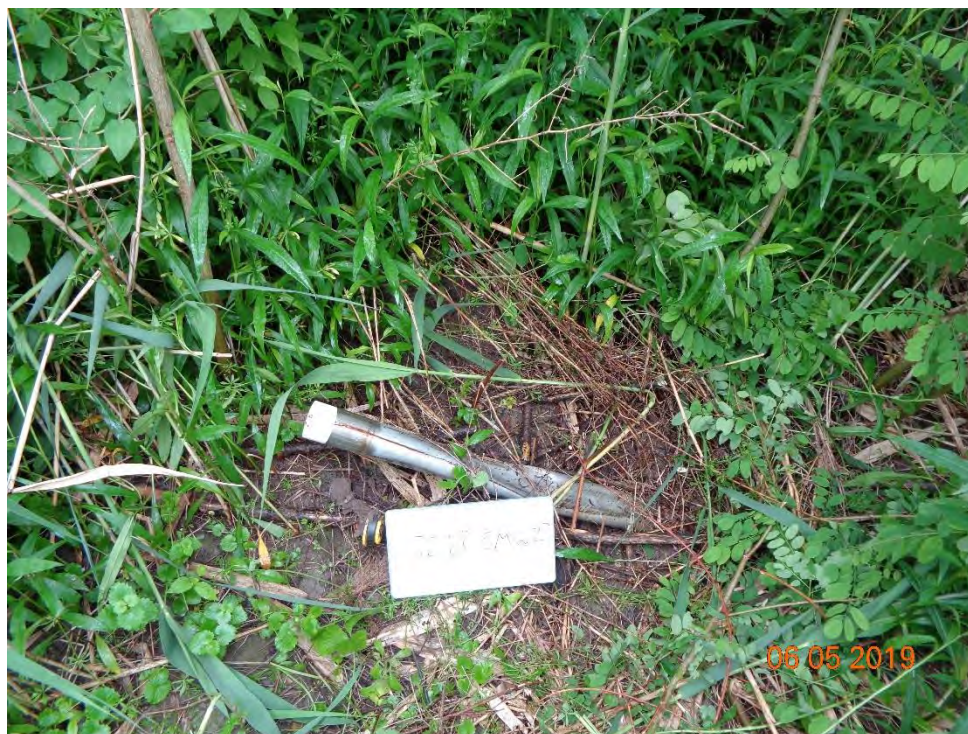
Photo 14 - View of S22

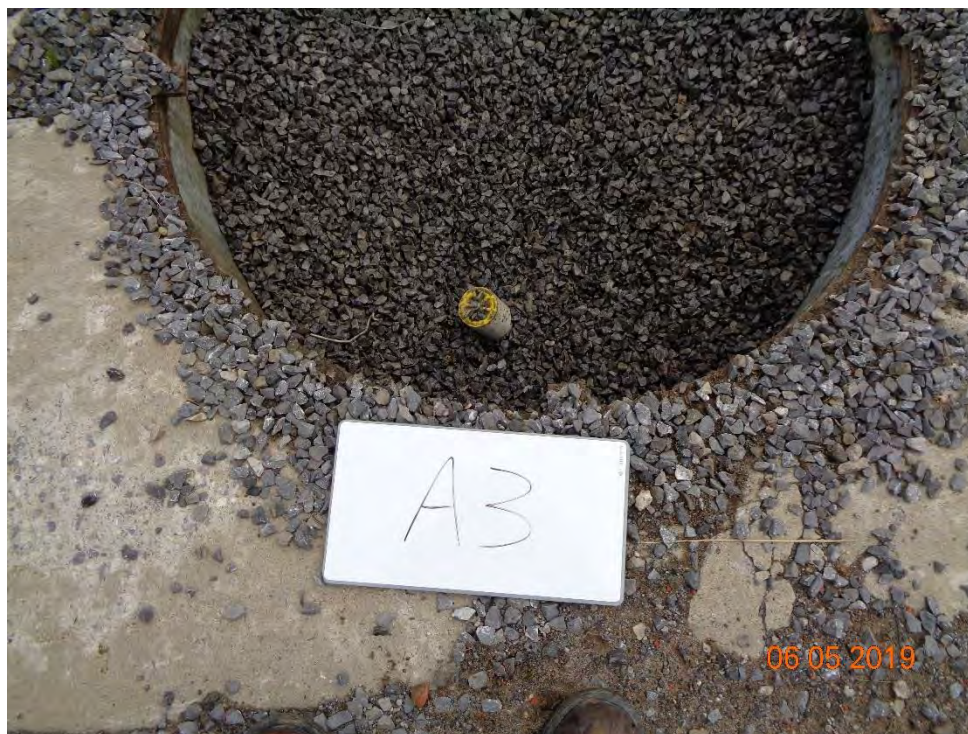
- A3 – Buried in stone within manhole structure with no cover
- A5 – Buried in stone within manhole structure with no cover
- A14 – Stainless steel casing was bent to side and in the edge of a brush/debris pile
- AMW1 – No flush-mount curb box cover, polyvinyl chloride (PVC) riser was broken and the J-plug was missing
- AMW-8 – Buried in stone within flush-mount curb box with no cover
- PZ104S – Flush-mount curb box cover broken
- PZ105D – Concrete pad and flush-mount curb box and cover were cracked and broken
- S3 – Buried in stone within manhole structure with no cover
- SMW-3 – Protective casing was tilted at an angle

Photo 24 - View of A3 after digging out stone

- A3 – A rubber flexible coupling and 16 inches of PVC pipe were installed on top of the existing 2-inch diameter PVC pipe within the manhole structure and the J-plug was reused. The manhole structure, which was missing a cover, was backfilled to grade with stone that was initially removed to locate the monitoring well for gauging.

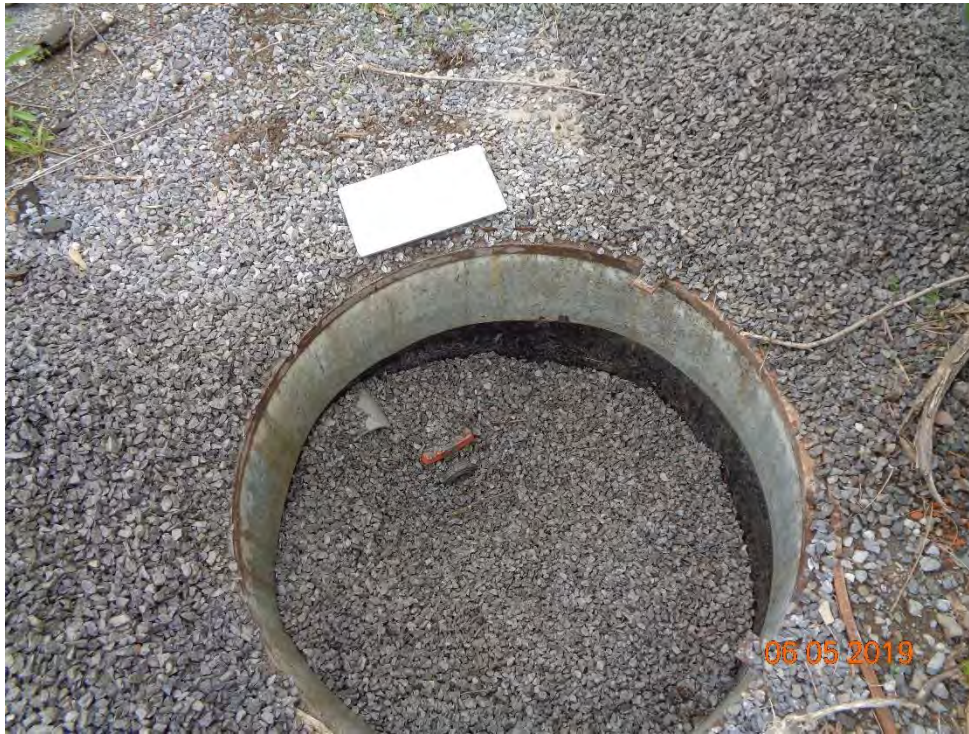
Photo 29 - View of S1 after digging out stone, well no longer present

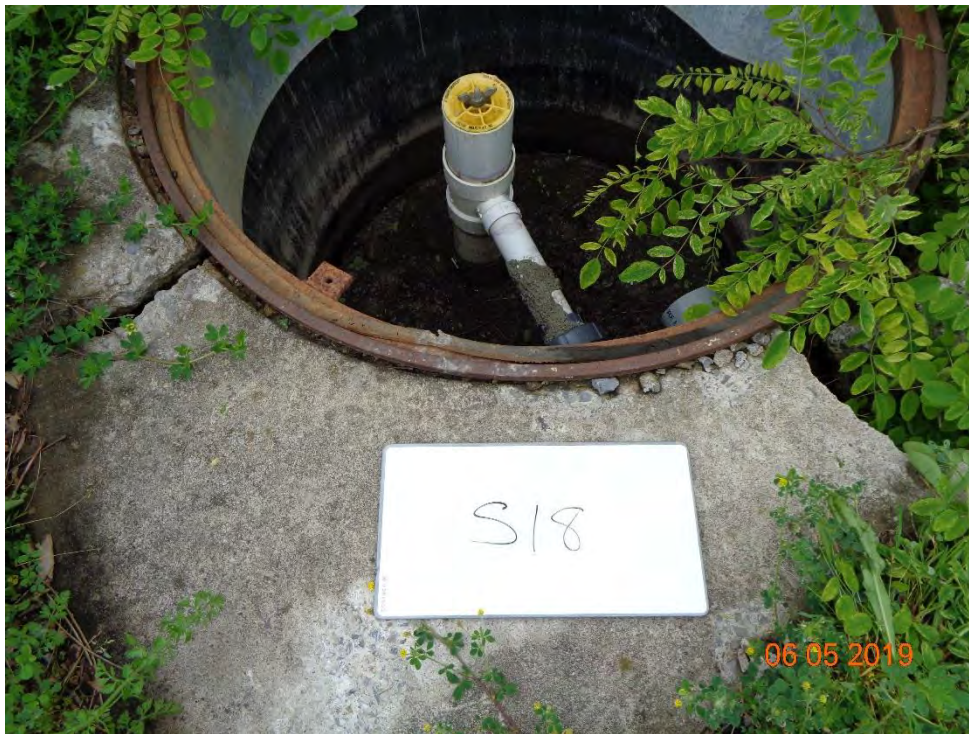
Photo 33 - View of S18

- S18 – The manhole structure that the monitoring well was located in and had no cover and was not previously backfilled to grade, creating an unnecessary hazard. As a result, a rubber flexible coupling and 14 inches of PVC pipe were installed on top of the existing 4-inch diameter PVC pipe within the

manhole structure and the J-plug was reused. The manhole structure, which was missing a cover, was backfilled to grade with riprap and stone from the Site.

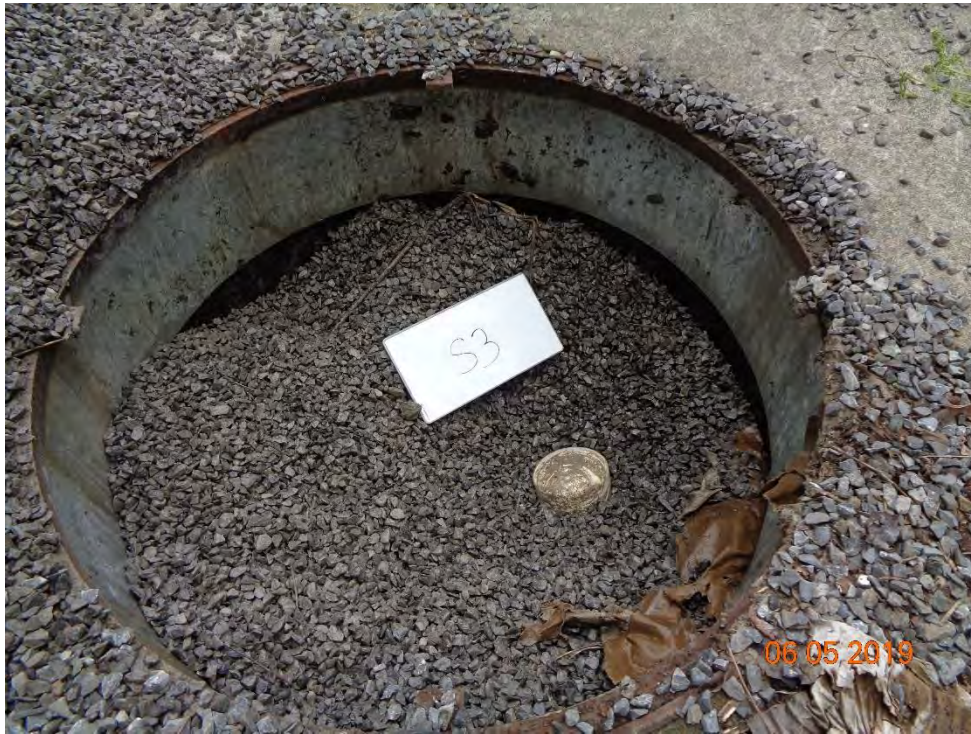
Photo 43 - View of S3 after digging out stone

- S3 – The existing rubber flexible coupling was reused and 36 inches of PVC pipe was installed on the top of the existing 4-inch diameter PVC pipe within the manhole structure and a new J-plug was added. The manhole structure, which was missing a cover, was backfilled to grade with stone that was initially removed to locate the monitoring well for gauging.

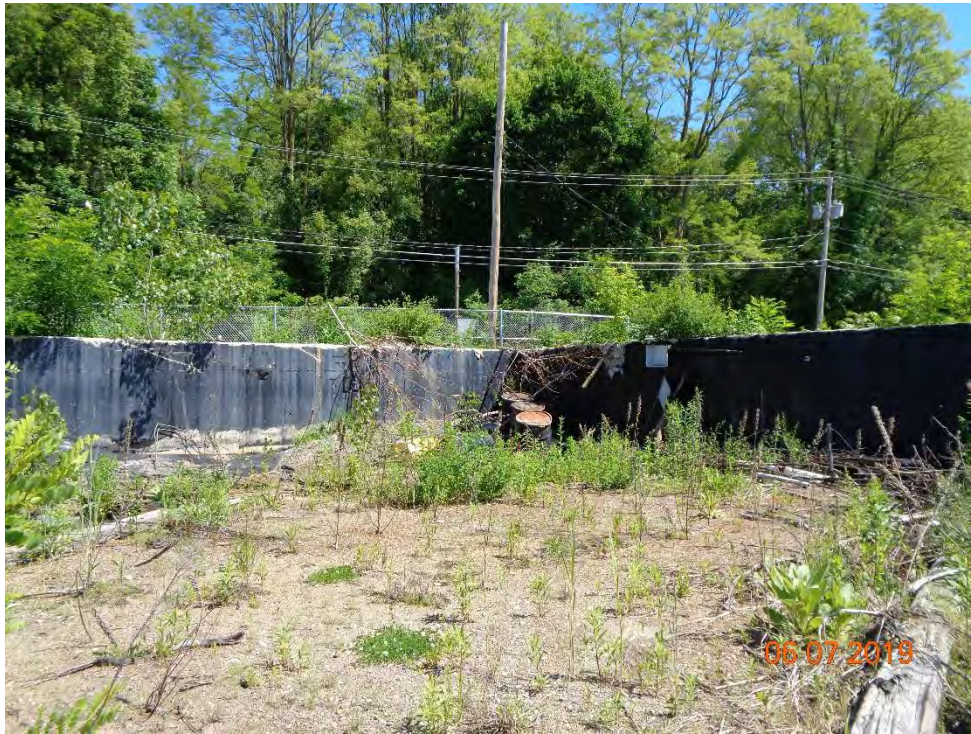
- Four drums, in poor condition, were identified in the northeast corner of the southwestern terminal secondary containment area. The contents of those drums are unknown. There was no staining observed in the vicinity.
- One drum, in poor condition, was identified in the southwest corner of the southwestern terminal secondary containment area. The contents of the drum is unknown. There was no staining observed in the vicinity of the drum.
- Four drums appearing to be in fair condition were identified inside the trailer located near the westernmost extent of the ST. The drums were closed-top style and contained unknown materials. Staining was observed on the floor of the trailer in their vicinity. Based on the presence of various debris in the trailer, it was not possible to determine if the staining was associated with the drums or another source.

Photo 59 - View of drums located in northeastern corner of southwestern terminal containment area

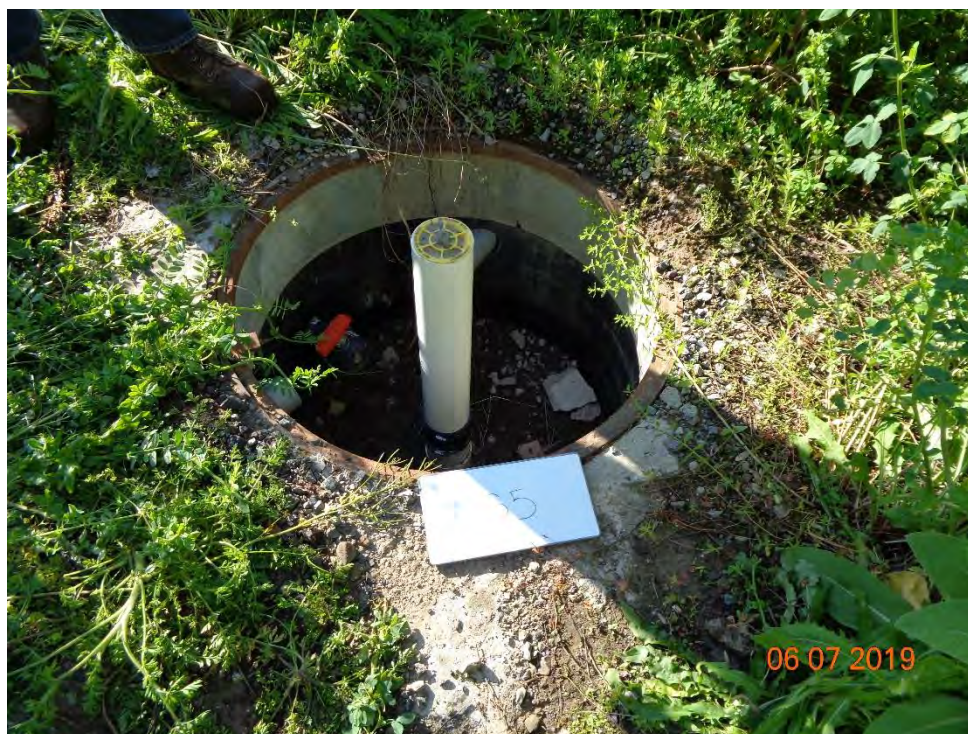
Photo 63 - View of S5 after extending and prior to backfilling manhole

- S5 – The manhole structure that the monitoring well was located in had no cover and was not previously backfilled to grade, creating an unnecessary hazard. A rubber flexible coupling and 27 inches of PVC pipe were installed on top of the existing 4-inch diameter PVC pipe within the manhole structure and the J-plug was reused. The manhole structure, which was missing a cover, was backfilled to grade with concrete rubble and stone from the Site.

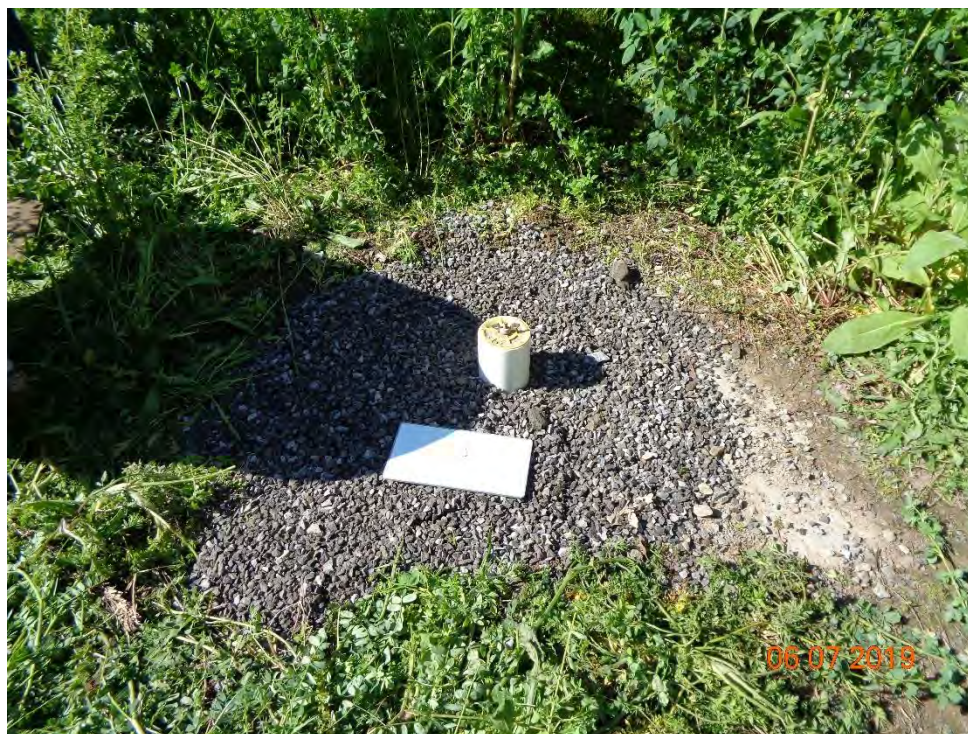
Photo 64 - View of S5 after backfilling manhole with stone

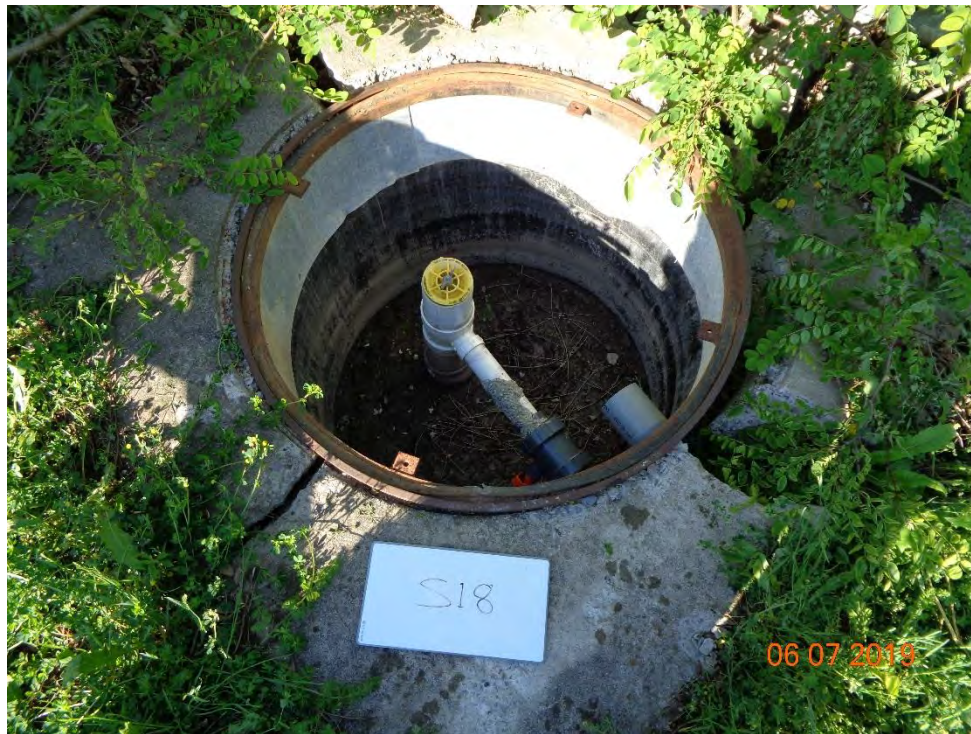
Photo 65 - View of S18 prior to extending and backfilling manhole

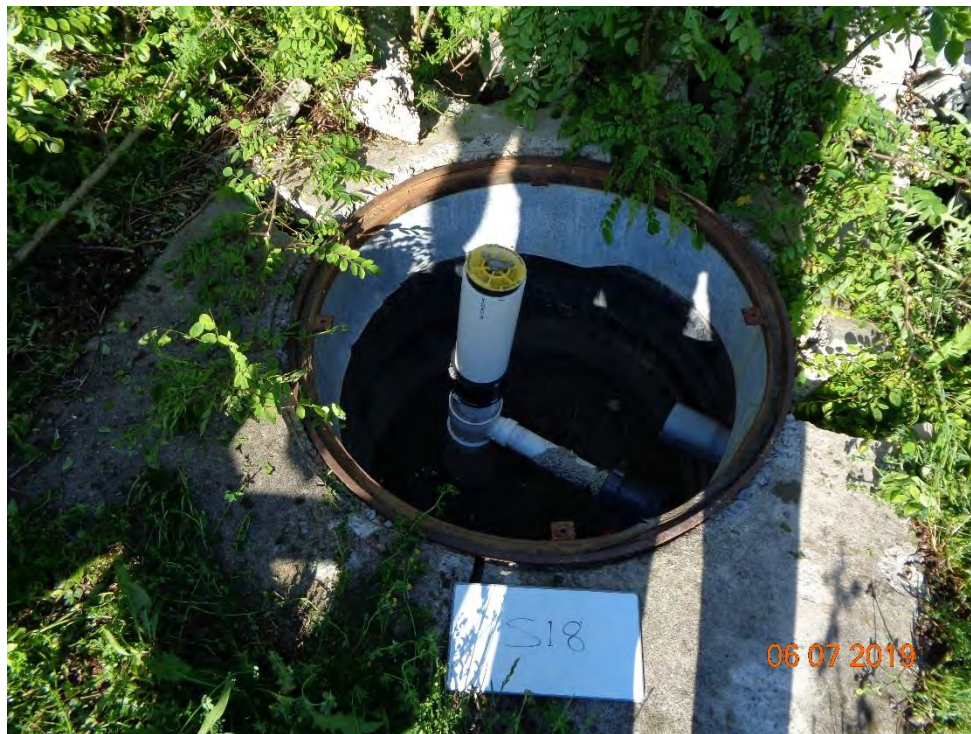
Photo 66 - View of S18 after extending and prior to backfilling manhole

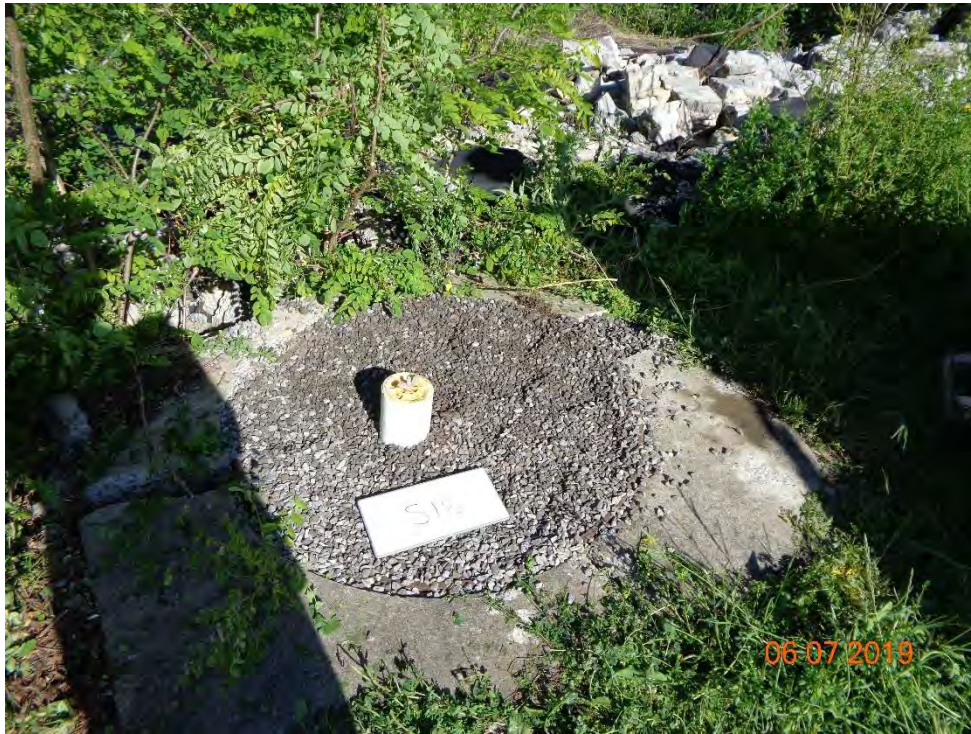
Photo 67 - View of S18 after backfilling manhole with stone

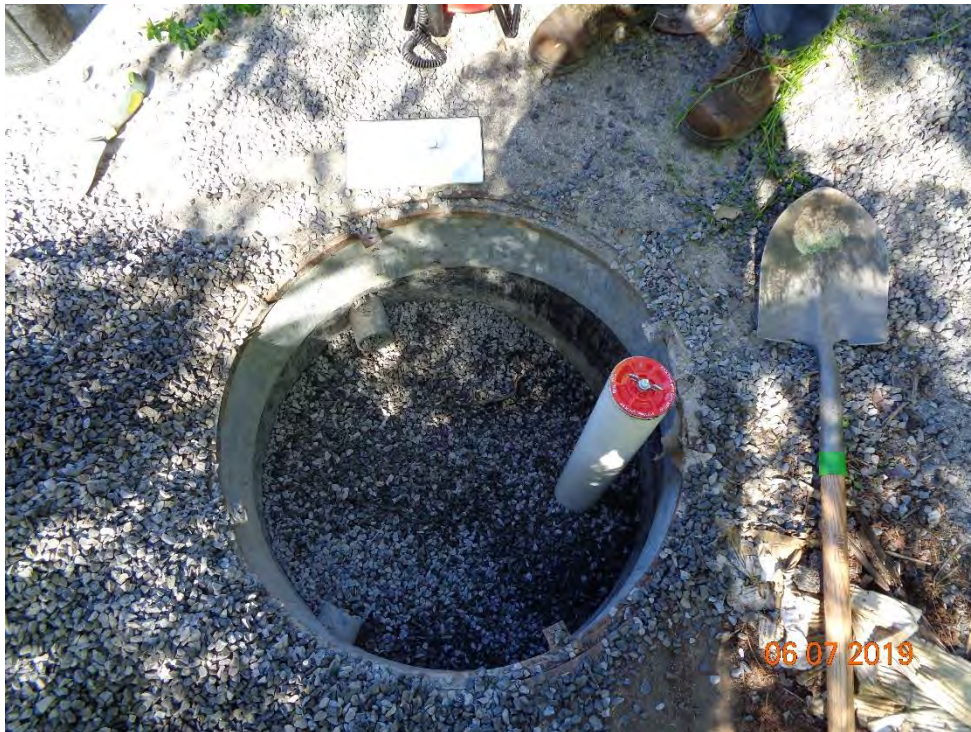
Photo 68 - View of S3 after extending and prior to refilling manhole

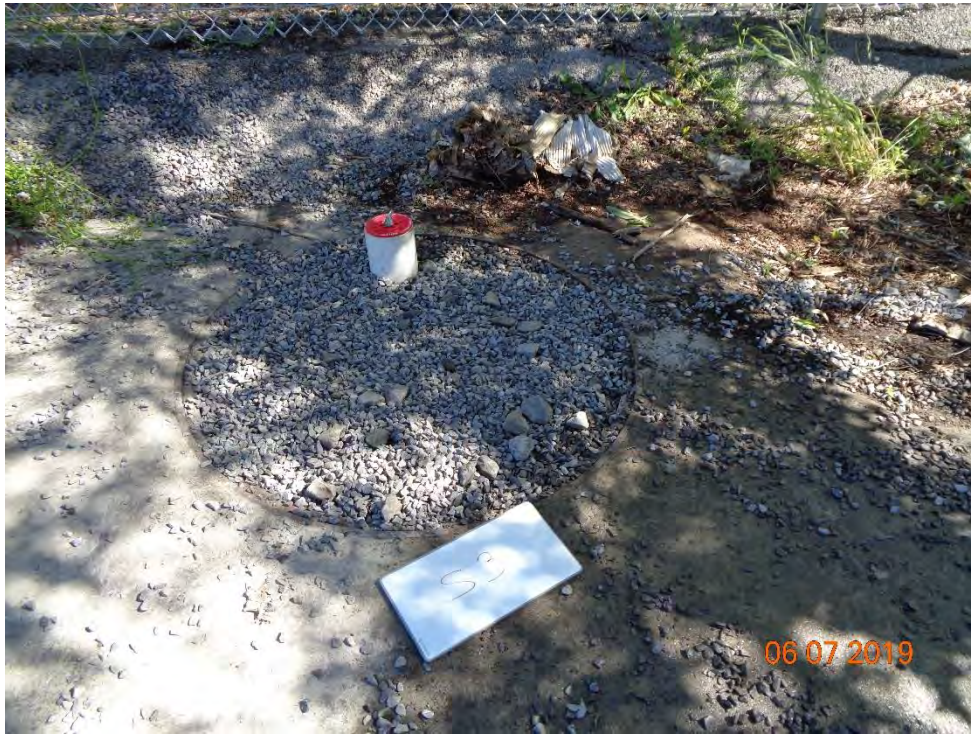
Photo 69 - View of S3 after refilling manhole with stone

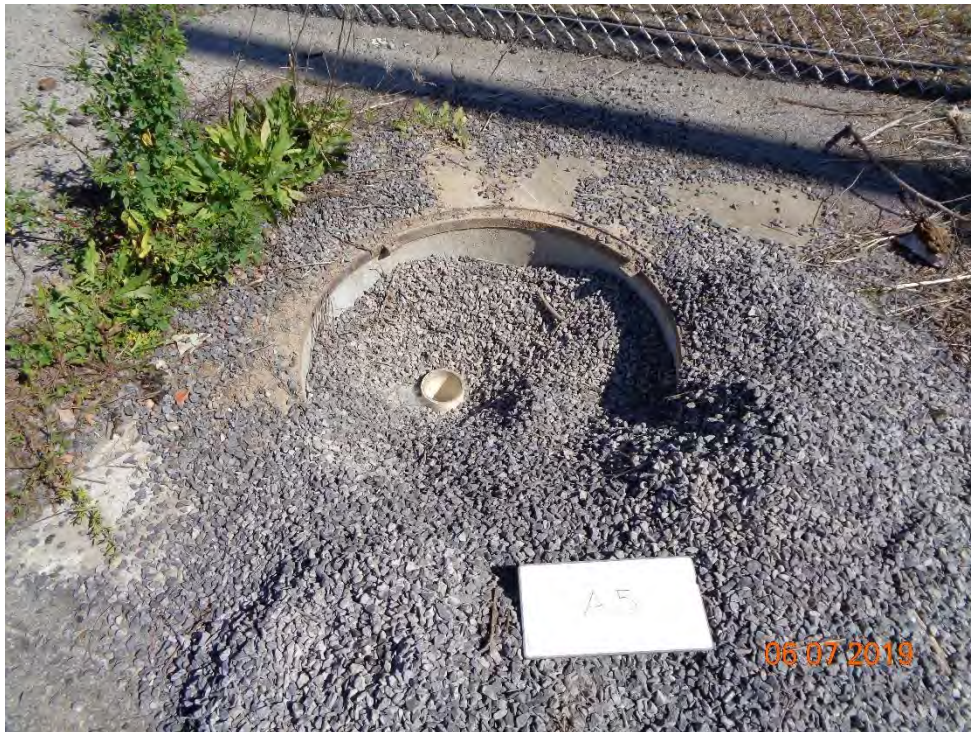
Photo 70 - View of A5 prior to extending and refilling manhole

- A5 – A rubber flexible coupling and 14 inches of PVC pipe were installed on top of the existing 4-inch diameter PVC pipe within the manhole structure and the J-plug was reused. The manhole structure, which was missing a cover, was backfilled to grade with stone that was initially removed to locate the monitoring well for gauging.

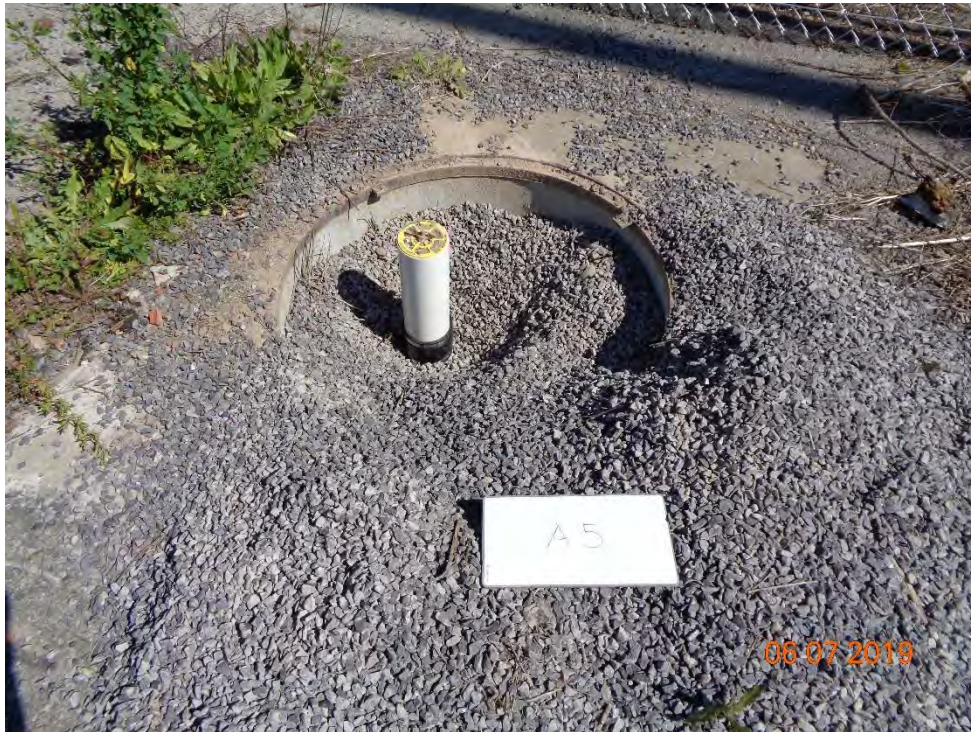
Photo 71 - View of A5 after extending and prior to refilling manhole

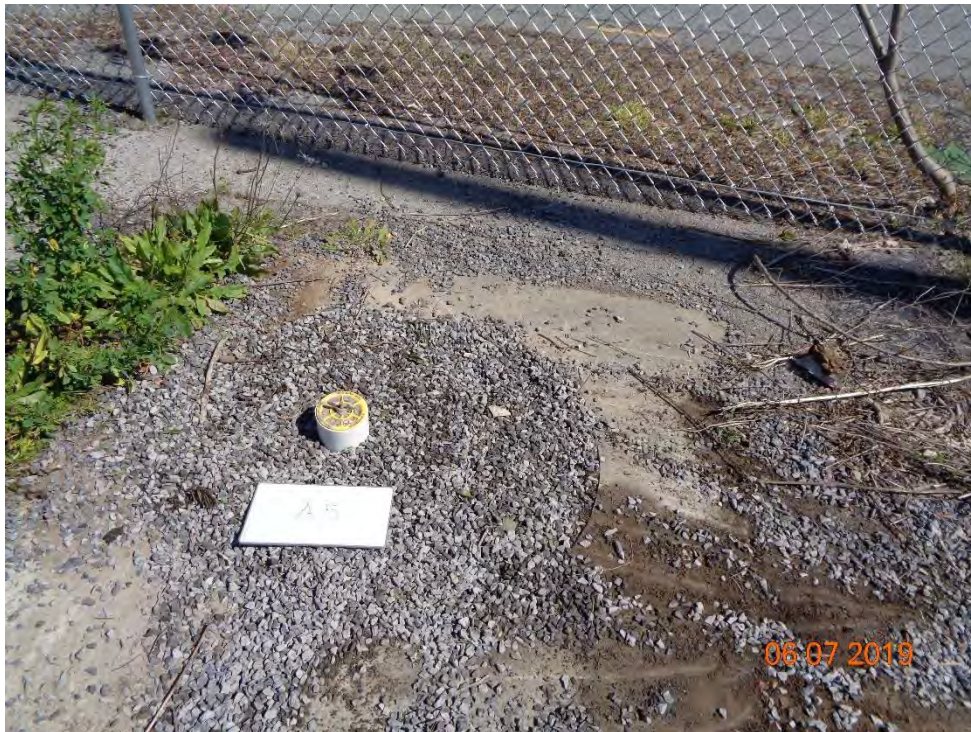
Photo 72 - View of A5 after refilling manhole with stone

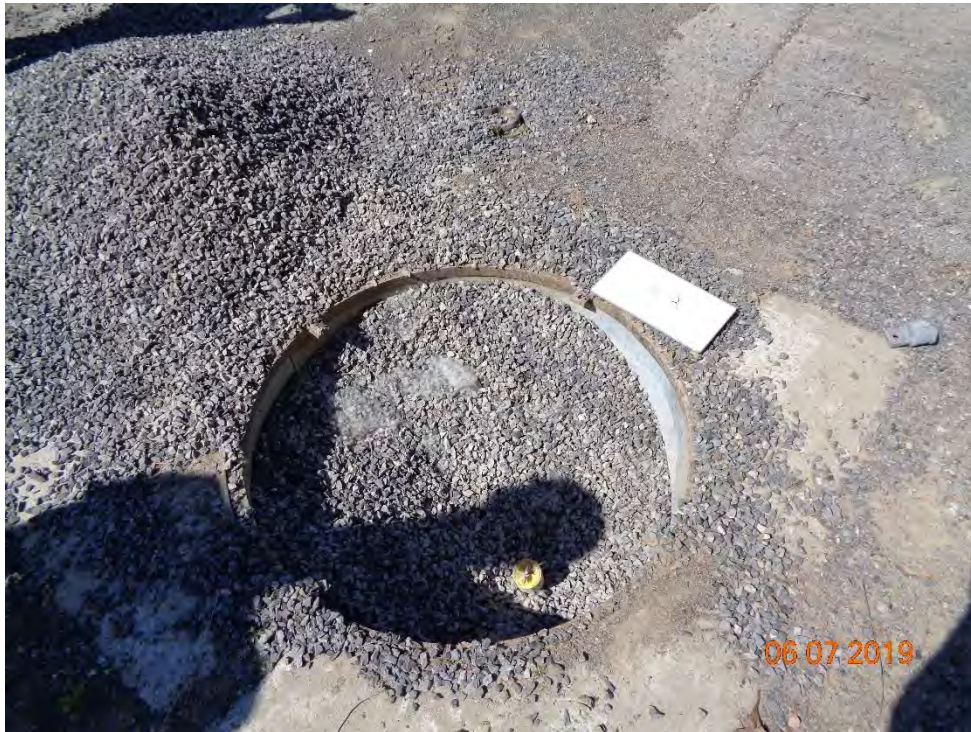
Photo 73 - View of A3 prior to extending and refilling manhole

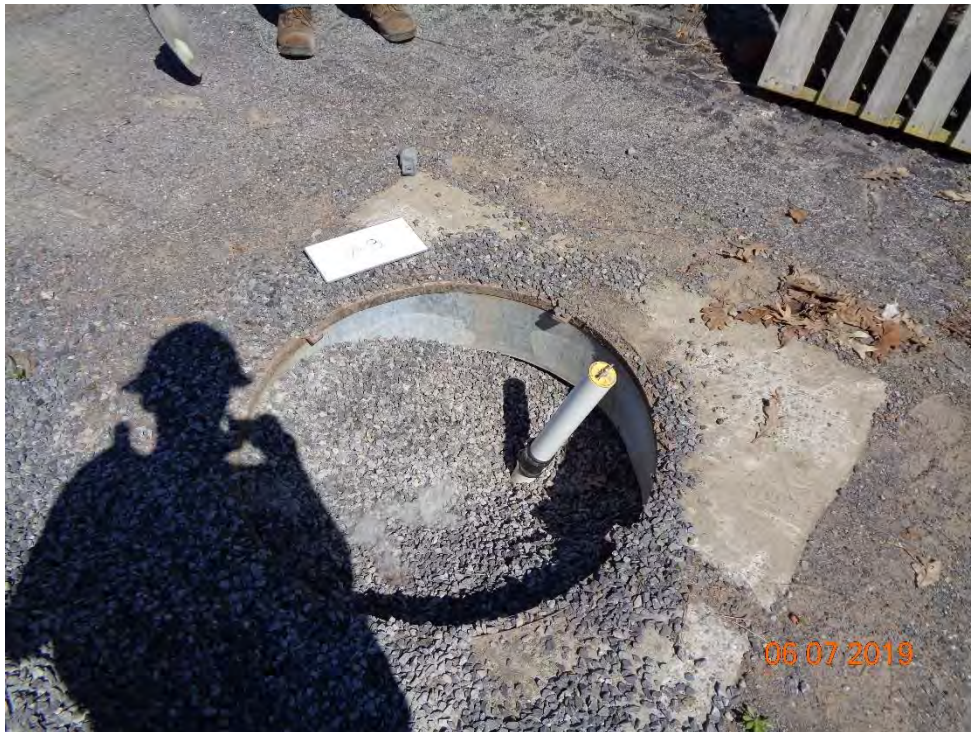
Photo 74 - View of A3 after extending and prior to refilling manhole

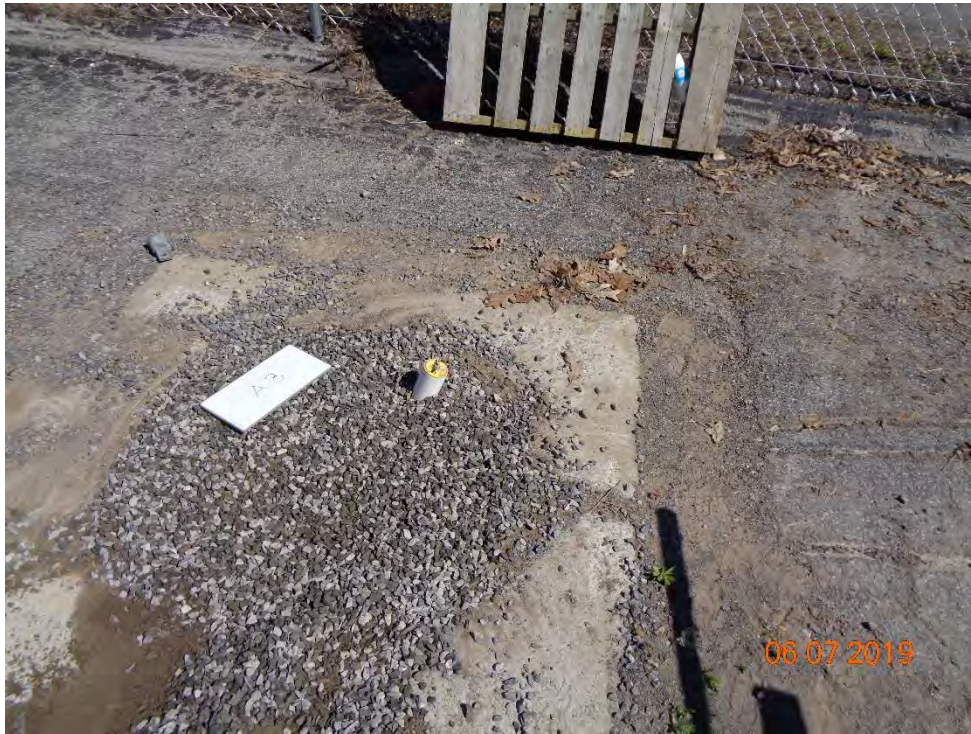
Photo 75 - View of A3 after refilling manhole with stone
