August 9, 2019

Reference No. 11137172

**Re:    Monitoring Well Assessment and LNAPL Gauging Event Letter Report  
        Southern Terminals  
        Cold Springs Terminal Site, Hillside Road  
        Lysander, New York**

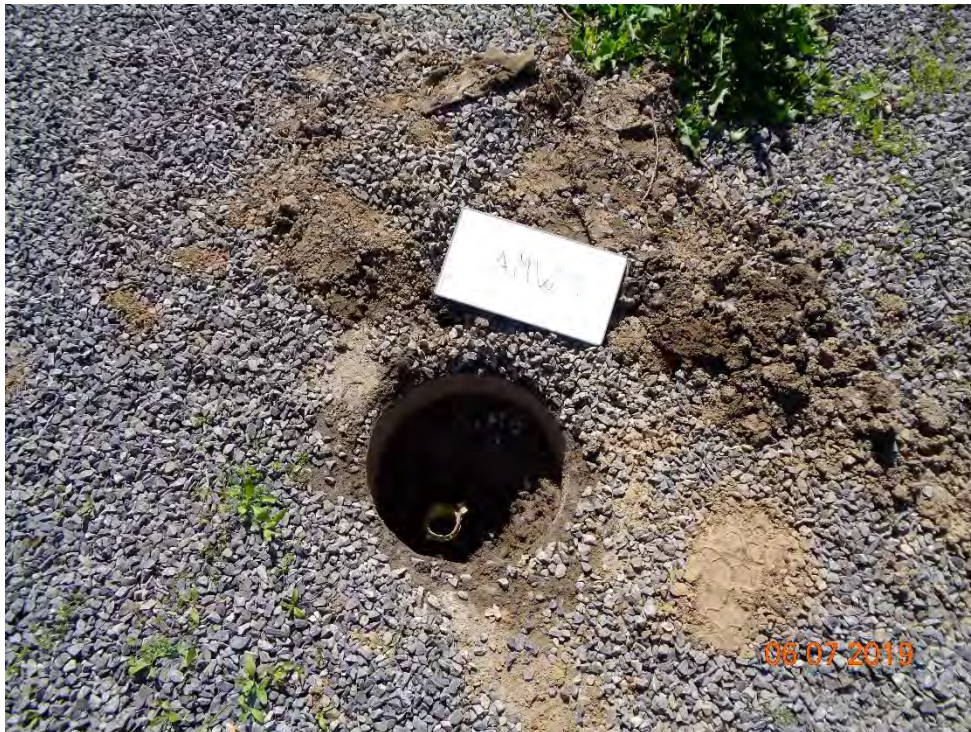
Photo 76 - View of AMW8 prior to extending and backfilling

- AMW8 – Removed the slip fitting cap from the top of the PVC well riser (which was 3.25 inches above grade) and added a rubber flexible coupling and 14 inches of PVC pipe on the top of the existing 2-inch diameter PVC well riser. The J-plug was reused. The manhole structure, which was missing a cover, was backfilled to grade with stone that was initially removed to locate the monitoring well for gauging.

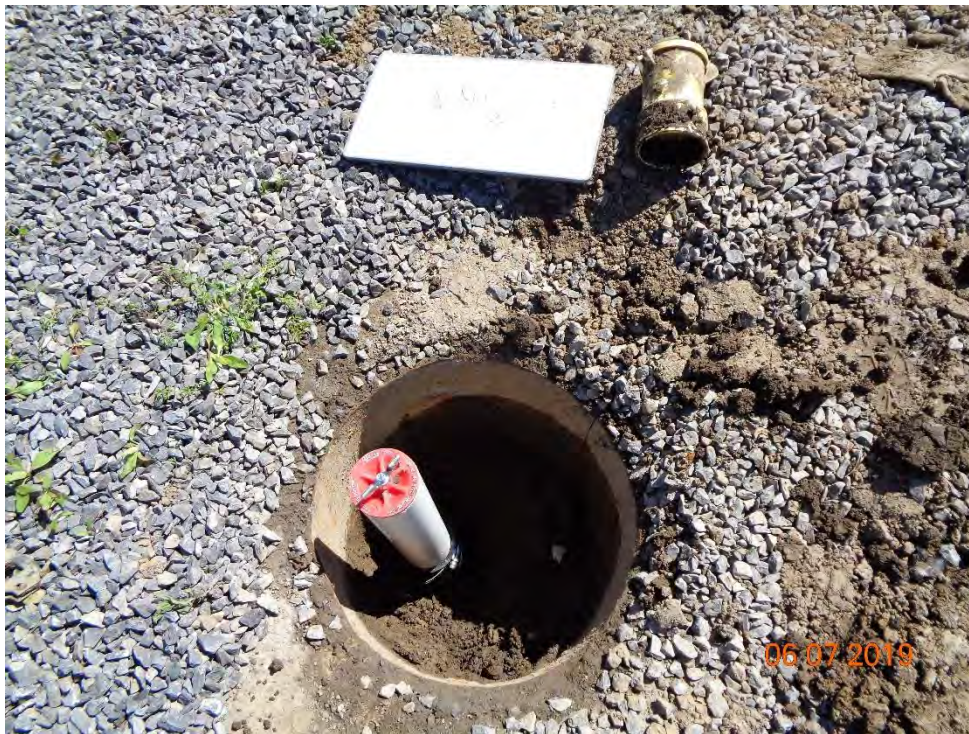
Photo 77 - View of AMW8 after extending and prior to backfilling (note slip cap piece removed from well casing prior to extending)

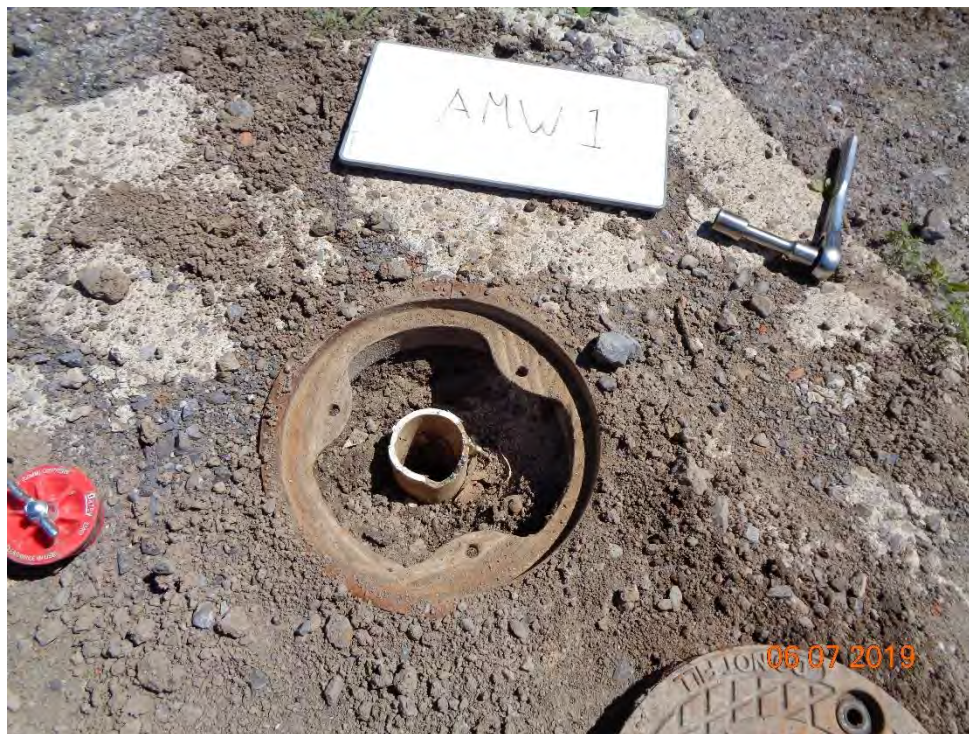
Photo 79 - View of AMW1 after cutting down broken PVC casing

- AMW1 – 1.5 inches of the existing 2-inch diameter PVC well riser was removed and a new J-plug was added. The missing flush-mount curb box cover was replaced with the flush-mount cover from the uprooted and overturned concrete pad and flush-mount curb box from assumed PZ104D. The top of the PVC pipe is cracked and the well is in overall poor condition.

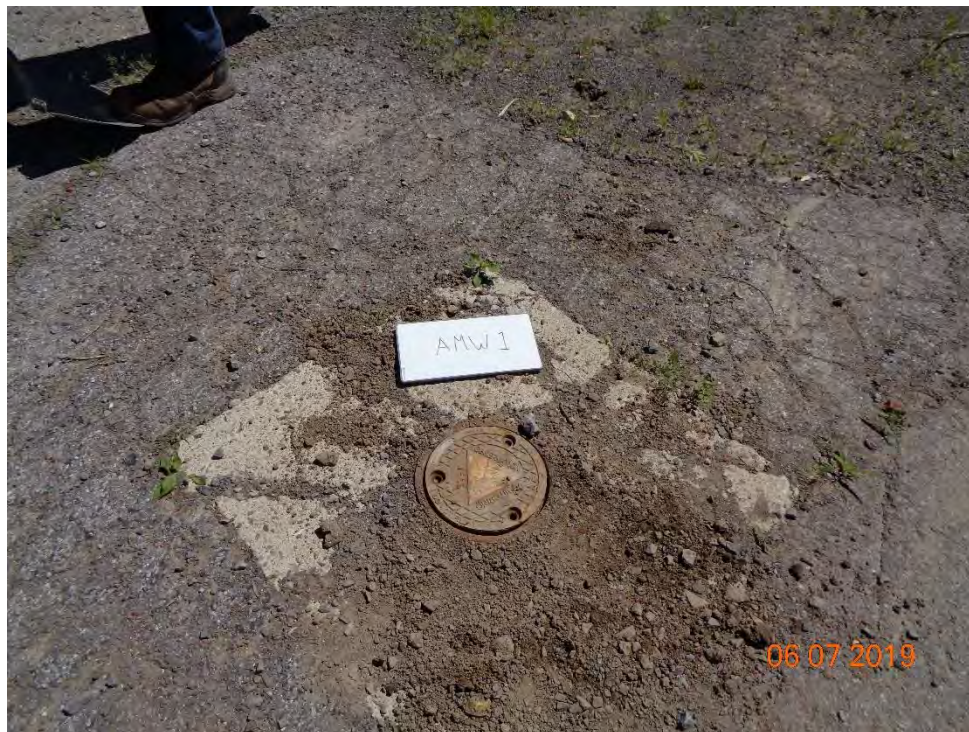
Photo 80 - View of AMW1 after placing salvaged cover from dislodged casing of PZ104D
