Date: October 20, 2023
Our Ref: 30141863 / 30152100
Subject: **Well Abandonment Completion Report**
Northern Cold Springs Terminal
Hillside Road, Lysander, New York

NORTHERN COLD SPRINGS TERMINAL
 LYSANDER, NEW YORK
WELL ABANDONMENT COMPLETION REPORT

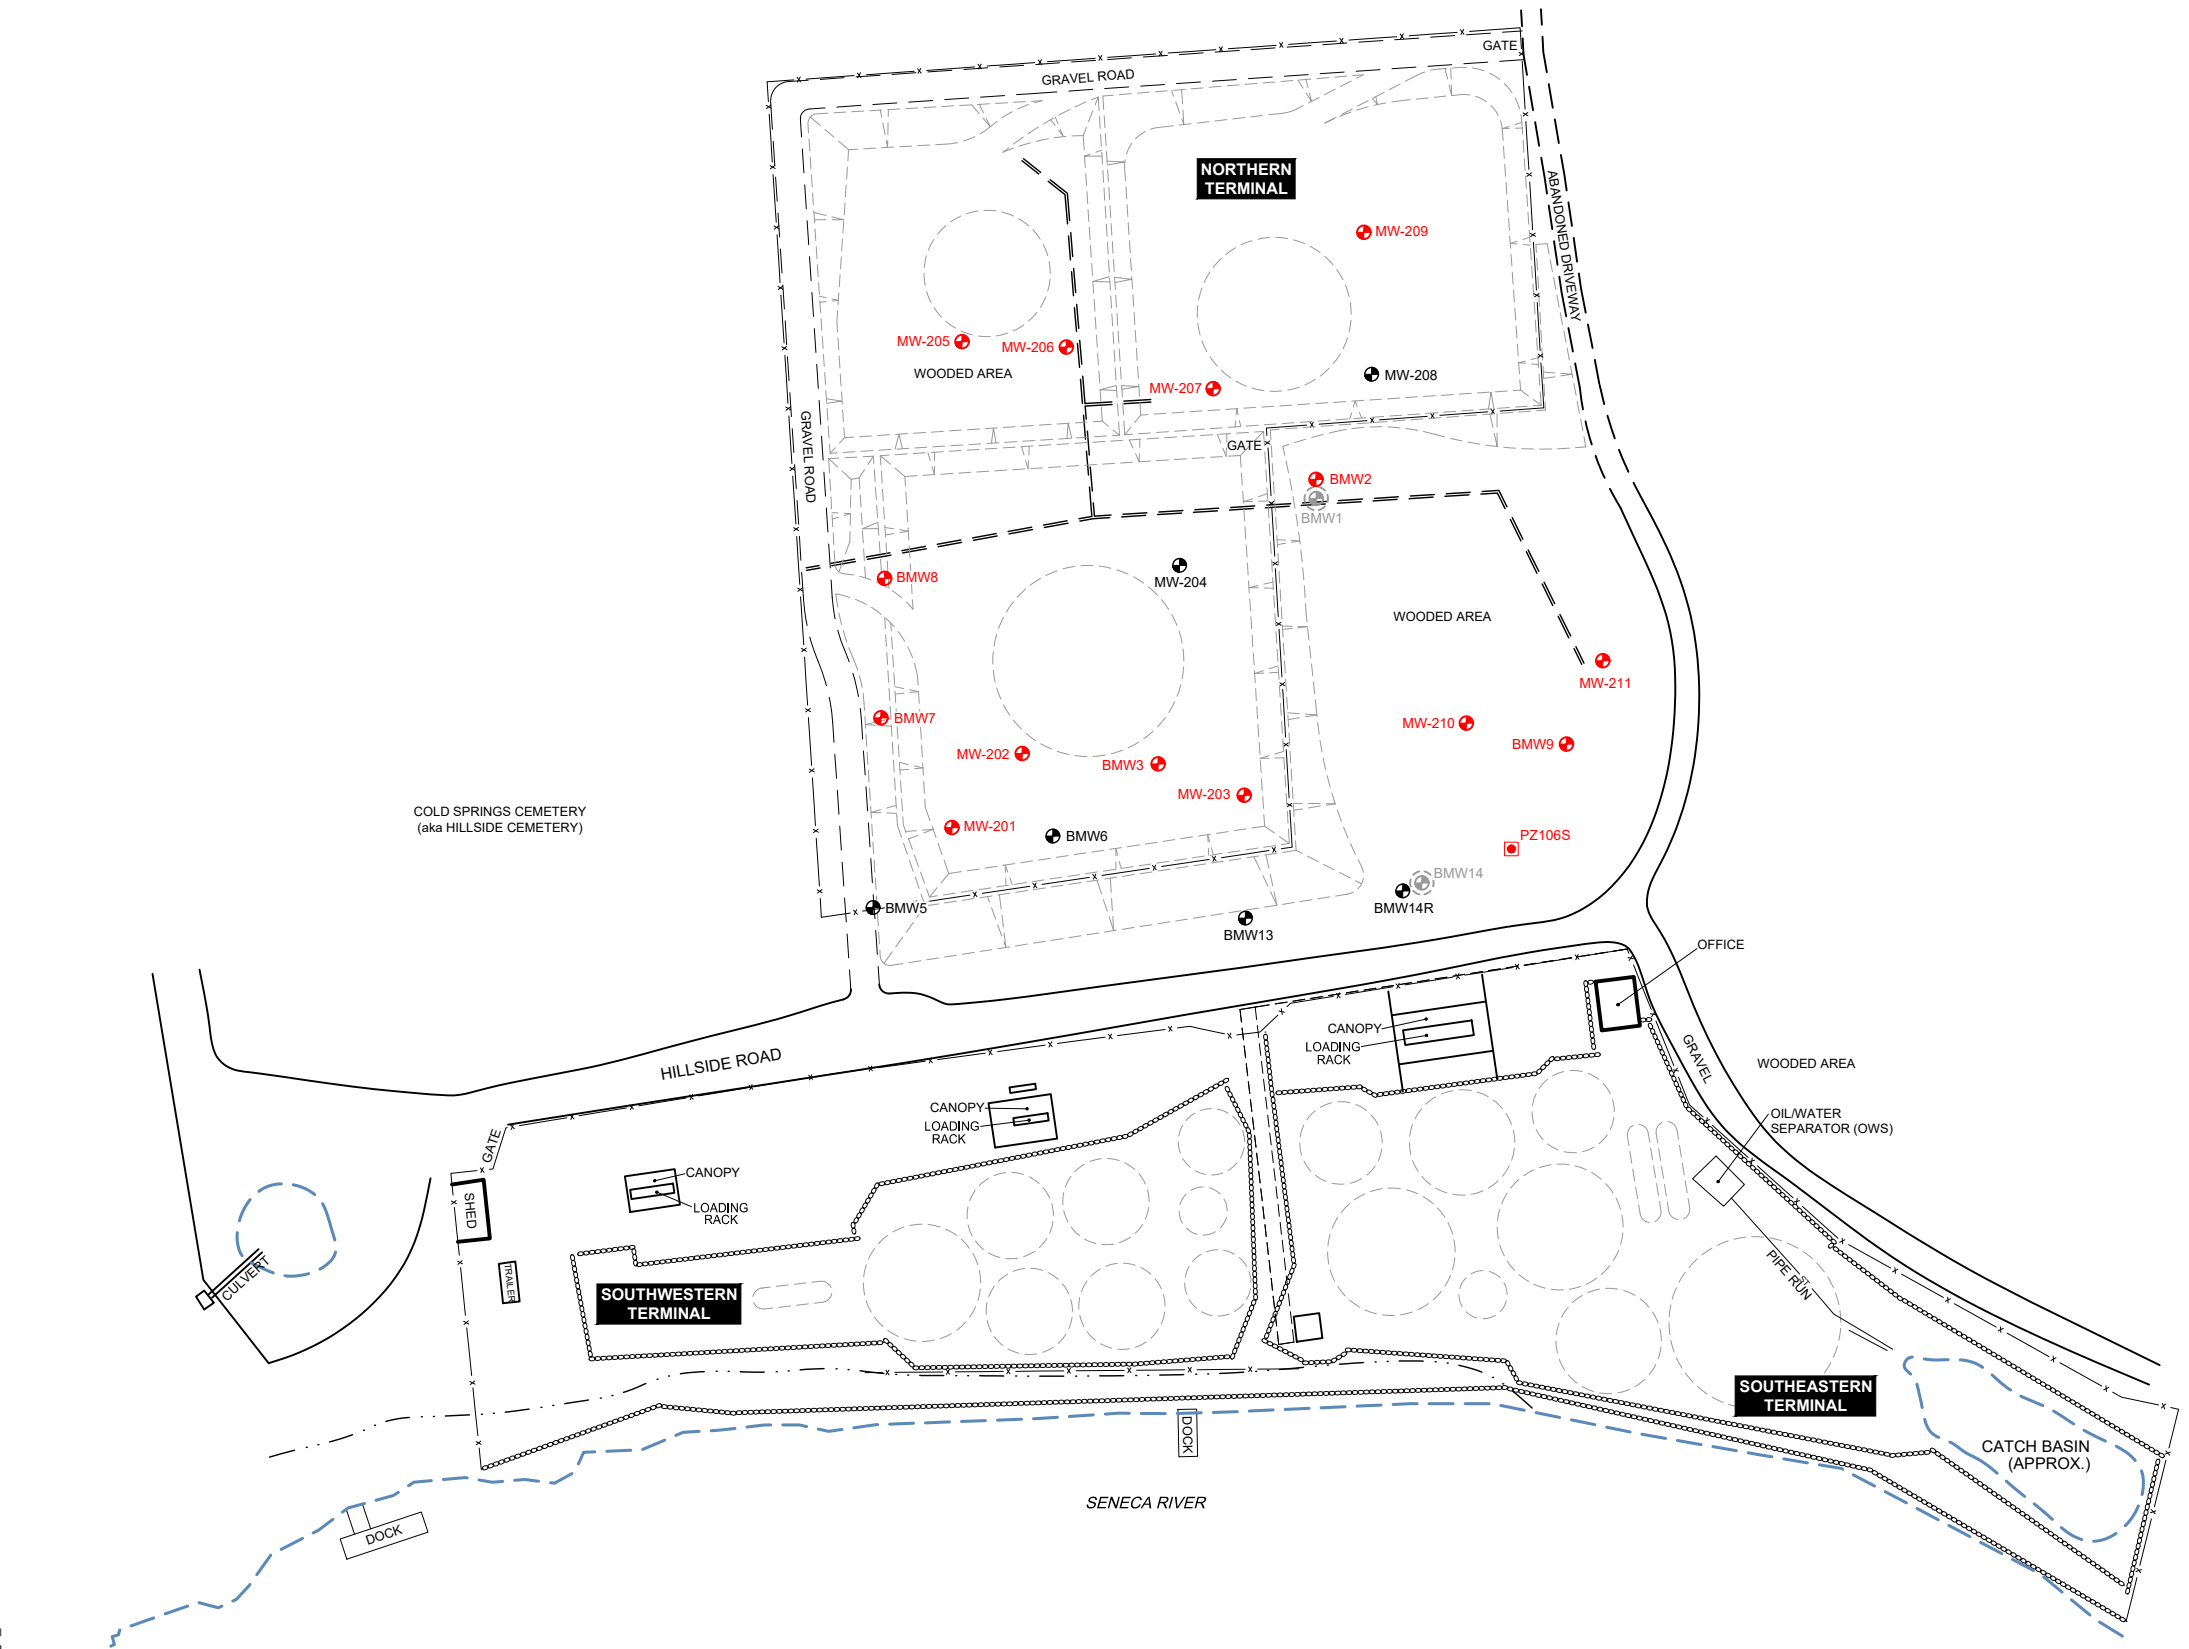
FIGURE
2

Figure 2 presents the locations of wells that were abandoned. Wells abandoned during the event included BMW2, BMW3, BMW7, BMW8, BMW9, MW-201, MW-202, MW-203, MW-205, MW-206, MW-207, MW-209, MW-210, MW-211, and PZ106S.

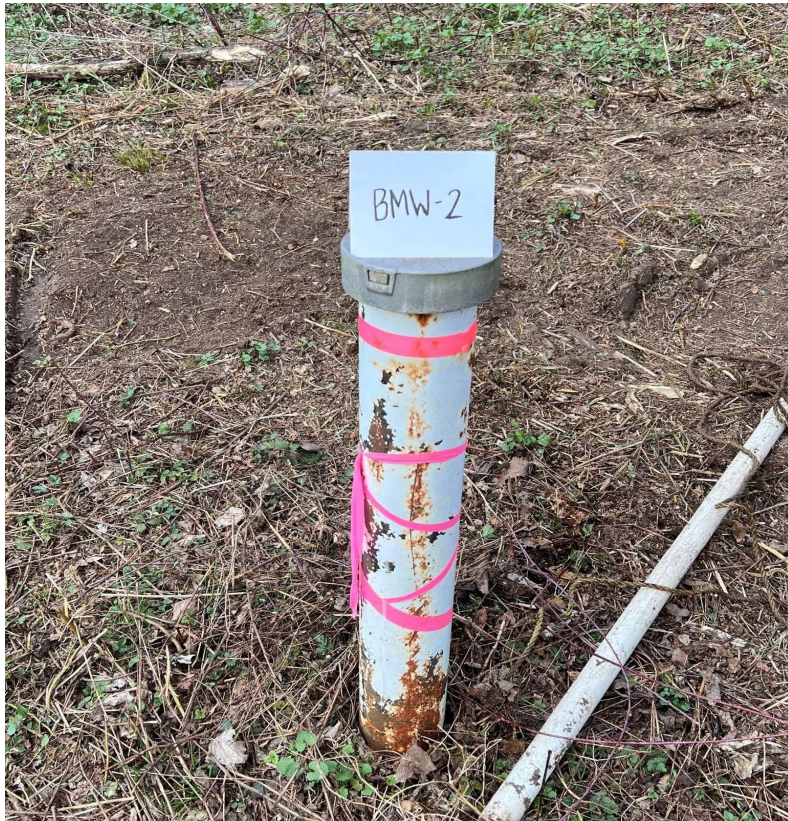
Photograph No. 1: BMW2 Pre abandonment 04/12/2023

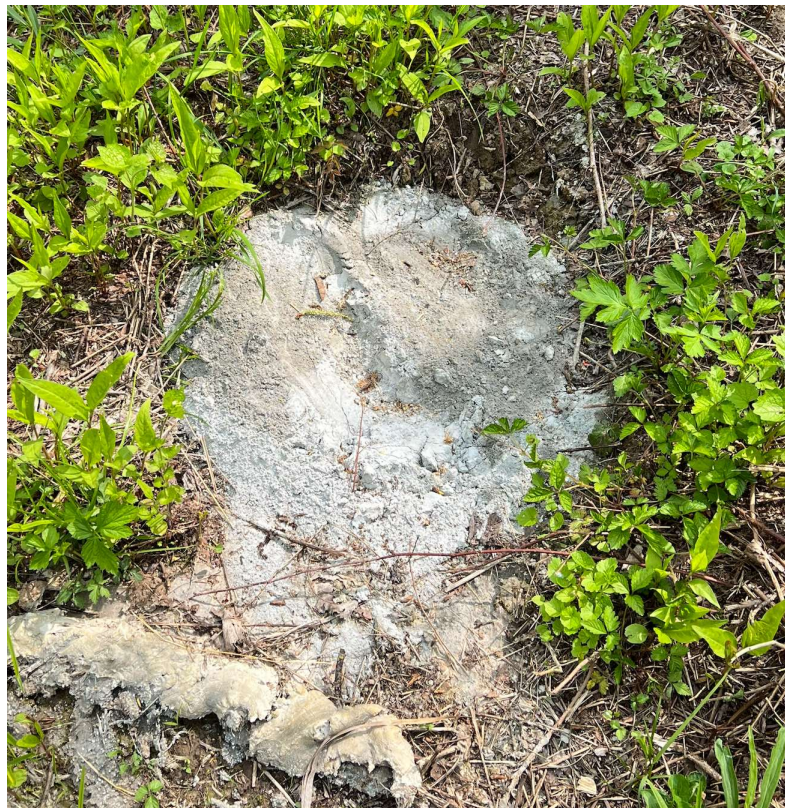
Photograph No. 2: BMW2 Post abandonment 05/09/2023

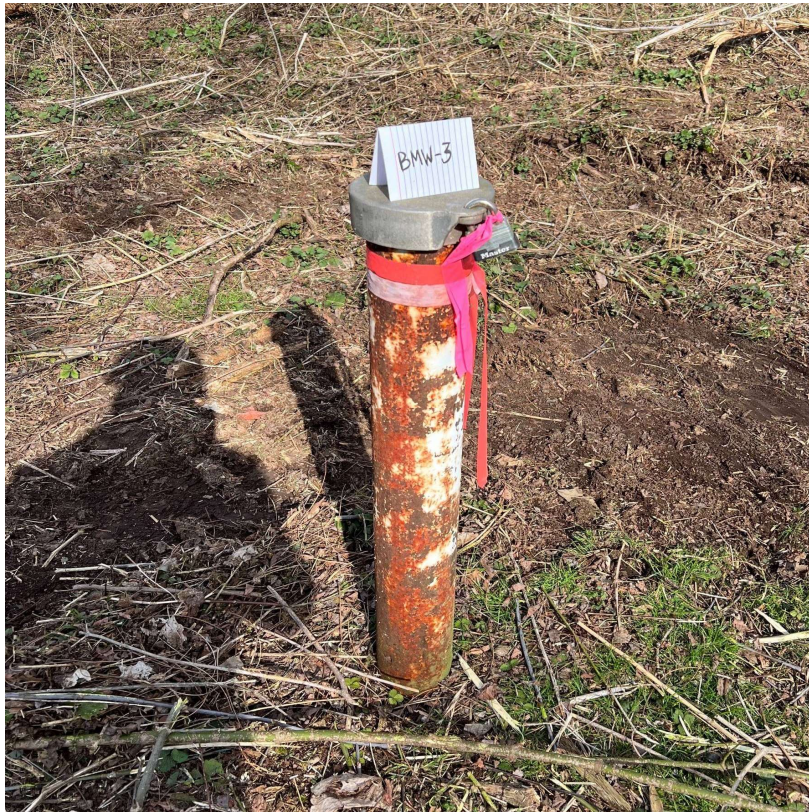
Photograph No. 3: BMW3 Pre abandonment 04/11/2023

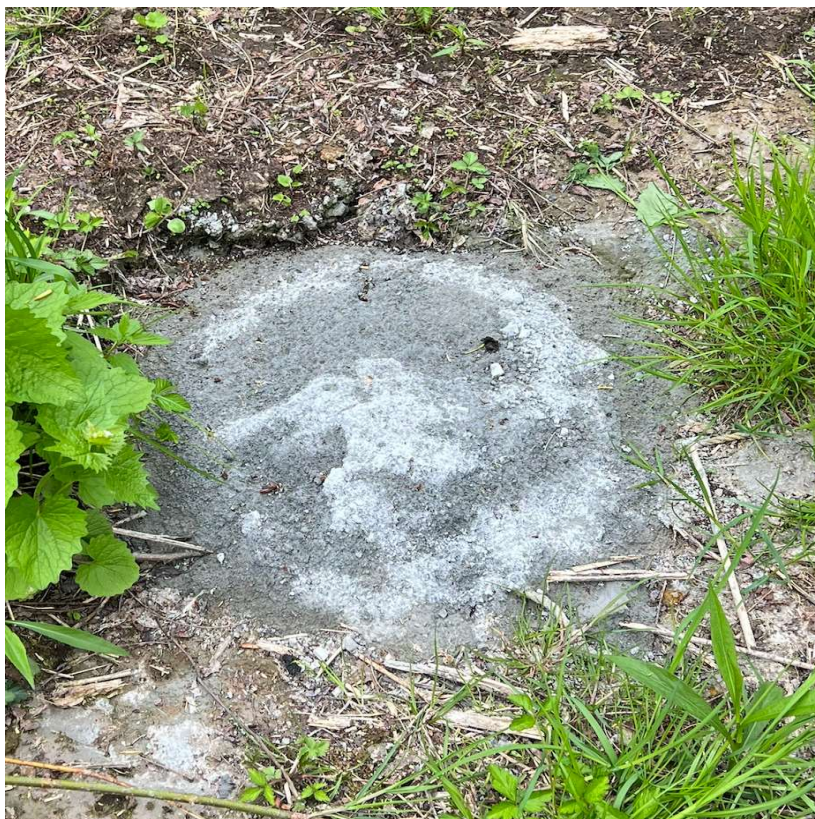
Photograph No. 4: BMW3 Post abandonment 05/09/2023

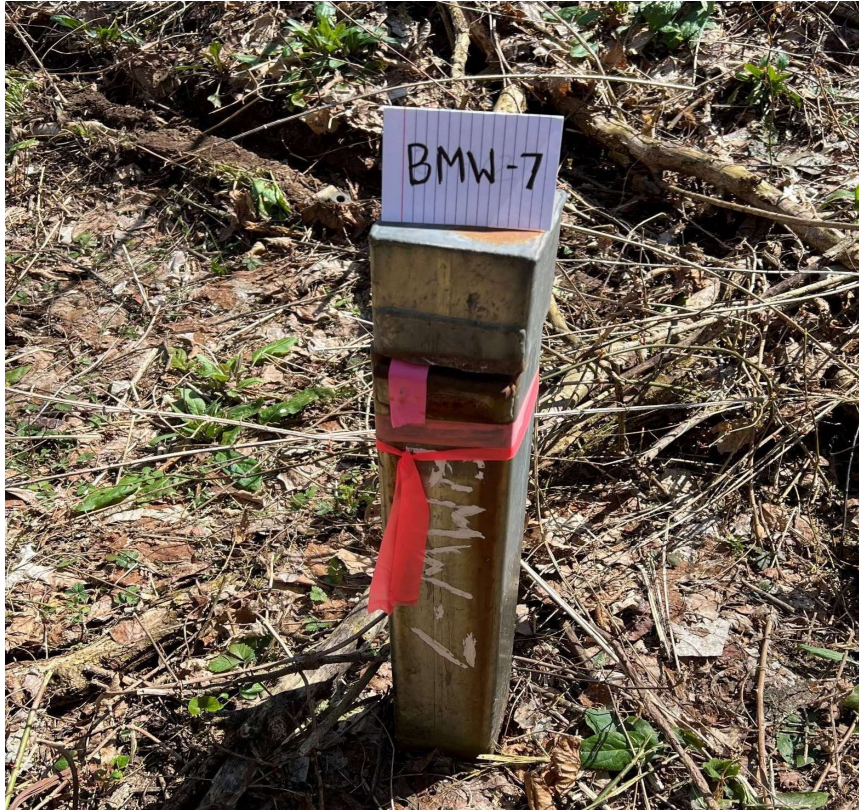
Photograph No. 5: BMW7 Pre abandonment 04/12/2023

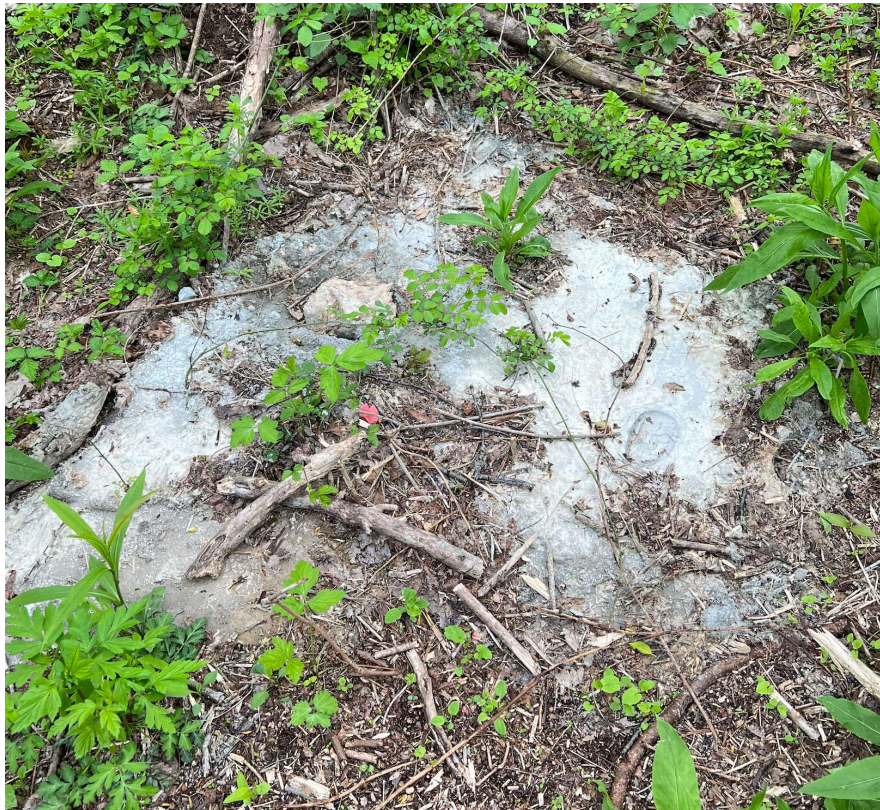
Photograph No. 6: BMW7 Post abandonment 05/09/2023

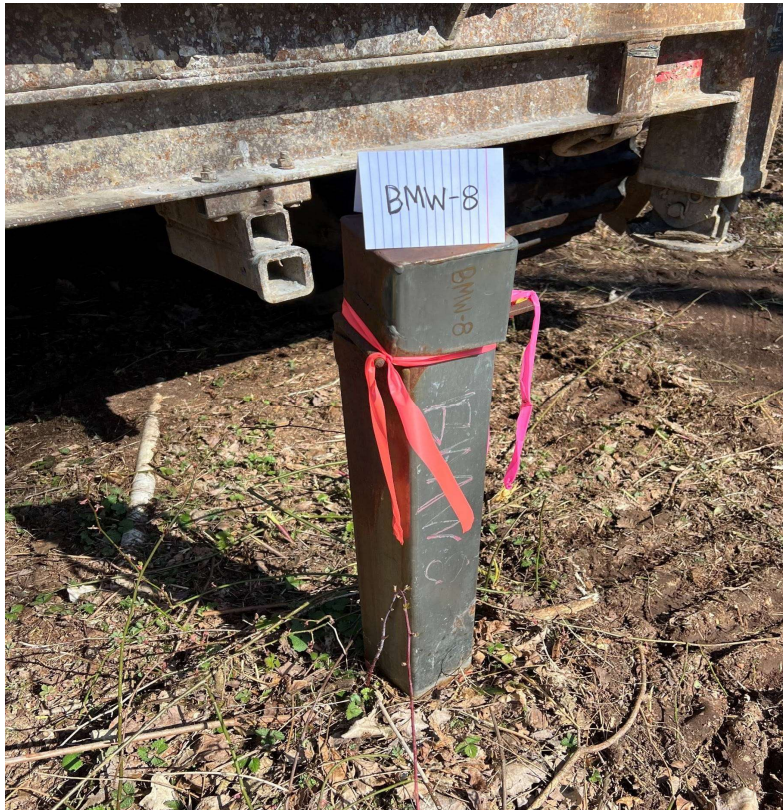
Photograph No. 7: BMW8 Pre abandonment 04/10/2023

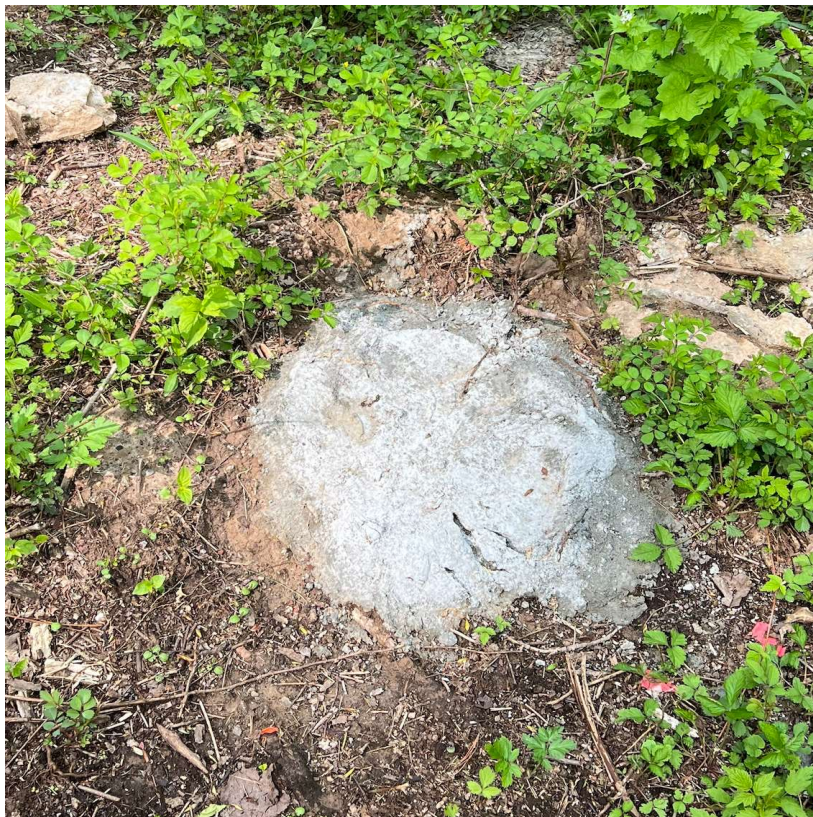
Photograph No. 8: BMW8 Post abandonment 05/09/2023

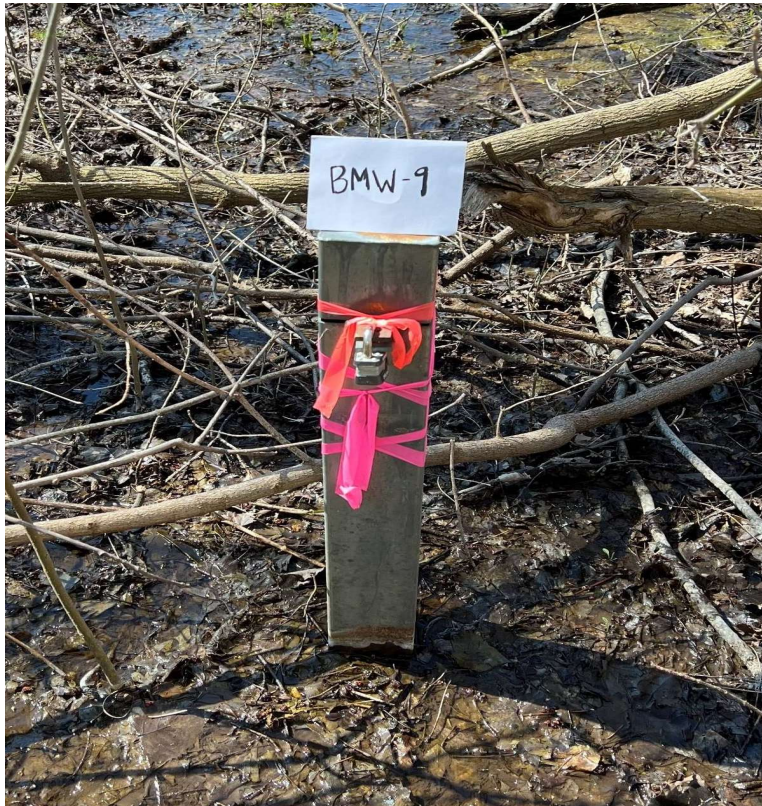
Photograph No. 9: BMW9 Pre abandonment 04/12/2023

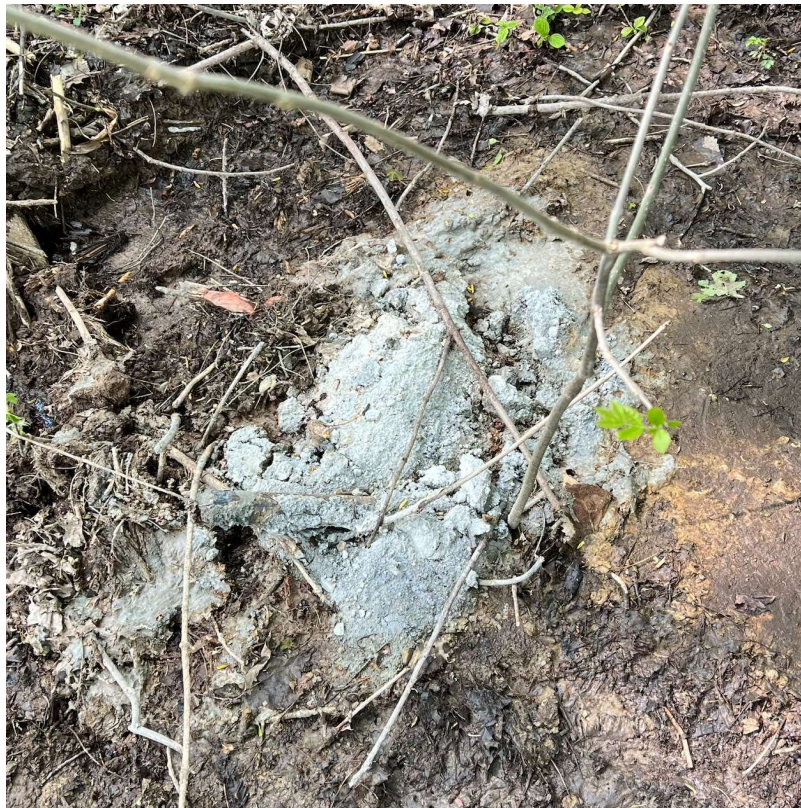
Photograph No. 10: BMW9 Post abandonment 05/09/2023

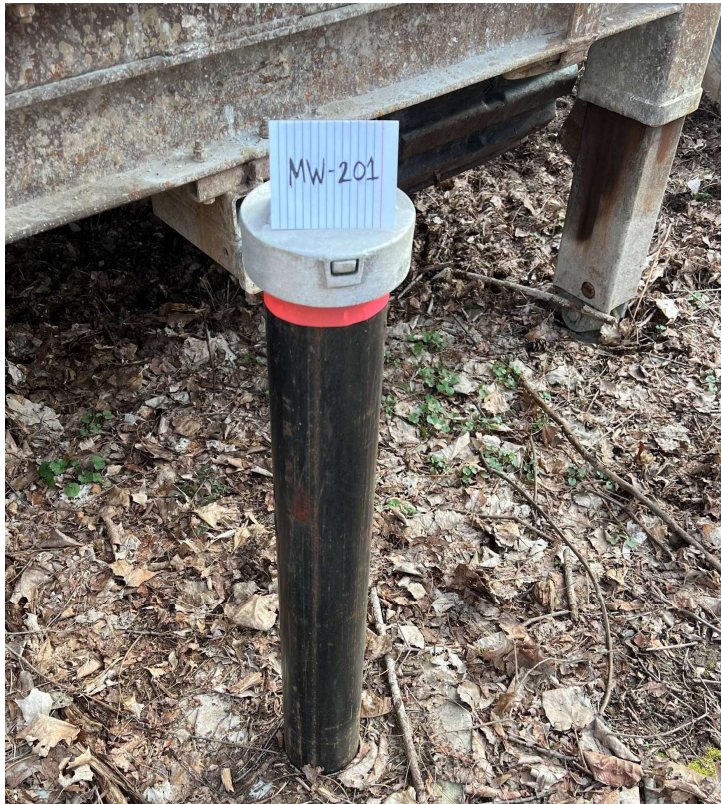
Photograph No. 11: MW-201 Pre abandonment 04/11/2023

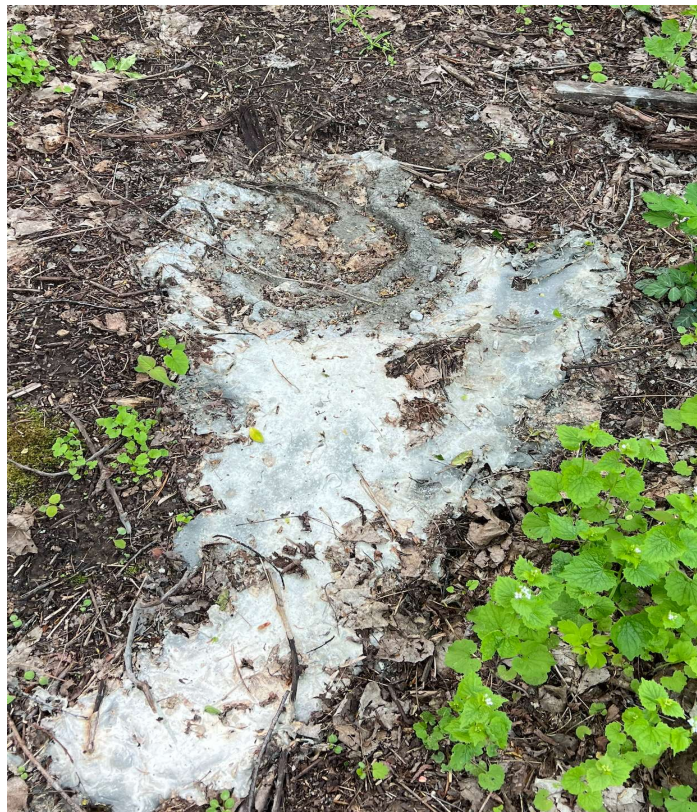
Photograph No. 12: MW-201 Post abandonment 05/09/2023

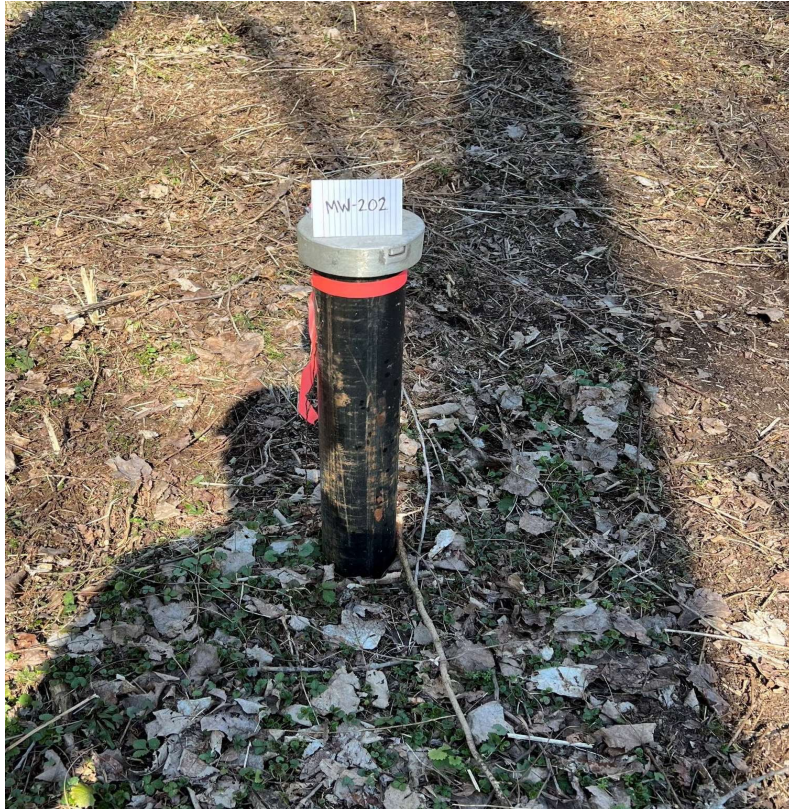
Photograph No. 13: MW-202 Pre abandonment 04/10/2023

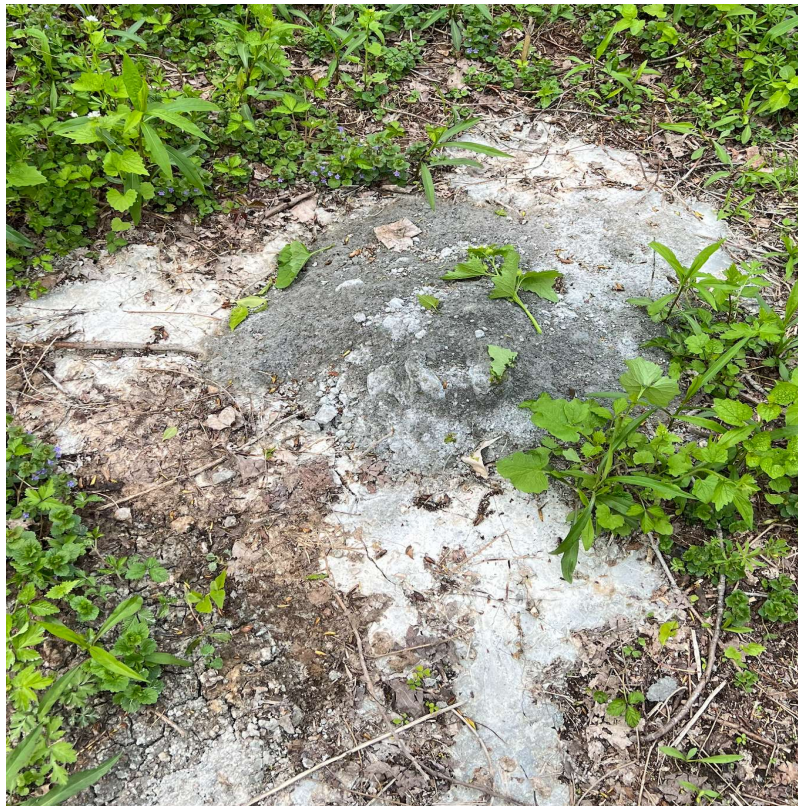
Photograph No. 14: MW-202 Post abandonment 05/09/2023

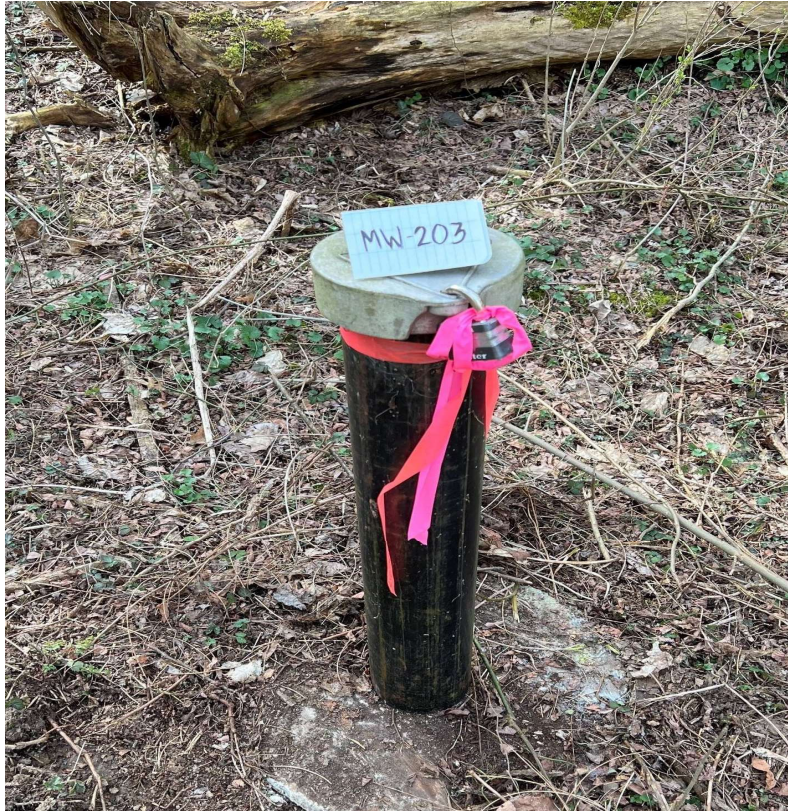
Photograph No. 15: MW-203 Pre abandonment 04/11/2023

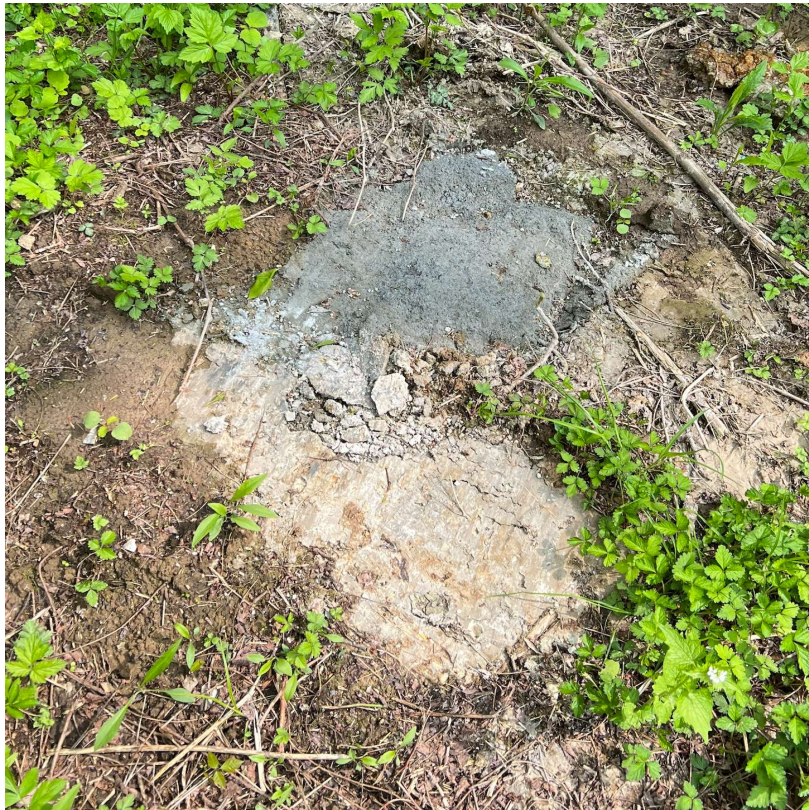
Photograph No. 16: MW-203 Post abandonment 05/09/2023

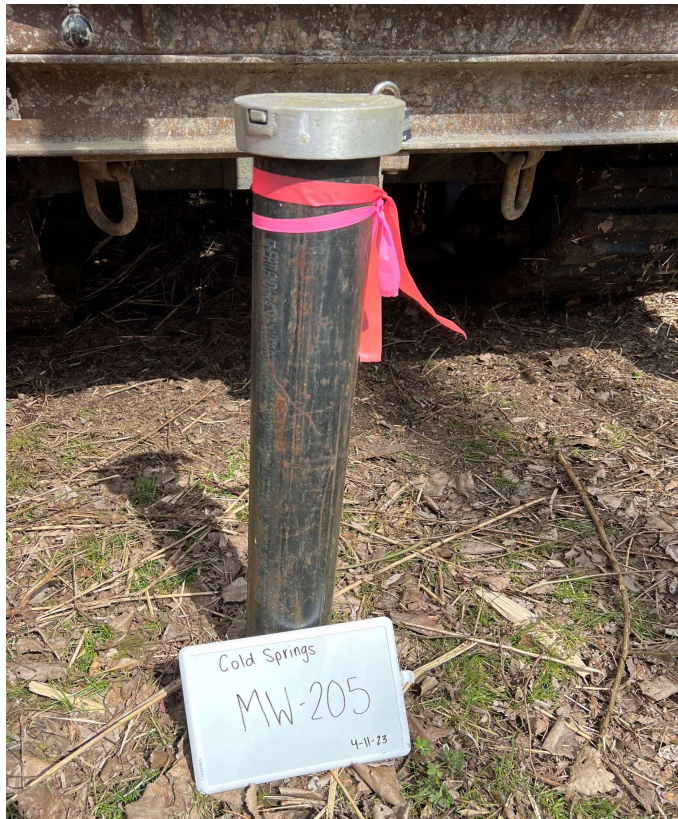
Photograph No. 17: MW-205 Pre abandonment 04/11/2023

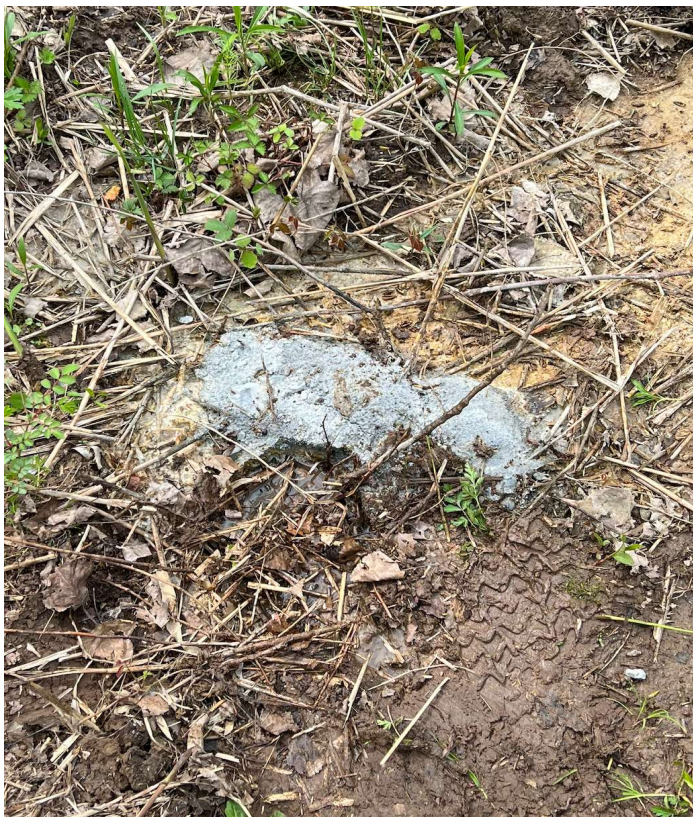
Photograph No. 18: MW-205 Post abandonment 05/09/2023

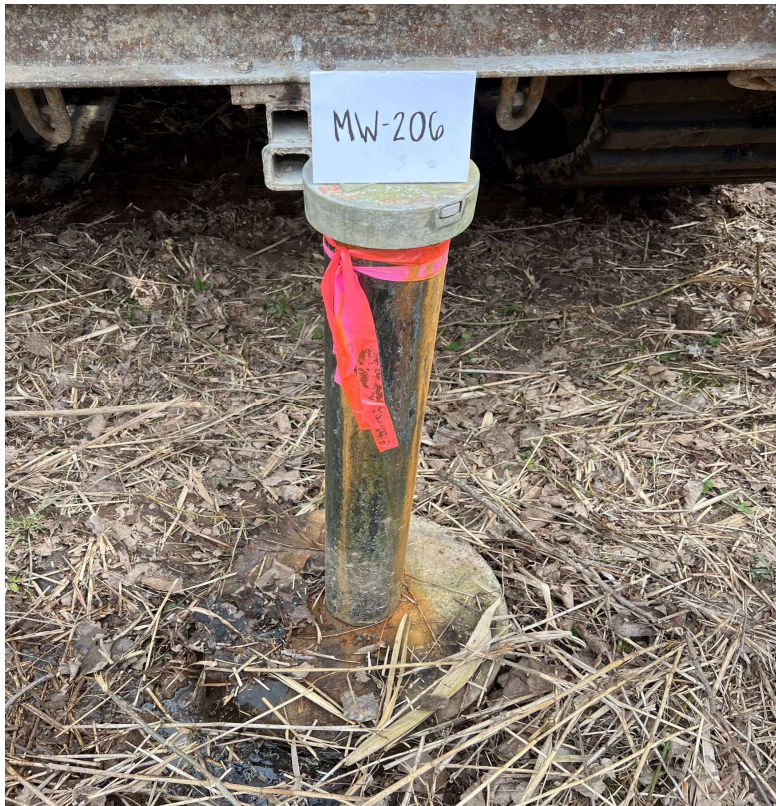
Photograph No. 19: MW-206 Pre abandonment 04/11/2023

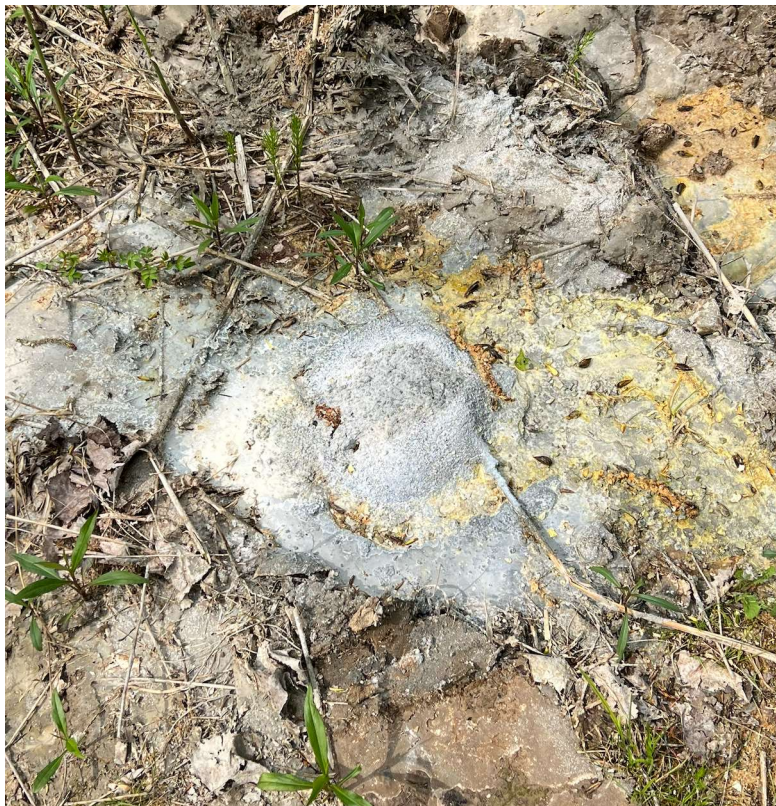
Photograph No. 20: MW-206 Post abandonment 05/09/2023

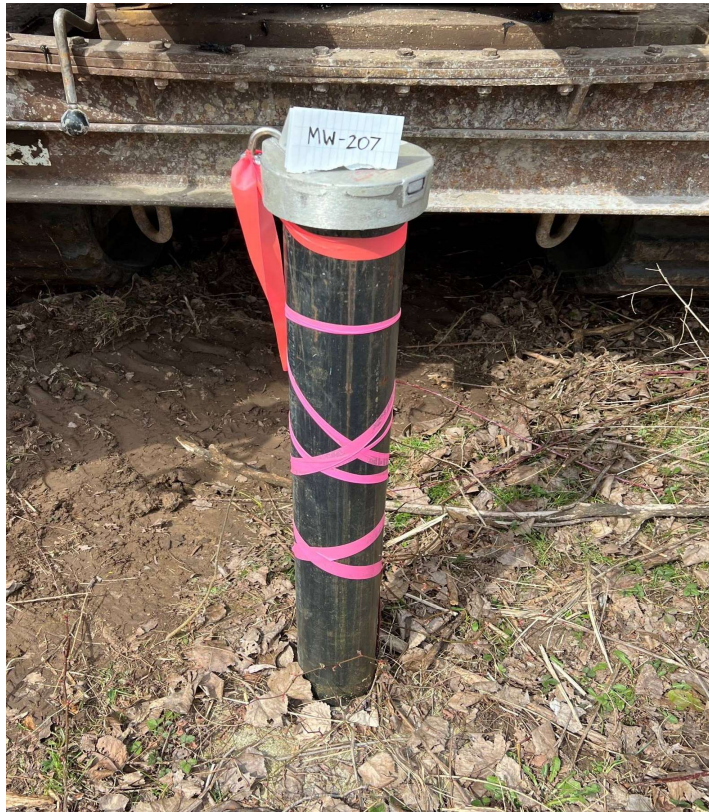
Photograph No. 21: MW-207 Pre abandonment 04/11/2023

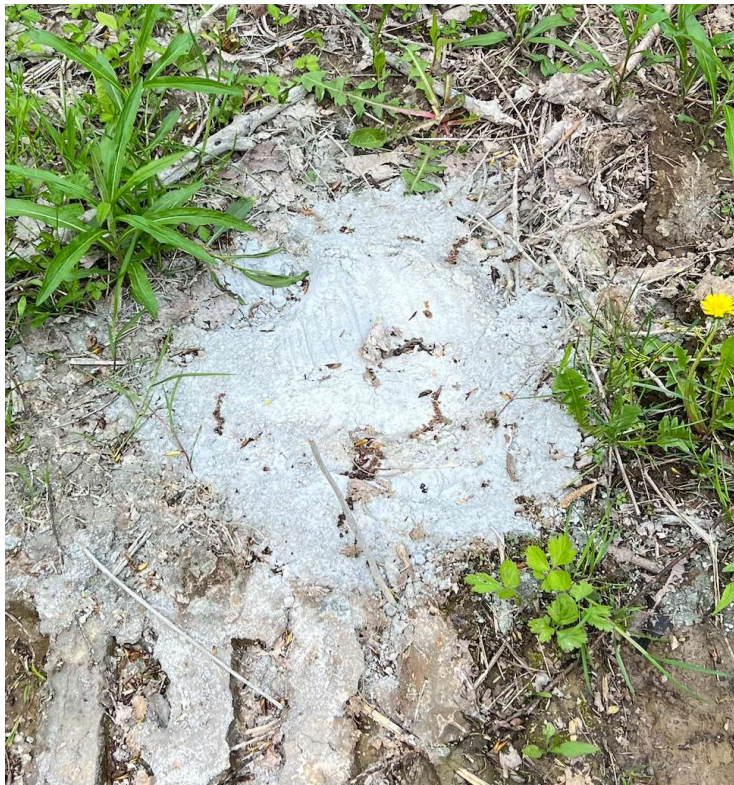
Photograph No 22: MW-207 Post abandonment 05/09/2023

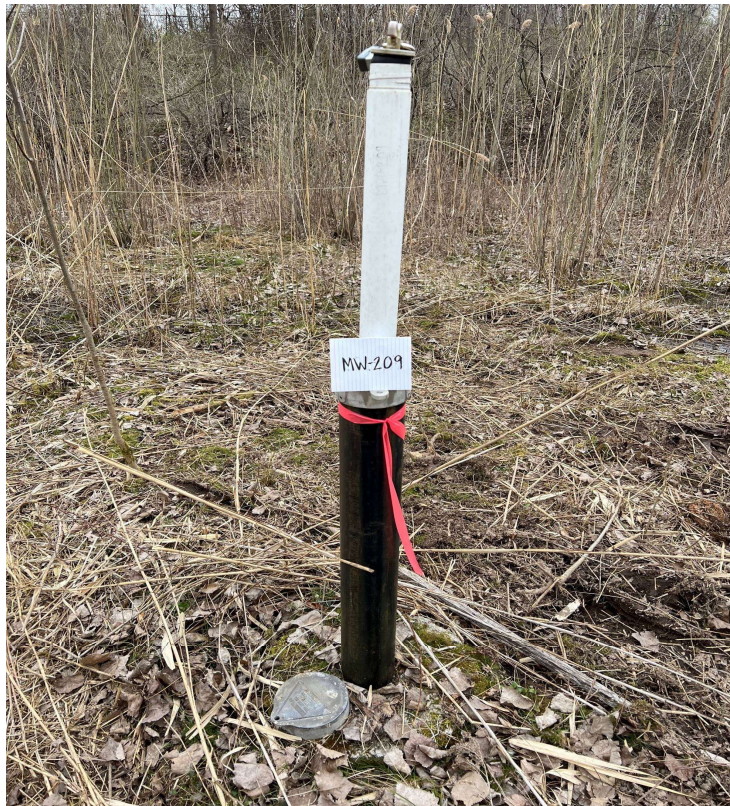
Photograph No. 23: MW-209 Pre abandonment 04/11/2023

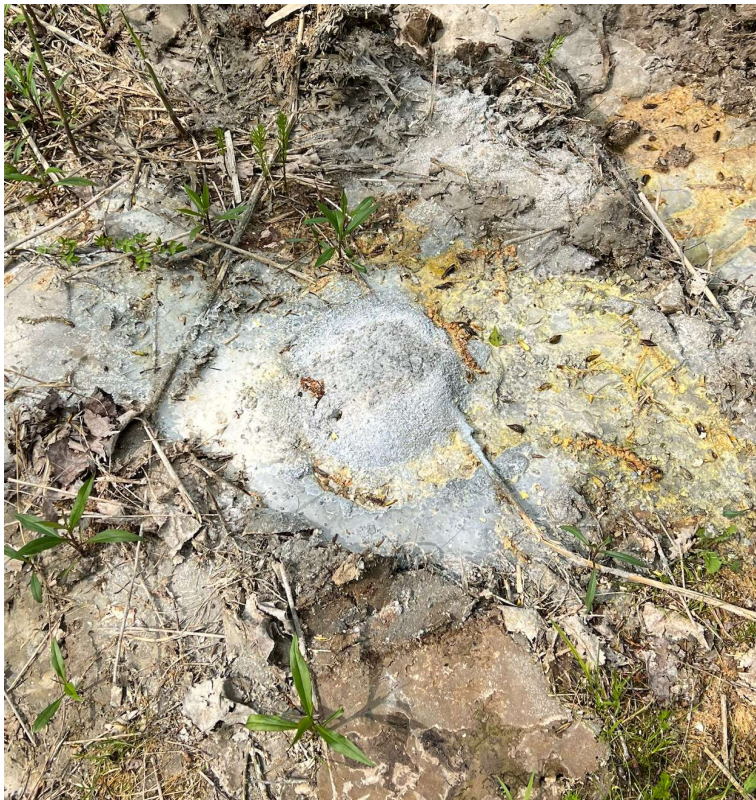
Photograph No. 24: MW-209 Post abandonment 05/09/2023

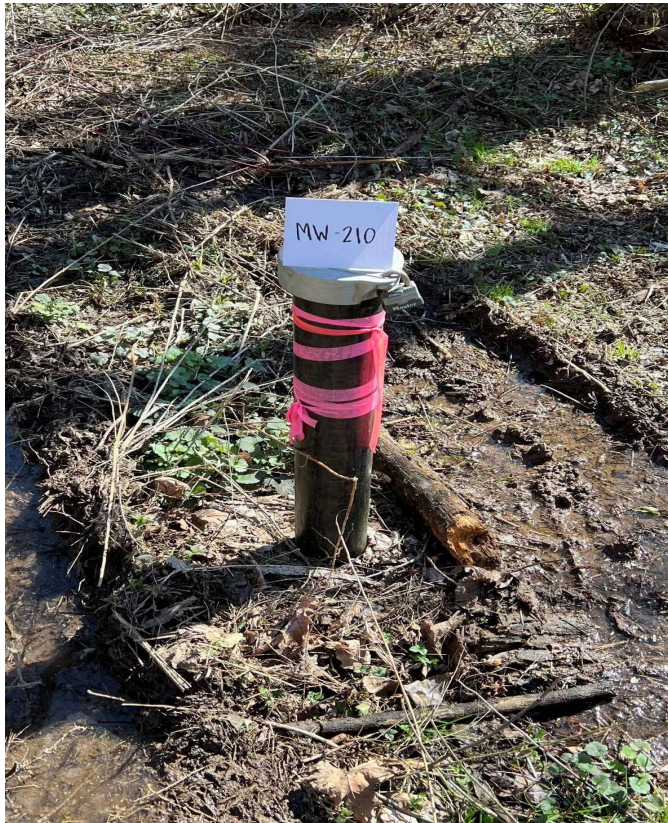
Photograph No. 25: MW-210 Pre abandonment 04/12/2023

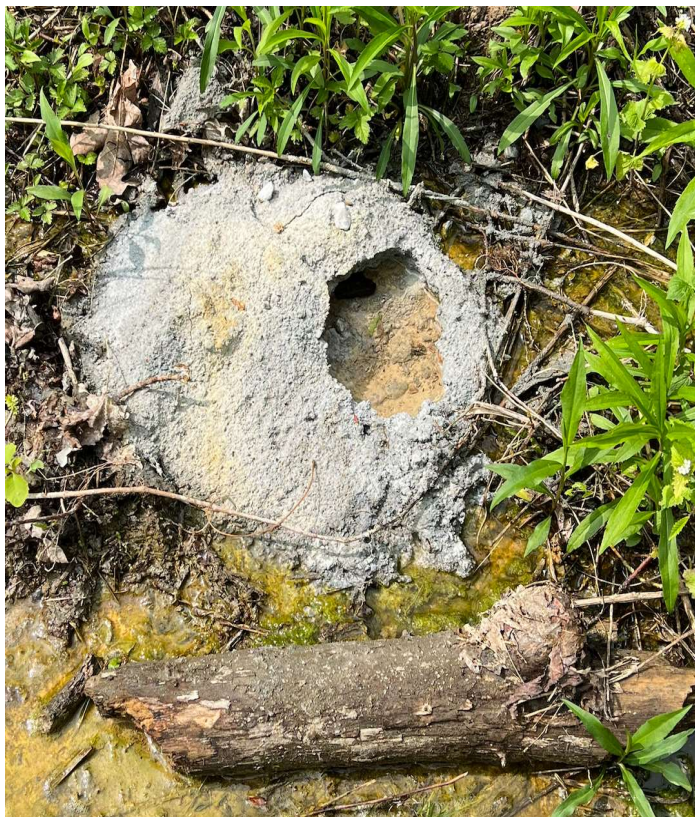
Photograph No. 26: MW-210 Post abandonment 05/09/2023

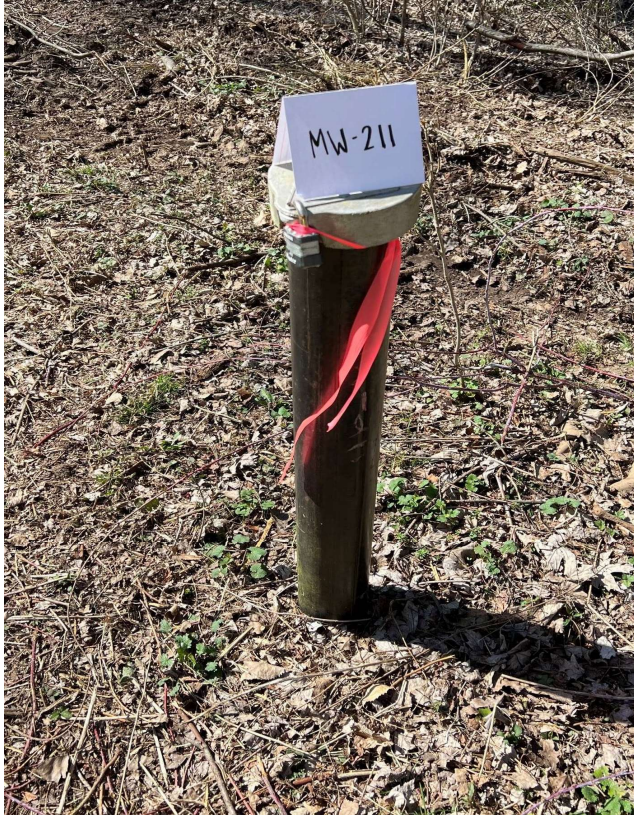
Photograph No. 27: MW-211 Pre abandonment 04/12/2023

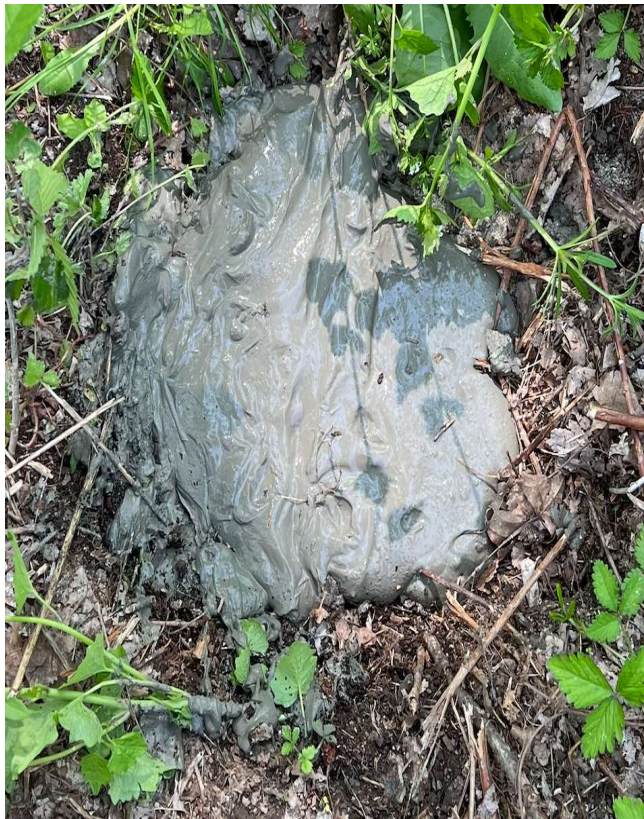
On May 10, 2023, Arcadis conducted a post abandonment site walk and area inspection, in which one (1) former monitoring well (MW-211) of the 15 former monitoring wells previously abandonment required additional

Photograph No. 28: MW-211 Post abandonment 05/09/2023

abandonment material. Parratt-Wolff was able to mobilize to the site the same day and successfully added additional Portland cement and bentonite clay mixture to former MW-211 location.

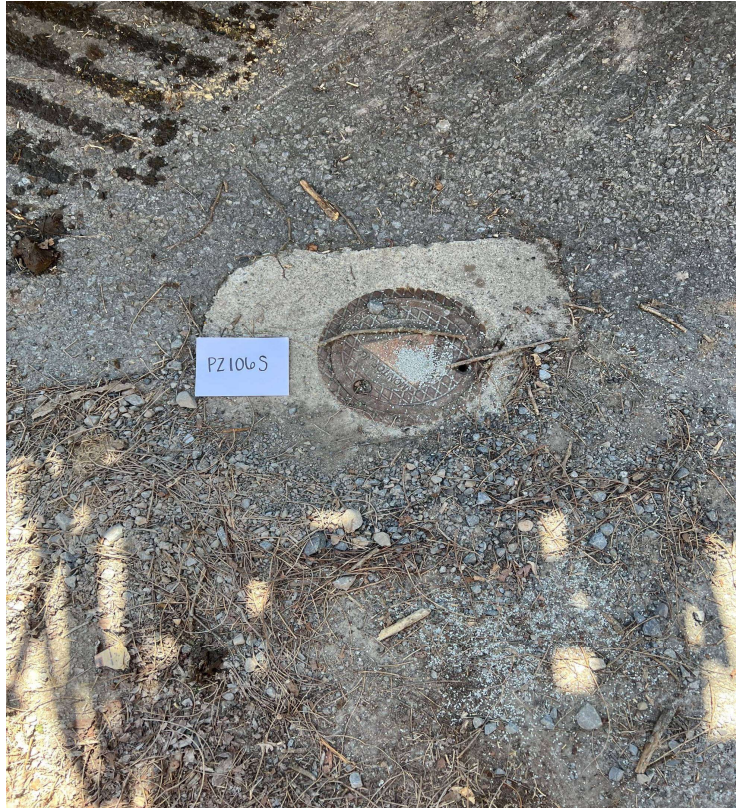
Photograph No. 29: PZ106S Pre abandonment 04/12/2023

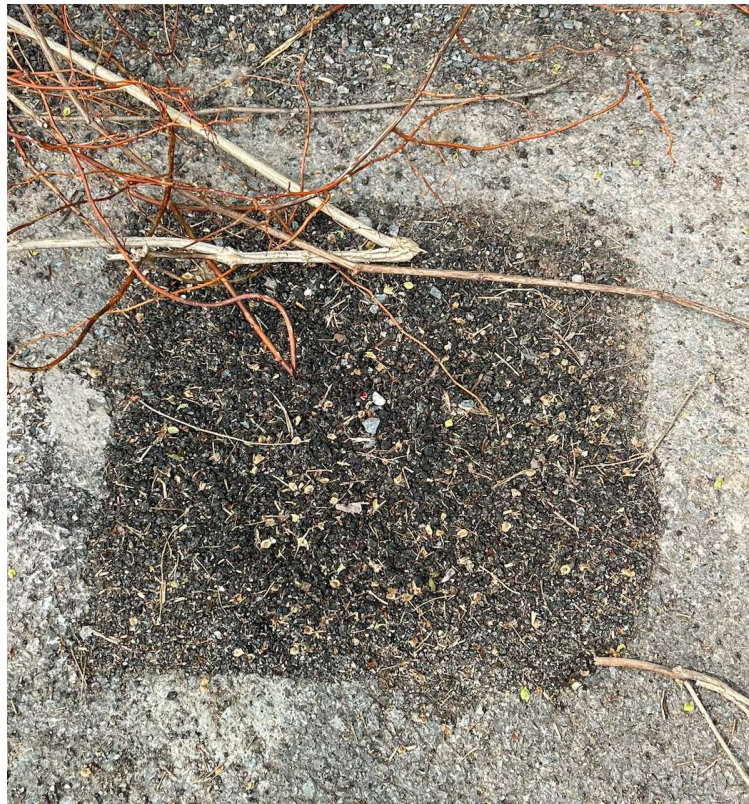
Photograph No. 30: PZ106S Post abandonment 05/09/2023
