Asbestos Survey Report

**Speedy's Cleaners
190 Court Street
Rochester, New York 14604**

MM&A Project No.: 932-17

ASBESTOS SURVEY SUMMARY

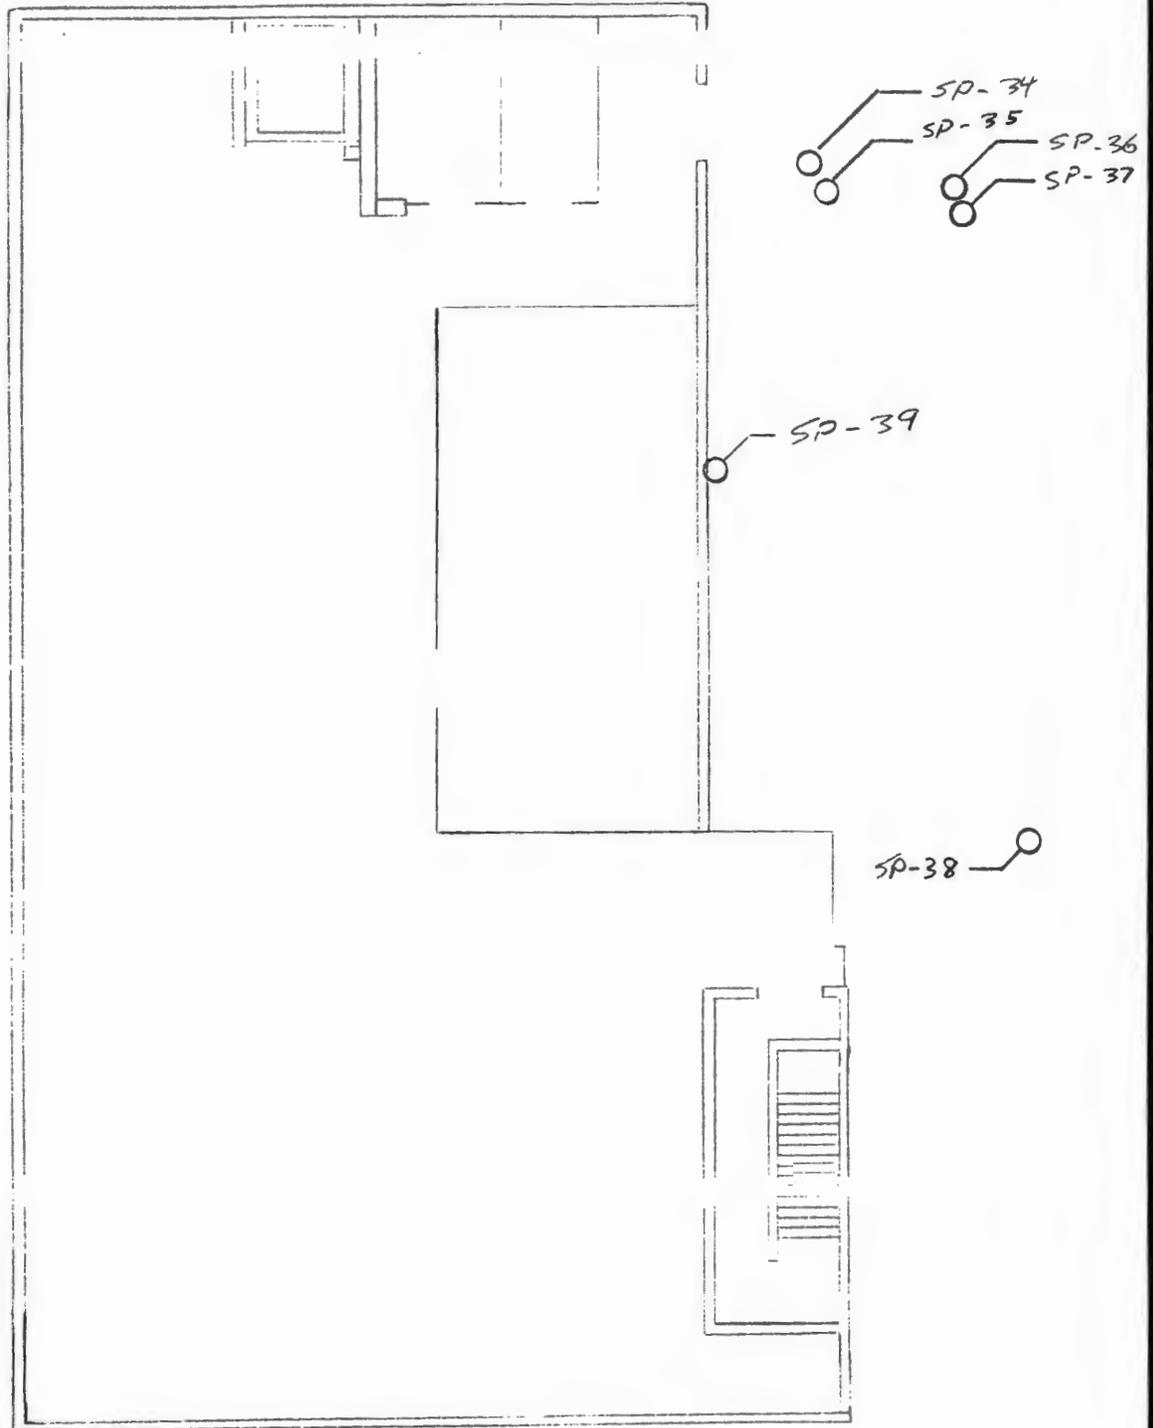
DRAWING: *ROOF SAMPLES*

The flashing/patching materials (both gray/black and silver) were found to contain greater than 1% asbestos, as was the asphalt roll roofing.

Built-up roofing material was found to contain trace (less than 1%) asbestos in one layer, and was not detected in other samples.

Based on the results detailed above, MM&A recommends that the rolled roofing and all flashing be treated as asbestos containing.

TEM confirmation testing of the built-up roofing materials should be made prior to treating these materials as non-asbestos.

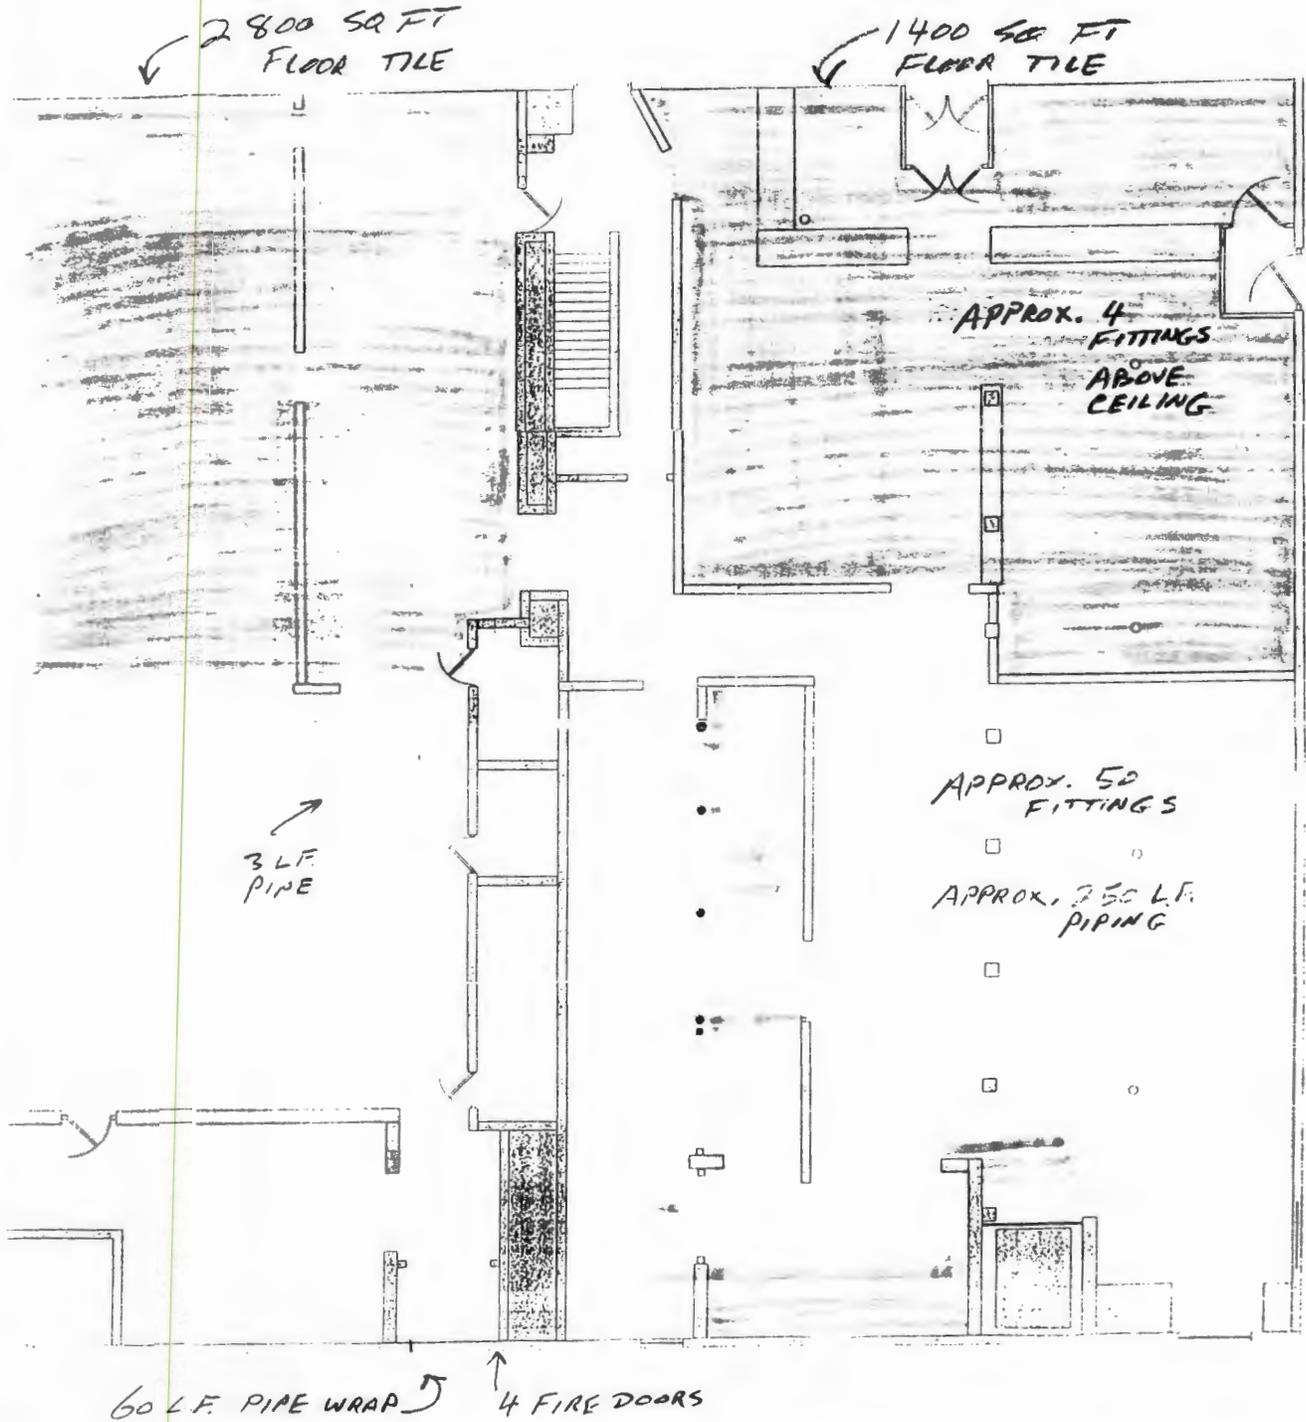
DRAWING: *ASBESTOS LOCATIONS*

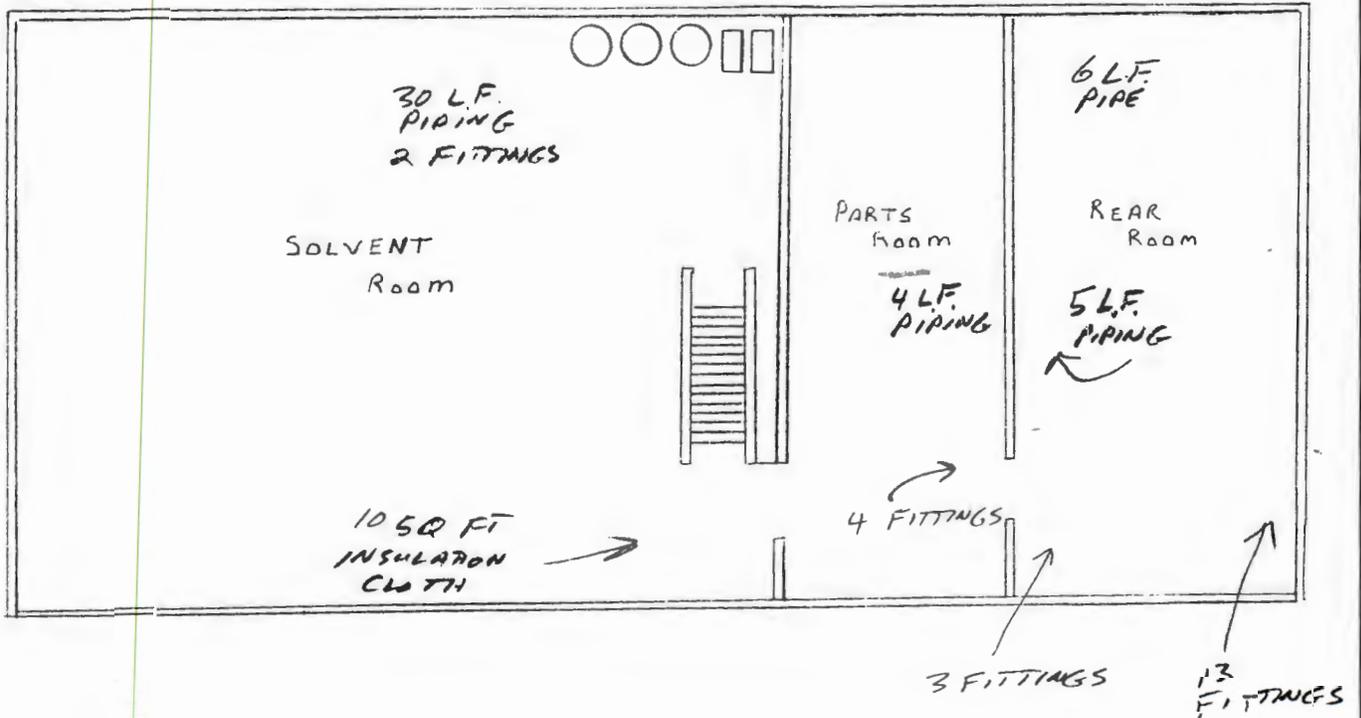
BASEMENT LEVEL

Only the white paper material in the basement on several floor joists was found to contain asbestos.

White paper insulation on basement floor joists must be treated as asbestos containing.
