Site Management Periodic Review Report and IC/EC Certification (2025)

Front Street Former MGP Site (V00073-8)
City of Rochester, Monroe County, New York

2025 River Wall, Annual Site-wide, and Storm Water Infiltration System Inspection Report

Subject: 2025 River Wall, Annual Site-wide, and Storm Water Infiltration System Inspection Report
RG&E Front Street Former MGP Site
Corner of Front and Andrews Street
City of Rochester, Monroe County, New York
NYSDEC Site #V00073-8

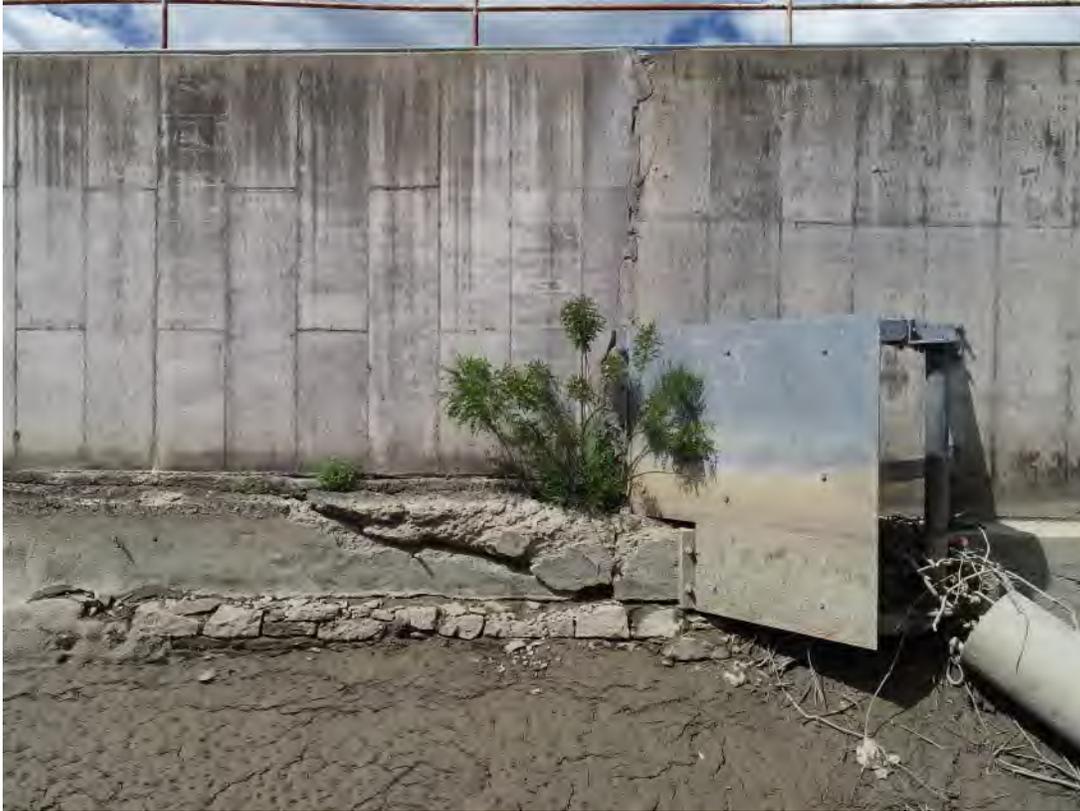
Downstream end of River Wall - North/Downstream of Column 1 and Near Groundwater Monitoring Wells "MW-9S" & "MW-9D"

- North of Column 1 (northern Gunite application area) – There was fine sediment and a small amount debris (mostly wood) present on the lower bedrock shelf. The Gunite application and newer section of River Wall are in good condition. No impacts observed from visual inspection of sediment in the area.

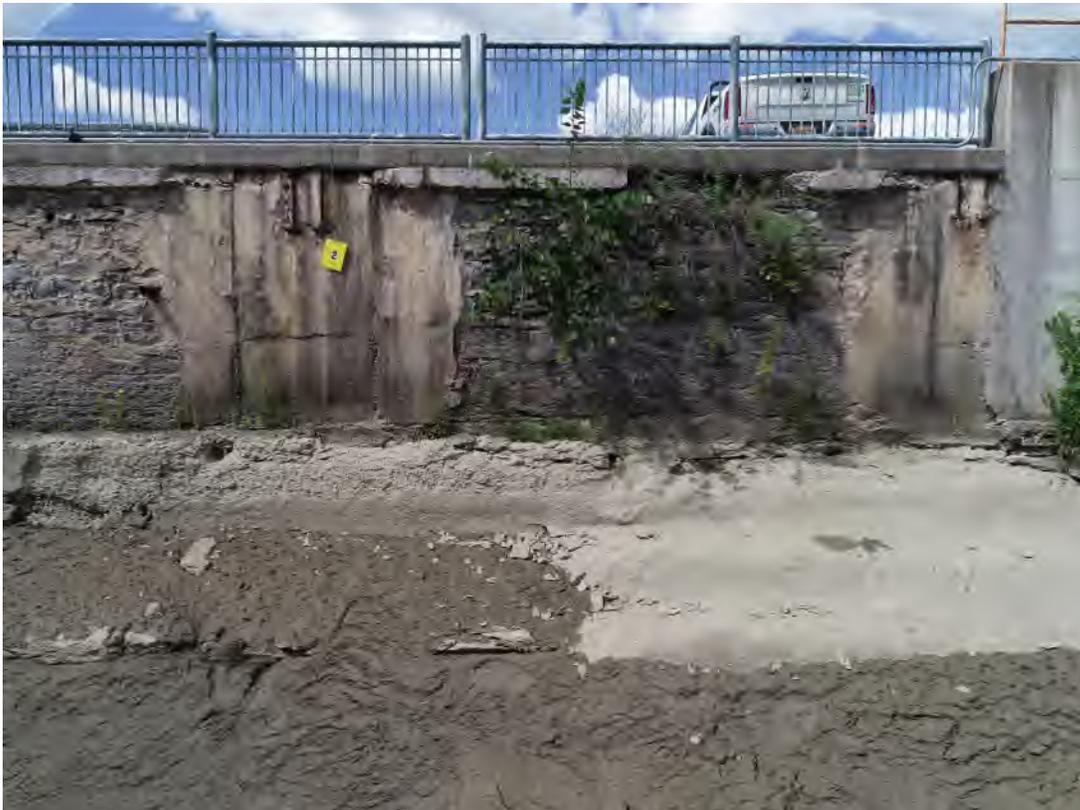
Area Between Columns 1 & 3

- Column 1 to 2 (northern Gunite application area) – Sediment is present. No observed impacts. Some minor Gunite erosion observed. No repairs warranted and/or recommended for the Gunite at this time.

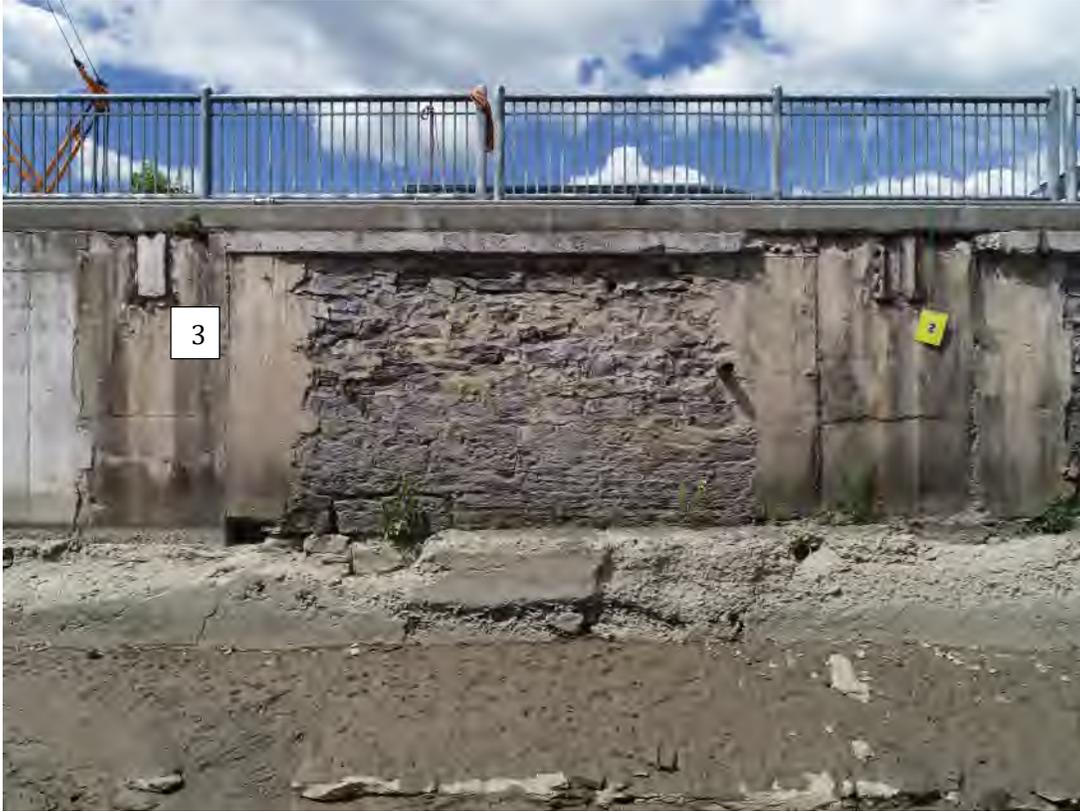
Area Between Columns 2 & 3

- Column 2 to 3 – Sediment is present on the lower bedrock shelf. No MGP-related impacts were observed.
- Column 3 to 4 - (new cast-in-place concrete wall section) – Sediment is present on lower bedrock shelf. No MGP-related impacts were observed.

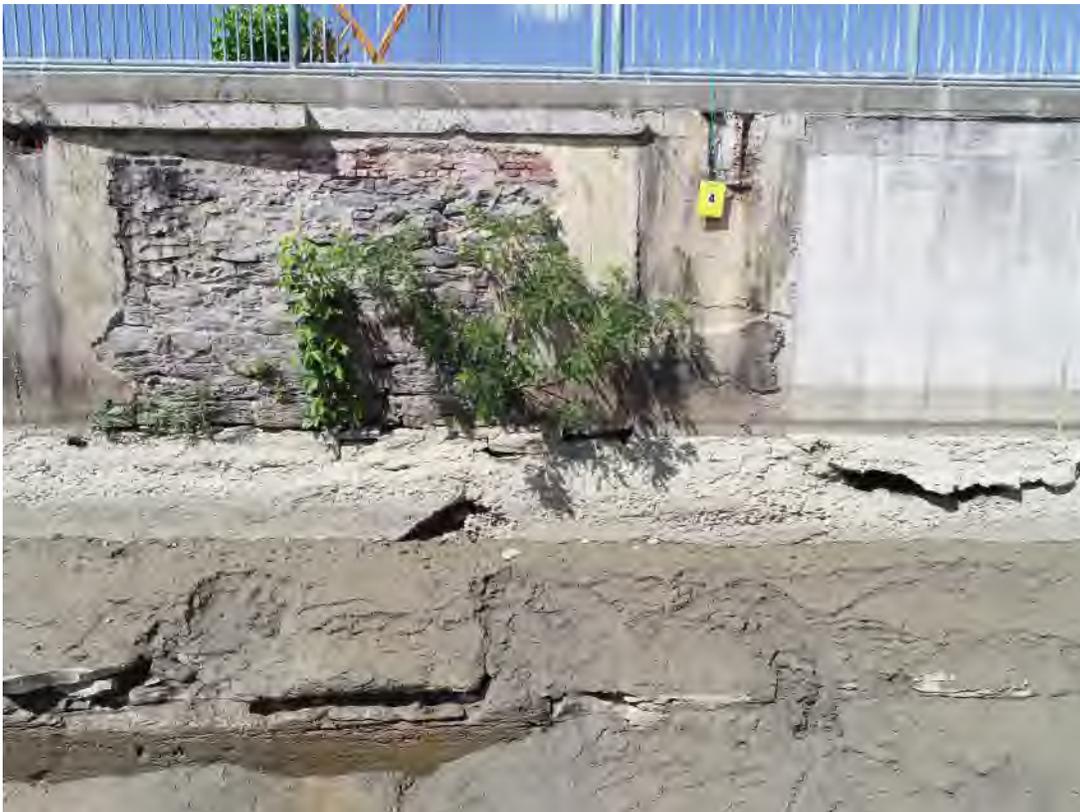
Vicinity of Columns 4 & 5

- Column 4 to 8 – Sediment is present on the lower bedrock shelf. Some erosion/scouring of lower foundation wall was observed proximal to (south of) column 4.

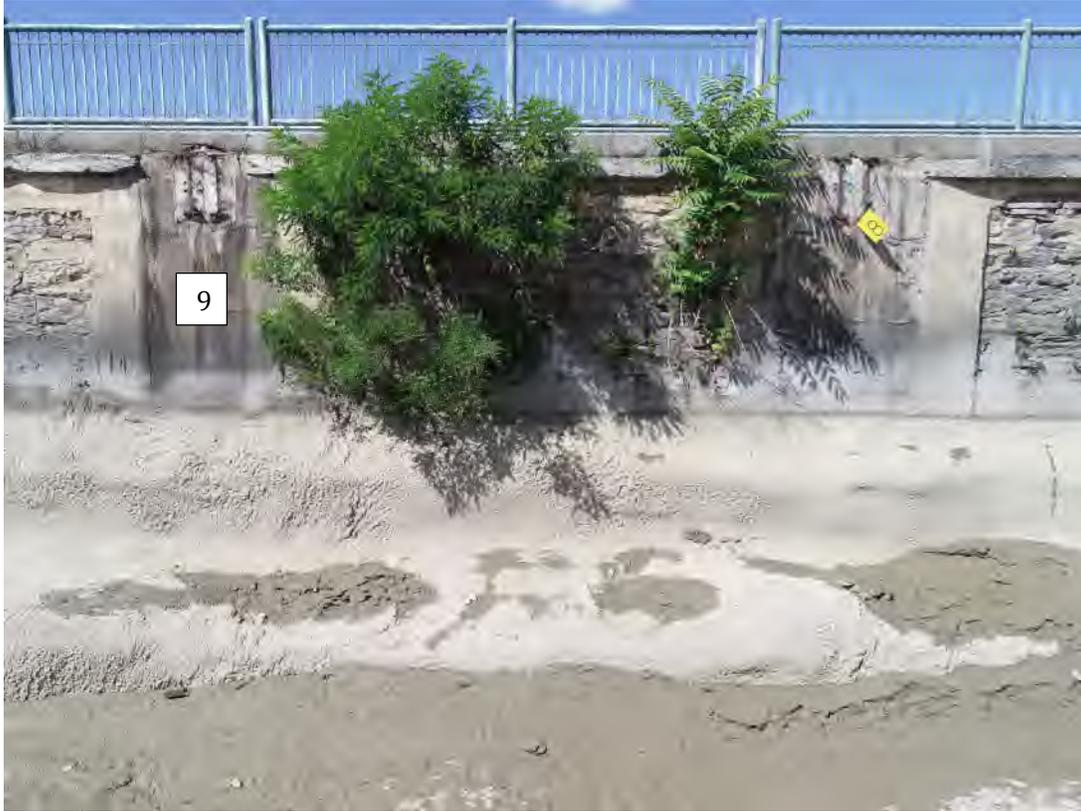
Vicinity of Columns 8 & 9

- Column 8 to Andrews Street Bridge – (southern Gunite application area) – Sediment is present on the lower bedrock shelf. No major debris and no visual or odor of MGP-related impacts were observed. Gunite was in good condition and without damage. Several woody shrubs are growing out of cracks in wall between columns 8 and 9 and near column 11.

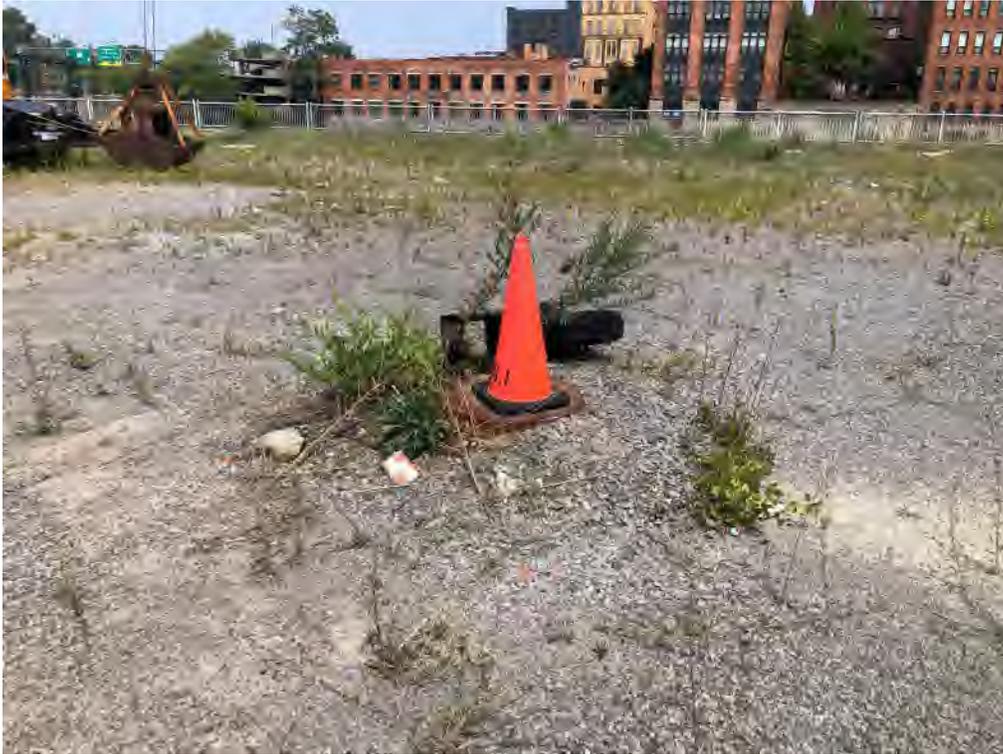
Central basin- viewing northeast

Central Basin
Central basin integrity, recommended corrective actions: NONE
Thickness of accumulated sediment in ~~north~~ ^{in central} catch basin: NONE observed
Quantity removed for off-Site disposal and disposal facility: NONE

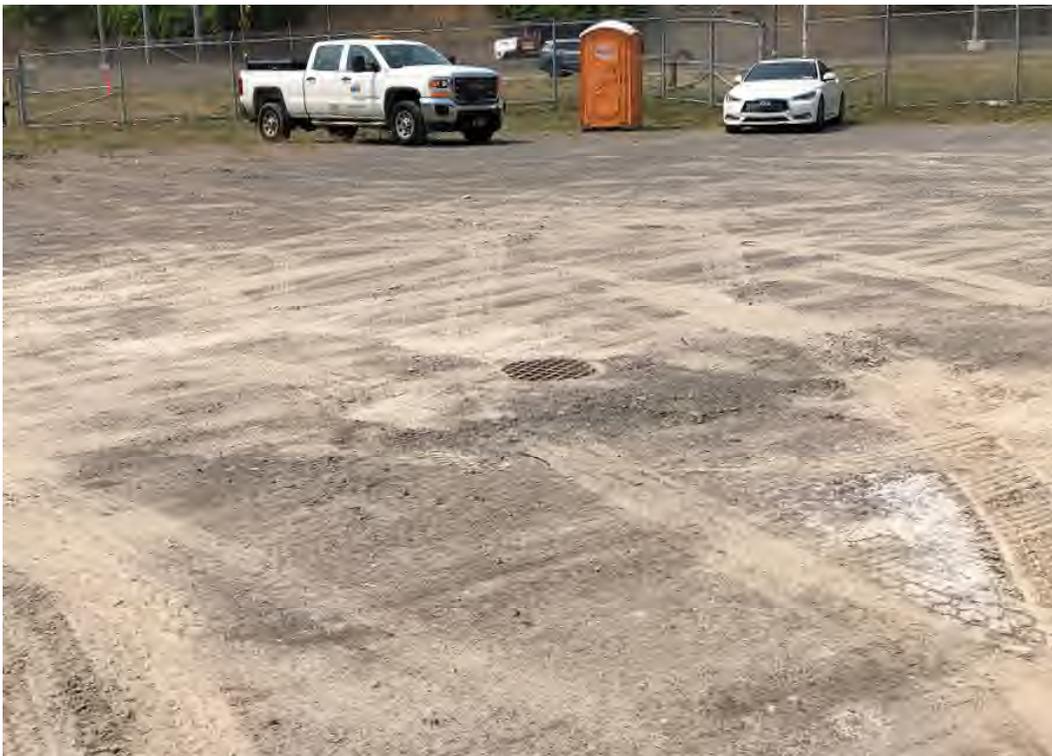
Northern catch basin – viewing west

North Basin Measurements below from top of D.I. Iron
North basin integrity, recommended corrective actions: NONE 5.5 feet to top of Grate:
sediment
Thickness of accumulated sediment in north catch basin: 3.1 feet to top of standing water
Quantity removed for off-Site disposal and disposal facility: NONE (∴ 2.4 feet of standing water)

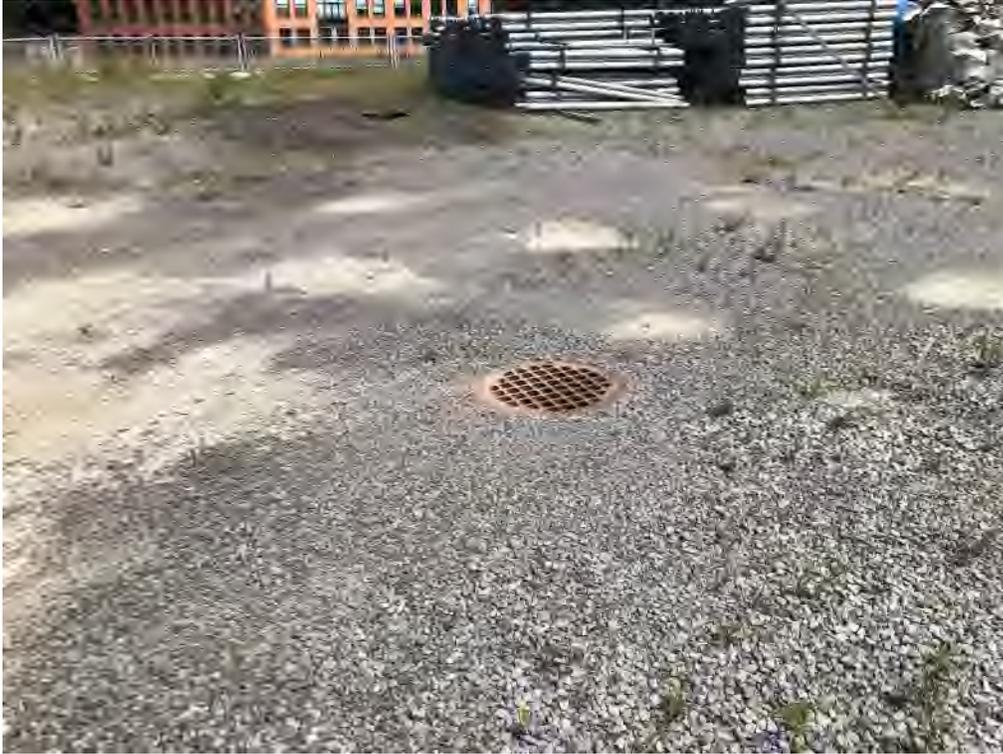
Southern storm water catch basin – viewing east

South Basin
South basin integrity, recommended corrective actions: NONE 5.4 feet to top of sediment
Thickness of accumulated sediment in north catch basin: 3.2 feet to top of standing water
Quantity removed for off-Site disposal and disposal facility: NONE (∴ 2.2 feet of standing water)
