report.vcp.V00083.2002-01-18.summary\_Report\_Subsurface  
\_Investigation\_ESI\_Spill\_0107005

**SUMMARY REPORT OF  
SUBSURFACE INVESTIGATION**

**Performed on the Sakmann Restaurant Corporation Property**

**Located on U.S. Route 9W  
Hamlet of Fort Montgomery, Town of Highlands,  
Orange County, New York  
(NYSDEC SPILL NUMBER 0107005)**

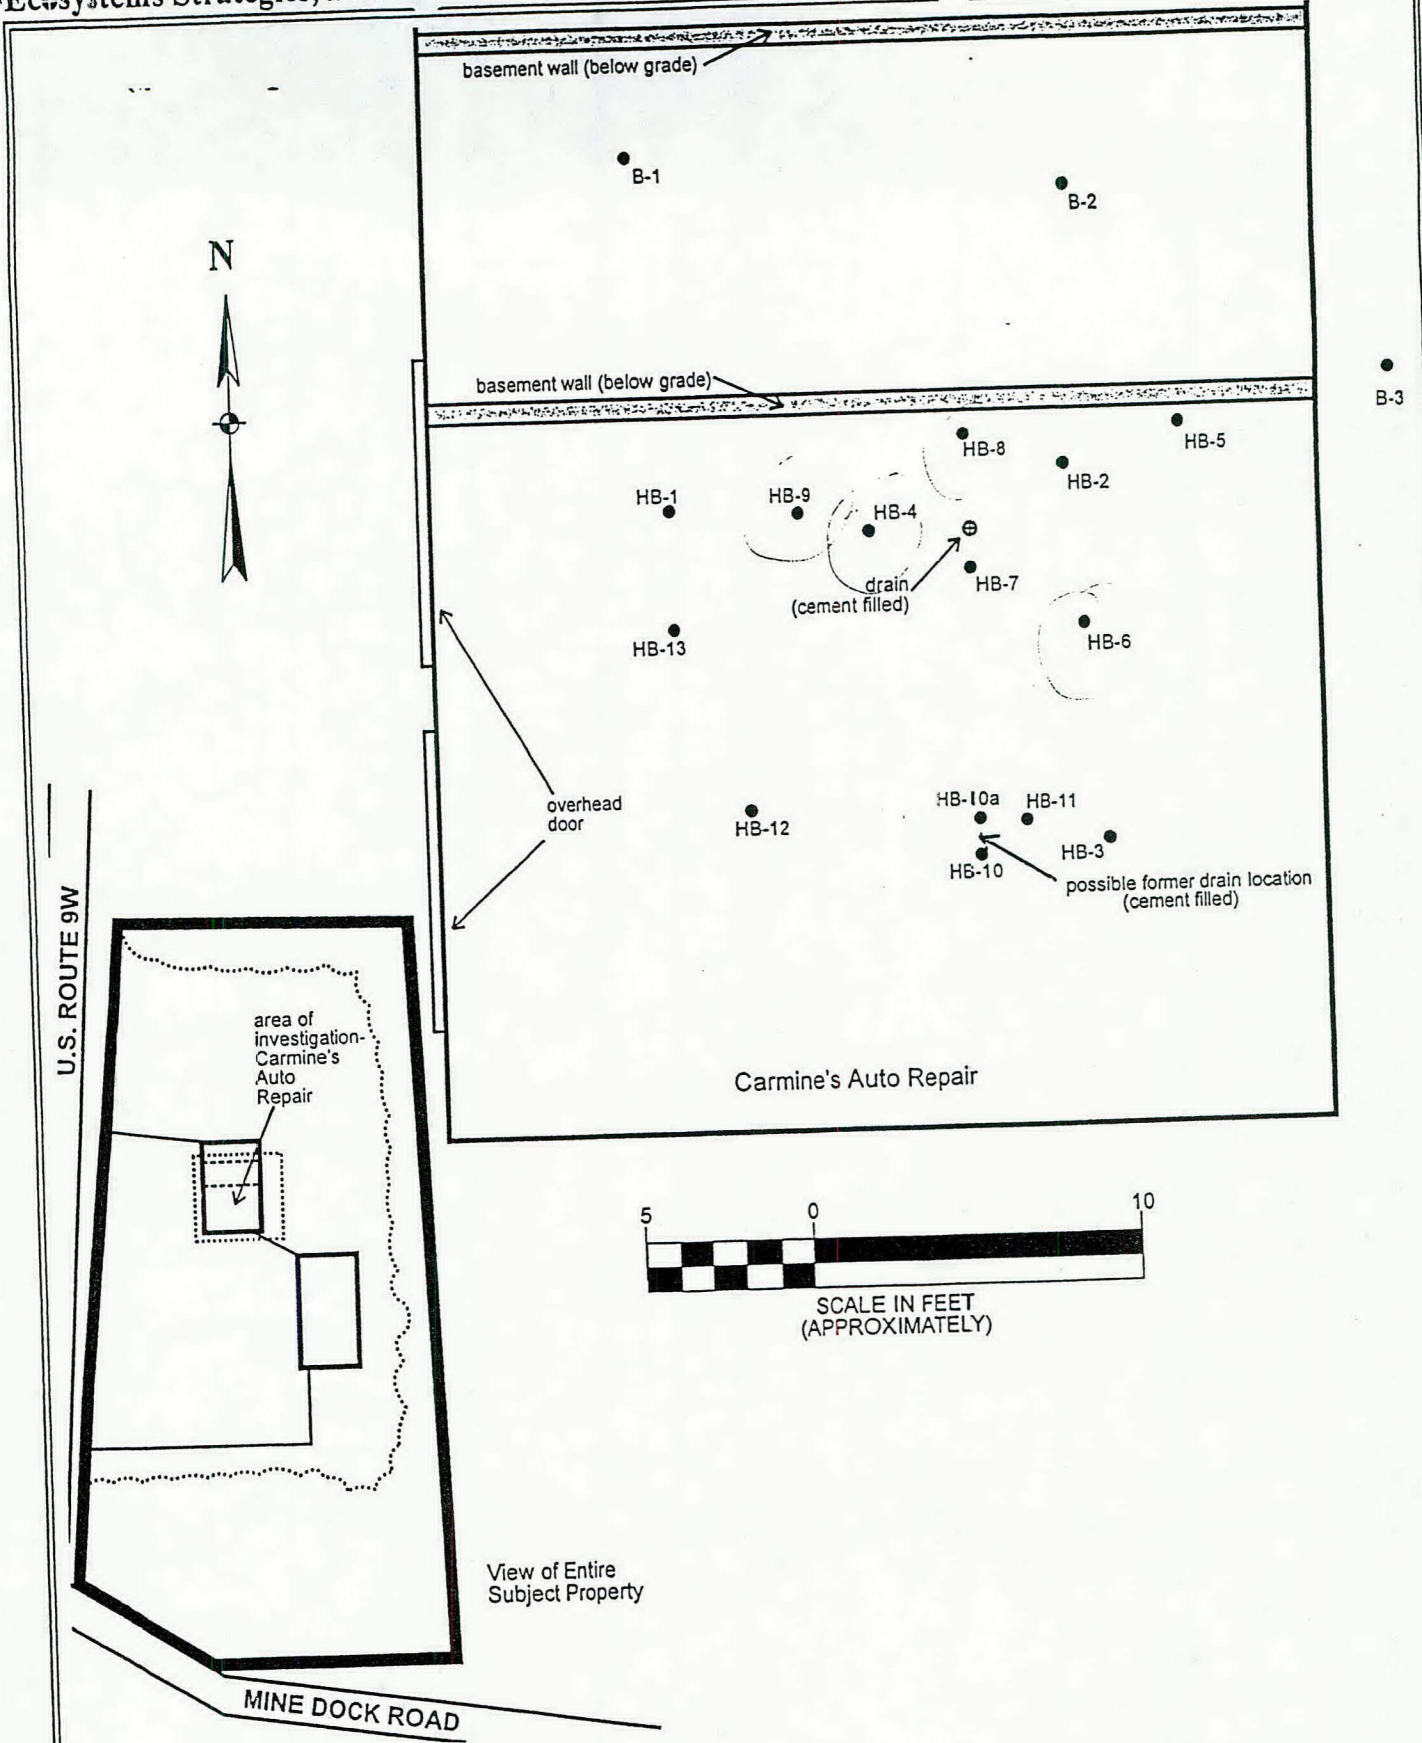
**Field Work Map - December 2001**  
Sakmann Restaurant Corporation  
U.S. Route 9W  
Hamlet of Fort Montgomery, Town of Highland  
Orange County, New York

- All borings extended at the Garage repair bays ("2HB" series) are located relative to the center of the former floor drain in the northern repair bay (located 16.5' east and 6.0' south of the northern end of the northern repair bay overhead door at western wall of Garage).
- All interior borings extended at the Garage basement floor ("B1" and "B2") are located relative to the southeastern corner of the basement.
- Boring "B-3" is located relative to the southeastern exterior corner of the Garage building.
