Asbestos Sampling Survey

Campus Industries Property
601 Amherst Street,
Buffalo, New York

LaBella Project No. 96102

January, 1996

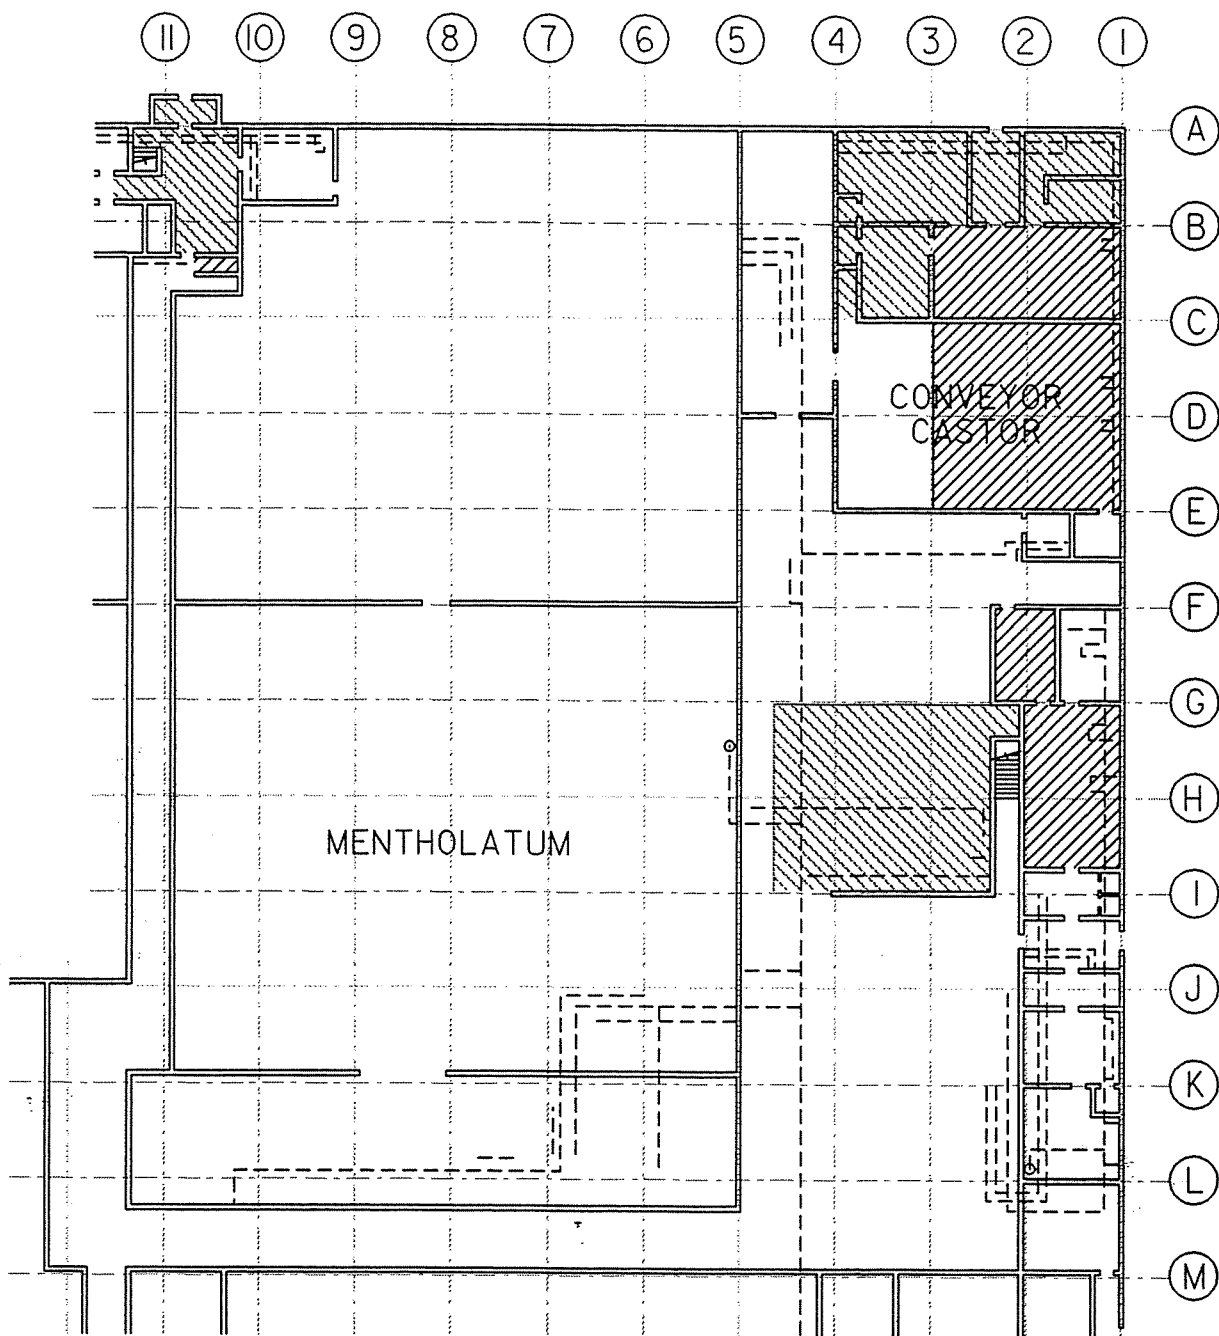
Drawing Title: FIGURE 4 PARTIAL FIRST FLOOR PLAN
APPROXIMATE LOCATIONS OF CONFIRMED
ASBESTOS CONTAINING MATERIAL

The total approximate amount of asbestos-containing pipe insulation is estimated to be 6,700 linear feet. The locations of this asbestos-containing pipe insulation are shown in FIGURES 4 -14.

The total approximate amount of asbestos-containing floor tile is estimated to be 11,830 square feet. Approximate locations of this asbestos-containing floor tile are shown in FIGURES 4, 6, 13 and 14.

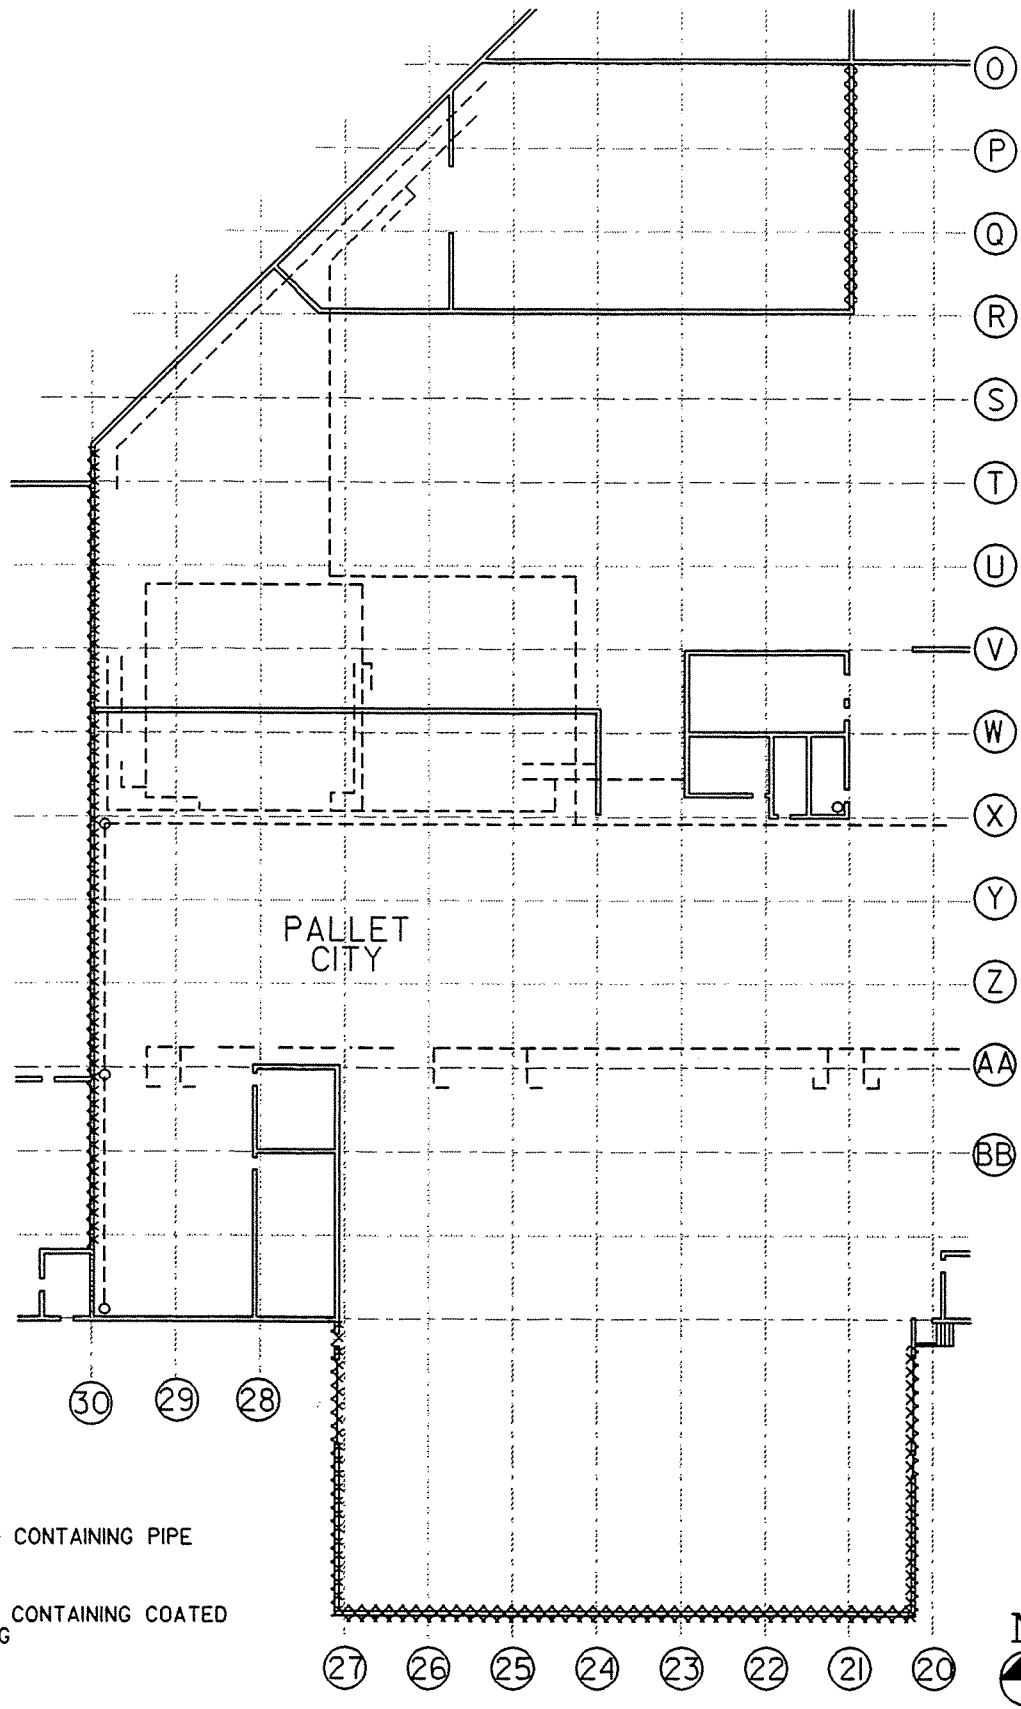
Drawing Title: FIGURE 10 PARTIAL FIRST FLOOR PLAN
APPROXIMATE LOCATIONS OF CONFIRMED
ASBESTOS CONTAINING MATERIAL

This material is generally in good condition. The approximate amount of asbestos-containing coated metal siding is estimated to be 11,500 square feet. The approximate locations of this material are shown in FIGURES 10 and 15.

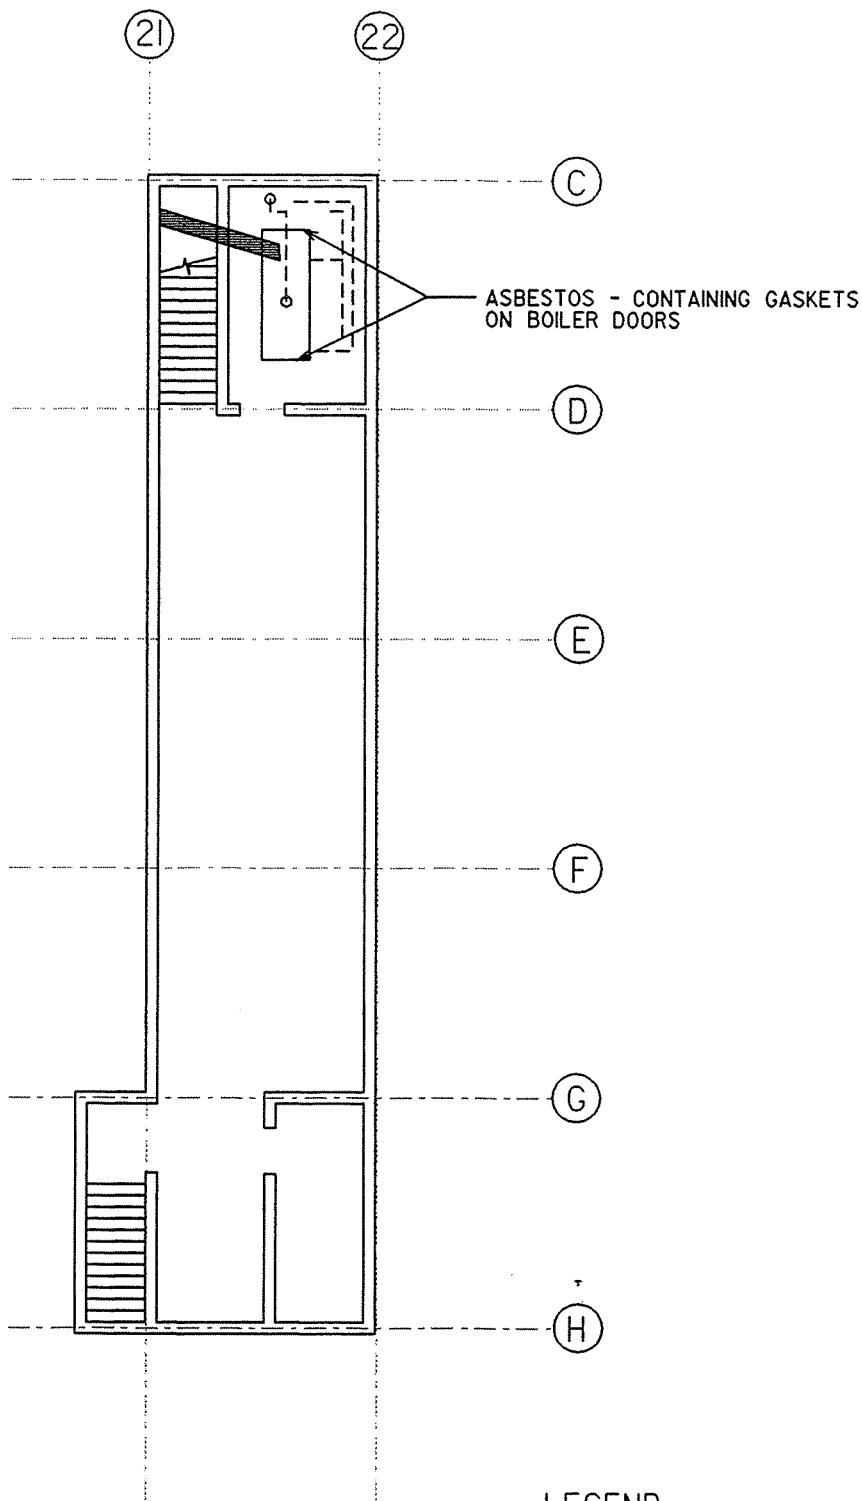
Drawing Title: FIGURE II PARTIAL BASEMENT PLAN
 APPROXIMATE LOCATIONS OF CONFIRMED
 ASBESTOS CONTAINING MATERIAL

These materials are generally in fair to good condition, with some areas of localized damage. The approximate amount of these asbestos-containing materials is estimated to be 1,000 square feet. The approximate locations of this material are shown in FIGURES 11 and 12.

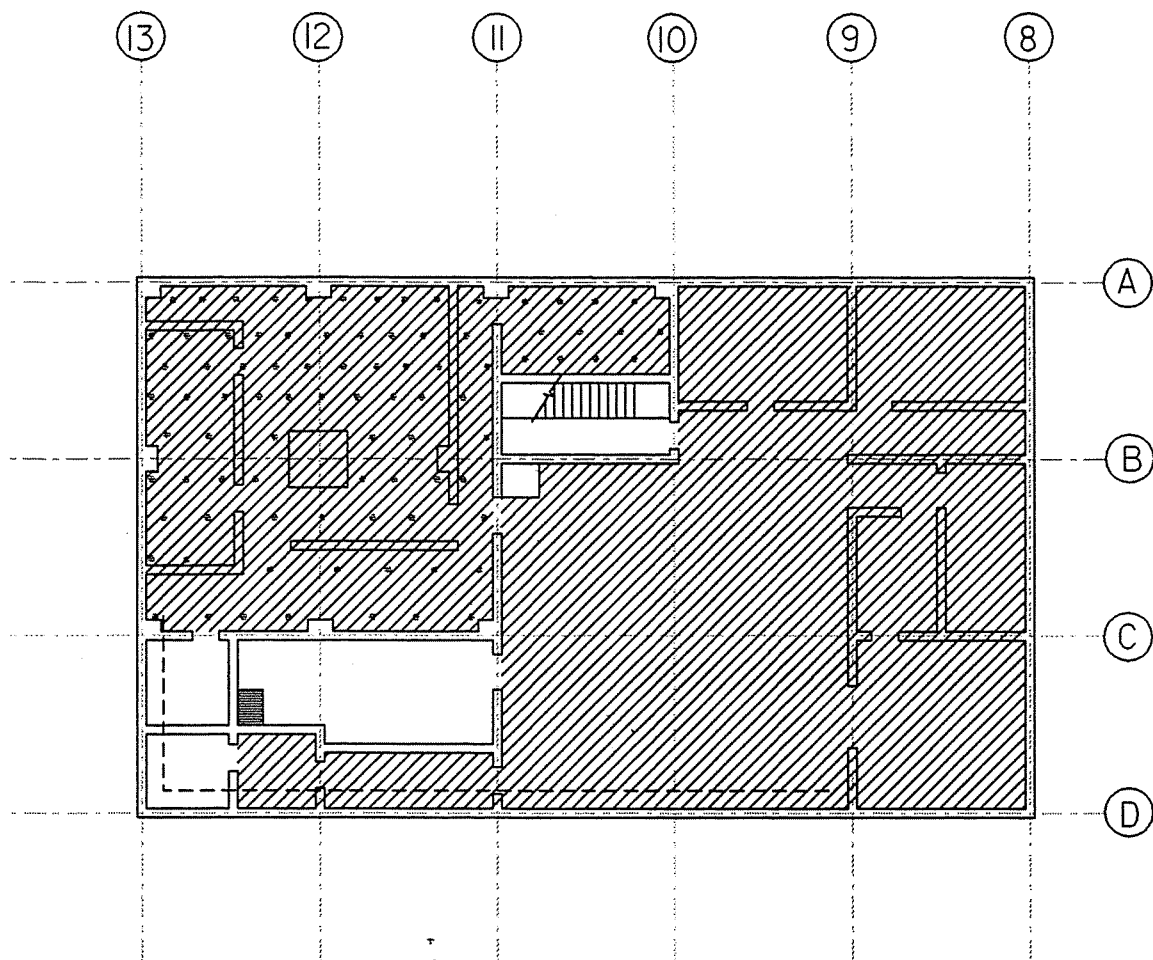
Drawing Title: FIGURE 14 PARTIAL SECOND FLOOR PLAN
APPROXIMATE LOCATIONS OF CONFIRMED
ASBESTOS CONTAINING MATERIAL

Asbestos-containing ceiling tile mastic is located in a portion of the second floor office area. This mastic is in good condition and is used to adhere the 12" X 12" ceiling tiles to the roof deck above.

In order to remove this mastic, the ceiling tiles in the area will also have to be removed. Therefore, for estimating purposes, it is assumed that the mastic covers the entire surface area of the ceiling tiles, or approximately 1,750 square feet. This ceiling tile mastic is shown in FIGURE 14.

Asbestos-containing safe insulation is located within the metal safe located in the second floor office area. This material is in good condition and covers an area of approximately 110 square feet. The presence of this metal clad fire door is noted in FIGURE 14.

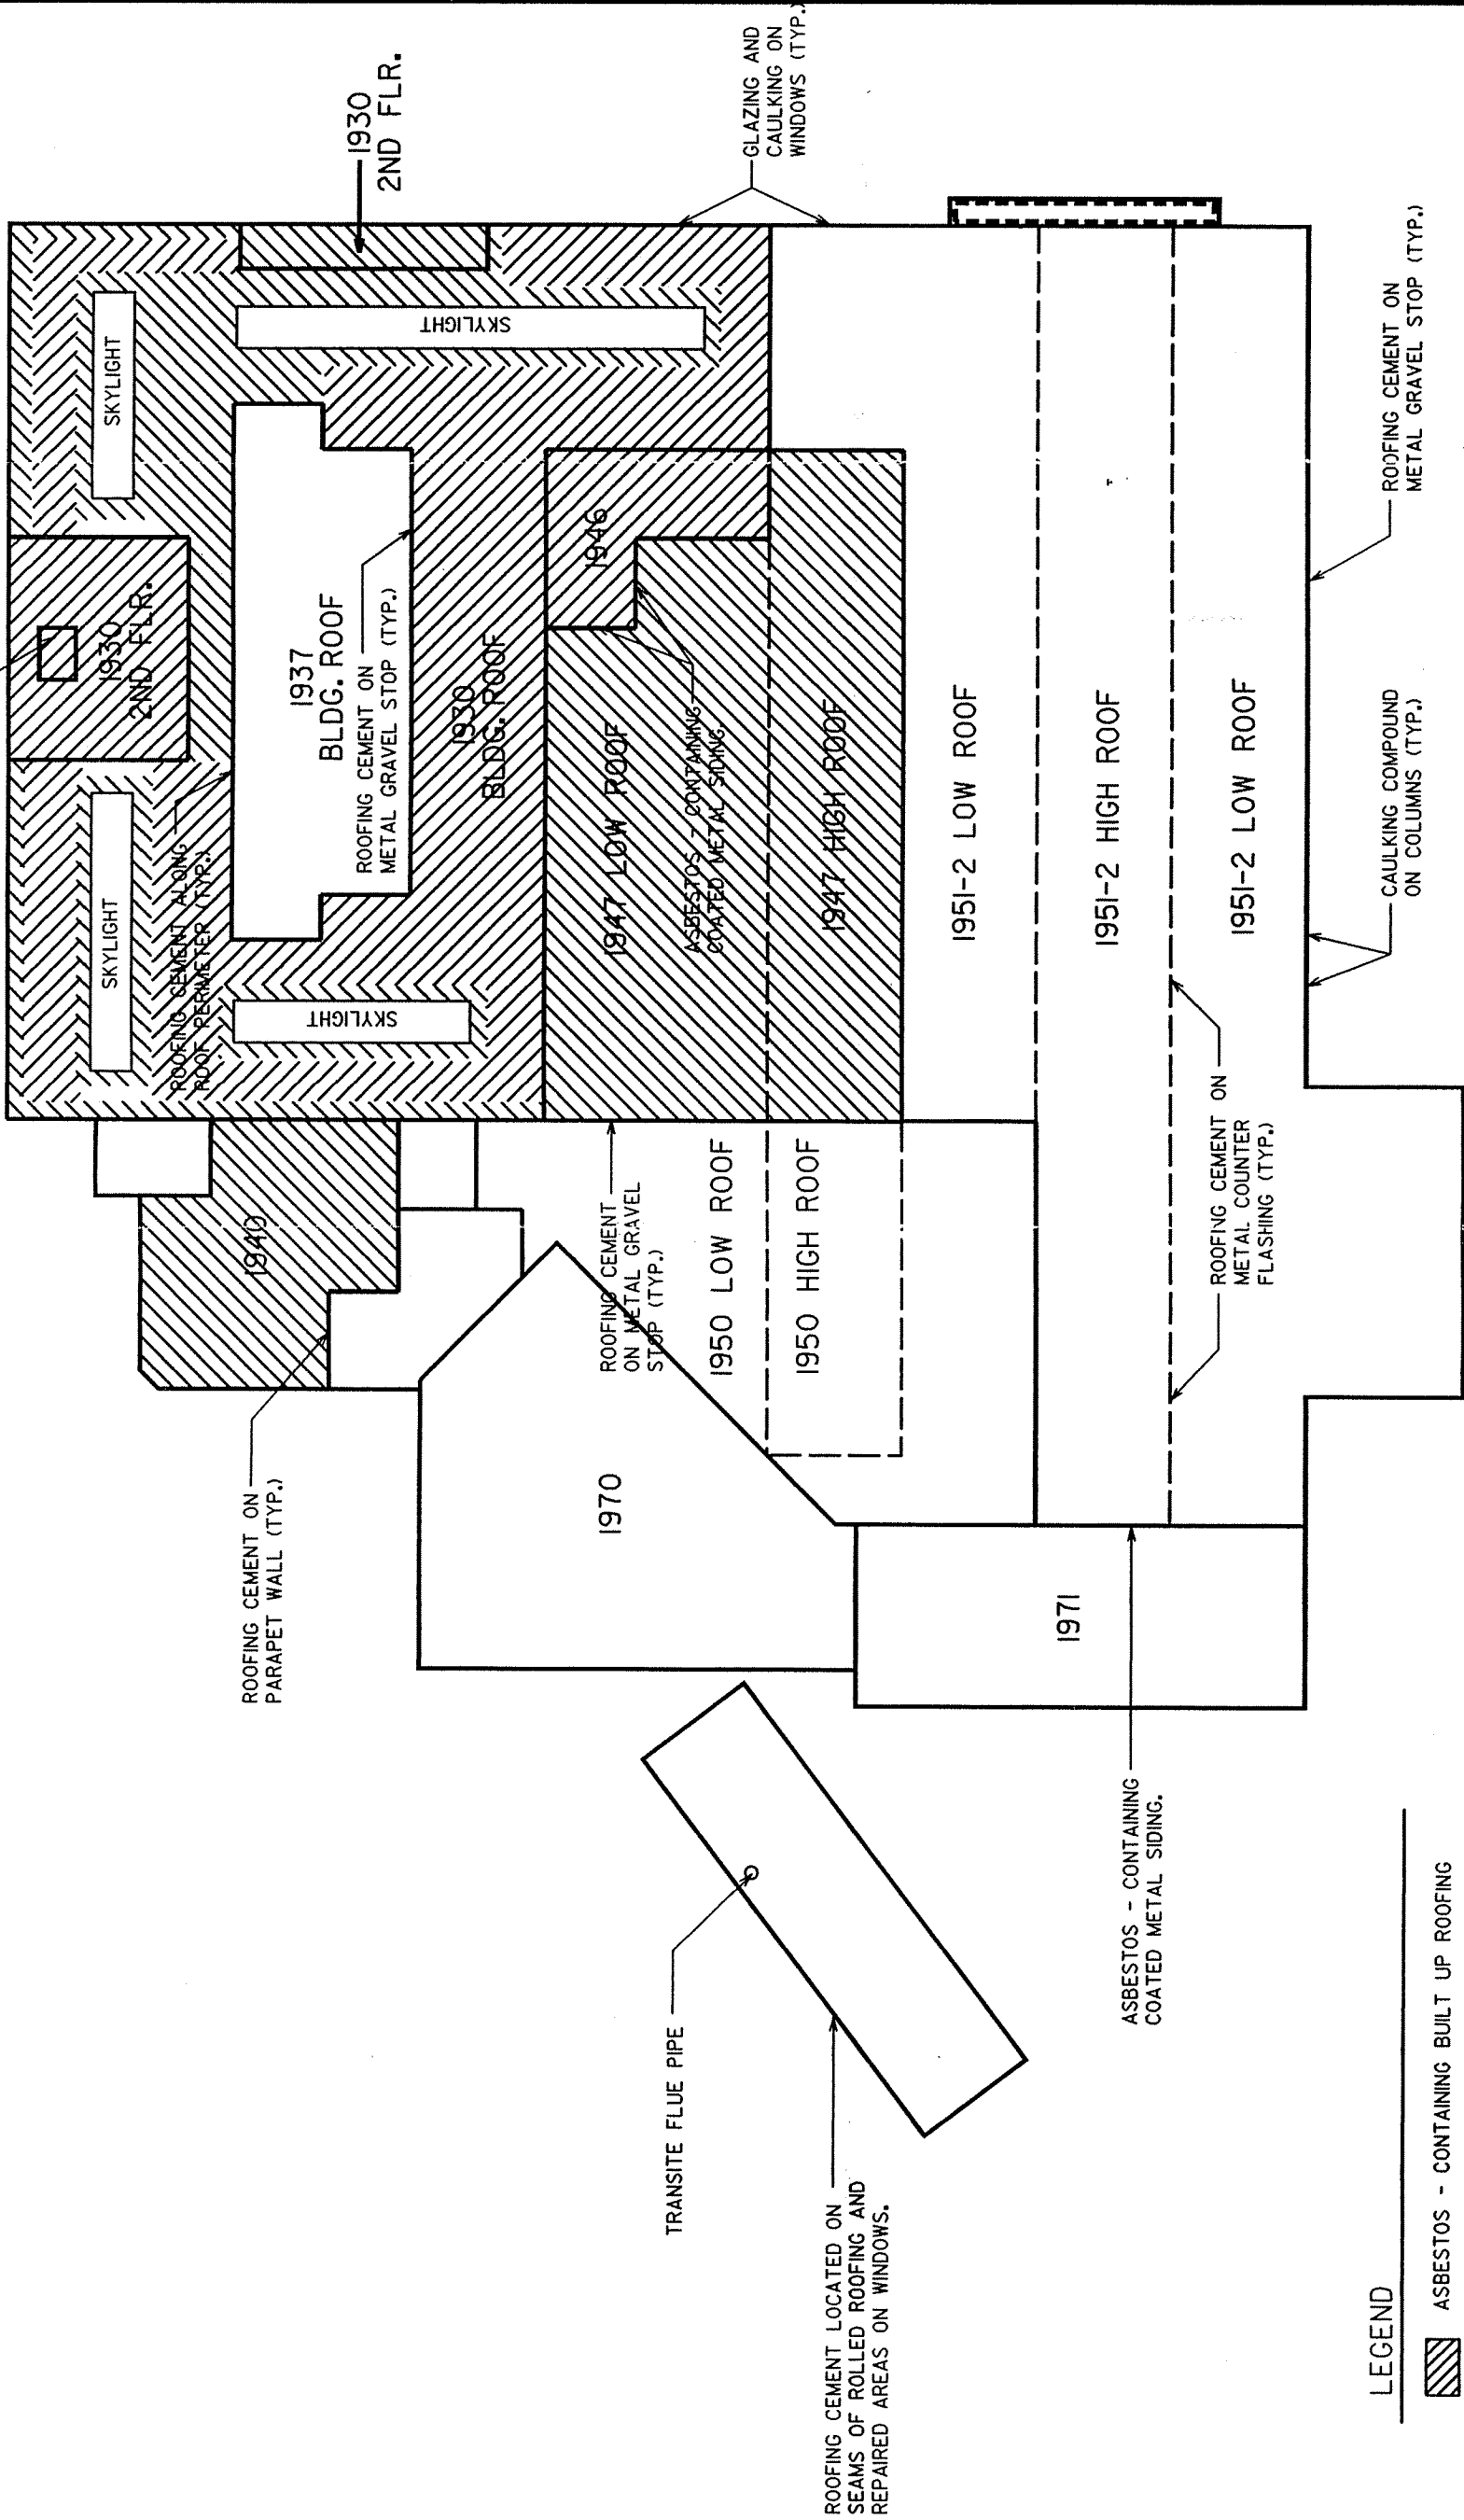
ROOF PLAN

In order to remove these materials it is likely that the windows will be removed in their entirety. Therefore, for estimating purposes, it is assumed that the caulk/glazing compound covers the entire surface area of the windows, or approximately 26,500 square feet. The presence of these materials is noted in FIGURE 15.

Asbestos-containing roofing cement and/or caulking compound is located on the exterior steel support columns of the 1937-1952 building additions. These materials are used as a weather proofing between the steel columns and the block/brick walls of the building. In most locations, these columns are exposed, but in several areas they have been covered over by metal siding. These materials have been exposed to the weather over the years, and as such range in condition from poor to good.

The approximate amount of asbestos-containing roofing cement is estimated to be 2,500 square feet. Typical locations/applications of this material are noted in FIGURE 15.

This material is generally in good condition. The approximate amount of asbestos-containing aluminum coating is estimated to be 46,400 square feet. The approximate locations of this material are shown in FIGURE 15.

This material is generally in good condition. Approximate amount of asbestos-containing built up roofing is estimated to be 125,000 square feet. Approximate locations of this material are shown in FIGURE 15.

For estimating purposes, it is assumed that the roofing cement covers the entire surface area of the roof, and about 10% of the area of the windows, or approximately 11,000 square feet. The presence of these materials is noted in FIGURE 15.

An asbestos cement (Transite) flue pipe is located on the north side of the building. This pipe is in good condition and is approximately 10 linear feet in length.

ELEVATOR PENTHOUSE COVERED W/
ASBESTOS - CONTAINING ROOFING CEMENT
