**RE: Periodic Review Report**  
Carmel Shop-Rite Plaza  
180 Gleneida Avenue  
Carmel, New York 10512  
NYSDEC Site Number V00104

**PERIODIC REVIEW REPORT**  
**October 2013**

**Carmel Shop-Rite Plaza**  
**Putnam County, New York**

**NYSDEC Site Number: V00104**

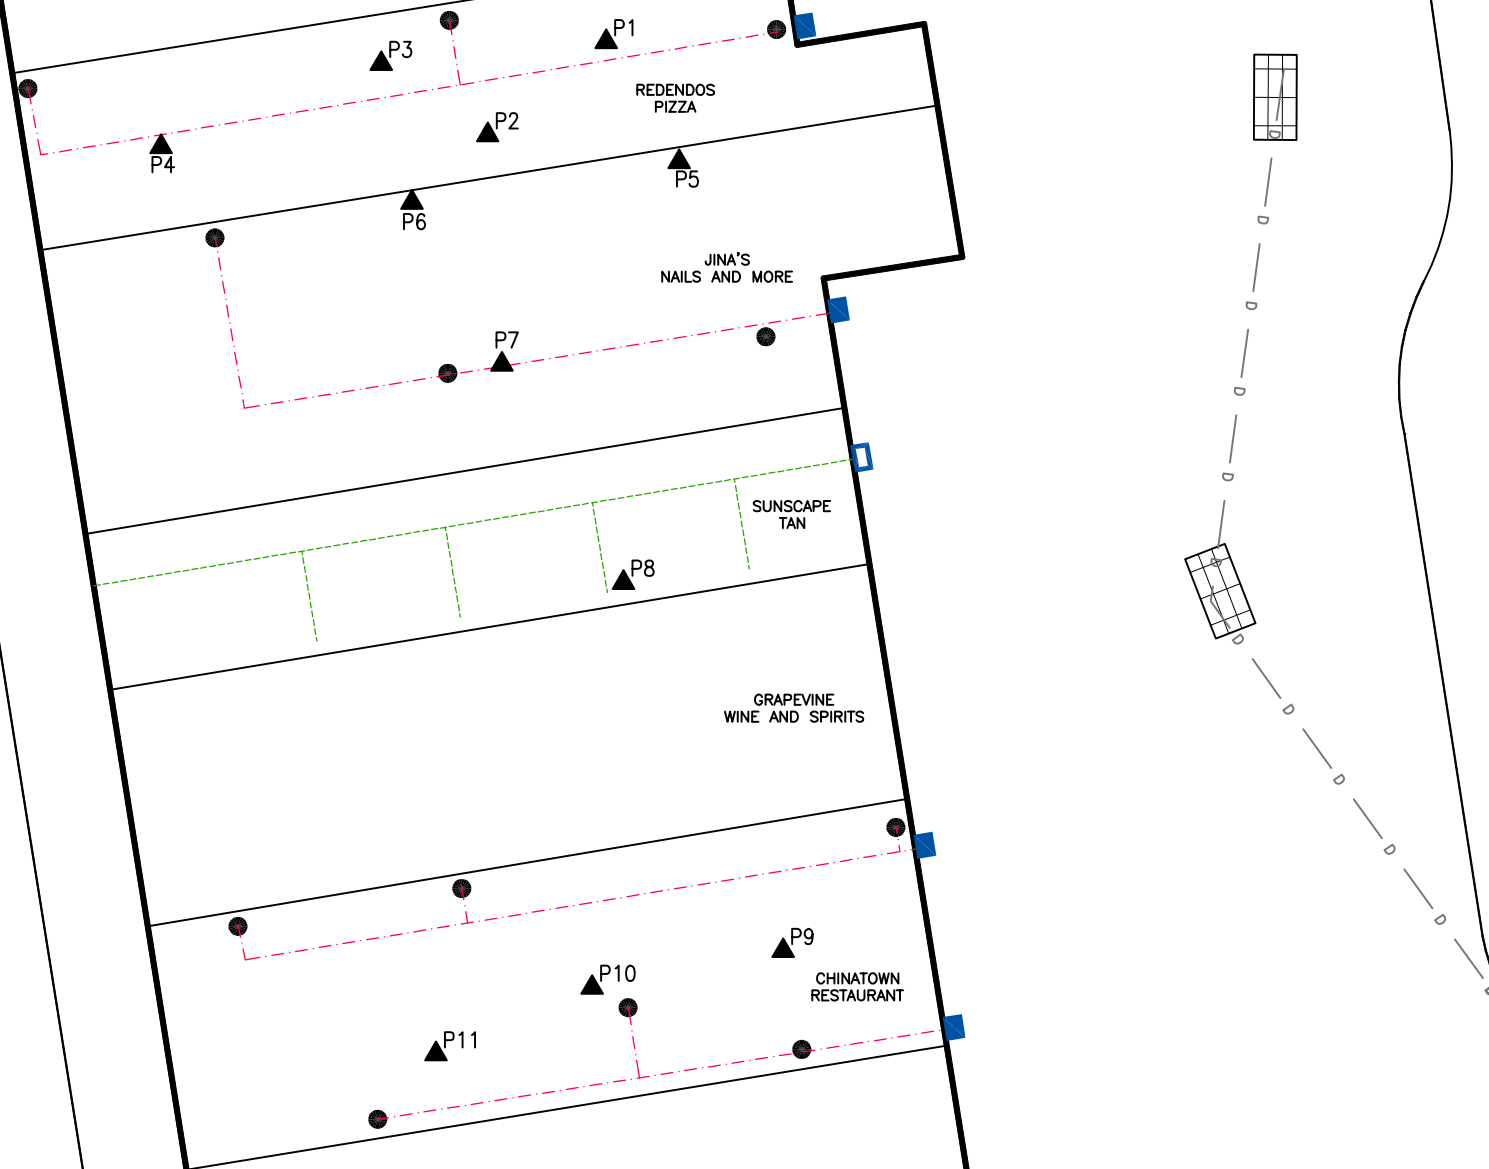
SCALE IN FEET 0 APPROXIMATE 20	DATE 9-23-13	FIGURE 3

The SMP requires that a single engineering control (SSDS) be maintained at the site. Maintenance and inspections of the SSDS at the site are required by the SMP to be completed within 18 month of the installation of the system and then every 12 to 18 months thereafter. In total, four separate SSDS were installed in three tenant spaces, as summarized in the below table and depicted on **Figure 3**.

Tenant Space	Number of Suction Points	Radon-Away Fan Type
Redendo's Pizza	3	HP-5000
Jina's Nail Salon	3	HP-5000
Sunscape Tan	Trench (existing)	RP-265
Chinatown Restaurant (2 systems)	3	HP-5000
	3	HP-5000
