Re: Periodic Review Report (Revised) – October 2022 to October 2023
Carmel Shop-Rite Plaza
180 Gleneida Avenue
Carmel, New York
NYSDEC Site Number V00104

Periodic Review Report

Carmel Shop-Rite Plaza

NYSDEC Site Number V00104

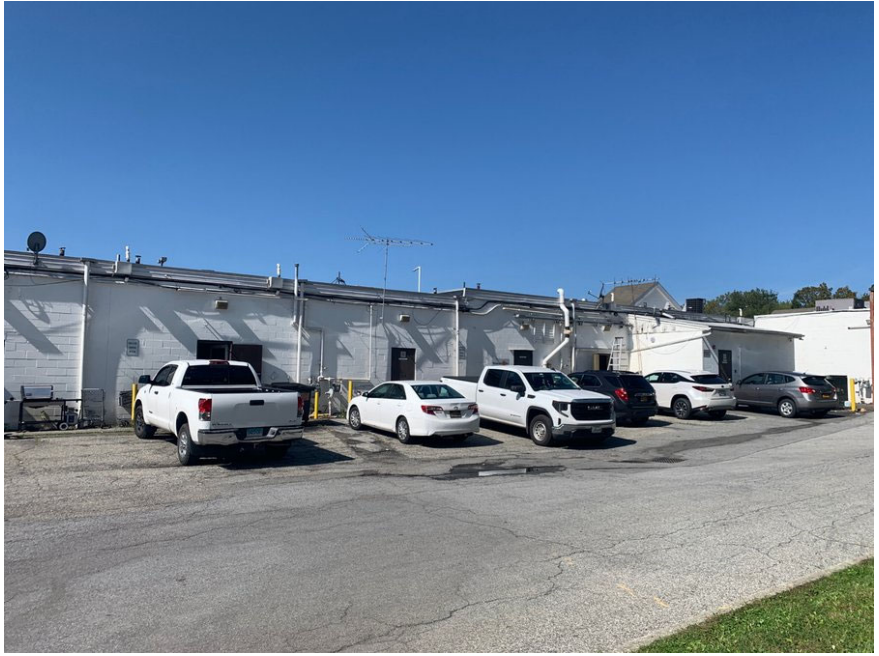
Client: Regency Centers		Project: 1102826/05/220
Site Name: Carmel Shop-Rite Plaza		Site Location: Carmel, NY
Photo #:	1

Date:	09/27/2023	
Direction:	Northwest	
Comments: Back of on-site building showing SSDS fans and external piping associated with the SSDS system.

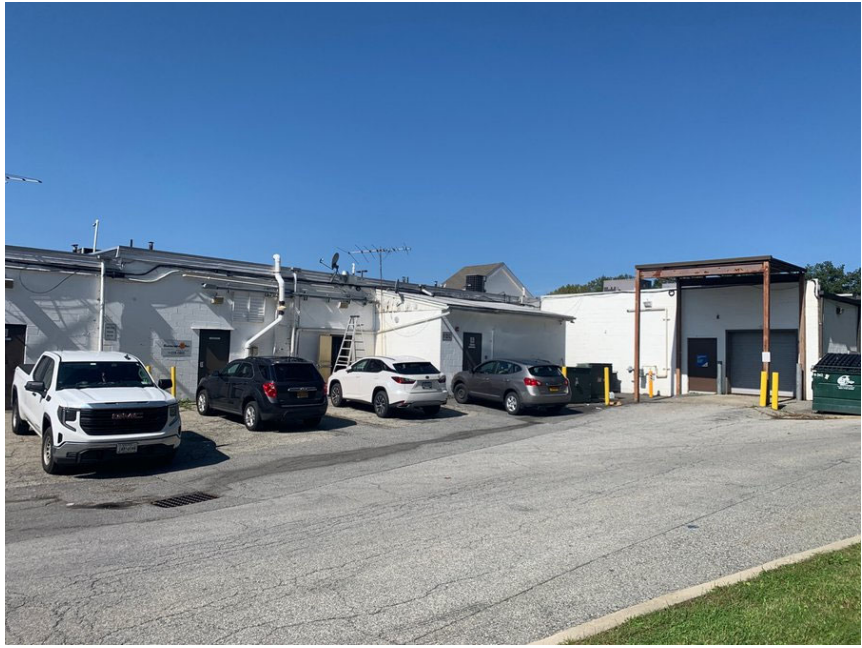
Client: Regency Centers		Project: 1102826/05/220
Site Name: Carmel Shop-Rite Plaza		Site Location: Carmel, NY
Photo #:	2

Date:	09/27/2023	
Direction:	Northwest	
Comments: Back of on-site building showing SSDS fans and external piping associated with the SSDS system.

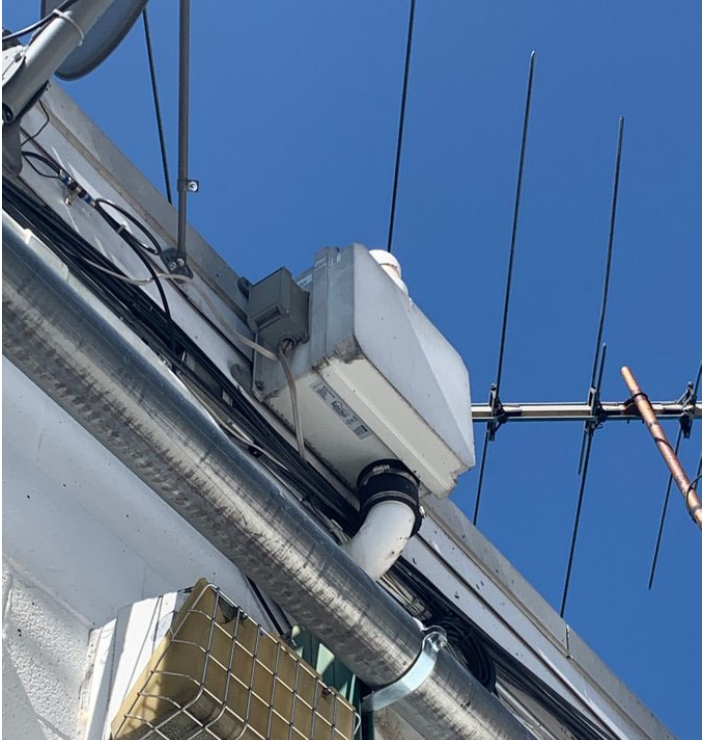
Client: Regency Centers		Project: 1102826/05/220	
Site Name: Carmel Shop-Rite Plaza		Site Location: Carmel, NY	
Photo #:	3

During the September 27, 2023 site inspection, one (1) of the SSDS fans located at the New Journey Nail & Spa (formerly Jina's Nails & Spa) tenant space was observed to be non-operational. GES replaced the malfunctioning SSDS fan on September 29, 2023. Following replacement of the SSDS fan, all SSDS components on-site were operational.

Date:	09/27/2023		
Direction:	N/A		
Comments:			
<p>SSDS fan at New Journey Nail & Spa tenant space was non-operational at the time of the 9/27/2023 site visit.</p>

On September 29, 2023, GES arrived on-site to inspect the existing Radon-Away HS-5000 fan located at the Carmel Nail tenant space. GES inspected the fan and determined it required replacement. An identical replacement fan (HS-5000) was installed and activated.

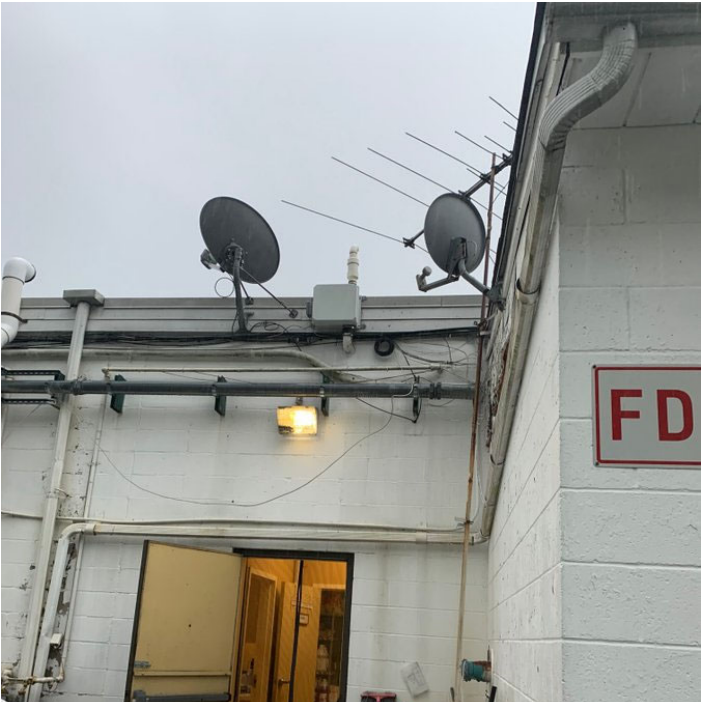
Client: Regency Centers		Project: 1102826/05/220	
Site Name: Carmel Shop-Rite Plaza		Site Location: Carmel, NY	
Photo #:	4

Date:	09/29/2023		
Direction:	West		
Comments:			
<p>SSDS fan at New Journey Nail & Spa tenant space was replaced on 9/29/2023. GES confirmed the fan and all SSDS components were operational at the time of the site visit.</p>
