Groundwater & Environmental Services, Inc.

November 25, 2024

Re: Non-Routine Maintenance Report
Carmel Shop-Rite Plaza
180 Gleneida Avenue
Carmel, New York
NYSDEC Site Number V00104

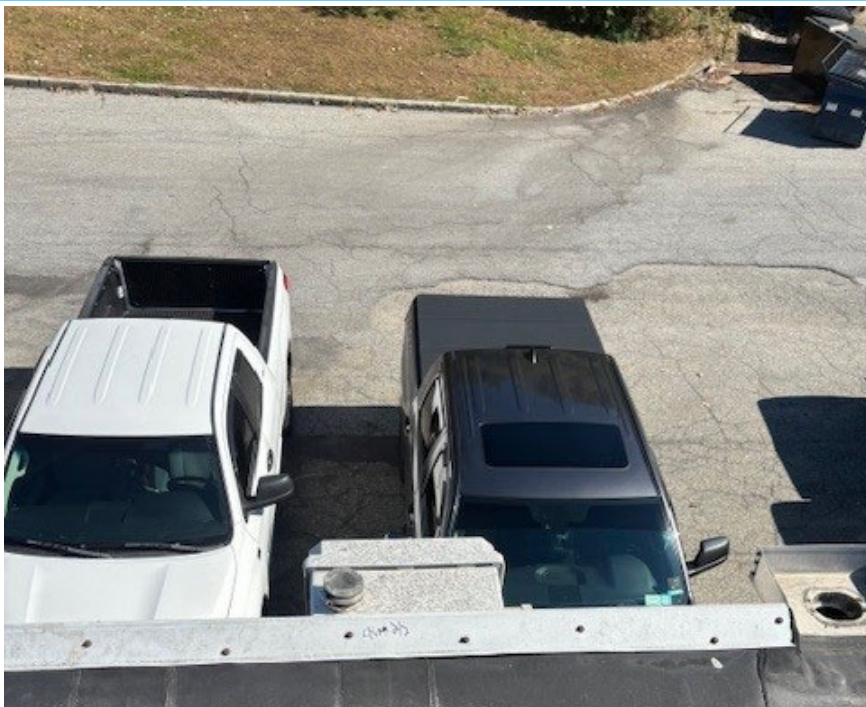
Client: Regency Centers		Project: 1192323/05/139
Site Name: Carmel Shop-Rite Plaza		Site Location: Carmel, NY
Photo #:	1

Date:	10/11/2024	
Direction:	East	
Comments: SSD exhaust capped in advance of the December soil vapor intrusion testing.

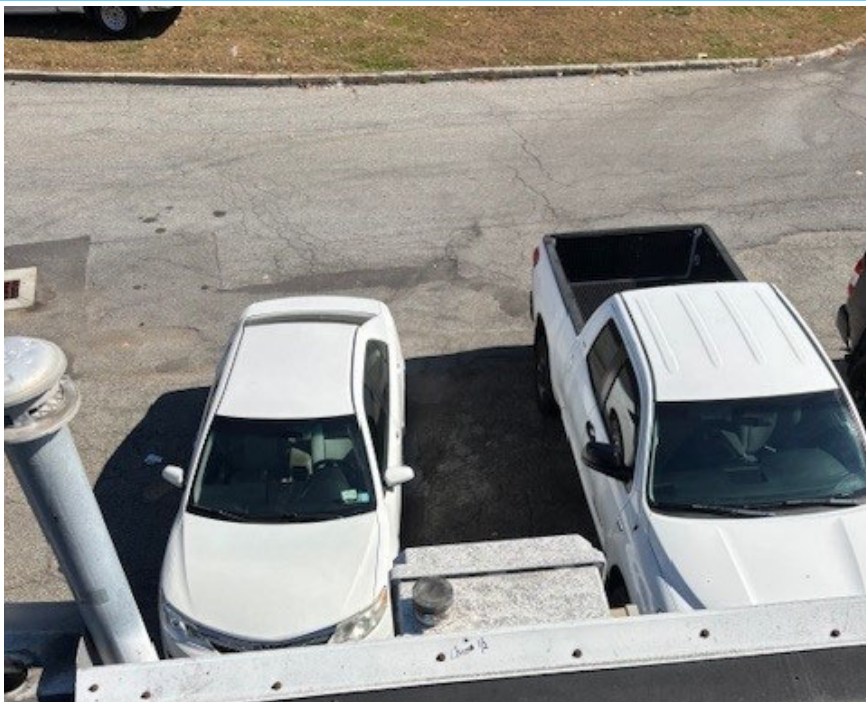
Client: Regency Centers		Project: 1192323/05/139
Site Name: Carmel Shop-Rite Plaza		Site Location: Carmel, NY
Photo #:	2

Date:	10/11/2024	
Direction:	East	
Comments: SSD exhaust capped in advance of the December soil vapor intrusion testing.

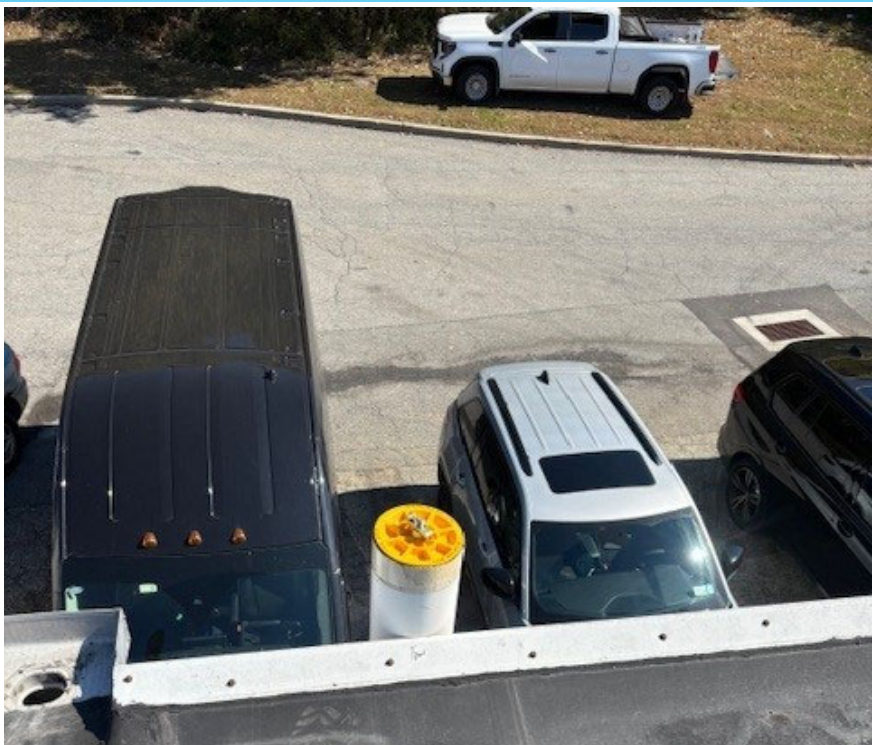
Client: Regency Centers		Project: 1192323/05/139
Site Name: Carmel Shop-Rite Plaza		Site Location: Carmel, NY
Photo #:	3

Date:	10/11/2024	
Direction:	East	
Comments: SSD exhaust capped in advance of the December soil vapor intrusion testing.

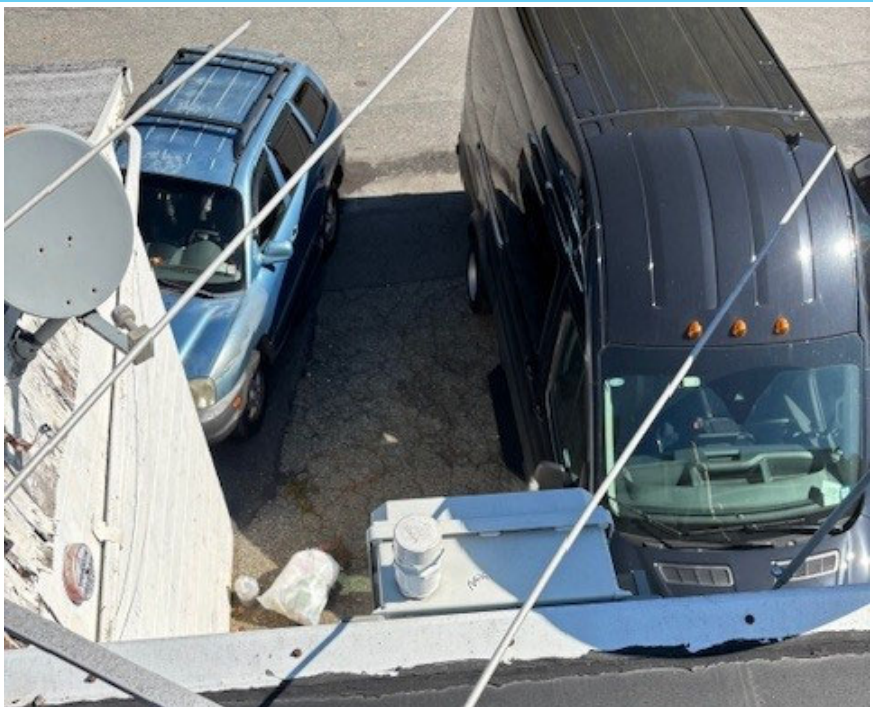
Client: Regency Centers		Project: 1192323/05/139
Site Name: Carmel Shop-Rite Plaza		Site Location: Carmel, NY
Photo #:	4

Date:	10/11/2024	
Direction:	East	
Comments: SSD exhaust capped in advance of the December soil vapor intrusion testing.

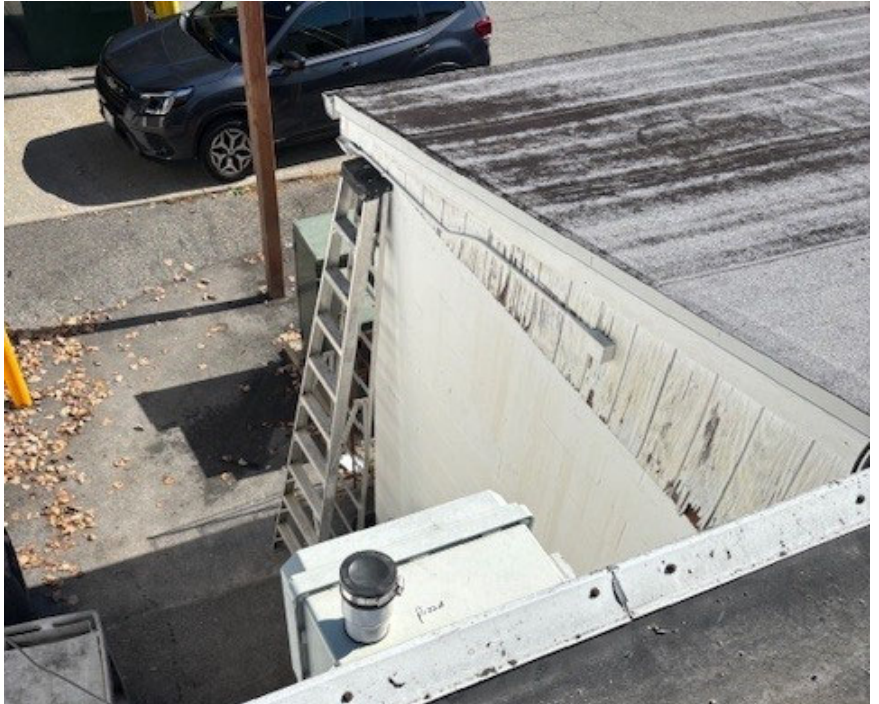
Client: Regency Centers		Project: 1192323/05/139
Site Name: Carmel Shop-Rite Plaza		Site Location: Carmel, NY
Photo #:	5

Date:	10/11/2024	
Direction:	East	
Comments: SSD exhaust capped in advance of the December soil vapor intrusion testing.
