Re: Periodic Review Report – October 2024 to October 2025

Carmel Shop-Rite Plaza 180 Gleneida Avenue Carmel, New York

NYSDEC Site Number V00104

Periodic Review Report

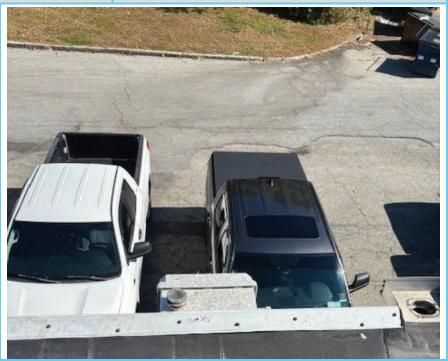
SSD exhaust capped in advance of the December soil vapor intrusion testing.

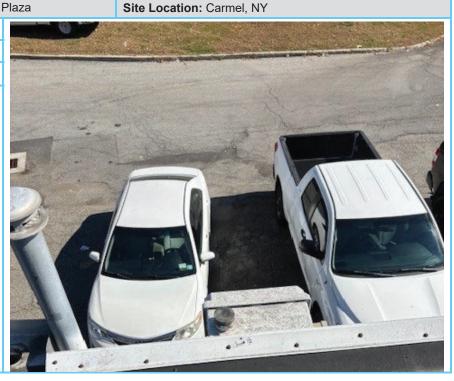
SSD exhaust capped in advance of the December soil vapor intrusion testing.

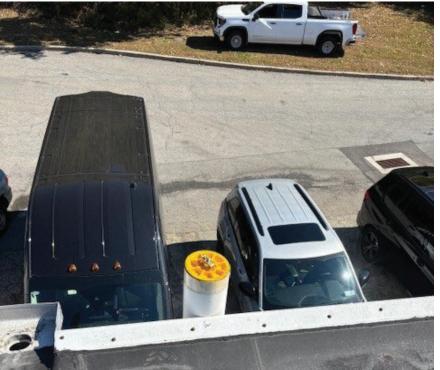
SSD exhaust capped in advance of the December soil vapor intrusion testing.

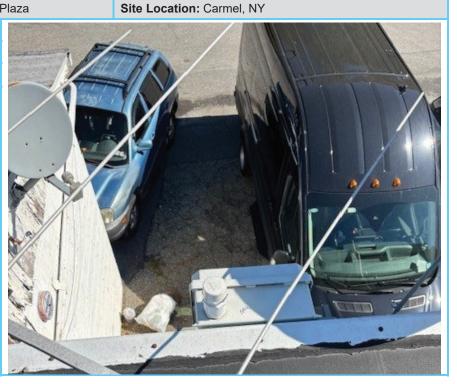
Photo #: 4

SSD exhaust capped in advance of the December soil vapor intrusion testing.

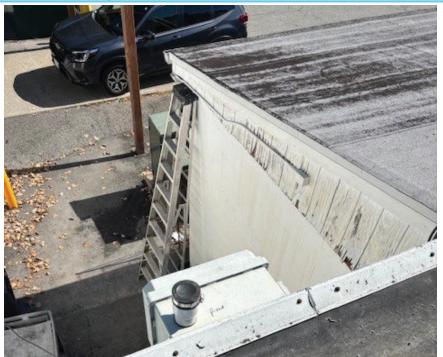
SSD exhaust capped in advance of the December soil vapor intrusion testing.

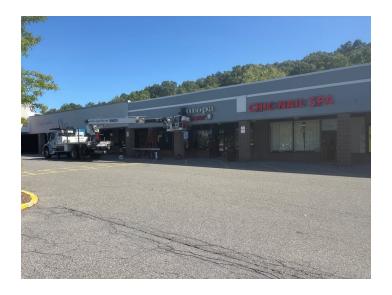
Europa Pizza and pavement

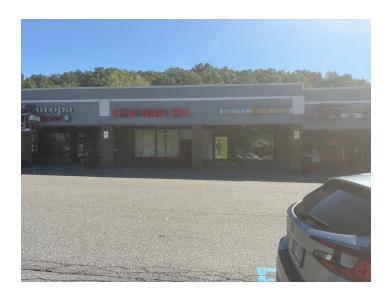
Chic Nail & Spa and pavement

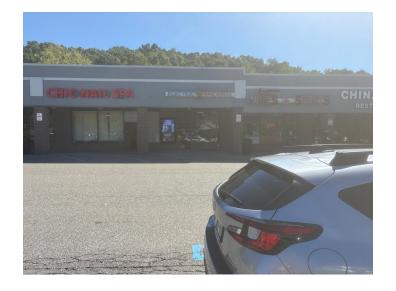
Electric Paradise Tanning and pavement

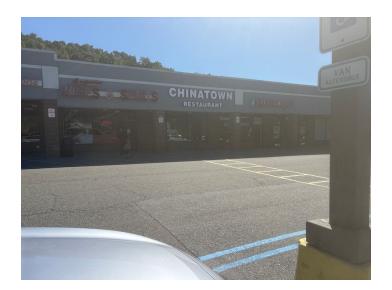
Chinatown Restaurant and pavement

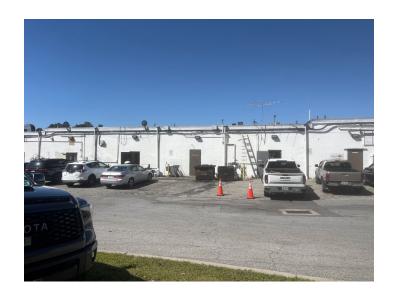
Pavement behind building

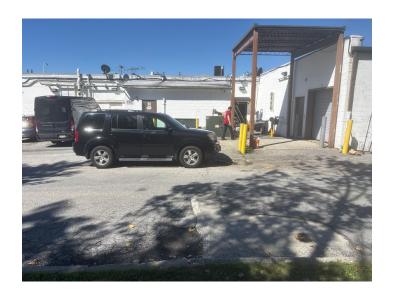
Pavement behind building pizzeria
