Re: Nassau Metals, OU-2

Voluntary Cleanup Program Site No. V00159

June 2024 Renovations Report

ASR Project #A22-115

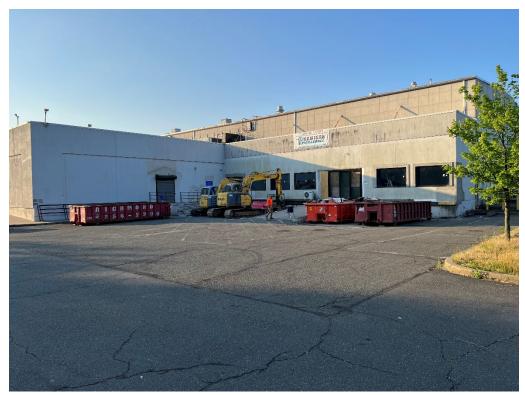
Photo 1: View of the work zone, facing south

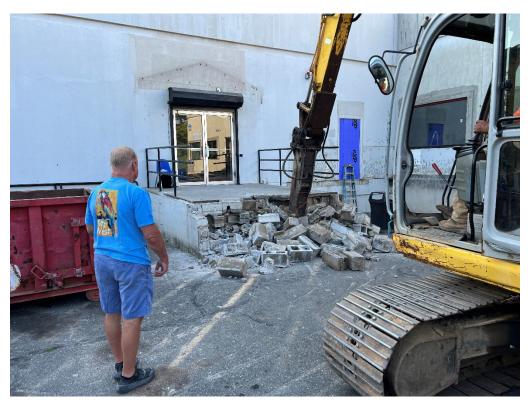
Photo 2: View of the concrete stairway being demolished

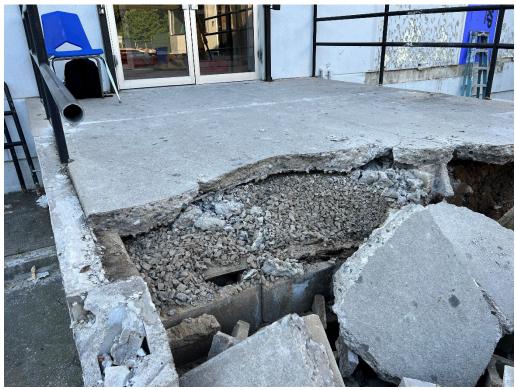
Photo 3: View of the crushed stone encountered in the void space beneath the stairs

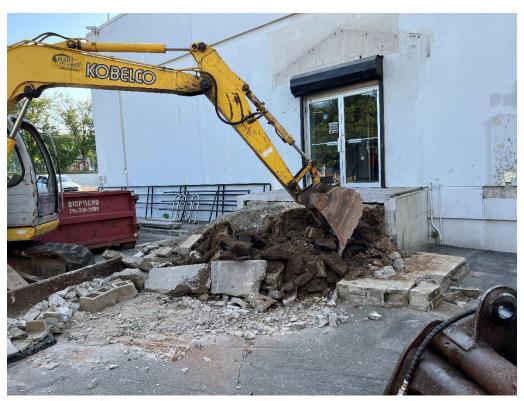
Photo 4: View of pea gravel encountered in the void space beneath the stairs

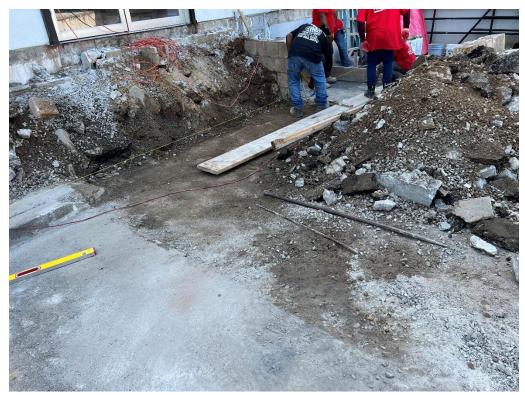
Photo 5: View of asphalt surface beneath the former stairs

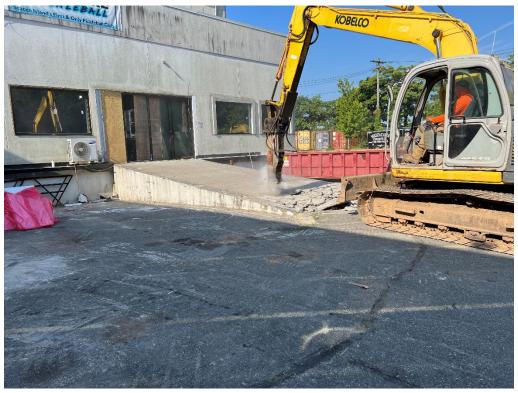
Photo 6: View of concrete ramp being demolished

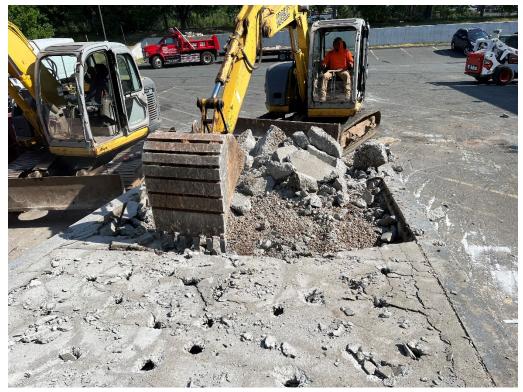
Photo 7: View of pea gravel encountered in the void space beneath the concrete ramp

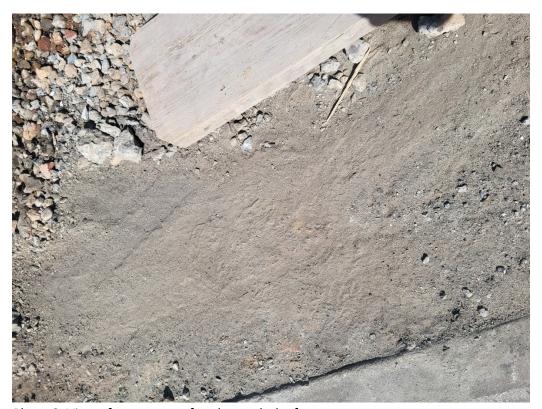
Photo 8: View of concrete surface beneath the former concrete ramp

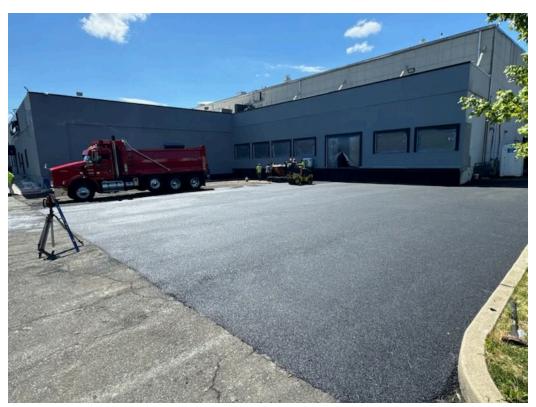
Photo 9: View of asphalt being placed on the pre-construction capping system(s)

As previously described, the pre-construction concrete and asphalt caps in this area of the Site were modified through the addition of approximately 6 to 8 inches of asphalt on top of the existing demarcation barriers. No material other than asphalt was imported to the Site as part of the capping system modification.

The updated as-builts will be included in the 2024 Periodic Review Report ("PRR") for the Site. The capping system was restored in accordance with Detail 9 of the 2018 As-Built Drawings (Typical As-Built Asphalt Added TO Existing Asphalt Cap). The restored cap consists of a pre-existing demarcation barrier, asphalt millings, bituminous base course, and a bituminous top course and is greater than 6 inches in combined thickness.

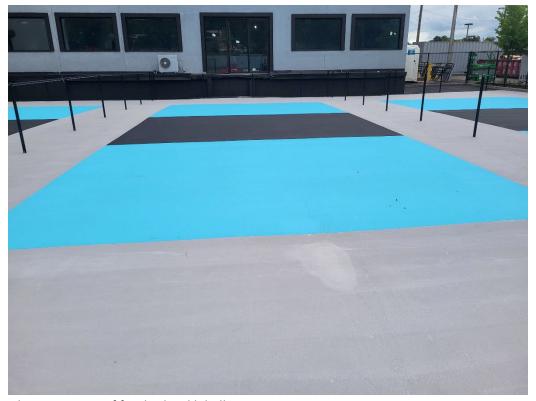
Photo 10: View of finished pickleball courts

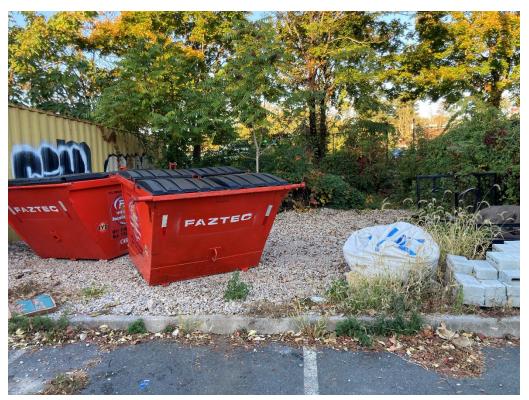
Photo 10: View of the reused material from the ramp in the dumpster area
