**AG Geology, D.P.C.**  
445 Hamilton Ave, Suite 504  
White Plains, NY 10601  
USA

October 18, 2022

Subject: 2022 Periodic Review Report  
Former Champion Products Facility  
200 North Main Street  
Perry, New York 14530  
NYSDEC Site No. V00189

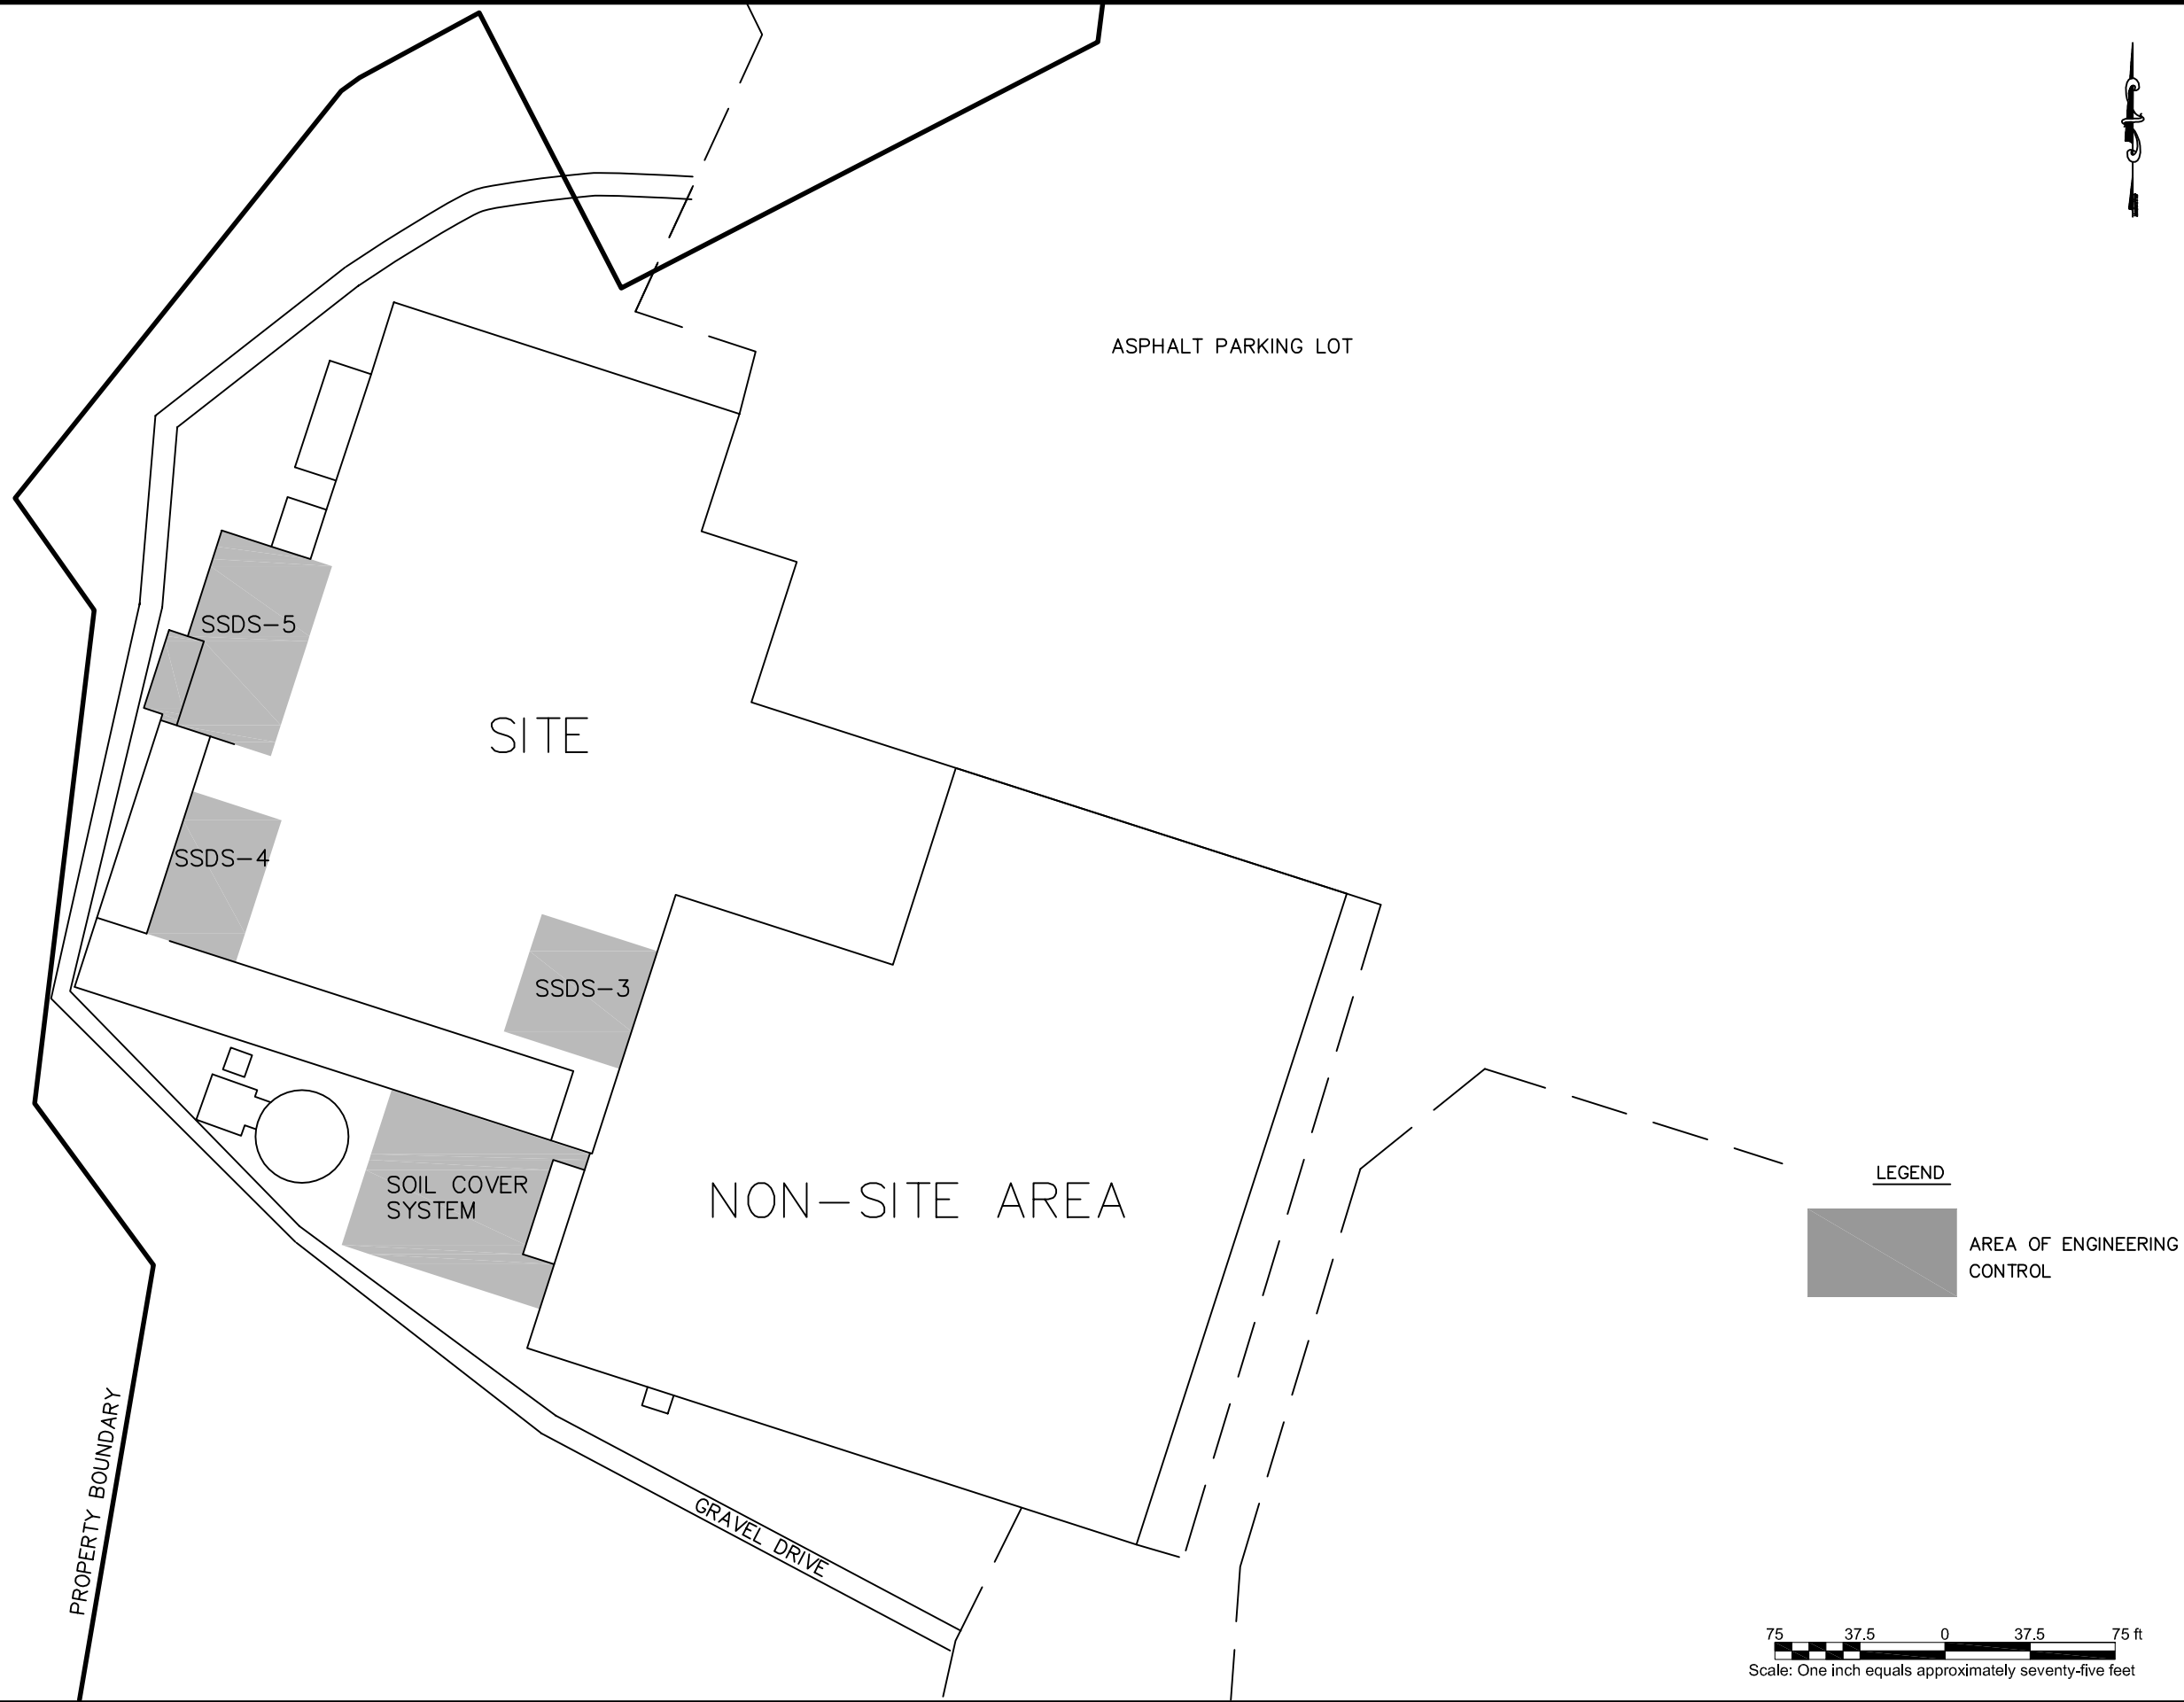
**FIGURE 3- ENGINEERING CONTROL LOCATIONS**  
FORMER CHAMPION PRODUCTS FACILITY  
200 N. MAIN STREET  
PERRY, NY

- Floor slabs (cover systems) in the area of the soil vapor mitigation system were noted to be intact and in good condition at SSDS-4 and SSDS-5. A crack in the floor slab was identified in the vicinity of SSDS-3 during vapor intrusion investigation (VII) sampling conducted on January 4, 2022. This crack will be repaired during monitoring well decommissioning currently scheduled to take place in November 2022. A subsequent VII sampling event will be conducted following repairs to the floor slab in the vicinity of SSDS-3.

Exposure to remaining VOC impacts in soil/fill at the site is prevented by the use of two types of cover systems. In the former empty drum storage area, which is located outside of the south central area of the building, the cover system is comprised of a minimum of 6 feet of soil backfill (**Figure 3**). In the interior of the building, the cover system is comprised of the building's existing 4-inch to 6-inch thick concrete floor slabs (**Figure 3**). The cover systems are permanent controls and the quality and integrity of these systems is verified by annual inspections, which evaluate the integrity of the cover materials. These systems were fully in place and completely effective during the reporting period. A crack in the floor slab was identified in the vicinity of SSDS-3 during VII sampling conducted on January 4, 2022. This crack will be repaired during monitoring well decommissioning currently scheduled to take place in November 2022.

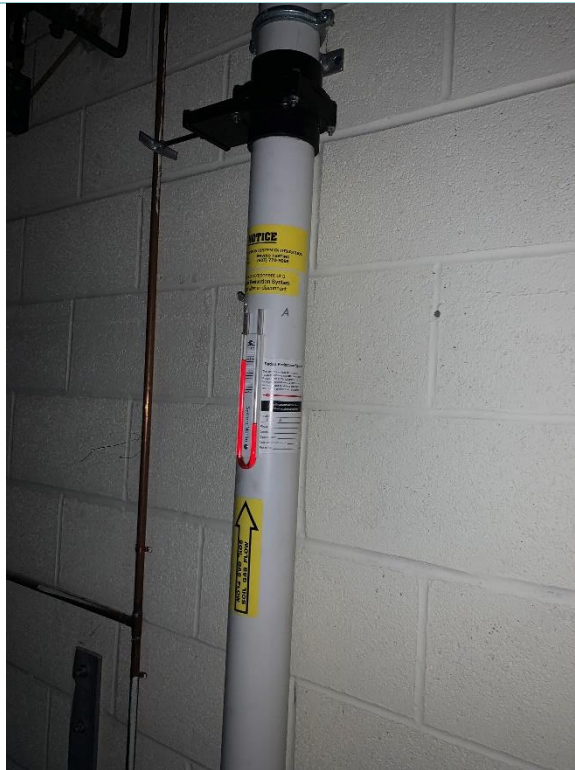
Photo 1 – View of  
“Leg A” of Sub-Slab  
Depressurization  
System

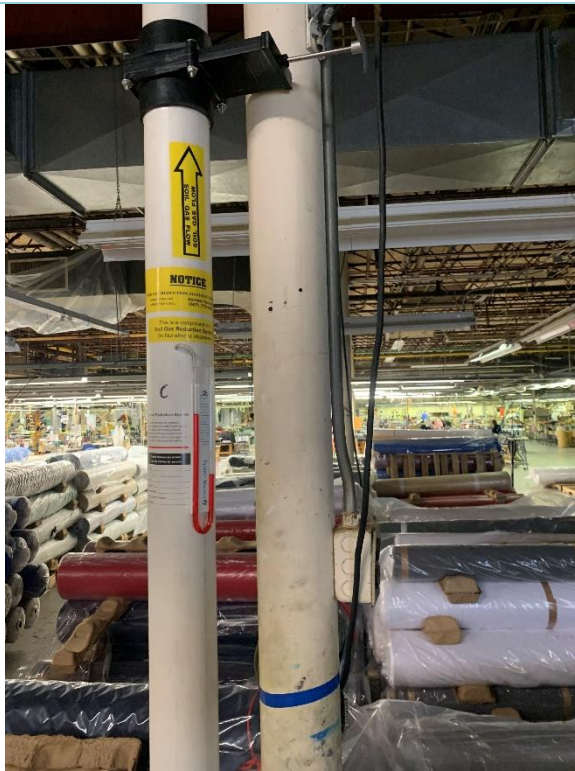
Photo 2 – View of  
“Leg C” of Sub-Slab  
Depressurization  
System

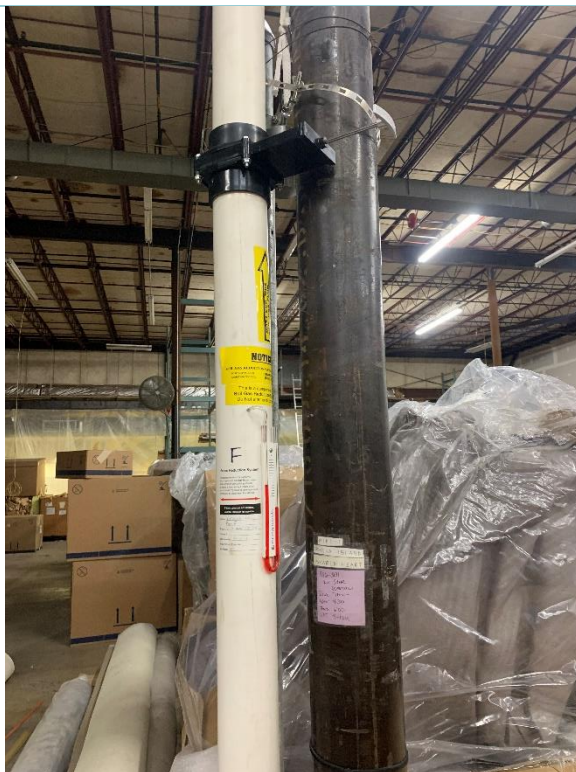
\* One clasp on Pipe F loose, all others intact

Photo 3 –  
View of “Leg F” of  
Sub-Slab  
Depressurization  
System

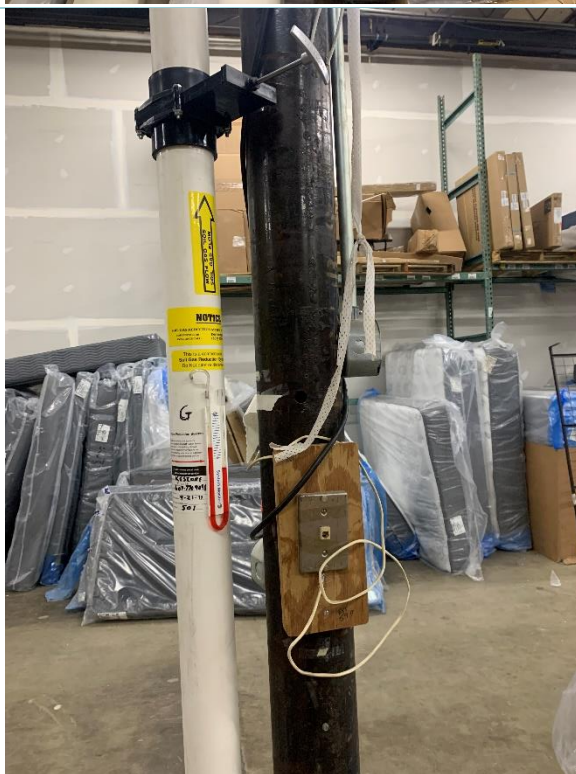
Photo 4 – View of  
“Leg G” of Sub-Slab  
Depressurization  
System

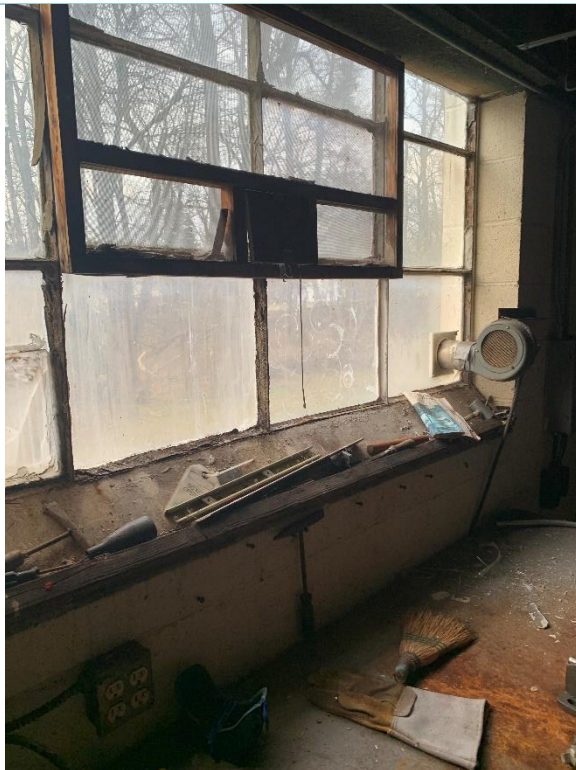
Photo 5 – View of blower associated with sub-slab depressurization system.

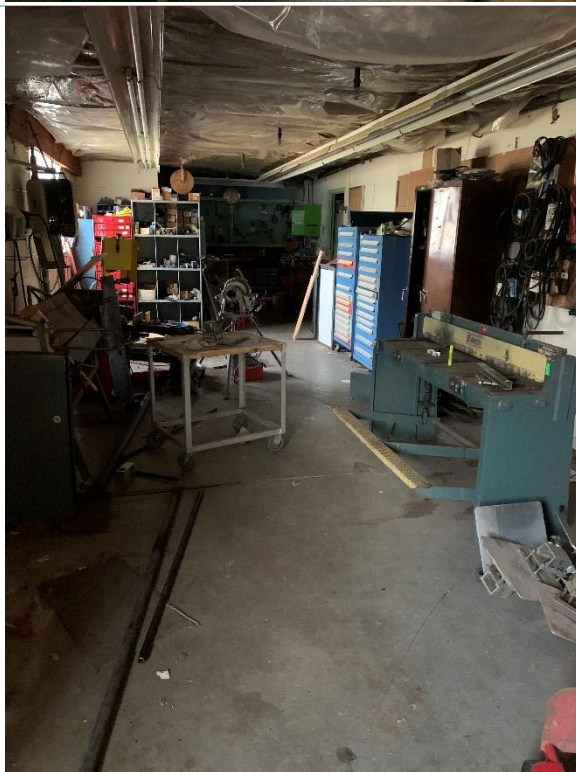
Photo 6 – View of maintenance shop and associated cover system (concrete floor).

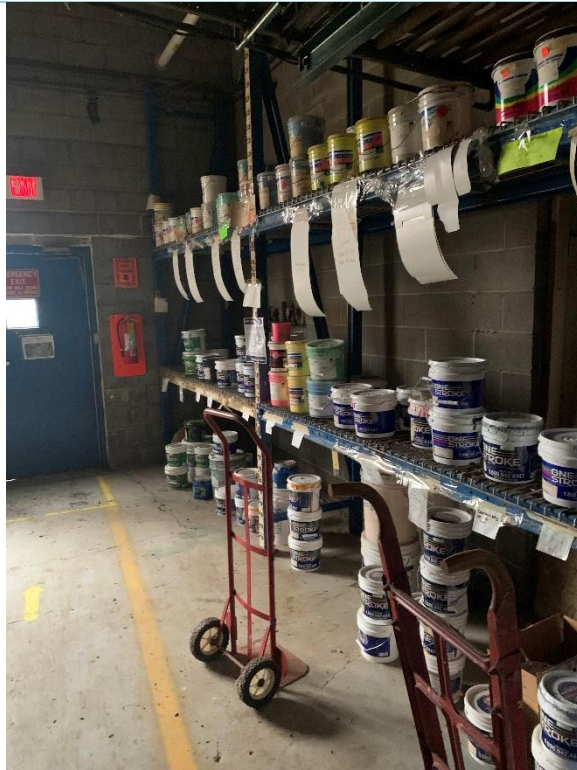
Photo 7 – View of storage area and associated cover system (concrete floor).
