**New York Department of Environmental Conservation  
Division of Environmental Remediation  
Region 9 Office-Buffalo**

**FIELD INSPECTION REPORT**

**Date:** April 24, 2007  
**Site Name:** National Fuel gas - Mineral Springs Site  
**Site Number:** V00195  
**Location:** West Seneca (T), Erie County  
**Project Engineer:** David Szymanski, NYSDEC - Buffalo  
**Contractor:** Retec - Mark Hofferbert; National Fuel - Charlie Burke

**Purpose of Inspection:** Annual Site Inspection

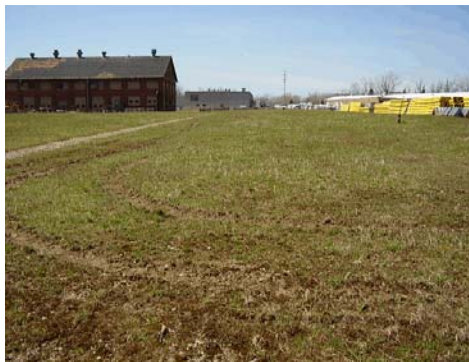
- Asphalt caps are in good shape. Areas previously sealed show some cracking, but overall everything looks intact
- Soil caps are intact and well-grassed over. Some tractor ruts noticed on Eastern cap next to pipe yard and Southern cap next to drainage stream. Noted by Retec for follow up.

Cap with  
Tire Damage

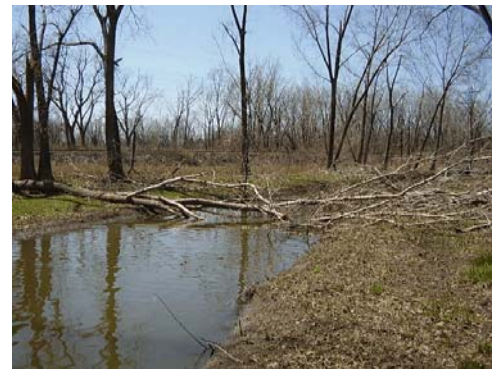
- No observed boils or seeps in past remedial areas.
- Eastern drainage swale has high water. Further examination of the pipe inlet showed large debris including a tire, a log, and grasses/leaves. Requires cleanout to open it up.

- Some fence damage and numerous trees downed due to the October 2006 snow storm.
- Deer evident on site. Geese and ducks along the drainage swale and stream.

High Water  
And Tree  
Damage
